Enclosure (1) Report on the Collision between USS LAKE CHAMPLAIN (CG 57) and Fishing Vessel NAM YANG 502

REPORT ON THE COLLISION BETWEEN USS LAKE CHAMPLAIN (CG 57)
AND FISHING VESSEL NAM YANG 502

29 NOV 2017

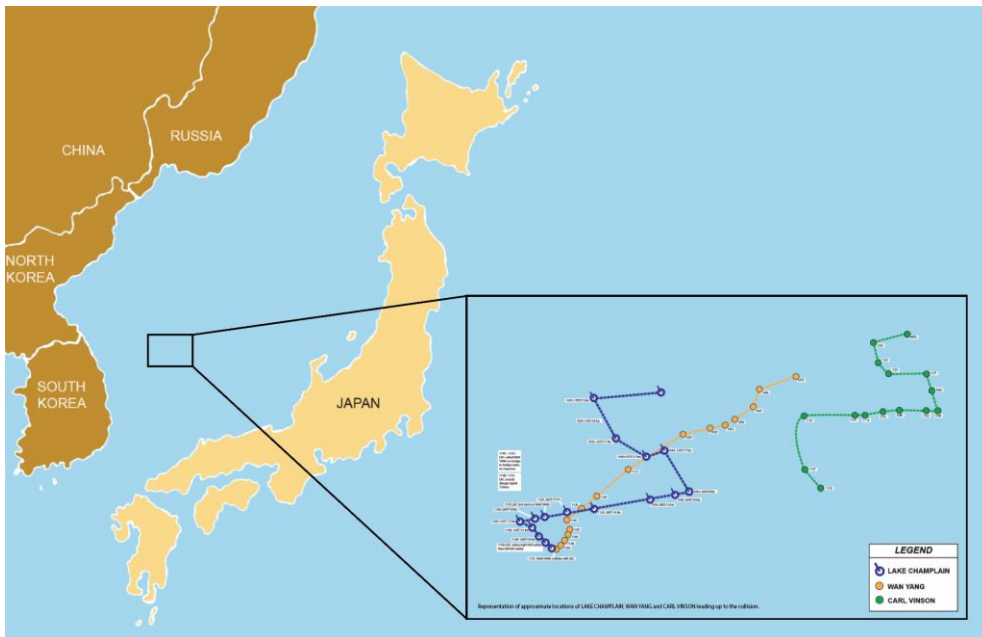
Figure 1 – Illustration Map of Approximate Collision Location

Prior to the collision, LAKE CHAMPLAIN was deployed to the Western Pacific, conducting patrols within the Sea of Japan, and routinely operating within the vicinity of fishing vessels. Inside of 24 hours before the collision, LAKE CHAMPLAIN conducted the following operations: refueling at sea, engineering training, flight operations, and a damage control drill. On the morning of 9 May 2017, LAKE CHAMPLAIN was operating in the Sea of Japan with the U.S. aircraft carrier USS CARL VINSON (CVN 70) and the South Korean warship ROKS YANGMANCHUN (DDH 973). See Figure 1.

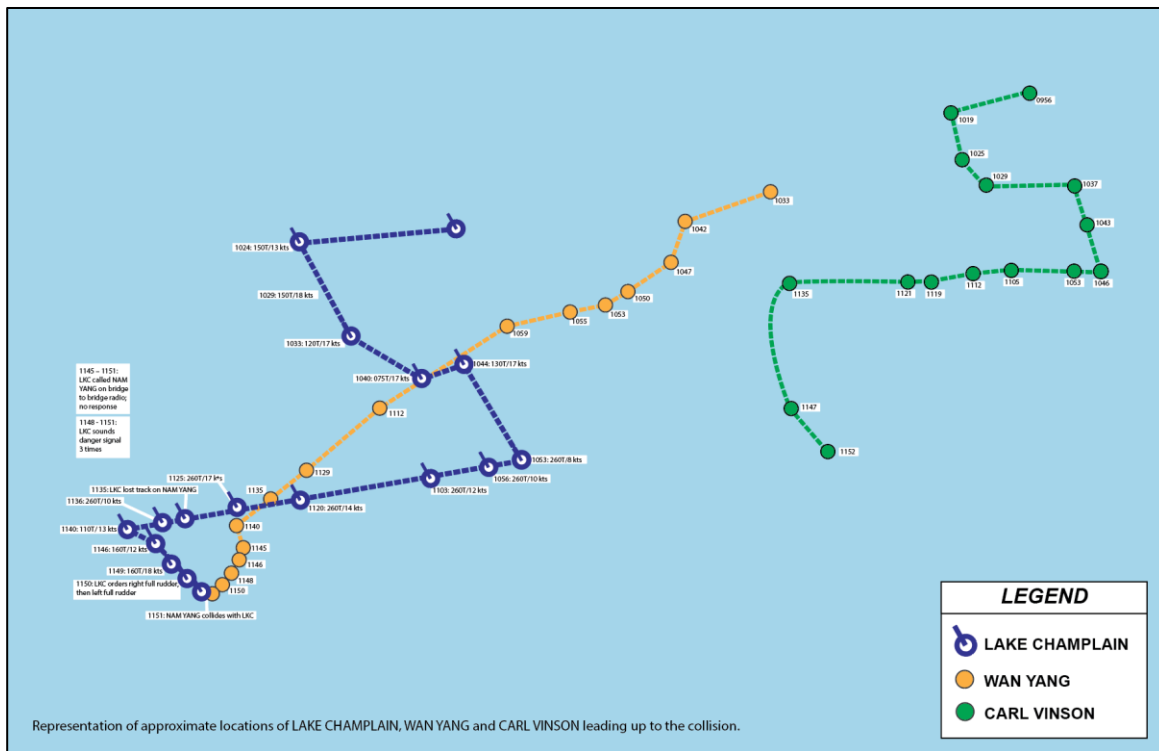
Figure 2 – Illustration Map of Approximate Collision Location

At 11:35 am, LAKE CHAMPLAIN lost radar track on NAM YANG 502, which was then operating at a range of 2.4 nautical miles. While changing course to maintain relative position with the escorted aircraft carrier, LAKE CHAMPLAIN turned in front of the fishing vessel without realizing the risk of collision. The bridge watch team was slow to react and executed improper and untimely maneuvers in an attempt to avoid collision. Specifically, LAKE CHAMPLAIN ordered maximum speed (18 knots due to engine configuration) and maximum rudder orders (30 degrees) – first to the right and then to the left. Several minutes before the collision, LAKE CHAMPLAIN twice unsuccessfully attempted to establish communications with NAM YANG 502 on bridge-to-bridge radio. LAKE CHAMPLAIN also sounded five short blasts of the ship’s whistle (which represents the internationally-recognized danger signal for ships) at least three times. NAM YANG 502 did not respond to LAKE CHAMPLAIN’s radio attempts, use its whistle, or take necessary action to avoid collision. At 11:51am, NAM YANG 502 collided with LAKE CHAMPLAIN’s port beam. See Figure 2 and Figure 3.

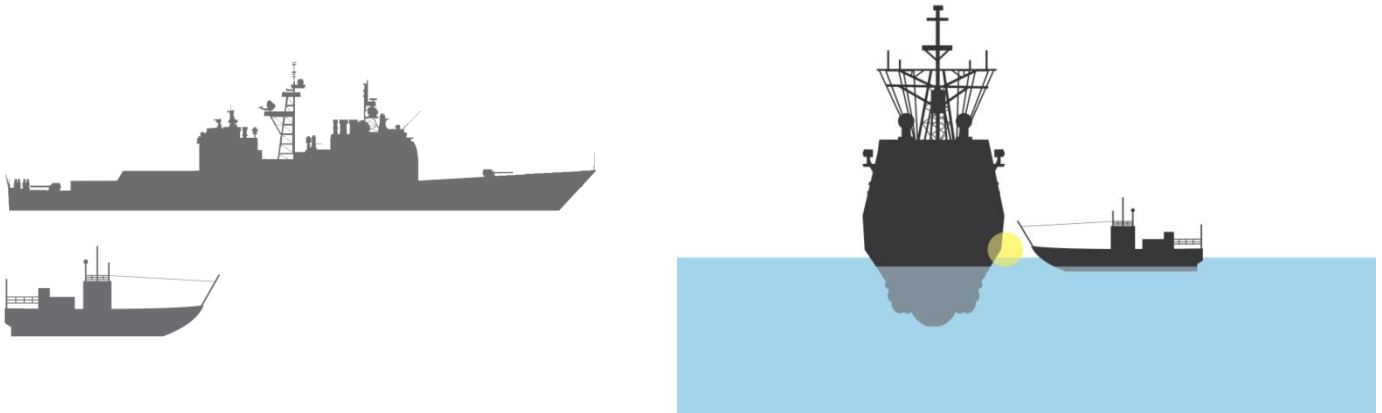
Figure 3 – Depiction of the Relative Size of Ships and Collision

The bow of NAM YANG 502 impacted LAKE CHAMPLAIN on the port (left) midships (center). NAM YANG 502 then pivoted with her starboard (right) side against LAKE CHAMPLAIN and scraped down the side of the hull. NAM YANG 502 finally separated near LAKE CHAMPLAIN's port quarter. The impact created a 3 foot by 5 foot wide dent on LAKE CHAMPLAIN, as well as visible scrapes to the paint from the point of impact to the point of separation. There were no cracks or leaks to LAKE CHAMPLAIN. There were no reported personnel injuries onboard LAKE CHAMPLAIN or NAM YANG 502 as a result of the collision.

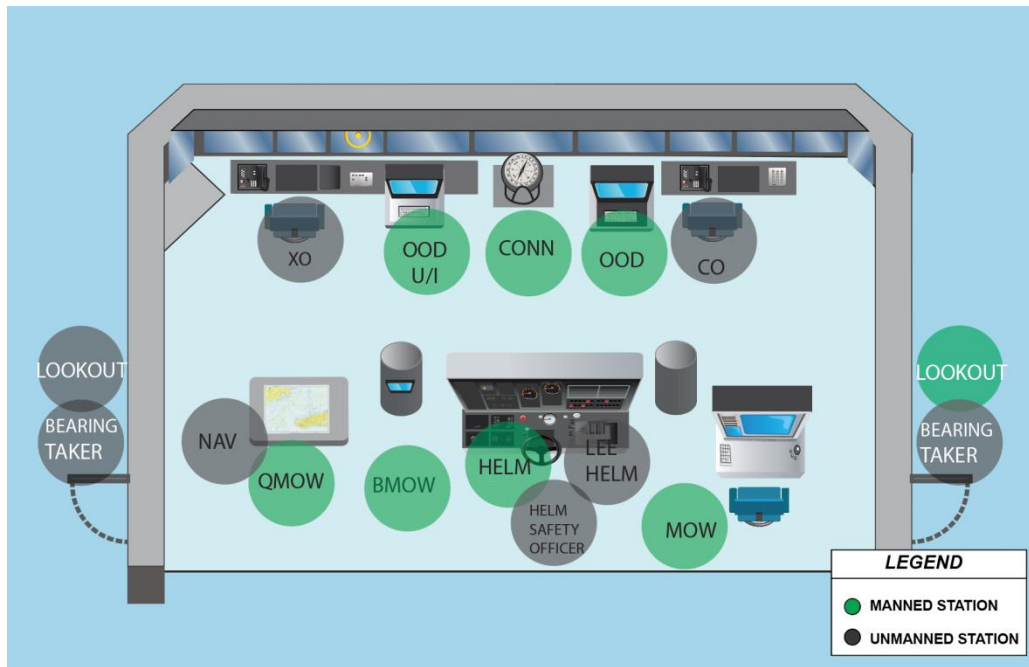
Figure 4 – Bridge schematic of LAKE CHAMPLAIN

The bridge team was inexperienced and had not discussed or trained for emergency actions. See Figure 5 for bridge team schematic of LAKE CHAMPLAIN at the time of the collision. Watchstanders highlighted in green were on the bridge at the time of the collision, and watchstanders in gray were not. The senior bridge team watchstander was the Officer of the Deck (OOD), and supporting watchstanders included the Officer of the Deck Under Instruction (OOD U/I), Conning Officer (CONN), Quartermaster of the Watch (QMOW), Boatswain Mate of the Watch (BMOW), Helmsman (HELM), the Messenger of the Watch (MOW), and the lookout. The CO, XO, and Navigator (NAV) were not on the bridge at the time of the collision.
