SUBJECT: GM IGNITION 2/3 TUMBLER POCKETS

NO: AS-1147

DATE: 10/15/96

GM 10-Cut Ignition 2/3 Tumbler Pockets Filled

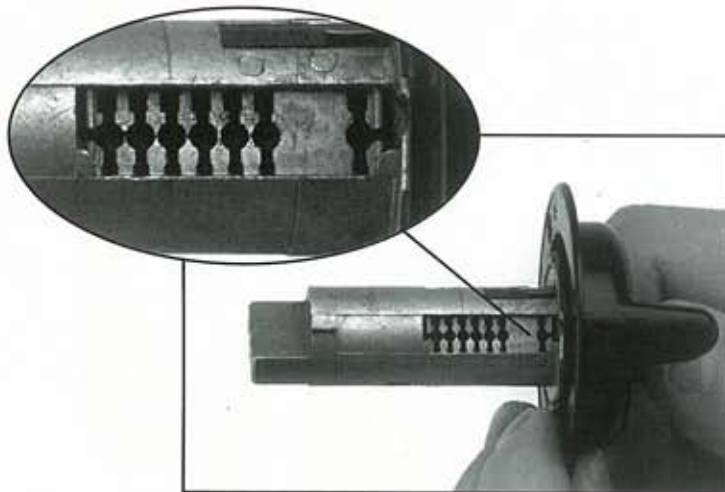
Some GM ignition locks are supplied with the 2/3 tumbler positions filled. This is not a defect.

For an undetermined period, STRATTEC is producing some GM 10-Cut ignitions with the #2 and #3 position tumbler pockets filled, leaving positions 1 and 4-9 open for pinning. Distributors, dealers and technicians should be aware that this is not a defect.

This temporary design change is introduced to eliminate the possibility of lock malfunction. In a few reported cases, ignition locks became inoperative after continued use, where the key tip was tilted up and into the tumblers on insertion. The tilted key would strike and deform the tumbler pockets in the 2nd and 3rd positions causing the tumblers to jam.

Technicians coming across ignition failure in the field should first check to see if all tumblers on the ignition lock are functional. If a jammed tumbler is present, lubricate the lock and use a hook pick to free the tumbler. Insert a working key and turn to allow lock removal. If the lock does not turn, gently rap the head of the key with a small, hard mallet and try again. If the lock still does not turn, it will be necessary to use an alternate means for lock removal.

Once the lock has been removed, replace with the appropriate STRATTEC original equipment lock. Locks may be supplied with or without the #2 and #3 tumbler positions filled.
