Uncovering Gullies:

Protecting the Chicago River in the Forest Preserves of Cook County

Friends of the Chicago River

Released September 2014.

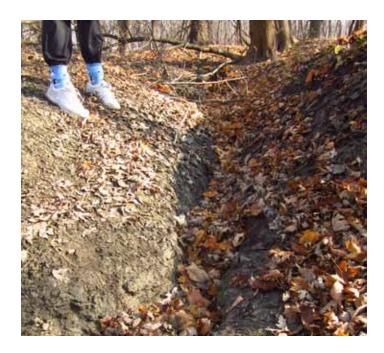
The gully in Figure 1 is located in Bunker Hill Woods. Its maximum depth is 2.5 feet and it runs for 15 feet before draining into the North Branch of the Chicago River. This gully is similar in size and scope to many gullies identified by Gullywalker volunteers throughout the assessment area and it is a good target for restoration.

Figure 1: A Level Two gully at Bunker Hill Woods.

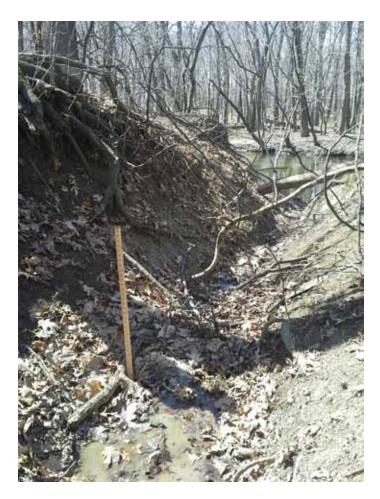
Figure 2: Example of a Level Three gully at Linne Woods. Vienpoint is looking downhill along the gully towards the North Branch.

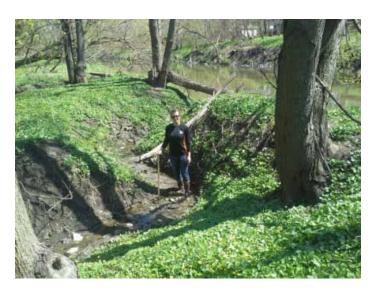
Figure 3: Example of a Level Three gully at Kickapoo Woods. Viewpoint is looking towards the Little Calumet River.

Gullywalker volunteers identified 13 gullies along the banks of the Little Calumet River in Kickapoo Woods. Of these, eight (62%) contained portions with depths greater than 3.5 feet, ranging from 3.8 to 6 feet deep. Such a high percentage of deep gullies is indicative of an underlying problem at the site. These gullies represented some of the most severe cases in the southern portion of the assessment area.

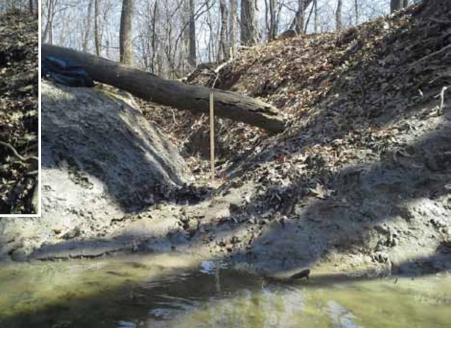
Figures 4 & 5: An extreme gully at Linne Woods. The source is from a pipe (top image), which drains 60 feet to the North Branch of the Chicago River (right image). Depth of the gully is up to five feet in places.

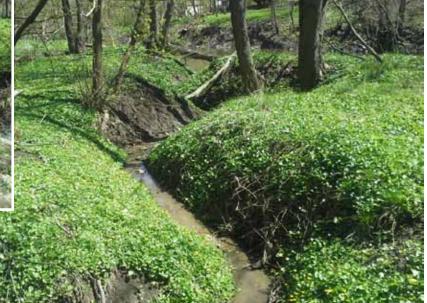
The gully source in Figures 6 & 7 is a pipe, likely draining water from the graded and drained section of the preserve, as well as some residential development east of Halsted Street. The gully runs for more than 100 feet before draining into the Little Calumet River. It is deep throughout its course, ranging from 1.5 to 4.5 feet in depth. This gully is quite extensive and has a major impact on the health of the preserve and the woodland and prairie restoration that are present at the site. If unchecked, such a large gully will add large amounts of sediment and contaminants to the river.

Figures 6 & 7: A Level Three gully at Kickapoo Woods. The source is from a pipe (top image), and drains to the Little Calumet River (right image). The river can be seen at the top of the image.

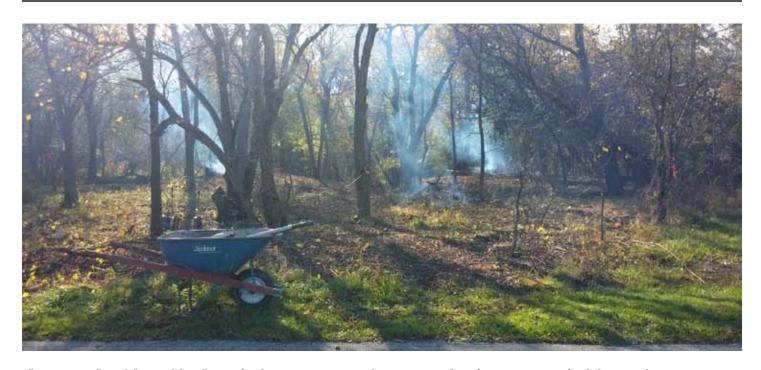
Conservation Land Stewardship, Inc., a landscape restoration and management firm, burning invasive buckthorn as they assist Friends of the Chicago River and volunteers to fix a gully at Kickapoo Woods.
