Accessibility Audit  
for the  
Downtown Development Authority  
City Of Grand Rapids, Michigan

Based upon actual survey  
Performed April 11 – June 23, 2006

Prepared by  
Disability Advocates of Kent County  
July 12, 2006

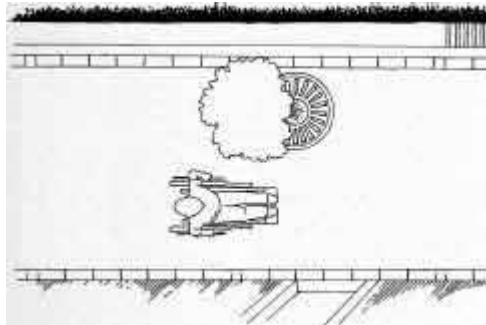
*Figure 4-34. Concrete with brick trim edging is easier for people with mobility impairments to negotiate.*
