**NIST NCSTAR 1A**

# **Final Report** on the **Collapse of** **World Trade Center Building 7**

National Institute of  
Standards and Technology  
U.S. Department of Commerce

November 2008

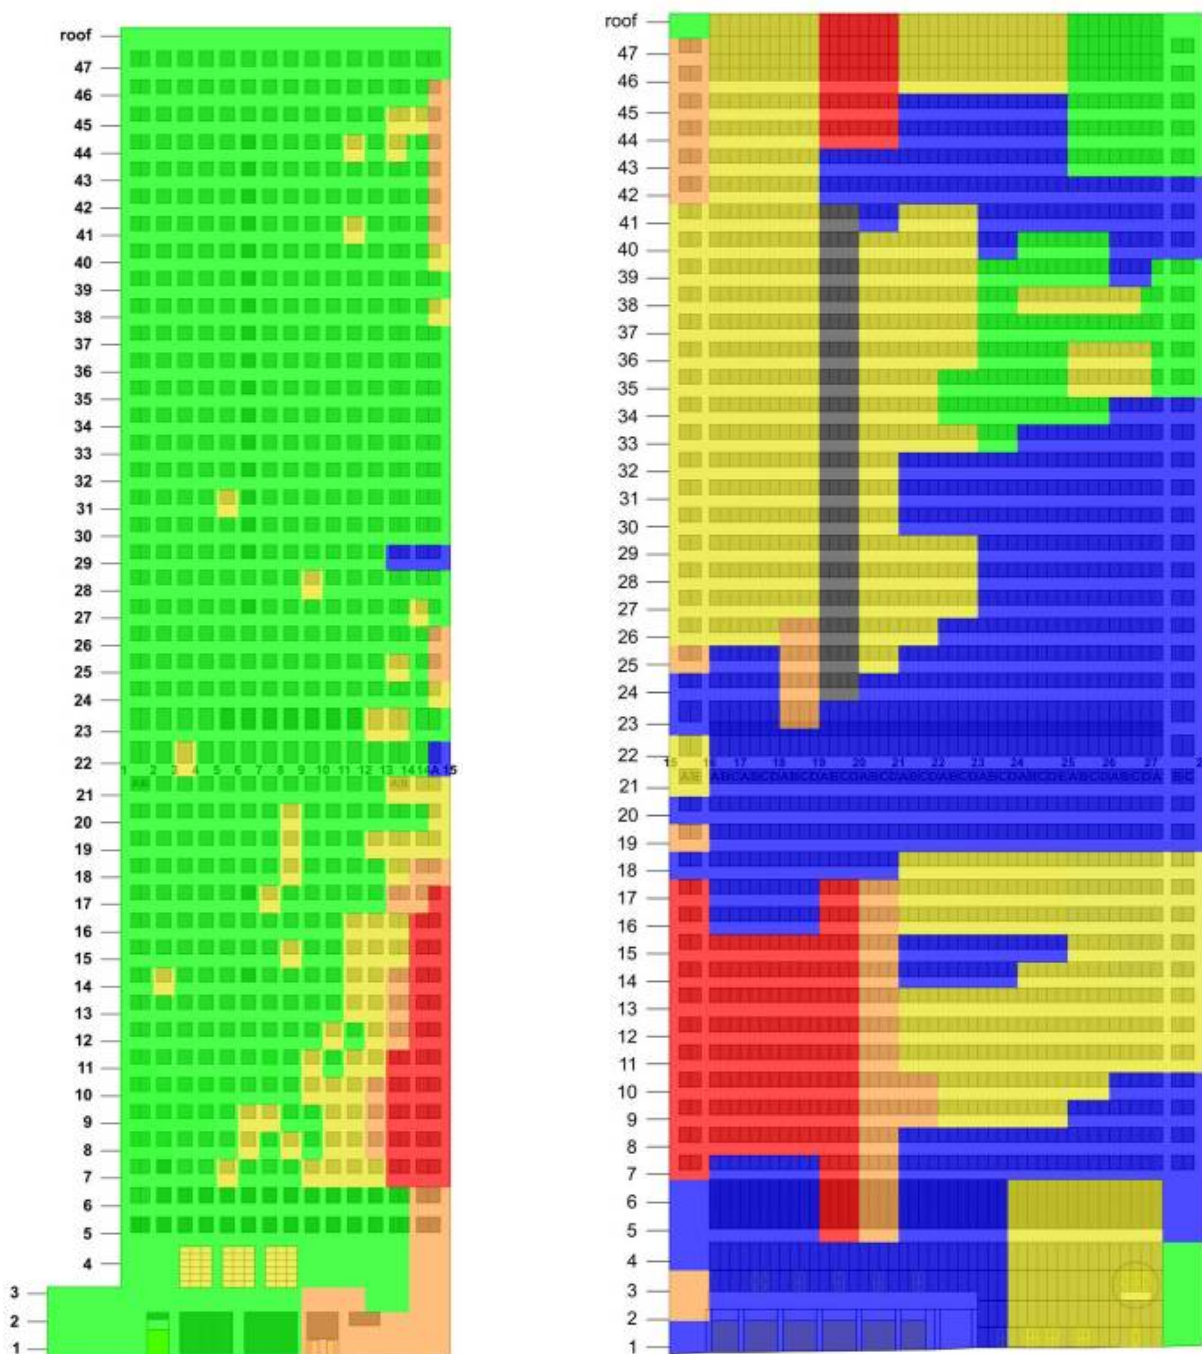
When WTC 1 collapsed at 10:28:22 a.m., most of the debris landed in an area not much larger than the original WTC 1 building footprint. However, some fragments were forcibly ejected and traveled distances up to hundreds of meters. Pieces of WTC 1 hit WTC 7, severing six columns on Floors 7 through 17 on the south face and one column on the west face near the southwest corner. The debris also caused structural damage between Floor 44 and the roof. The damage to the building face is depicted in Figure 2–1. Based on photographic evidence, witness accounts, and engineering judgment, it is likely that the structural damage (steel and floor slabs) did not penetrate beyond the perimeter of the building core. At the southwest corner, the structural damage extended only about one-third of the distance from the exterior wall to the building core. The debris also broke a large number of windows on the south face. Compared to the airplane impact damage to the WTC towers, there was relatively little damage to the interior of WTC 7. For instance, damage to the sprayed fire resistive material (SFRM) was limited to the immediate vicinity of the WTC 1 debris impact. There was no superficial or structural damage to the north and east faces (NIST NCSTAR 1-9, Chapter 5, Section 5.5.2).

**Figure 2-1. Observed damage to WTC 7 following the collapse of WTC 1.**  
West face (left) and south face (right)

The damage is color coded as follows: green (■)- no visible damage, yellow (■) – window glass broken, orange (■) – granite and underlying truss damage, red (■) – damage to exterior structural steel, gray (■) – possible structural damage, and blue (■) – not visible due to smoke, dust, and intervening buildings.

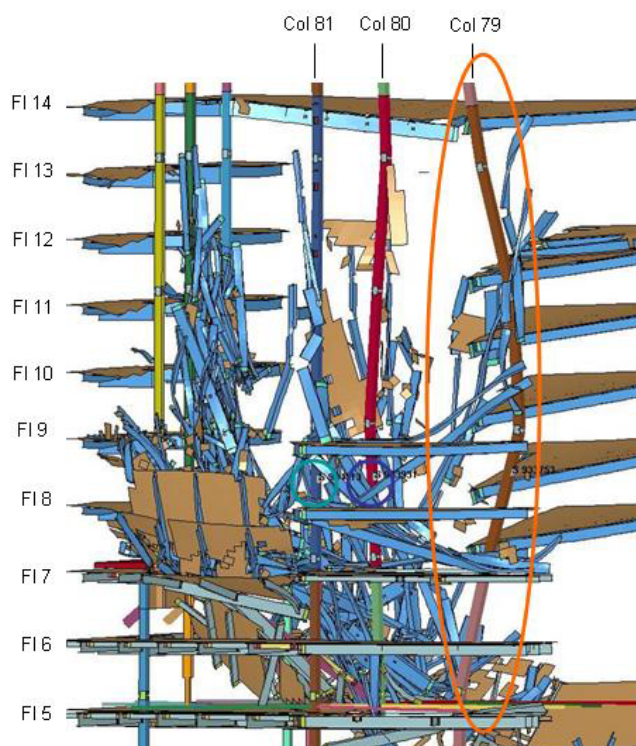
Fire-induced thermal expansion of the floor system surrounding Column 79 led to the collapse of Floor 13, which triggered a cascade of floor failures. In this case, the floor beams on the east side of the building expanded enough that they pushed the girder spanning between Columns 79 and 44 to the west on the 13<sup>th</sup> floor. (See Figure 1–5 for column numbering and the locations of girders and beams.) This movement was enough for the girder to walk off of its support at Column 79.

The unsupported girder and other local fire-induced damage caused Floor 13 to collapse, beginning a cascade of floor failures down to the 5<sup>th</sup> floor (which, as noted in Section 1.2.3, was much thicker and stronger). Many of these floors had already been at least partially weakened by the fires in the vicinity of Column 79. This left Column 79 with insufficient lateral support, and as a consequence, the column buckled eastward, becoming the initial local failure for collapse initiation.

**Figure 2–2. Eastward buckling of Column 79, viewed from the southeast.**

Due to the buckling of Column 79 between Floors 5 and 14, the upper section of Column 79 began to descend. The downward movement of Column 79 led to the observed kink in the east penthouse, and its subsequent descent. The cascading failures of the lower floors surrounding Column 79 led to increased unsupported length in, falling debris impact on, and loads being re-distributed to adjacent columns; and Column 80 and then Column 81 buckled as well. All the floor connections to these three columns, as well as to the exterior columns, failed, and the floors fell on the east side of the building. The exterior façade on the east quarter of the building was just a hollow shell.

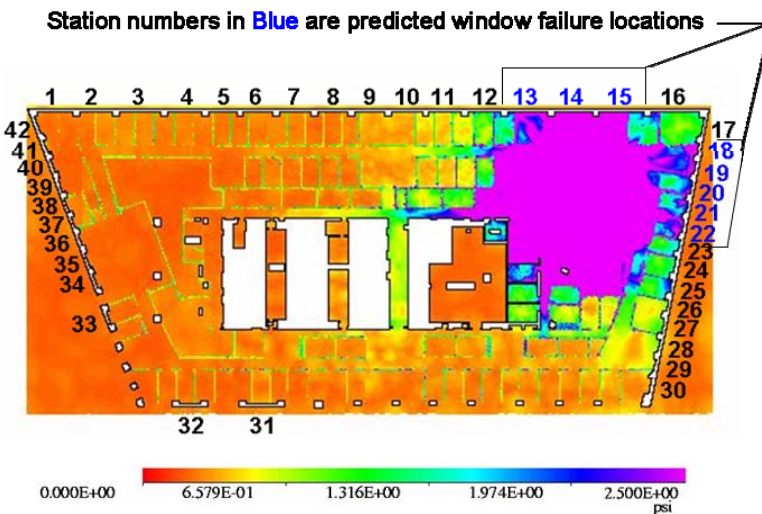
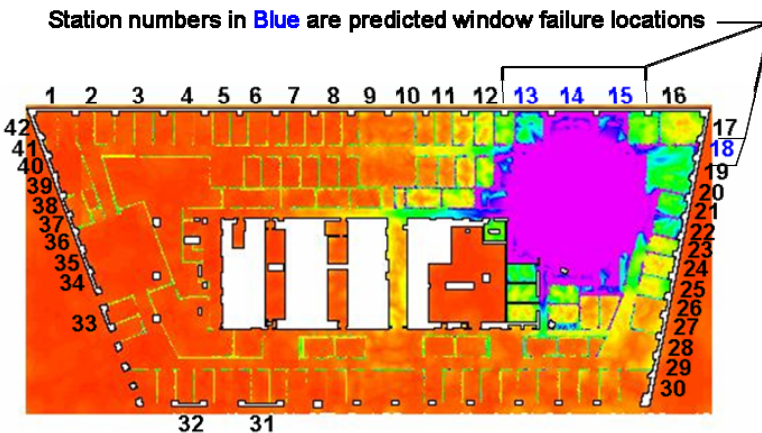
Figure 3–1 shows the results for the two shaped charges applied to Column 79 on a tenant floor that was highly partitioned, such as Floor 12. Nearly all the windows on the northeast section of the floor subjected to a blast would have been broken, even by the smaller charge. Simulations for a floor that was not highly partitioned led to more extensive window breakage.

**Figure 3–1. Peak overpressure and broken window locations.**

Top: 9 lb shaped charge; bottom: 2 lb charge.

The actual window breakage pattern on the visible floors on September 11, 2001 (NIST NCSTAR 1-9, Chapter 5) was not at all like that expected from a blast that was even 20 percent of that needed to damage a critical column in WTC 7. The visual evidence did not show such a breakage pattern on any floor of WTC 7 as late as about 4:00 p.m. or above the 25<sup>th</sup> floor at the time of the building collapse initiation. Views of the northeast corner of WTC 7 at the time of the collapse were obstructed by other buildings.

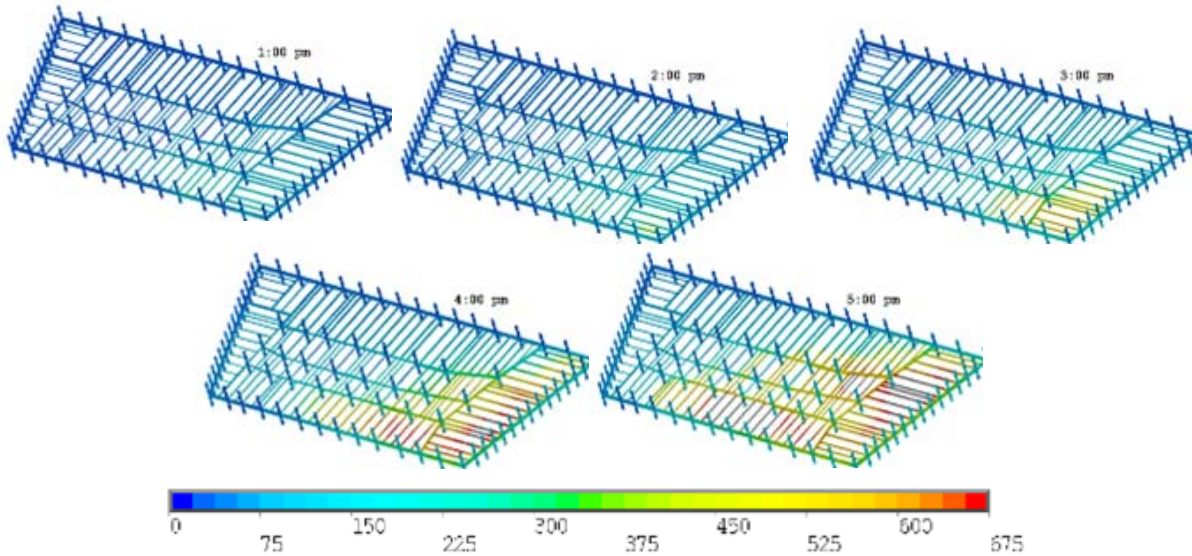
Figure 3–7 shows the calculated heating of the structural steel on the lower 16 floors of WTC 7 for the Case B temperatures from the fire simulation. The floor slabs have been removed from the figure for clarity. Figure 3–8 is a typical rendition of the calculated heating of the top of a floor slab as a result of the Case B fire.

**Figure 3–7. Computed temperature distribution (°C) of Floor 13 steel framing at five different instants in time.**

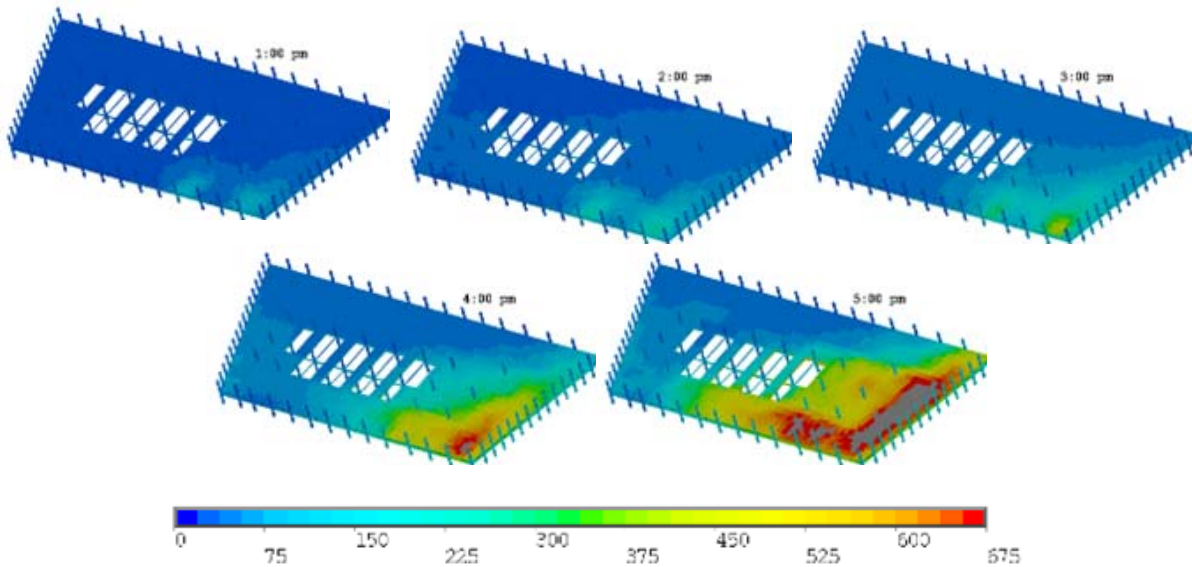
**Figure 3–8. Computed temperature distribution (°C) in the top layer of the concrete slab of Floor 12 at five different instants in time.**

Grey shading indicates temperatures >675 °C

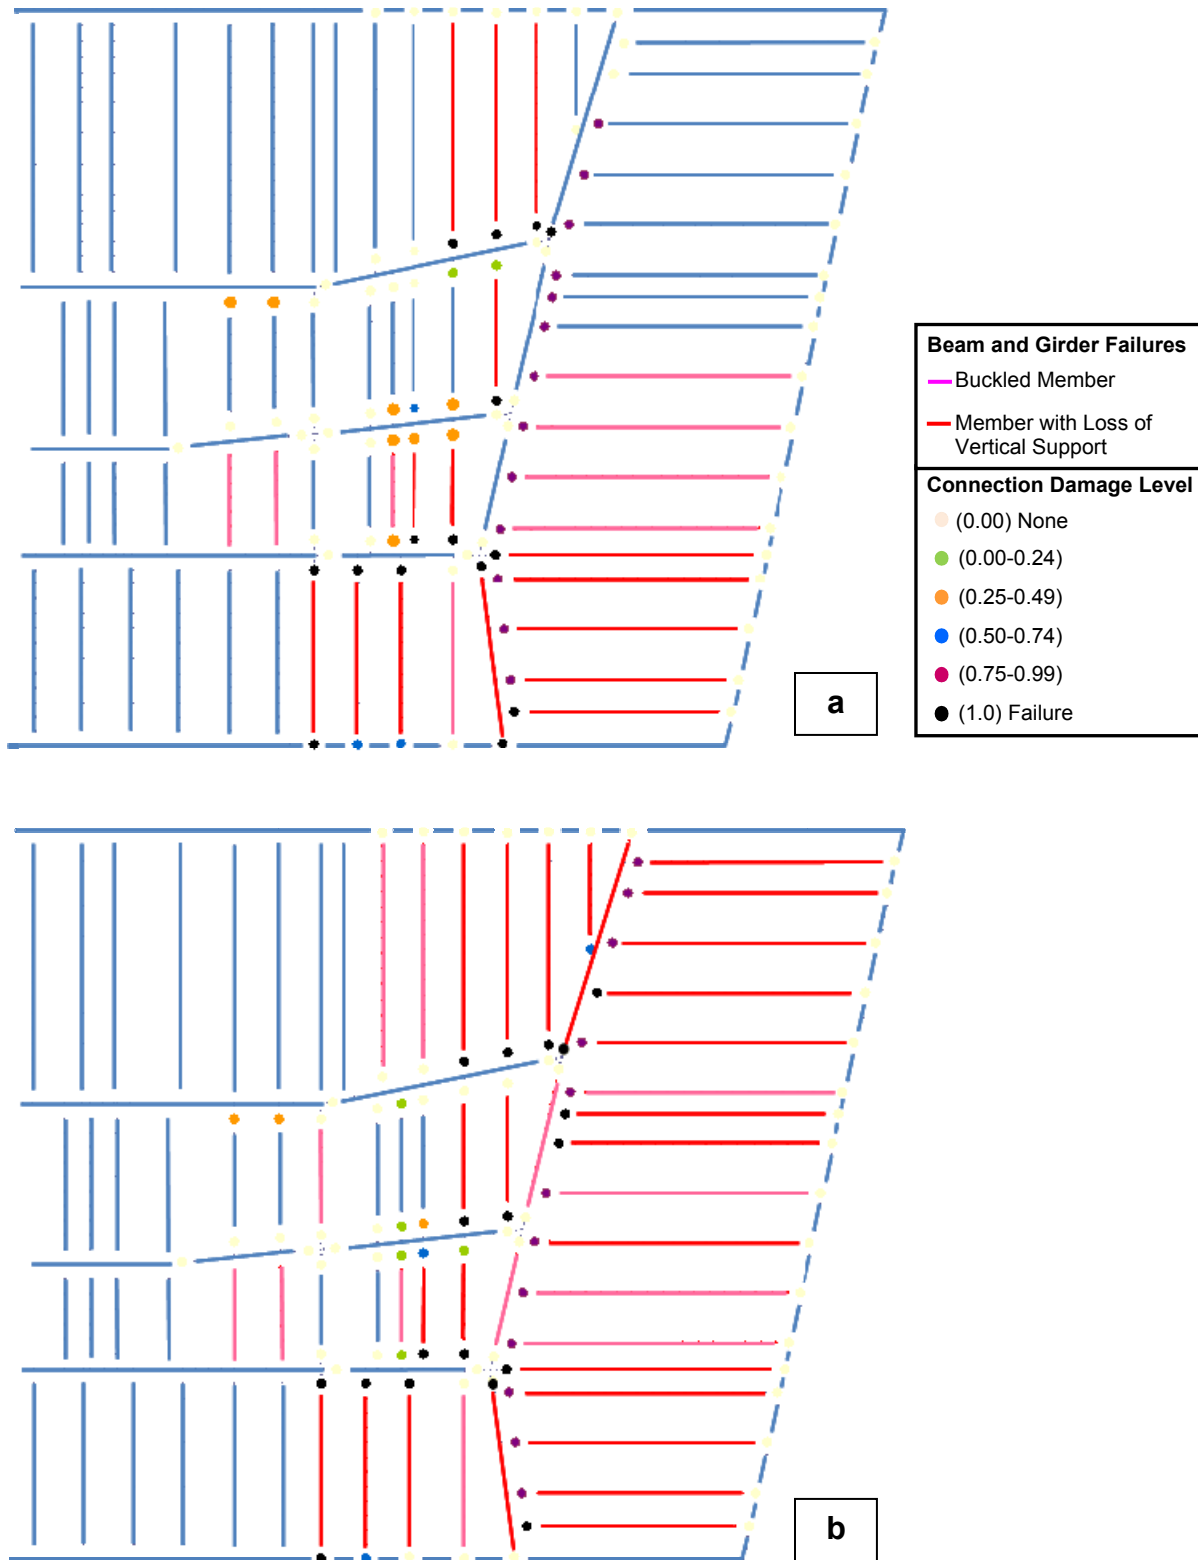
The ANSYS results were input to the LS-DYNA analysis when it appeared that an initial failure event might be imminent. Damage diagrams for the 16 floors modeled in ANSYS, such as those shown in Figure 3–9, indicated some degree of uncertainty in selecting the time and damage state for the transition. However, it appeared likely the critical damage state occurred between 3.5 h and 4 h. Accordingly, as shown in the next section, LS-DYNA analyses were performed for both of these damage states.

**Figure 3–9. Damage state of connections in Floor 13 for Case B temperatures.**  
a: at 3.5 h; b: at 4.0 h

The second LS-DYNA analysis (lesser degree of fire-induced damage) did not lead to a collapse-initiating event, despite the extensive damage shown in Figure 3-9a.

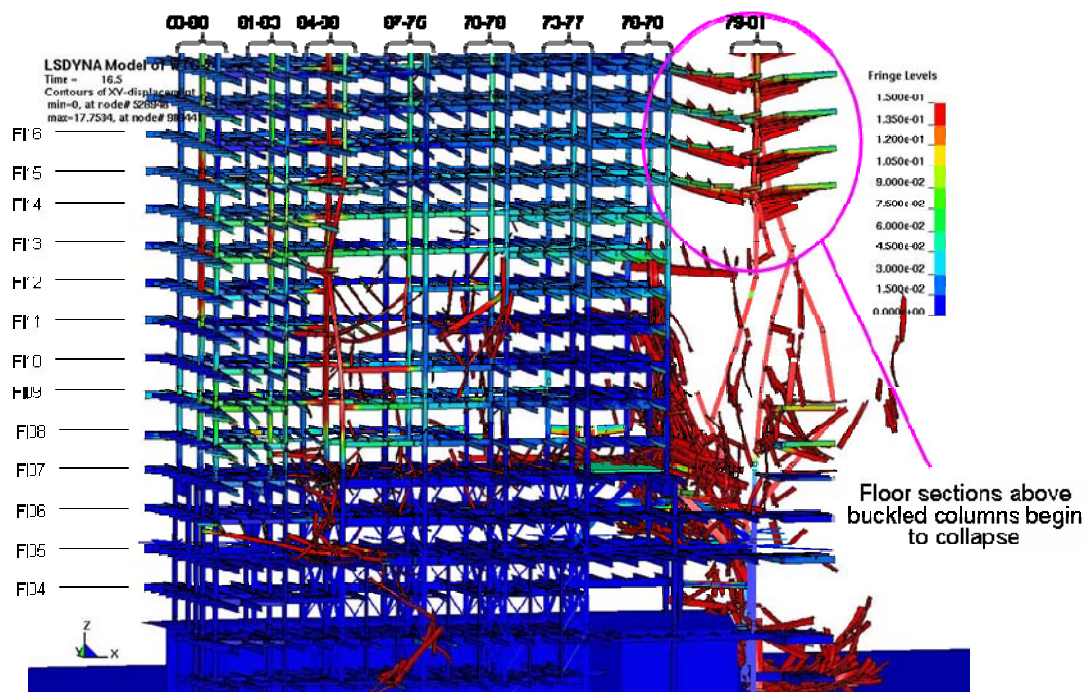
**Figure 3–10. Vertical progression of failures on the east side of the building at 0.5 s following the initiation of the collapse.**

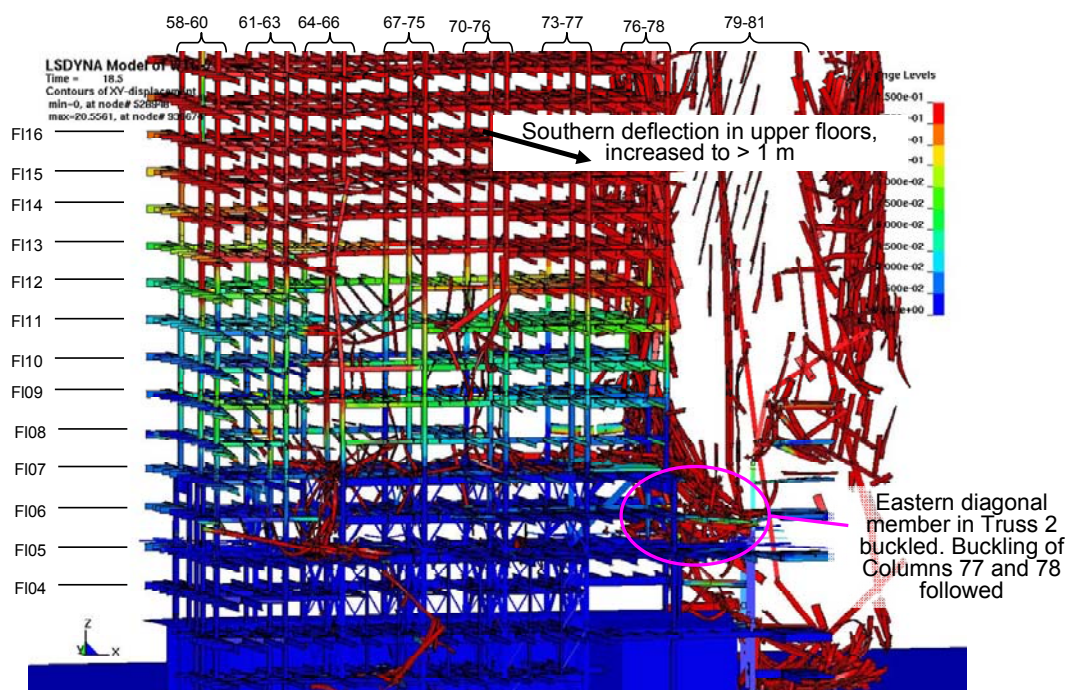
**Figure 3–11. Failure of Columns 77 and 78 due to failure of Truss 2 fails from debris impact at 2.5 s following the initiation of the collapse.**

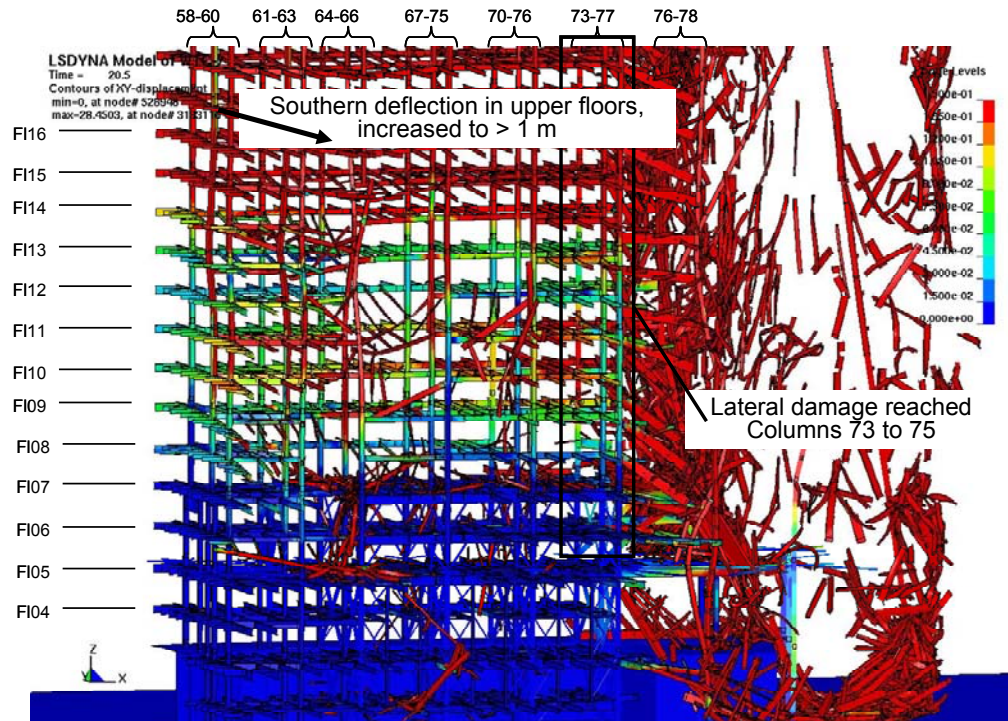
**Figure 3-12. Failure of Columns 73 to 75 from the load redistribution and debris impact at 4.5 s following the initiation of the collapse.**

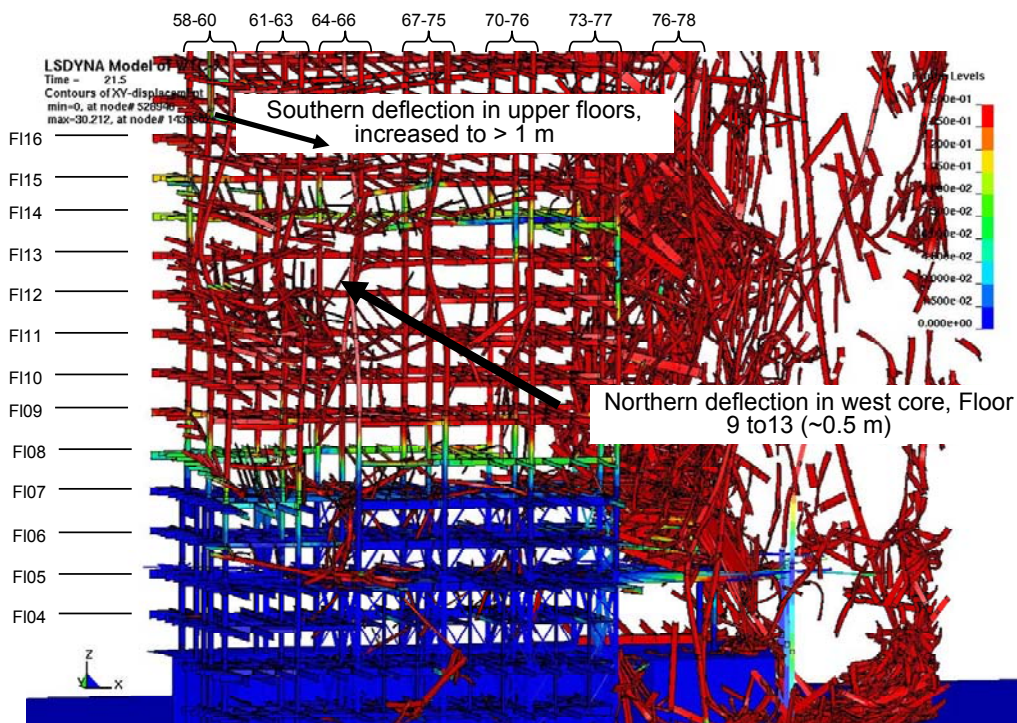
**Figure 3-13. Buckling of all interior columns at 6.5 s following the initiation of the collapse.**

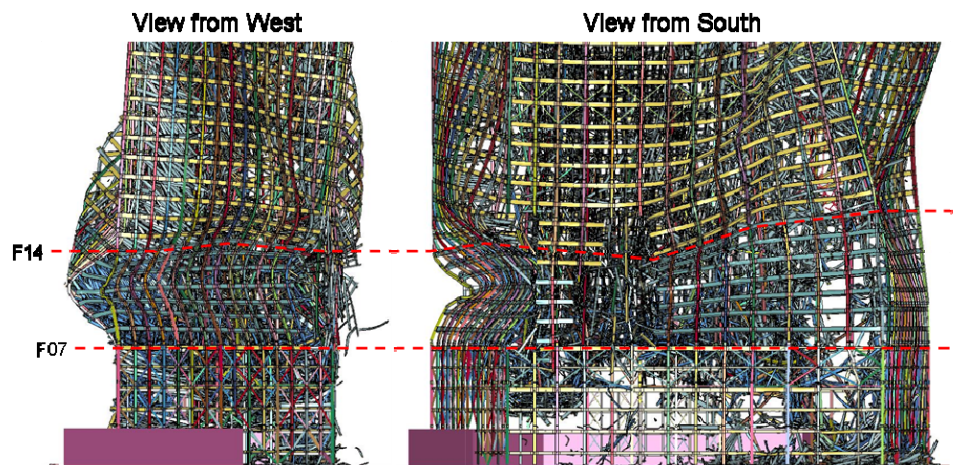
**Figure 3-14. Buckling of the lower exterior columns within 1 s of Figure 3-13.**
