As requested by the City of New Bedford Environmental Stewardship Department, the Massachusetts Department of Public Health (MDPH), Bureau of Environmental Health's (BEH) Indoor Air Quality (IAQ) Program conducted an IAQ assessment at New Bedford High School (NBHS), 230 Hathaway Boulevard, New Bedford, MA. Concerns regarding particulate/debris emanating from unit ventilators (univents; Picture 1) and its potential for exacerbating eye/respiratory/allergy symptoms prompted the request. On February 9, 2012, the NBHS B-Block was visited by Cory Holmes and Sharon Lee, Environmental Analysts/Inspectors in BEH's IAQ Program.

Beginning in December 2011, building occupants in B-Block classrooms expressed concerns that a white, powdery material was being ejected from univents that were installed during July/August 2010. This material was reportedly being distributed throughout the classroom and settling on flat surfaces. City/School officials contacted their environmental consultant, TRC Companies, Inc, who analyzed the white, powdery material using a number of methods including: polarized light microscopy, reflected light microscopy, scanning electron microscopy and energy dispersive x-ra

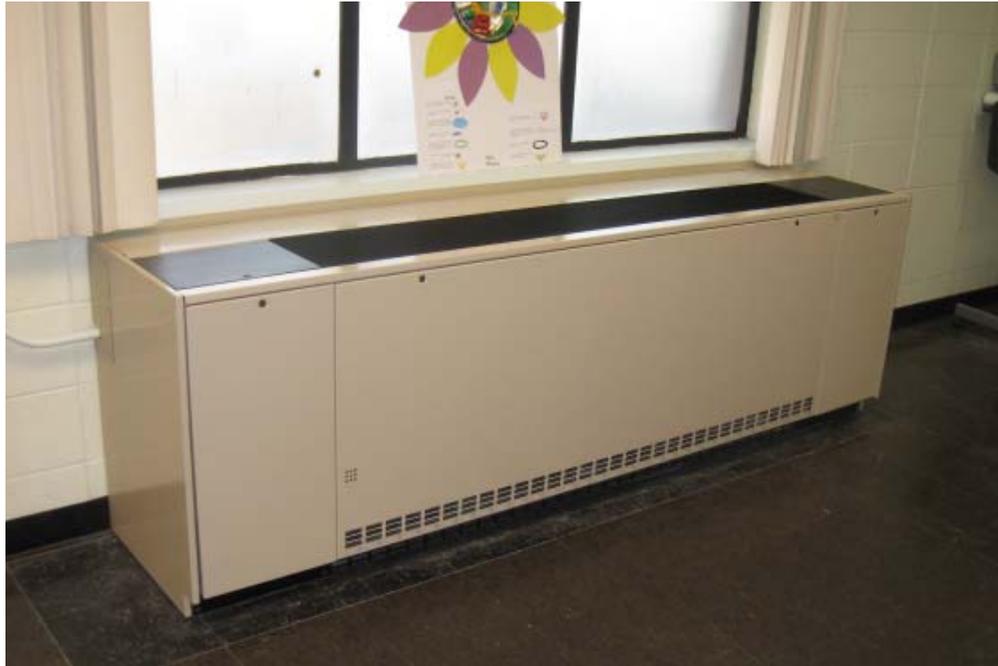
**Picture 1**

**Typical Classroom Univent Installed Summer 2010 B-Block**

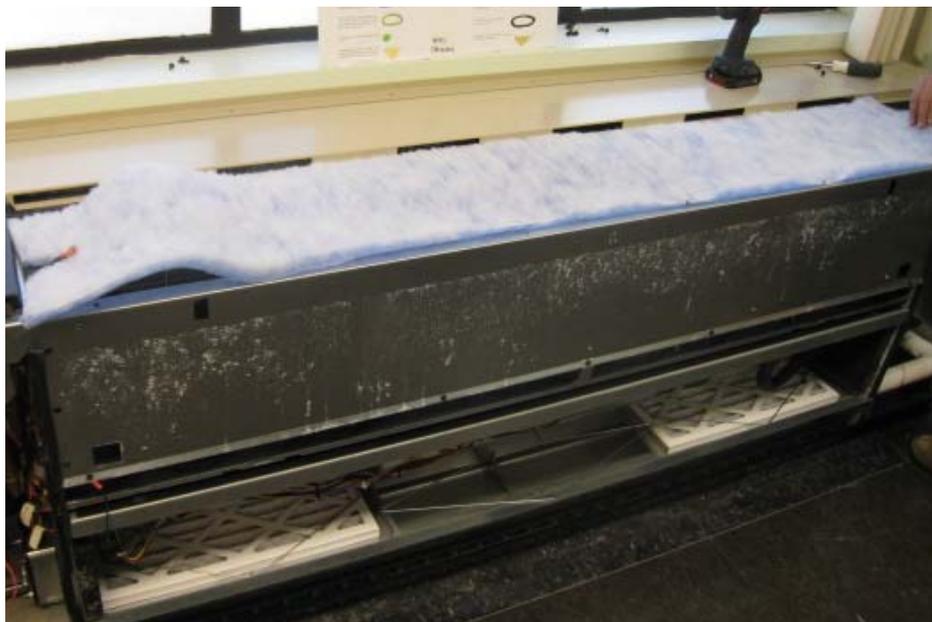
**Picture 2**

The New Bedford School Department (NBSD) has since assembled a team consisting of a Certified Industrial Hygienist (CIH); a mechanical ventilation engineer; NBSD engineering and maintenance staff; and a representative from the univent manufacturer (Trane) to discuss issues related to this aluminum oxide issue. More recently, Trane has provided the NBSD with an Engineering Bulletin that addresses the oxidation occurring in the univents (Appendix A). Based on discussions with members of the NBSD team and information from the Engineering Bulletin, all affected univents have been retrofitted with a filter medium. This secondary filter is installed beneath the air diffuser to reduce/capture debris that may be distributed via the univent fans (Picture 2). School maintenance staff were also instructed to increase cleaning efforts.

**Filter Media Retrofitted into Univent Air Diffuser (Top of Unit), 2<sup>nd</sup> and 3<sup>rd</sup> Floor Classrooms B-Block**

1. Continue to utilize retrofitted filters in affected classroom univents as a temporary measure. Efforts should be made to fit filter media to eliminate gaps/spaces where particulates can bypass filters.

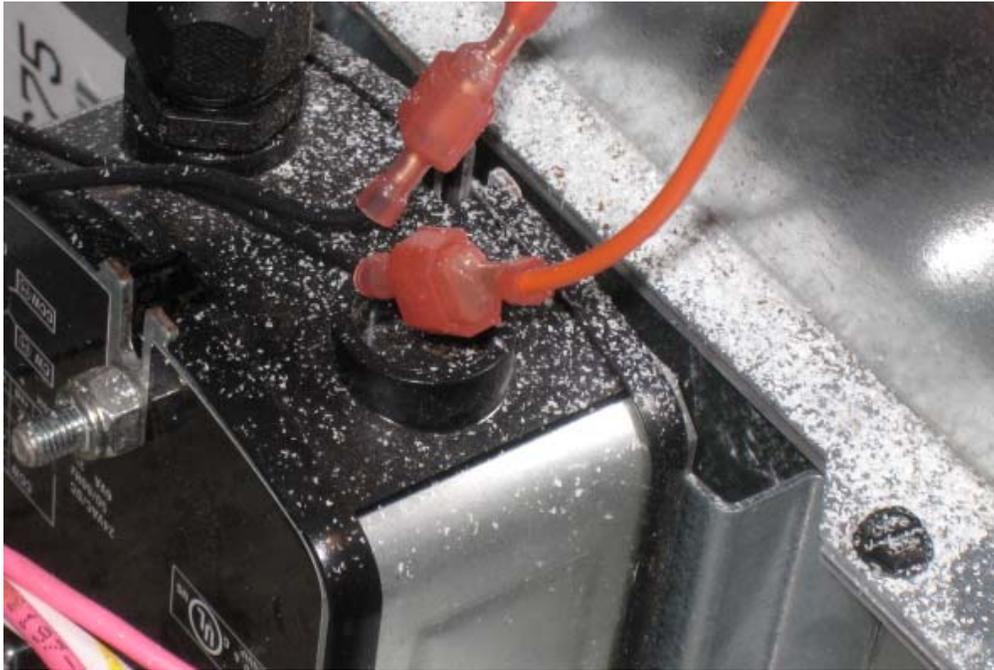
**Picture 3**

Although indoor levels of PM2.5 were below the NAAQS, a substantial amount of visible powder/debris was observed accumulated within the univent cabinets. This material may present a source of eye and respiratory irritation (OSHA, 2012). Some of the aluminum oxide debris was being distributed by the univent fans, and settling on flat surfaces on and around the unit (Pictures 3 through 5). Even in areas where the retrofitted filter medium was installed, some debris was noted on and around univents (Picture 6). Materials accumulated on flat surfaces

**White Particulate/Debris inside Univent Cabinet Classroom B-309**

4. Consider disassembling univents for cleaning. Because it would appear that there is a finite amount of material currently accumulated in univents, the units should be disassembled (e.g., coils/components be removed) over the February vacation, in order to conduct as thorough a cleaning as possible. The removal and cleaning of the bulk of accumulated material should greatly reduce the distribution of debris in classrooms.

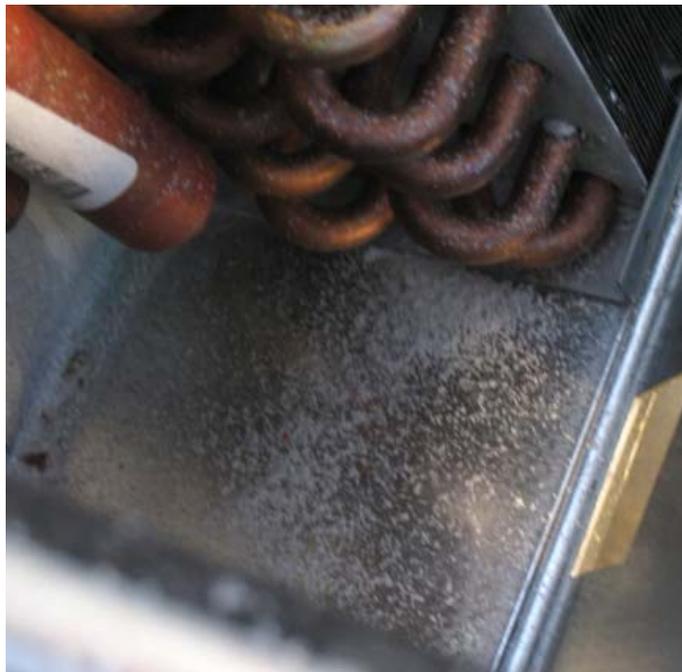
**Picture 4**

**White Particulate/Debris inside Univent Cabinet Classroom B-309**

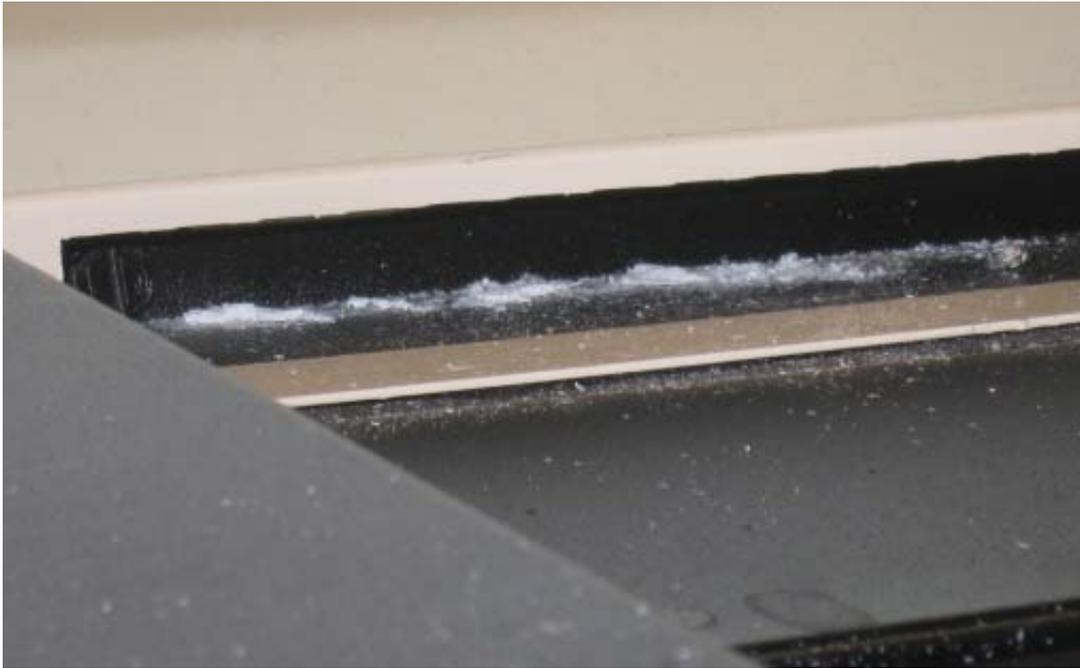
**Picture 5**

**White Particulate/Debris inside Univent Cabinet Classroom B-309**

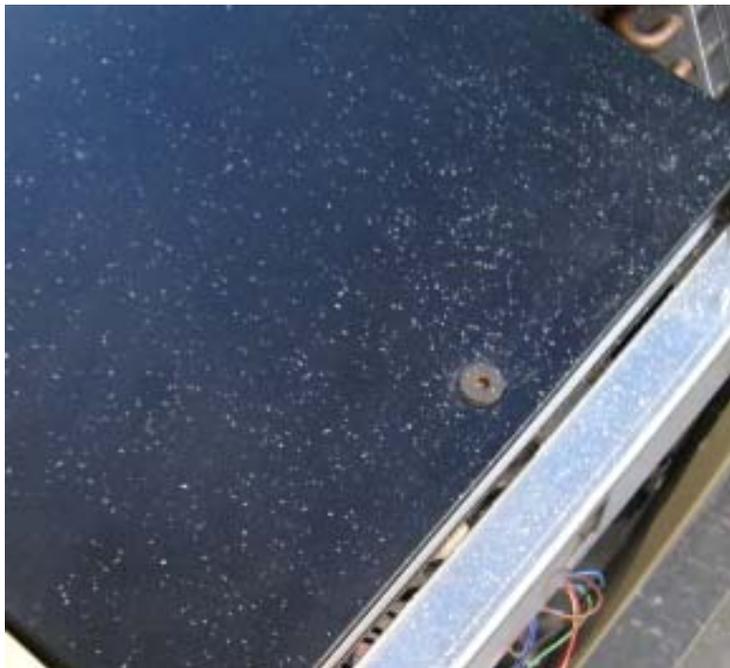
**Picture 6**

**White Particulate/Debris on Univent Cabinet in Classroom B-309 Where Univent was Retrofitted with Filter Media**

2. Use a high efficiency particulate arrestance (HEPA) filter equipped vacuum cleaner in conjunction with wet wiping of surfaces is recommended as needed (e.g., before/after school) to control dusts/particulates.
