STAFF REPORT

NEW BEDFORD HISTORICAL COMMISSION MEETING

CASE #2018.20: CERTIFICATE OF APPROPRIATENESS

56-62 N Water St (Map 53, Lot 175)

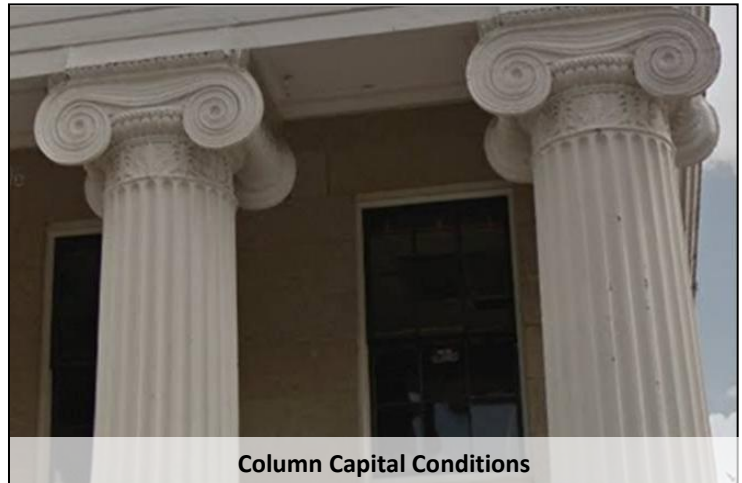
CONDITIONS ASSESSMENT: Over the years, the columns have been routinely maintained with caulking and paint application. Overall, the columns appear structurally sound and display general paint failure with minimal areas of rot and decay. The column base sits directly on granite, without a wood plinth, thereby wicking water and retaining moisture. Therefore the decayed areas requiring epoxy fill are located primarily along the column bases. The column shafts require scraping, sanding, caulking and paint application only. The column capitals are in good condition, with the most southern capital significantly repaired in 2016.

Column Capital Conditions

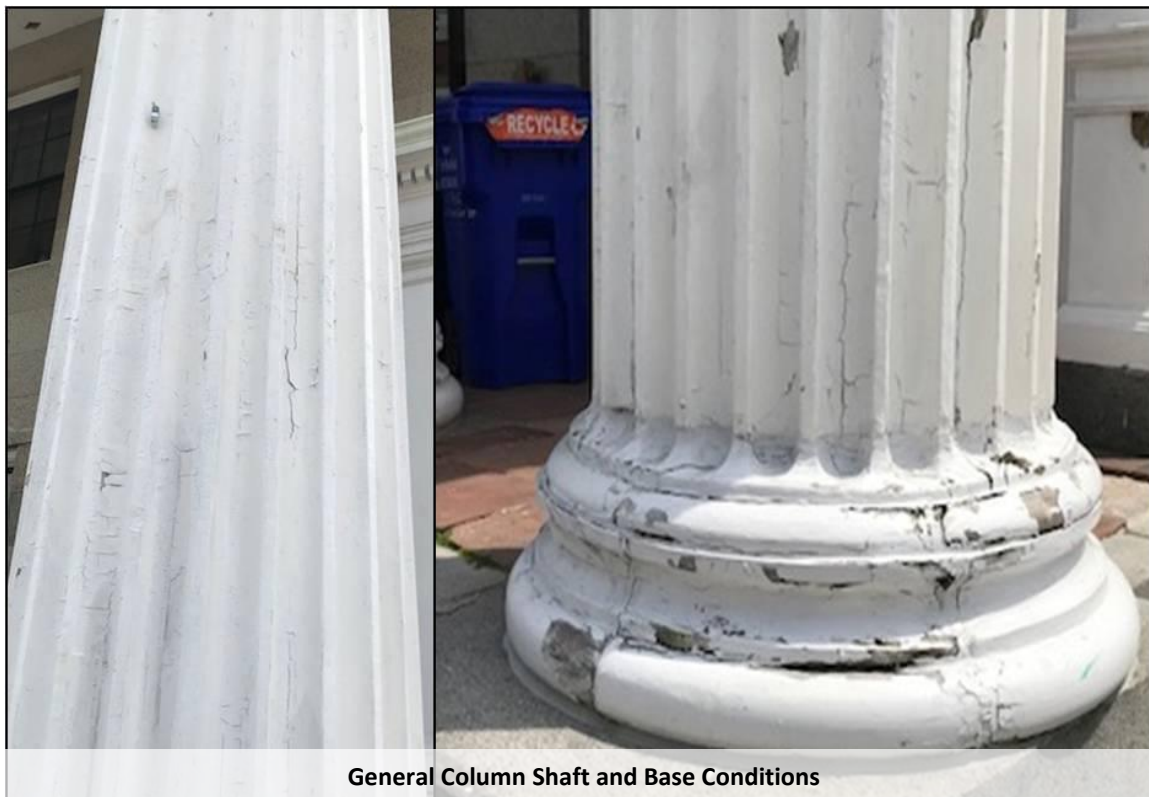
General Column Shaft and Base Conditions

- Paint removal methods will utilize hand tools only. Power tools are not to be used for paint removal.
- Any rotted or decayed material that is replaced or receives epoxy, must match existing dimensions, contours and profiles.
- All primer and top coat paint to match existing white paint.
- Commission Secretary to have final approval of submittals and samples prior to entire application.

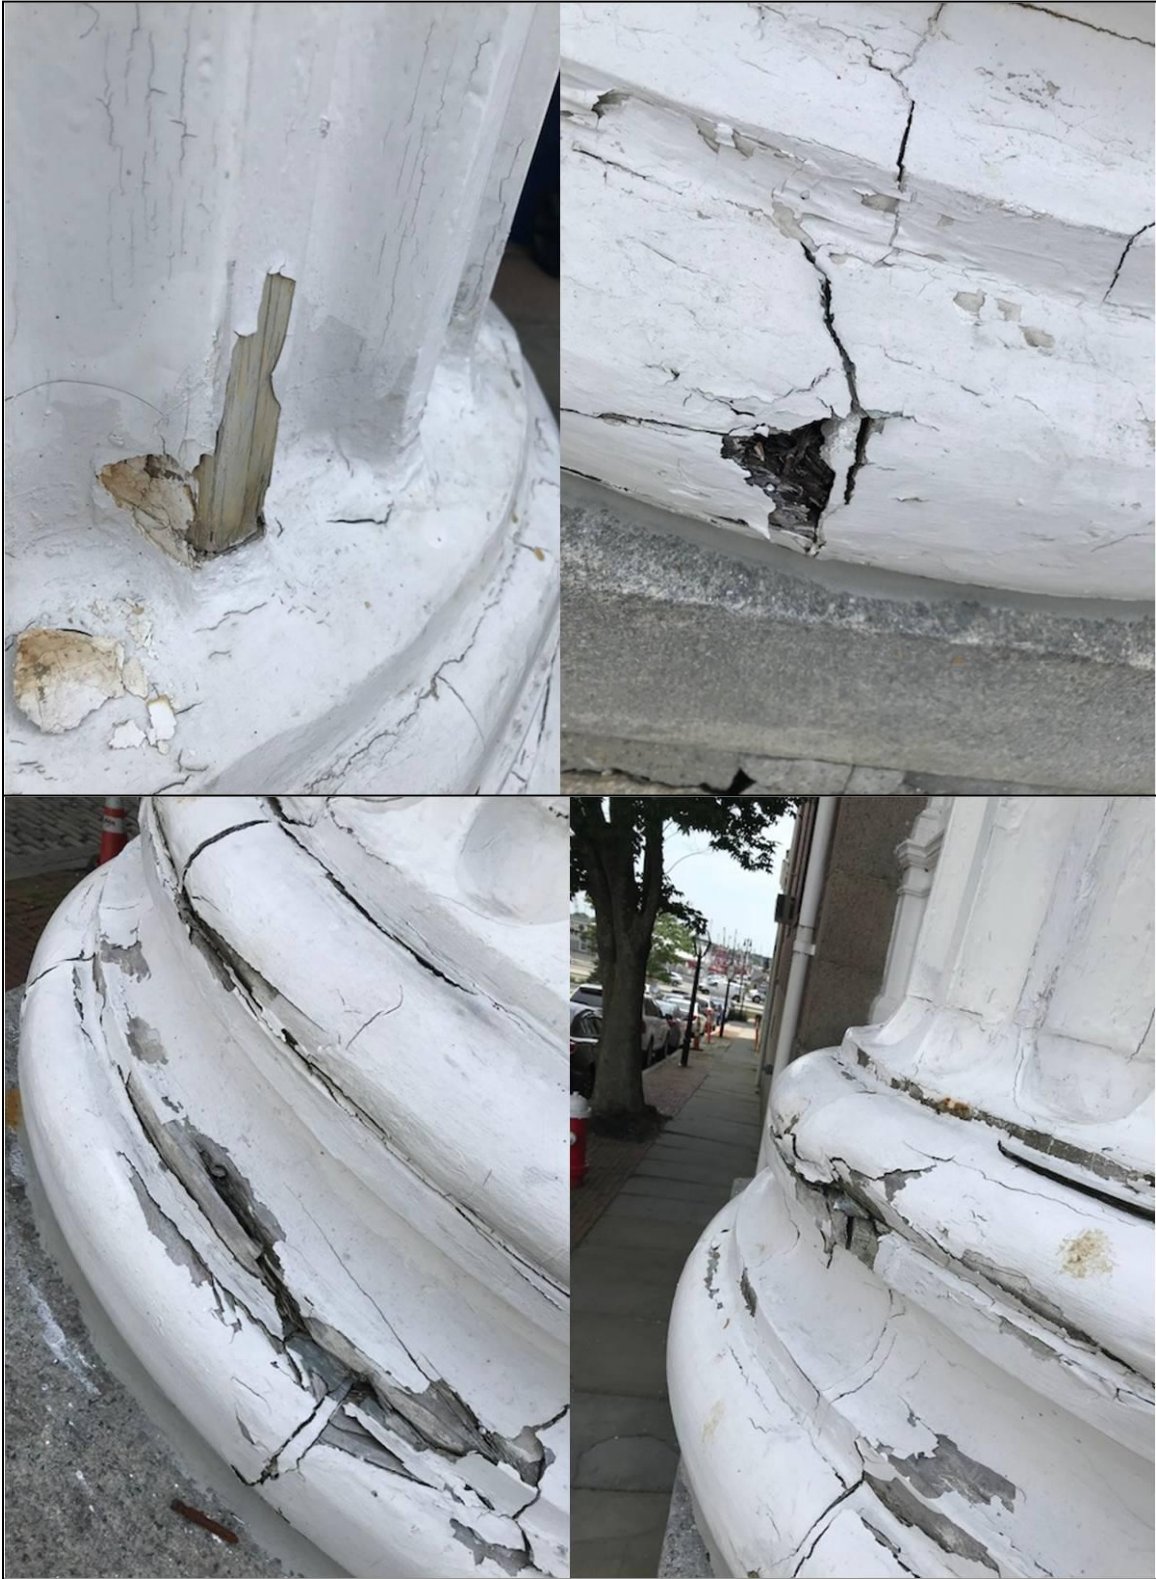
Detail of Column Base Conditions
