SERVICE NO. 1299 BULLETIN

Date: January 6, 2017

PERIODIC REPLACEMENT OF MAIN LANDING GEAR DRAG LINK BOLT

PA-23-150 Apache
PA-23-160 Apache
PA-23-235 Apache
PA-23-250 Aztec

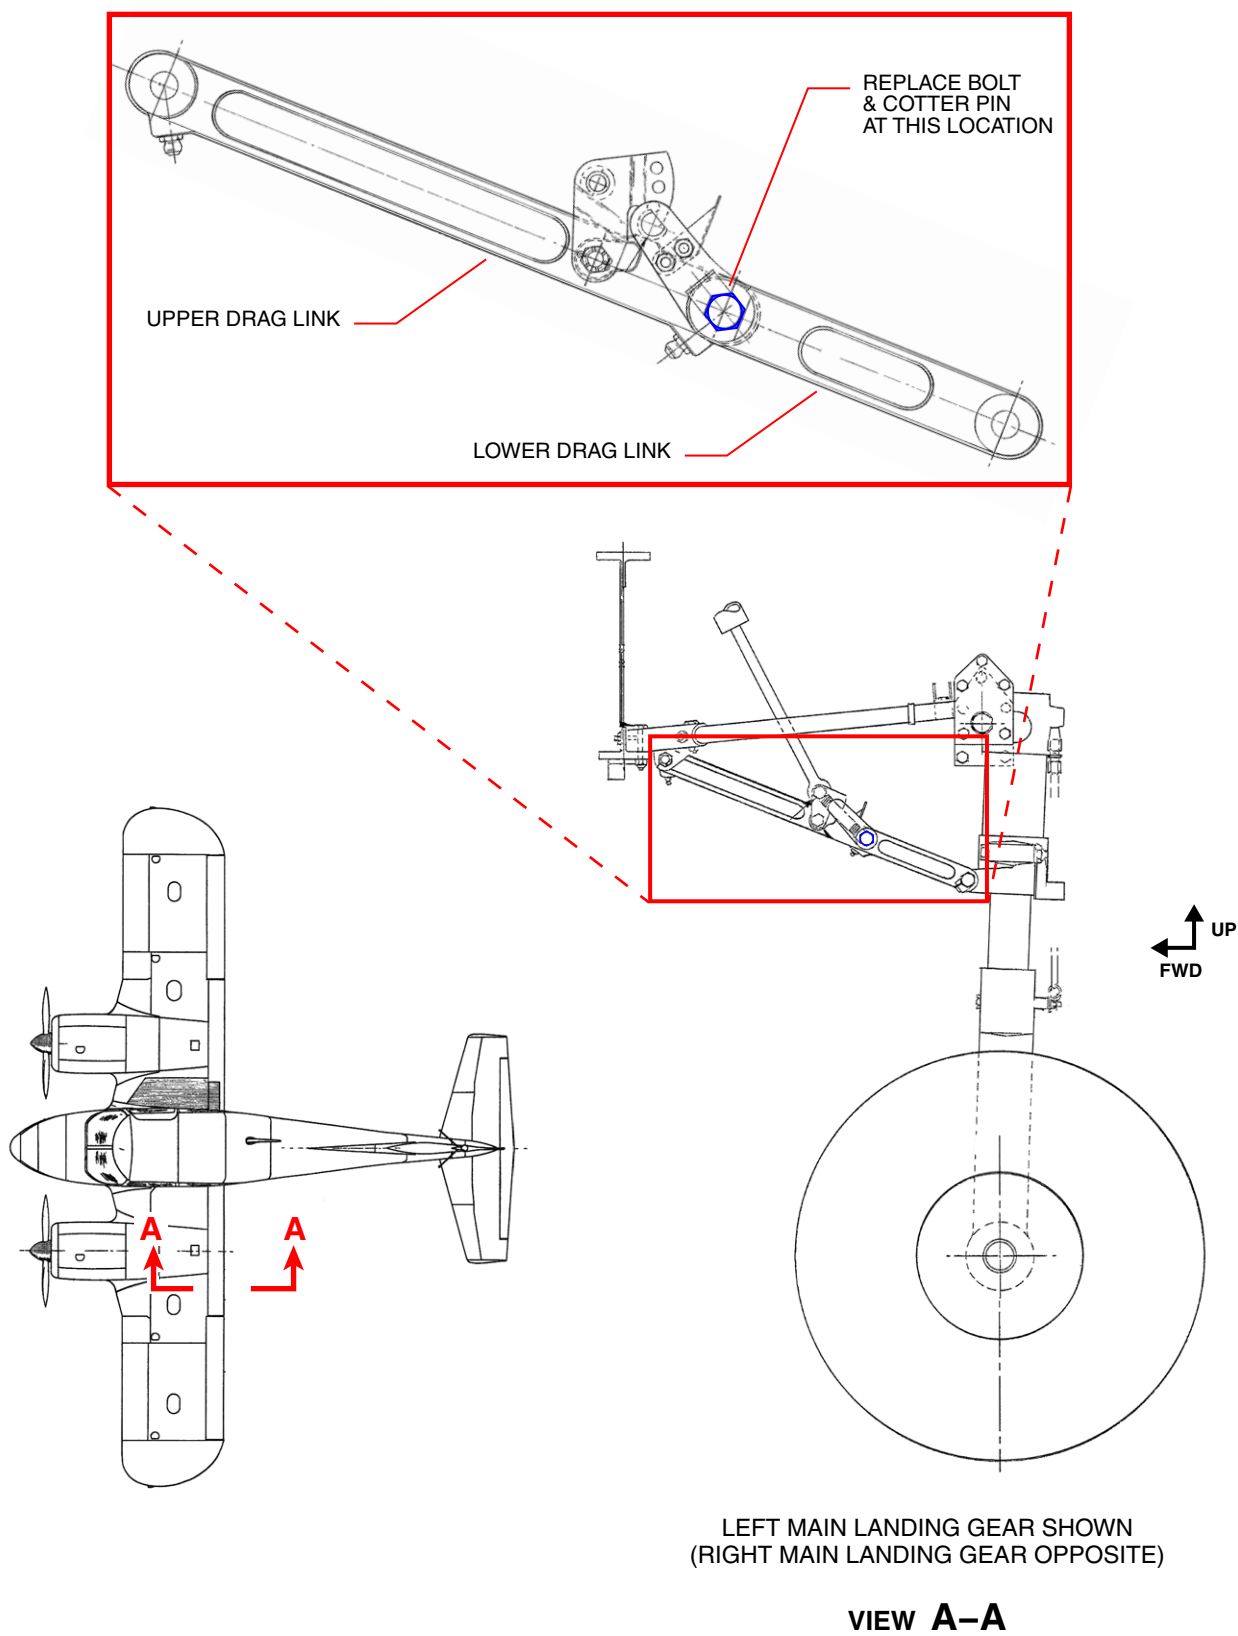
Figure 1
Drag Link Bolt Assembly Location

Under certain conditions, the bolt that fastens the upper and lower main gear (MG) drag links can develop wear in a manner that may not be detectable during routine maintenance and inspection. Specifically, score marks have been discovered around the circumference of the bolt shank, midway along the length of the bolt.

By design, the main landing gear drag link bolt is free to rotate inside a set of bushings to allow relative movement between the upper and lower drag links during landing gear strut extension and retraction. Over extensive operating hours, this rotation can generate the score marks described, causing stress concentrations to develop in the bolt, which, if left uncorrected, could result in bolt fatigue failure and subsequent main gear collapse.

1. Jack the aircraft per Section II of the appropriate service manual.
2. Disassemble the upper drag link from the lower drag link by removing the bolt, and associated hardware, which functions as a hinge pin for the two parts. See Figure 1.

3. Inspect the washers and castellated nuts for corrosion, damage and excessive wear, and replace on condition. Retain all serviceable hardware for later reassembly. Discard the used bolt and cotter pin.

4. Reassemble the upper and lower drag links, using new bolts and new cotter pins as listed in the Material Required section of this service bulletin. Existing nuts and washers may be reused, if they are in serviceable condition. If replacement nuts and/or bolts are required, order and install new parts as listed in the Material Required section of this service bulletin.
