# Medical Devices: The Therac-25\*

Nancy Leveson  
University of Washington

Between June 1985 and January 1987, a computer-controlled radiation therapy machine, called the Therac-25, massively overdosed six people. These accidents have been described as the worst in the 35-year history of medical accelerators [6].

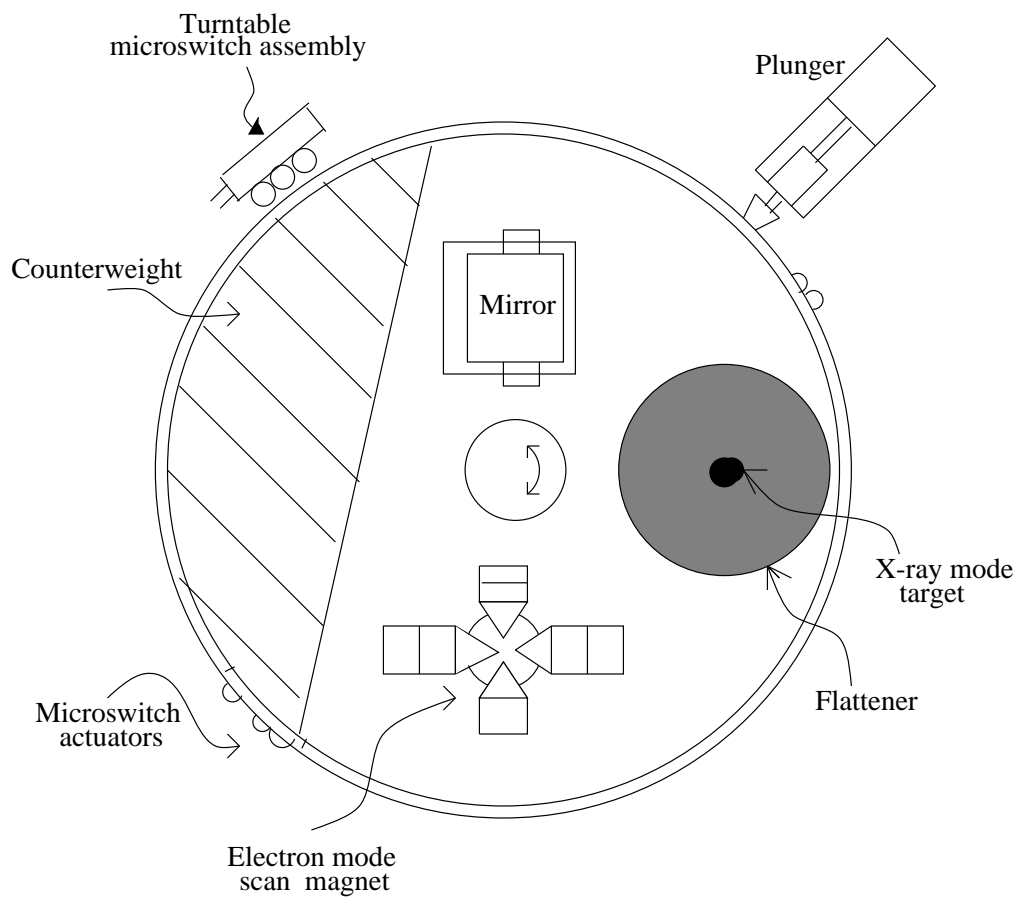
Figure 1: Upper turntable assembly.

**Turntable Positioning.** The Therac-25 turntable design plays an important role in the accidents. The upper turntable (see Figure 1) rotates accessory equipment into the beam path to produce two therapeutic modes: electron mode and photon mode. A third position (called the field light position) involves no beam at all, but rather is used to facilitate correct positioning of the patient. Because the accessories appropriate to each mode

are physically attached to the turntable, proper operation of the Therac-25 is heavily dependent on the turntable position, which is monitored by three microswitches.

The computer senses and controls turntable position by reading a 3-bit signal about the status of three microswitches in the turntable switch assembly. Essentially, AECL determined that a 1-bit error in the microswitch codes (which could be caused by a single open-circuit fault on the switch lines) could produce an ambiguous position message to the computer. The problem was exacerbated by the design of the mechanism that extends a plunger to lock the turntable when it is in one of the three cardinal positions: The plunger could be extended when the turntable was way out of position, thus giving a second false position indication. AECL devised a method to indicate turntable position that tolerated a 1-bit error so that the code would still unambiguously reveal correct position with any one microswitch failure.

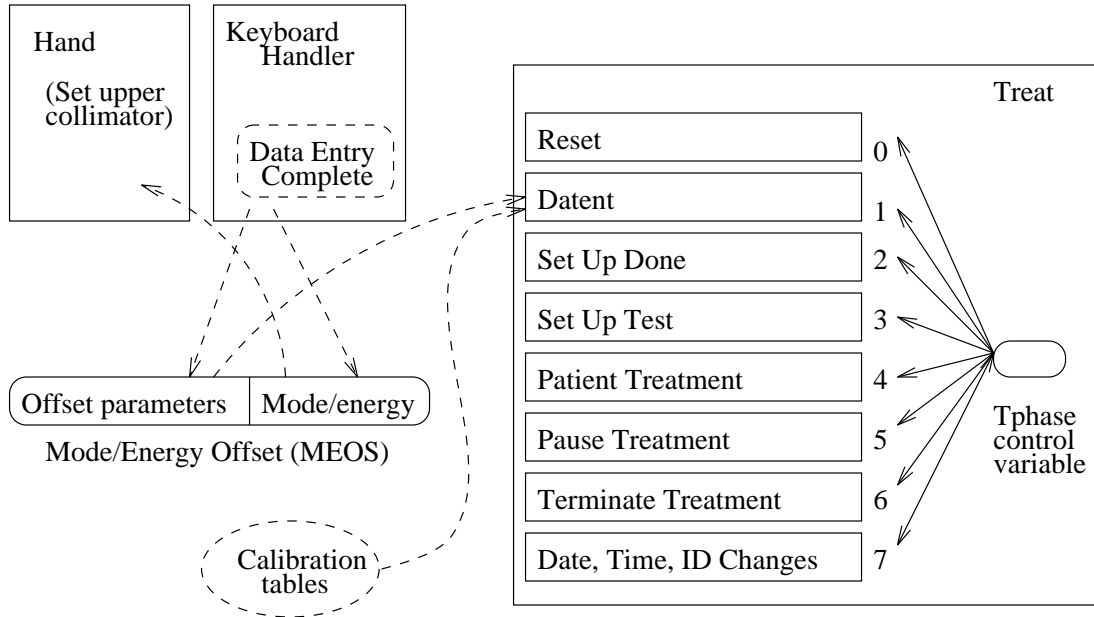
Figure 3: Tasks and subroutines in the code blamed for the Tyler accidents.

The treatment monitor task (Treat) controls the various phases of treatment by executing its eight subroutines. The treatment phase indicator variable (Tphase) is used to determine which subroutine should be executed (Figure 3). Following the execution of a particular subroutine, Treat reschedules itself.

But this is not the only problem. Upon exit from the Magnet subroutine, the data entry subroutine (Datent) checks the Data Entry Complete variable. If it indicates that data entry is complete, Datent sets Tphase to 3 and Datent is not entered again. If it is not set, Datent leaves Tphase unchanged, which means it will eventually be rescheduled. But the Data Entry Complete variable only indicates that the cursor has been down to the command line, not that it is still there. A potential race condition is set up. To fix this, AECL introduced another shared variable controlled by the keyboard handler task that indicates the cursor is not positioned on the command line. If this variable is set, then prescription entry is still in progress and the value of Tphase is left unchanged.

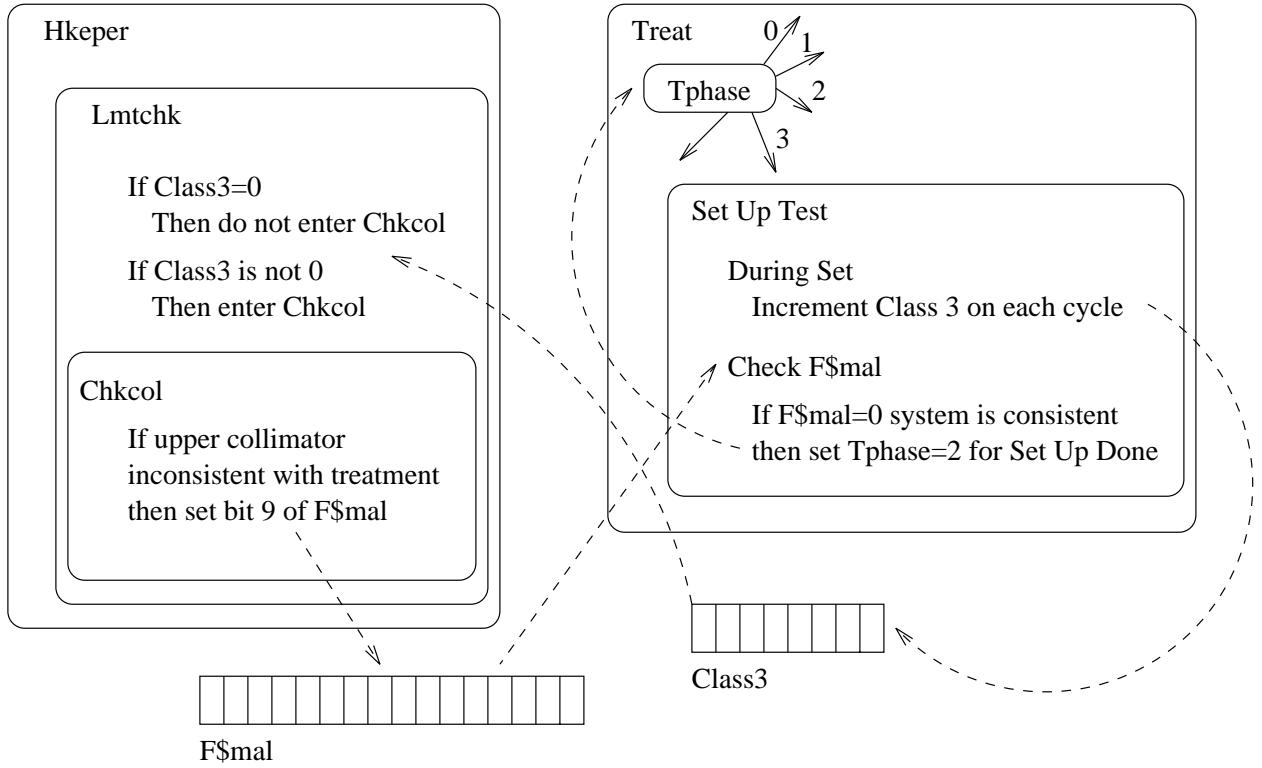
Figure 4: The Yakima software flaw.

The second Yakima accident was again attributed to a type of race condition in the software — this one allowed the device to be activated in an error setting (a “failure” of a software interlock). The Tyler accidents were related to problems in the data-entry routines that allowed the code to proceed to Set Up Test before the full prescription had been entered and acted upon. The Yakima accident involved problems encountered later in the logic after the treatment monitor Treat reaches Set Up Test.

The overexposure occurred when the operator hit the “set” button at the precise moment that Class3 rolled over to zero. Thus, Chkcol was not executed and F\$mal was not set to indicate that the upper collimator was still in the field-light position. The software turned on the full 25 MeV without the target in place and without scanning. A highly concentrated electron beam resulted, which was scattered and deflected by the stainless
