Compass Home Inspections L.L.C.

Inspection Property Address
1704 Hillsdale Ave.
San Jose, CA

Inspection Date
10/29/2005

Inspection Report Introduction

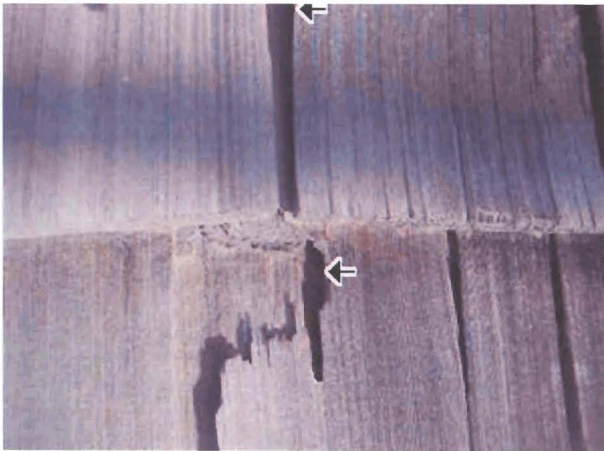
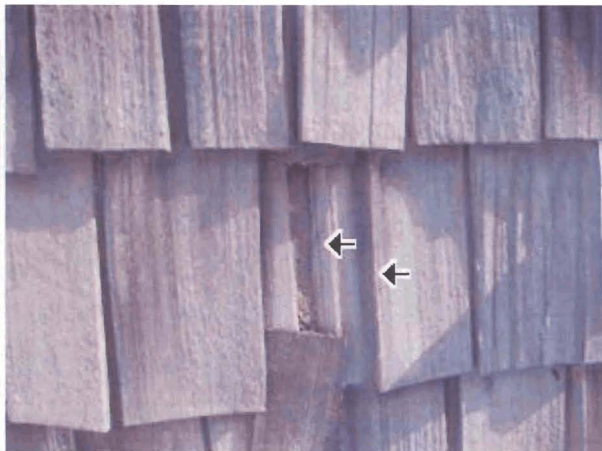
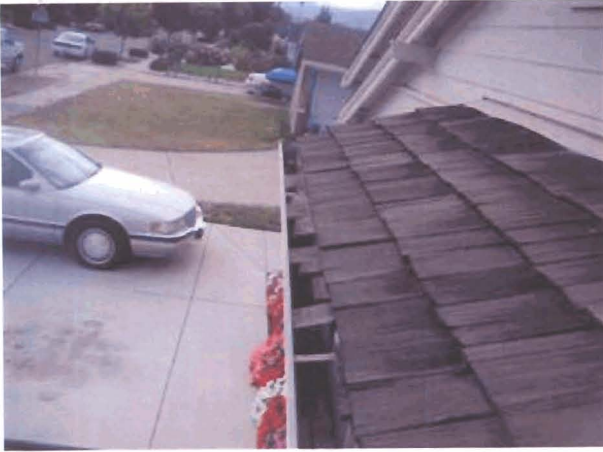
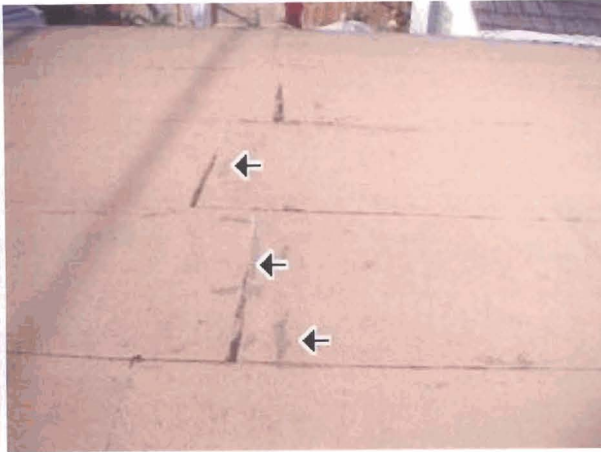
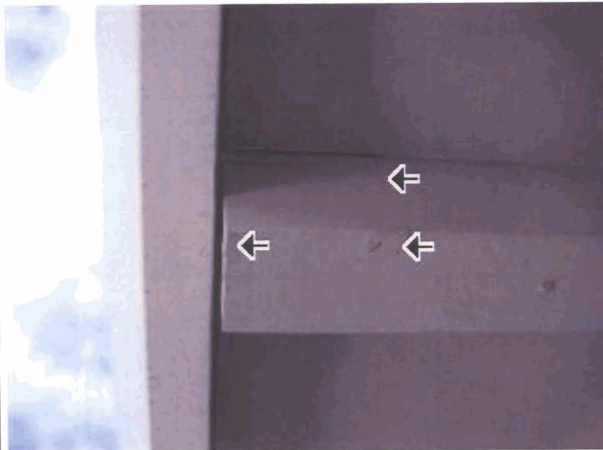
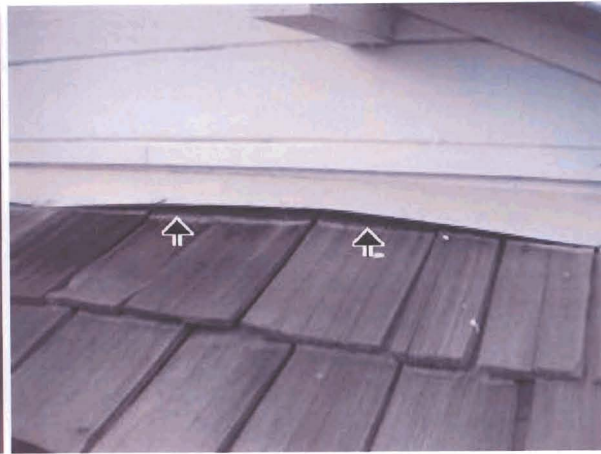
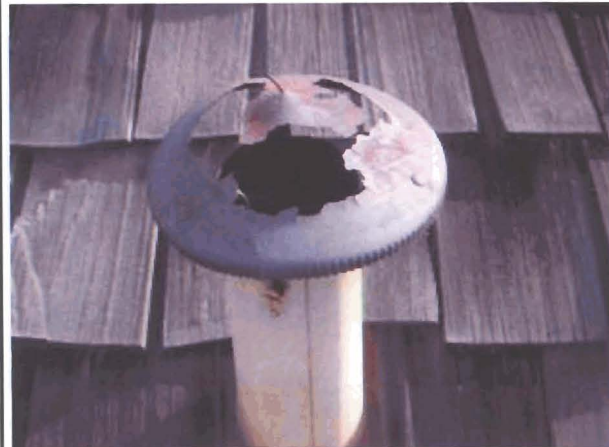
1.1 ROOF COVERING: UNSAFE, DEFICIENT. OR SIGNIFICANTLY DEFICIENT ITEMS:
There were several weathered, loose, and cracked wood shakes, and areas of exposed roofing felt paper visible on the roof (see photo #1-3 for example), there were worn spots on the composition rolled roofing over the family room(see photo #4 for example), there were water stains on the eaves of the family room(see photo #5 for example)and the flashing was lifted in an area adjacent to the front entry(see photo#6). There was a flue cap that was rusted through above the water heater area(see photo #7). These situations all need further evaluation and repairs as needed to help ensure a leak free installation. I recommend contacting a qualified licensed roofing contractor at this time for further evaluation and repairs of these items as needed.

There was some tree debris and moss noted in places on the roof . These areas need to be cleaned to ensure proper control of the roof water runoff.

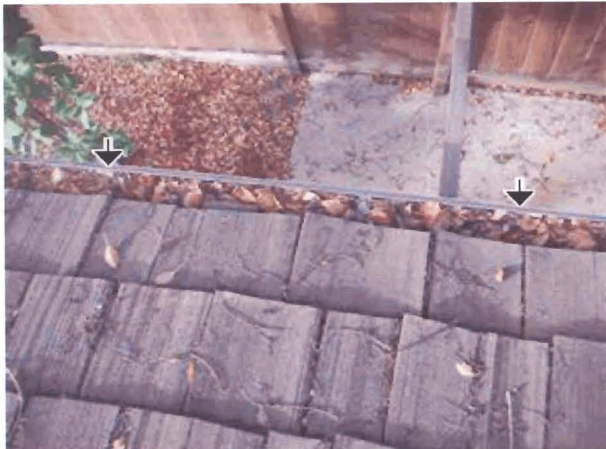
1.5 Picture 1

The rain gutter was noted to have debris in it in several places(see photo #1 for example). This system needs further evaluation and repairs / maintenance as needed at this time to be fully functional.

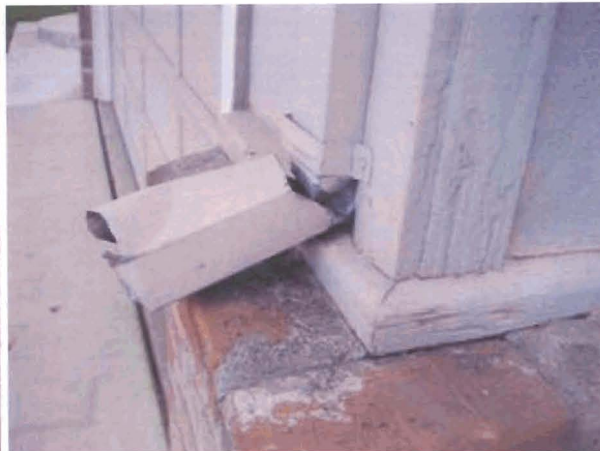
1.5 Picture 2

The downspout was damaged on the right front of the garage(see photo#2). This damaged downspout needs to be replaced to ensure proper control of the roof water runoff.

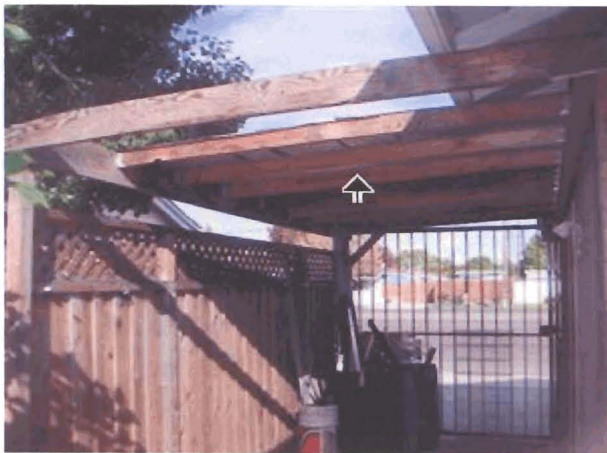
2.3 Picture 1

The wood over hang added at right side of the garage appears to encroach into the setback requirements for the property (see photo#1). This overhang needs to be removed. I recommend contacting a qualified licensed general contractor for correction as needed.

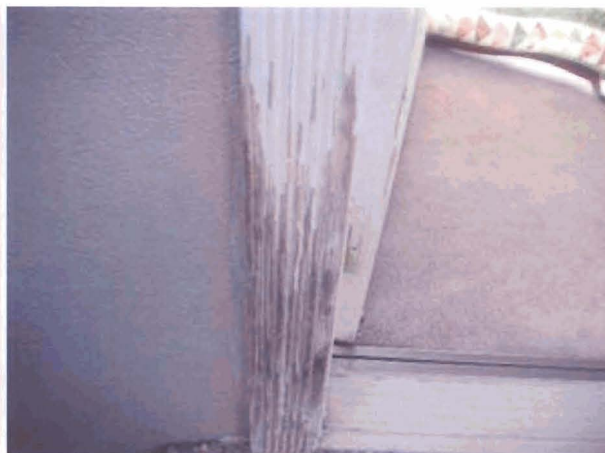
2.3 Picture 2

The paint was chipping and peeling on the exterior of the master bedroom door and door trim at the left side of the house (see photo#2 for example). These areas need to be properly prepared and painted where needed to fully protect the wood. I recommend contacting a qualified licensed painting contractor at this time for corrections.

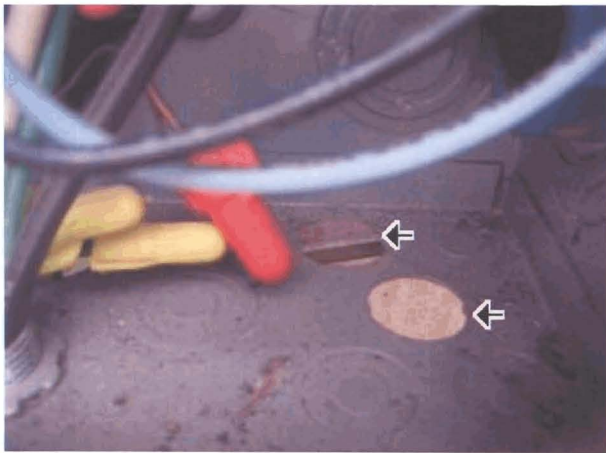
4.1 Picture 1

There were missing knockout plugs noted in the sub panel(see photo #1). Approved filler plates need to be installed to seal the hole at this time for safety. I recommend contacting a qualified licensed electrical contractor at this time for proper installation of this item.

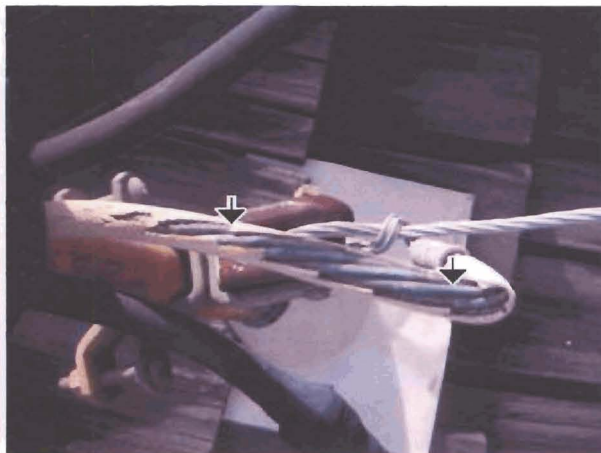
4.1 Picture 2

The insulation on the white overhead electrical service wires at the electrical mast head was noted to be deteriorated/cracked(see photo #2). This is a potential hazardous situation and needs to be corrected at this time for safety. This is high voltage wiring DO NOT ATTEMPT TO DO THIS YOUR SELF. I recommend contacting the local utility company or a qualified licensed electrical contractor at this time for correction as needed.

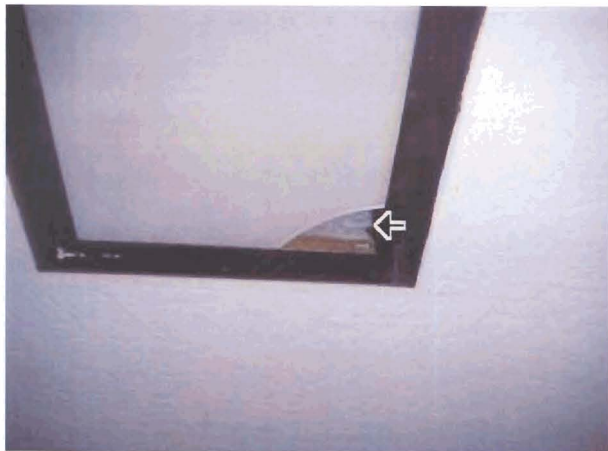
4.4 Picture 1

The glass lens in the ceiling light fixture in the front entry hall was broken(see photo #1). This glass lens needs to be replaced for safety.

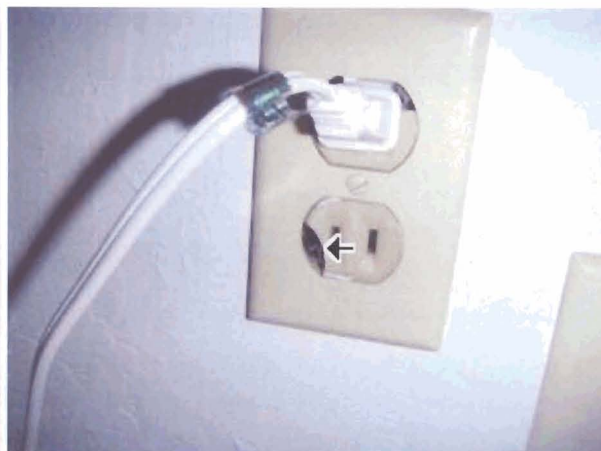
4.4 Picture 2

There was a broken electrical outlet noted in the family room(see photo #2). This outlet needs to be replaced at this time for safety. I recommend contacting a qualified licensed electrical contractor at this time for further evaluation, and correction as needed.

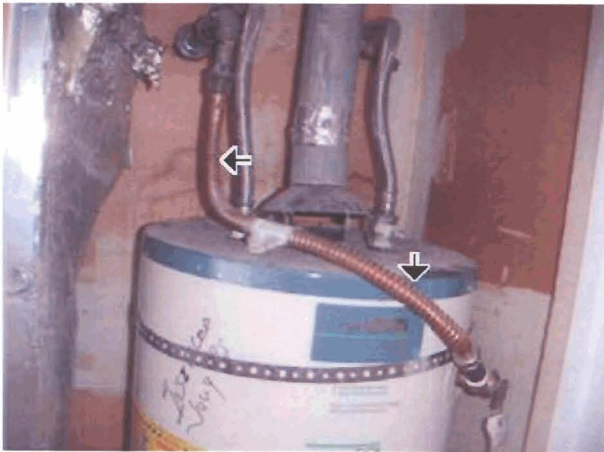
5.2 Picture 1

5.2 WATER HEATER SYSTEM: UNSAFE, DEFICIENT, OR SIGNIFICANTLY DEFICIENT ITEMS
 There was no drain pan installed under the water heater. A properly sized drain pan needs to be properly installed at this time. Consult with the manufactures guidelines. I recommend contacting a qualified licensed plumbing contractor for installation.
 The pressure relief valve drain pipe on water heater is not properly vented out to the exterior of the house (goes uphill). This drain line must be sloped continuously down hill to the exterior of the house. For safety this situation needs to be properly corrected at this time. I recommend contacting a qualified licensed plumbing contractor for corrections as needed.
 The water heater was installed too close to the closet door(within 4"). This is a potential fire risk and needs to be corrected at this time. I recommend contacting a qualified licensed general contractor for correction as needed.

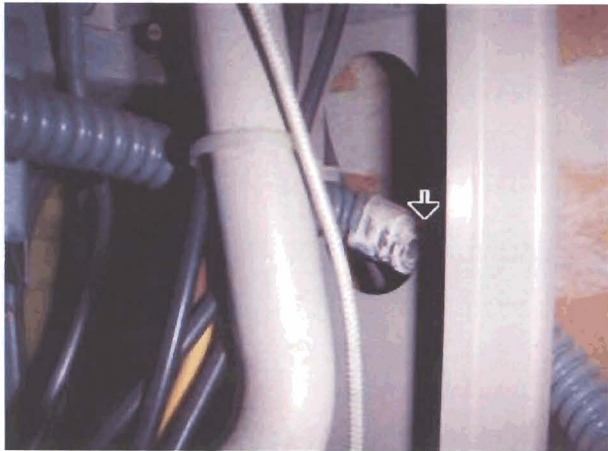
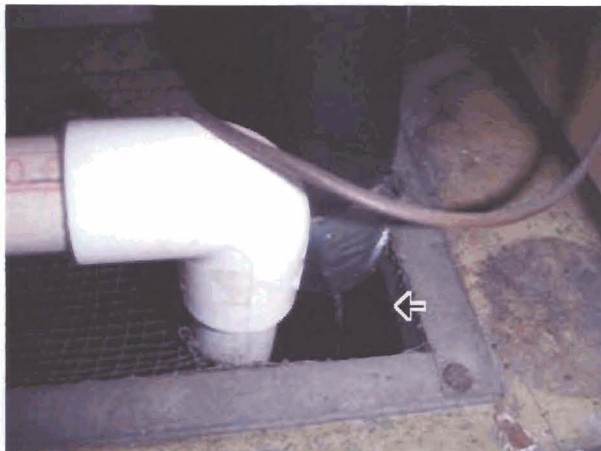
6.2 HEATING SYSTEM: UNSAFE, DEFICIENT, OR SIGNIFICANTLY DEFICIENT ITEMS
 The cold air return inlet for the furnace was within 10 feet of the furnace closet door. Due to the location of the cold air return the furnace door needs to be fully weather stripped and airtight when closed. I recommend contacting a qualified licensed heating contractor for further evaluation and correction of this item as needed at this time.
 The flexible gas line for the furnace was noted to run through the side wall of the furnace (see photo#1). This condition could cause damage to the gas line and needs to be corrected at this time for safety. I recommend contacting a qualified licensed plumbing contractor for corrections of this item.
 There was a torn air vent screen noted at the bottom of the closet(see photo #2). This screen needs to repaired / or be replaced at this time to help prevent access into the house by animals.

There was no clamp installed on the furnace filter. An approved clamping mechanism needs to be installed to ensure proper filtering of the returned air. I recommend contacting a qualified licensed heating contractor for further evaluation and correction of this item as needed at this time.

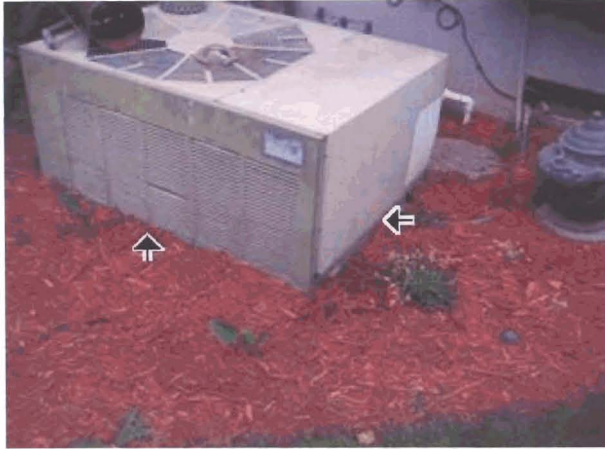
6.4 Picture 1

6.4 AIR CONDITIONING SYSTEM: UNSAFE, DEFICIENT, OR SIGNIFICANTLY DEFICIENT ITEMS
 The air conditioning unit did not respond to the controls. This air conditioning unit needs further evaluation at this time and repairs/replacement to be functional. I recommend contacting a qualified licensed heating contractor for further evaluation and possible repairs as needed.
 The air conditioning unit was located on a pad at ground level(see photo #1). This air conditioning unit needs to be

properly installed on a pad 3" above the grade at this time. I recommend contacting a qualified licensed heating / cooling contractor for correction.

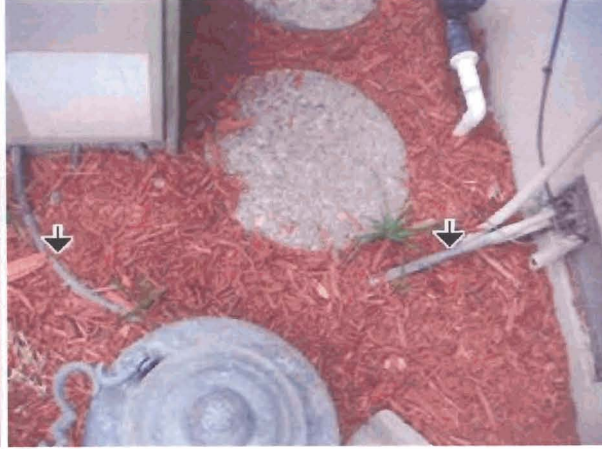
6.4 Picture 2

The insulation was deteriorating from the coolant line adjacent to the AC compressor at the exterior of the house(see photo #2). This insulation needs to be replaced for energy efficiency.

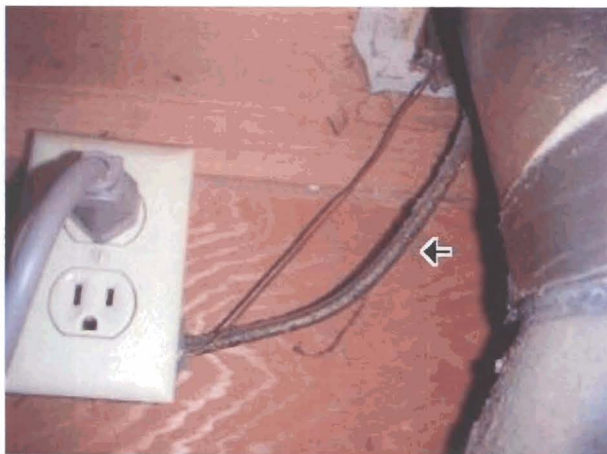
7.7 Picture 1

There was some unshielded nonmetallic sheathed electrical wiring noted in the wood cabinet above the stove cook top area (see photo#1). This wiring needs to be removed or be properly shielded at this time for safety. I recommend contacting a qualified licensed electrical contractor for corrections.

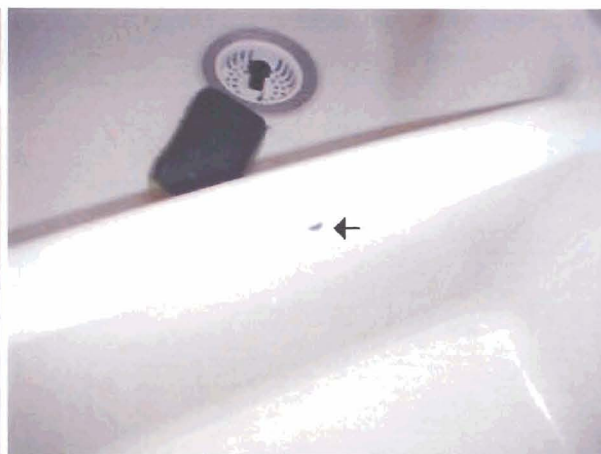
7.7 Picture 2

The sink finish in the kitchen was chipped(photo #2 for example). These chips need to be repaired as needed to prevent further damage. I recommend contacting a qualified licensed general contractor for correction as needed.

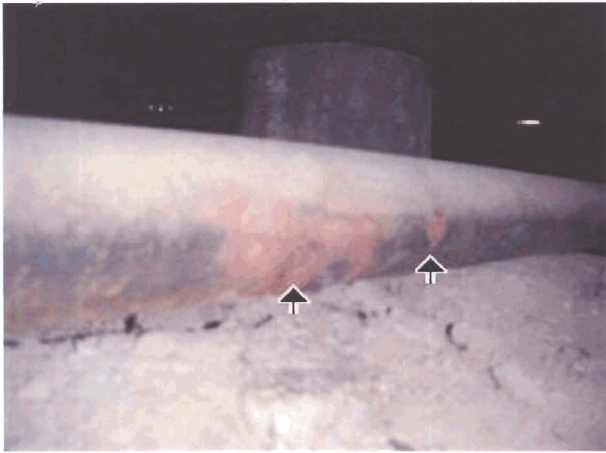
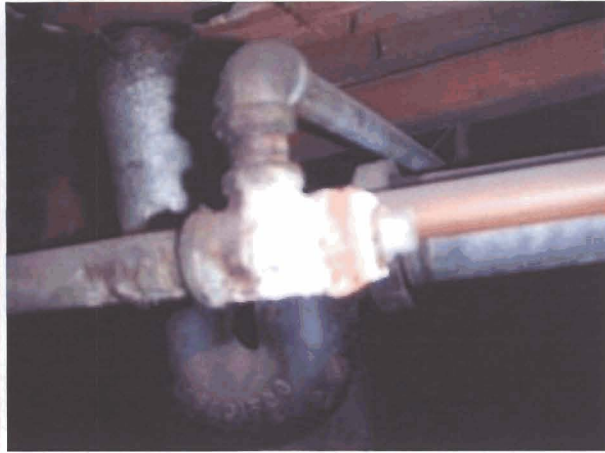
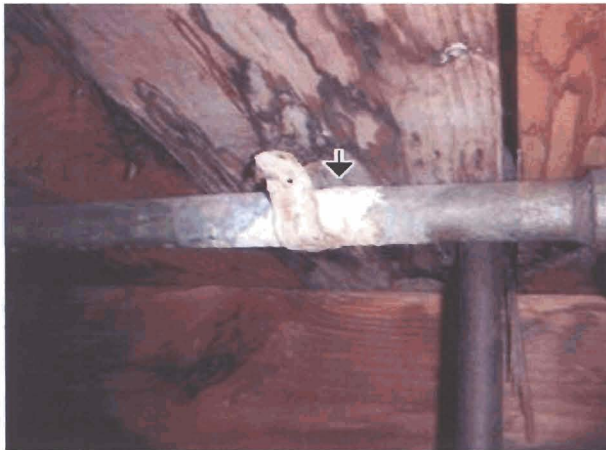
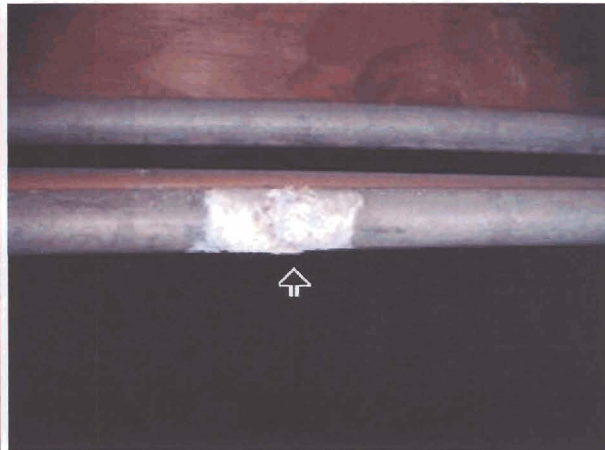
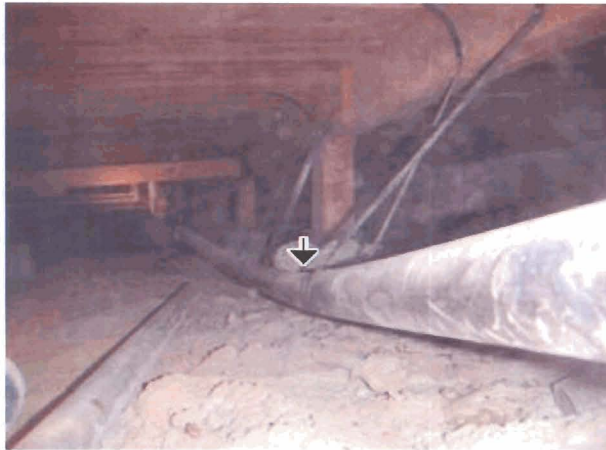
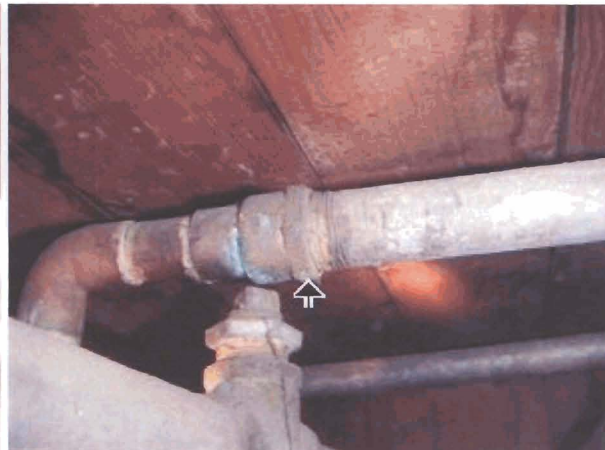
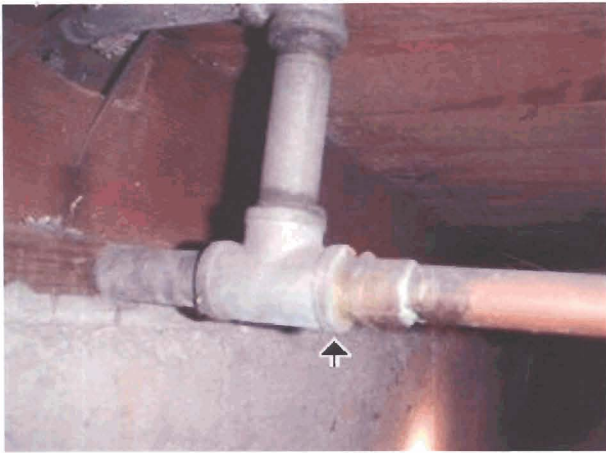
8.2	<p>PLUMBING SYSTEM: UNSAFE, DEFICIENT AND SIGNIFICANTLY DEFICIENT ITEMS.</p> <p>There was some significant corrosion noted to a cast iron drain line in the sub area below the master bathroom (see photo #1 for example). This corrosion is an area where leaking has occurred in the past and may leak again. I recommend contacting a qualified licensed plumbing contractor for correction as needed to prevent further corrosion and leaking. Please note that during the correction of these items additional issues may be discovered by the contractor that may require further repairs.</p> <p>There was some significant corrosion noted to some water supply lines in the sub area below the hall bathroom and kitchen (see photo #2-4 for example). This corrosion is an area where leaking has occurred in the past and may occur again. I recommend contacting a qualified licensed plumbing contractor for correction as needed to prevent further corrosion and leaking. Please note that during the correction of these items additional issues may be discovered by the contractor that may require further repairs.</p> <p>The was a negative slope to the ABS drain line in the sub area below the kitchen(see photo #5). This drain line needs to be properly installed with an approved slope to ensure proper draining. I recommend contacting a qualified licensed plumbing contractor for further evaluation and correction of this item as needed.</p> <p>There was some galvanized steel piping noted to be joined directly to a copper water line in the sub area below the kitchen and front bedroom(see photo #6&7). This situation needs to be corrected at this time to prevent premature deterioration of these metals. I recommend contacting a qualified licensed plumbing contractor for correction as needed at this time.</p> <p>There is a leak noted at the cold water faucet valve stem at the laundry sink. This leaking needs to be corrected at this time before it accelerates and to prevent possible damage. I recommend contacting a qualified licensed plumbing contractor for further evaluation and correction of this item as needed. The hot water supply to the sink was off. It's ability to function properly is unknown.</p>

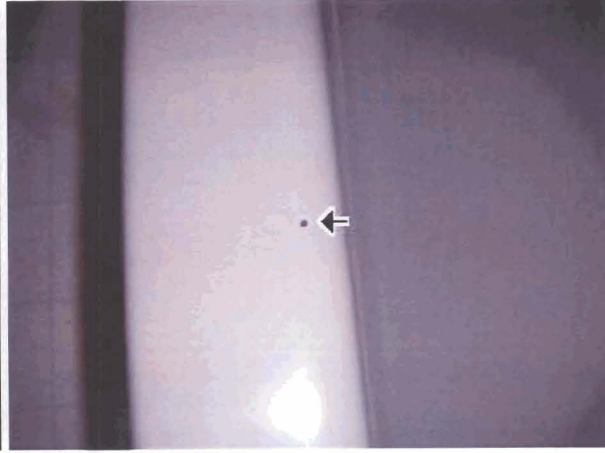
8.7 Picture 2

The tub finish in the master bathroom was chipped (see photo #2). These chips need to be repaired as needed to prevent further damage. I recommend contacting a qualified licensed general contractor for correction as needed.

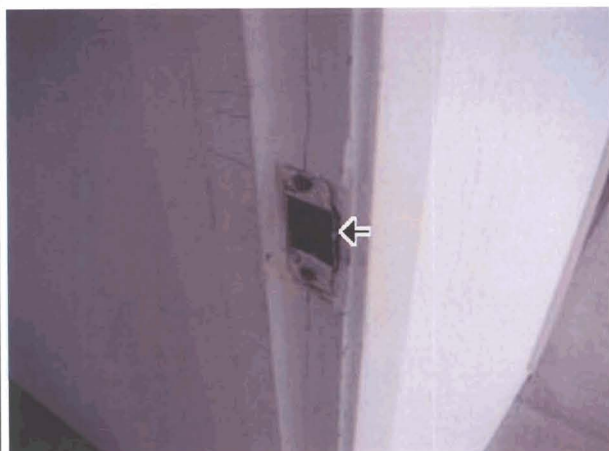
9.5 Picture 1

The door in the master bedroom was missing a strike plate on the door jamb(see photo #1). This door needs to have a strike plate installed to prevent possible damage to the jamb. I recommend contacting a qualified licensed general contractor for correction as needed.

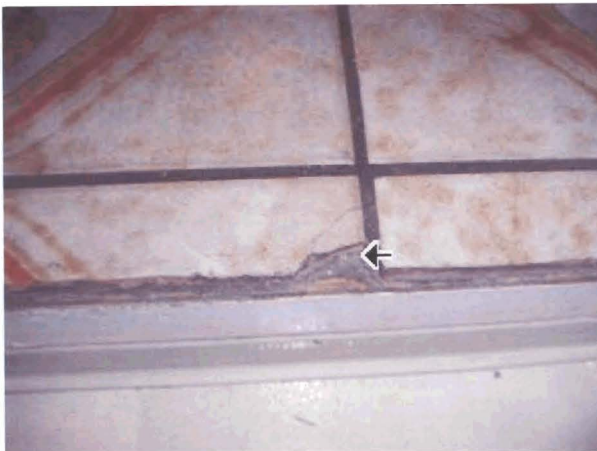
9.5 Picture 2

There was broken tile noted to the flooring in the kitchen adjacent to the laundry room(see photo #2). This tile needs to be replaced to prevent further damage and for safety of passing foot traffic. I recommend contacting a qualified licensed flooring contractor for further evaluation and correction as needed.

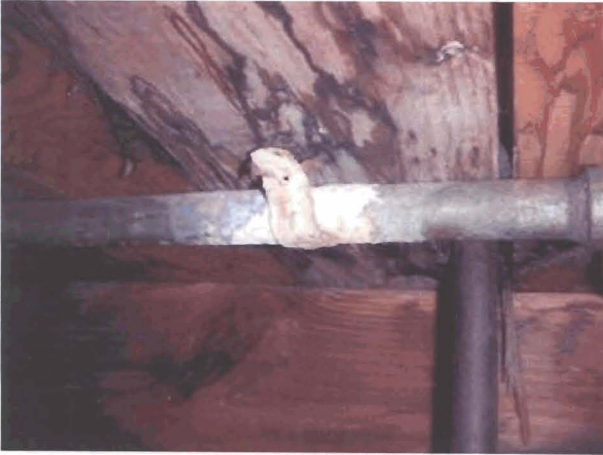
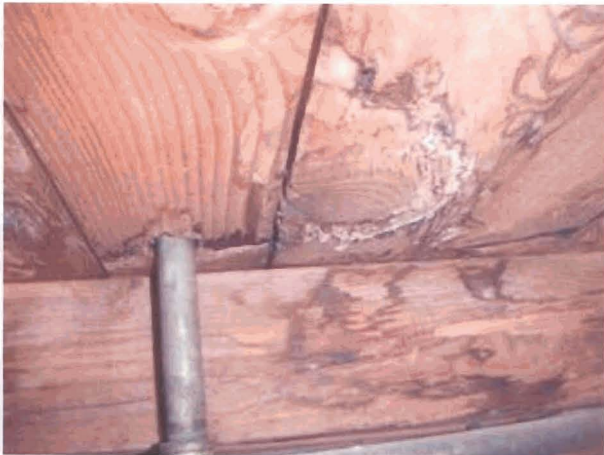
11.4 Picture 1

11.4	<p>ATTIC, FOUNDATION AND SUB AREA(S): UNSAFE, DEFICIENT, AND SIGNIFICANTLY DEFICIENT ITEMS</p> <p>There were water stains noted in numerous places on the sub floor and framing below the house (see photos #1&2 for example). There was no visible leaking at this time. A current pest control report should be consulted at this time to determine if there is any damage in this area, and the extent of any possible damage.</p> <div style="display: flex; justify-content: space-around;">
