A River Runs Under It: Re-supporting a Sinking Mansion

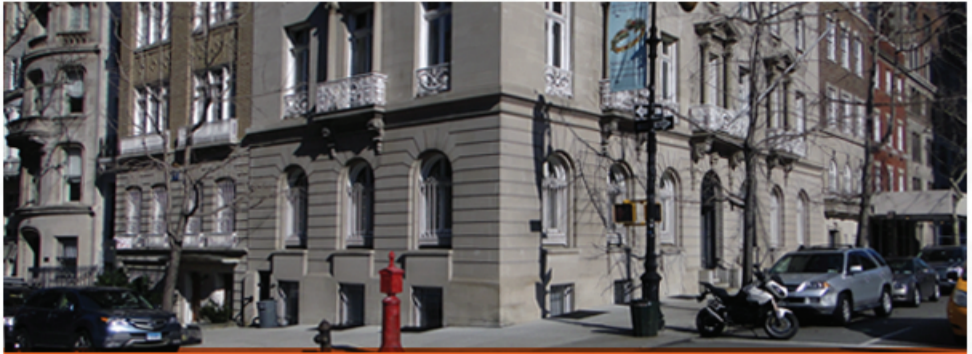
The settled southeast corner

Now a stepped crack in the southeast corner was clearly worsening and indicated active movement. Working with geotechnical consultants Langan Engineering, we conducted building and subsurface analysis to determine the cause of the settlement and its potential impact on the structural elements.

The investigation concluded that building overlies a river 40 feet below the surface, which had been buried in about 1908 during construction of an adjacent railroad tunnel and that the brick foundation was settling due to slow compaction of the river bed.

We analyzed the strength of the limestone and brick masonry and response of the components to various repair techniques. We recommended an innovative stabilization approach that was the least invasive: Thirty-eight 40-foot-long steel end-bearing piles connected to the existing foundation with cantilevered steel brackets and installed with a small pneumatic jack system. The goal was not to reverse the settlement, but to stabilize the building to eliminate further settlement.
