**Analysis of Water Quality Impacts at
the Buckhorn Mountain Mine and
Recommendations for Improvement**
Final Report

Prepared for:
Okanogan Highlands Alliance

Stratus Consulting Inc.
PO Box 4059
Boulder, CO 80306-4059
303-381-8000

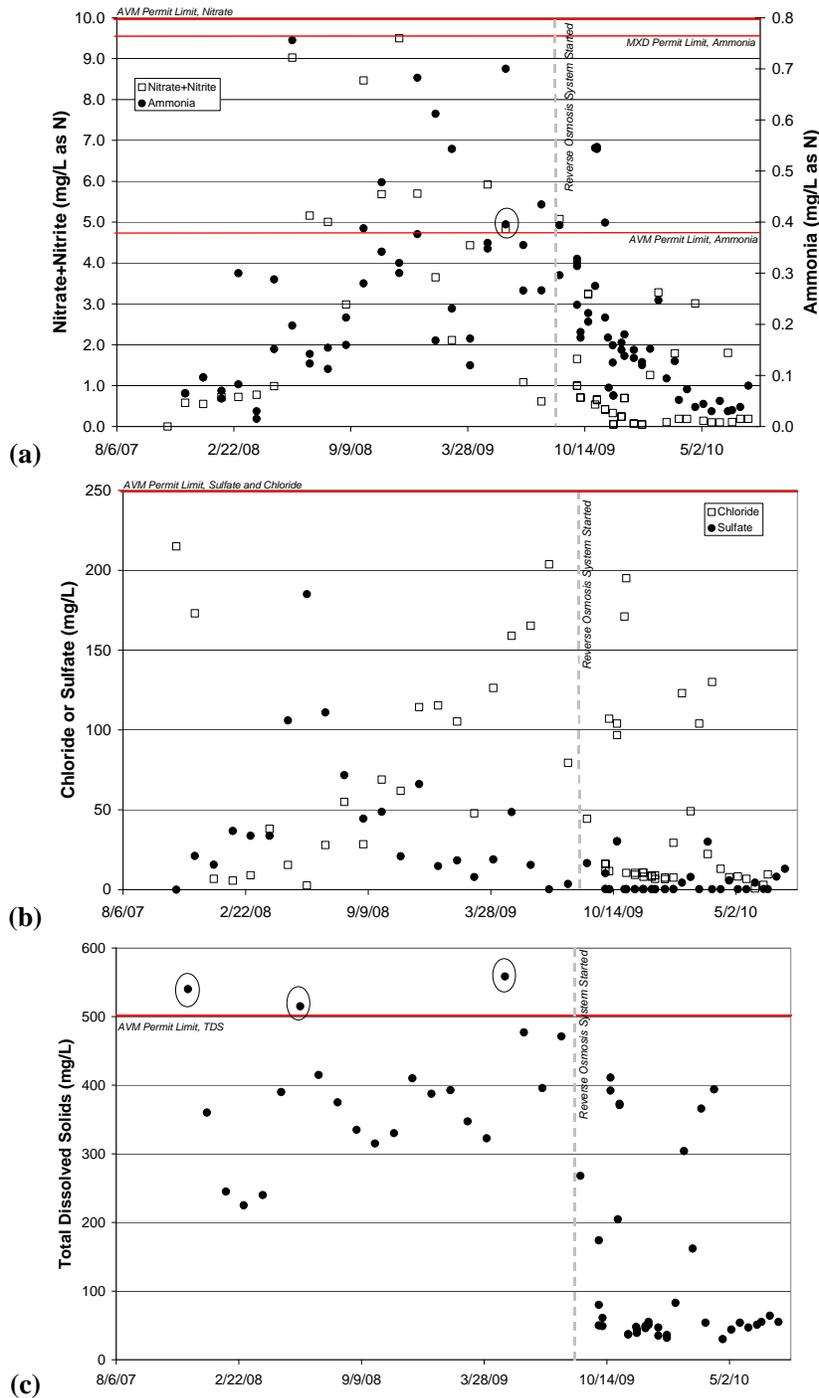
Figure 2. Treatment plant effluent concentrations over time: (a) nitrate+nitrite and ammonia, (b) chloride and sulfate, and (c) TDS. Measurements that exceeded permit limits are circled. AVM = average monthly permit limit; MXD = maximum daily permit limit.

Chloride and sulfate effluent concentrations are displayed in Figure 2b. Chloride can derive from the ion-exchange component of the treatment plant: the anion-exchange columns take up anions such as nitrate from mine water and release chloride to maintain ion balance. However, effluent chloride concentrations are not notably higher than influent chloride concentrations. Another possible source of chloride is the sodium chloride brine used to regenerate the anionic column in the treatment plant (AMEC Geomatrix, 2010). Chloride concentrations were highest in sampling locations related to the upper or lower portals, including stormwater locations SS3, SS4, and SS8; the Lower Portal Sump Water; seep GBES1 in Gold Bowl Creek; MW14 (Gold Bowl Creek); and surface water location SW9 (Gold Bowl Creek). Chloride values at these locations were higher than those in the effluent. Sodium chloride brine may have entered the surge pond,² and water from the surge pond was stored temporarily in the Upper Portal drift in the underground mine in May 2008 (Golder Associates, 2009). However, the source of chloride needs further investigation. Leakage from the sumps along fractures could explain the elevated concentrations of chloride near the mine.

As shown in Figure 2b, concentrations of chloride and sulfate in treatment plant effluent were roughly inversely proportional before the RO system was installed. For example, low concentrations of sulfate were associated with high concentrations of chloride right after the plant began operating, and high concentrations of sulfate in mid-2008 were associated with low concentrations of chloride. Effluent sulfate concentrations have remained low since installation of the RO system; chloride effluent concentrations were elevated through early 2010 but have decreased to the 10-mg/L range recently (see Figure 2b). Sulfate and chloride concentrations have begun to decrease in some, but not all, surface water and groundwater locations downgradient or downstream of effluent discharges, as discussed in Sections 3.3 and 3.4.

The elevated concentrations of TDS in the effluent are related to sulfate and cations such as sodium and calcium in the wastewater. As with sulfate, TDS concentrations have decreased since the RO system was installed, but values were occasionally as high as approximately 400 mg/L through April 2010. TDS values exceeded permit limits within the first month of operation (Figure 2c). More recently, effluent TDS concentrations have remained relatively stable in the 30- to 60-mg/L range (Figure 2c).

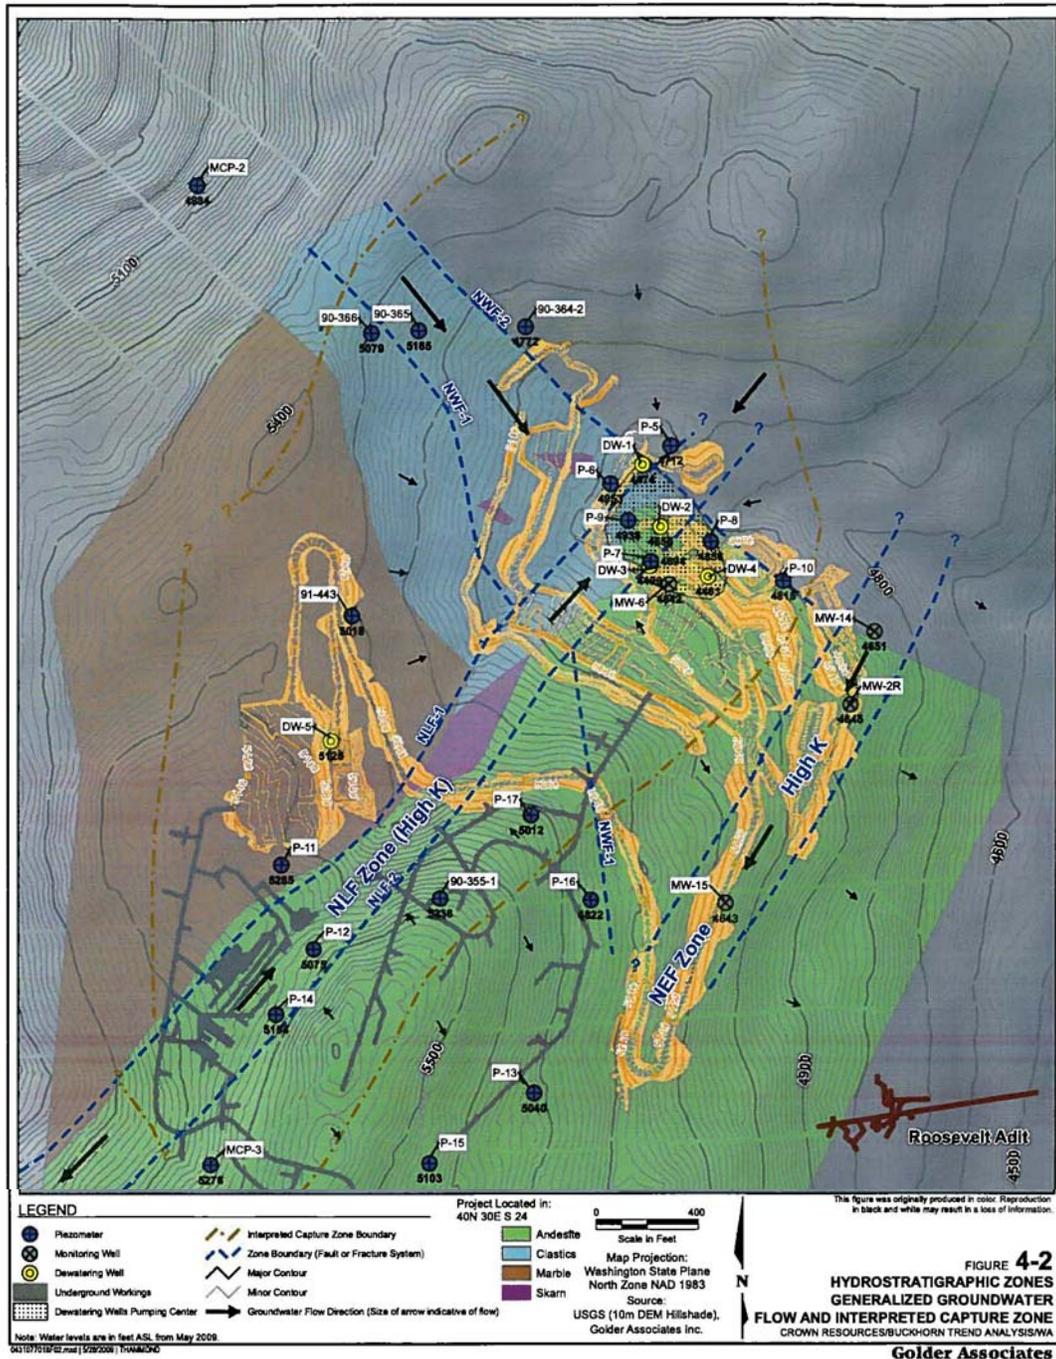
Figure 3. Groundwater flow directions, faults, and interpreted capture zone in the Buckhorn Mountain Mine area.

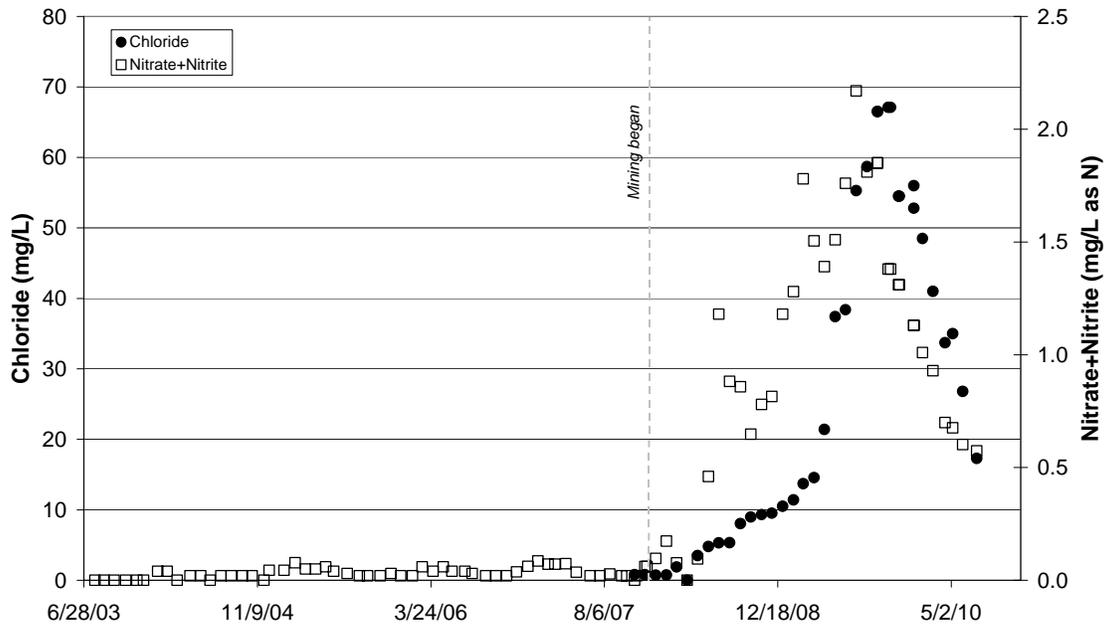
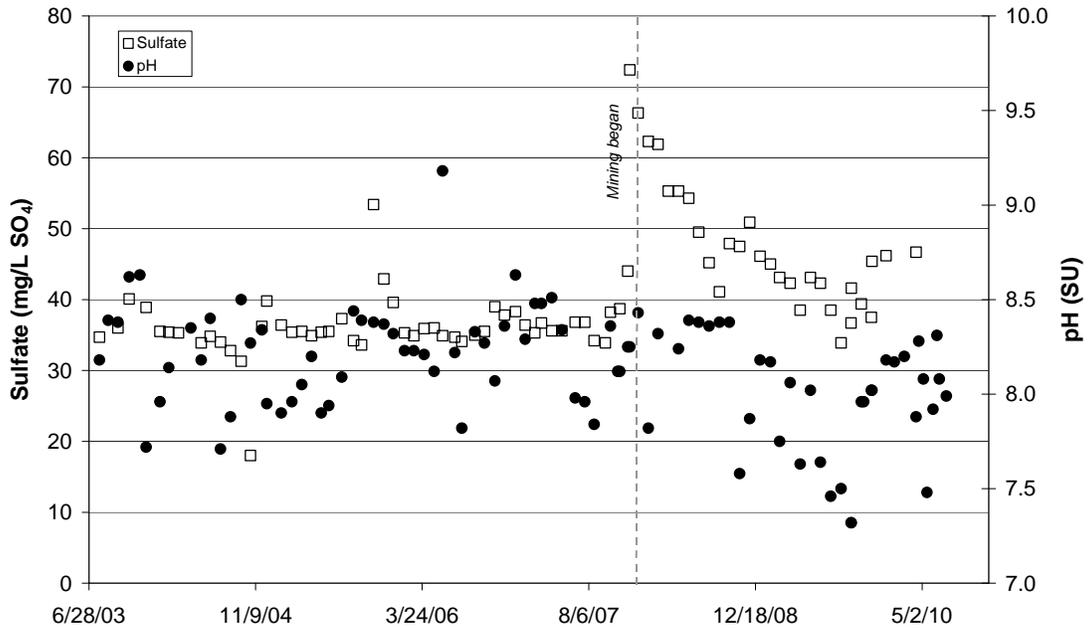
As shown in Figure 4, concentrations of chloride and nitrate+nitrite increased in South Fork Nicholson Creek (SW7), Gold Bowl Creek (SW9), and Upper South Fork Bolster Creek (SW14) shortly after mining and effluent discharge to Outfall 002 began. Concentrations of mine-related contaminants are higher in SW9, which is located closer to the mine and the effluent discharge location (see Figure 1 for location of Outfall 002).

No water quality exceedences have occurred at SW7, but sulfate concentrations increased shortly after mining began, possibly mirroring the elevated initial sulfate concentrations in the effluent (see Figure 2b). Although not noted as an exceedence in Kinross's monthly discharge monitoring reports (DMRs), concentrations of chloride, nitrate, and sulfate in SW9 exceeded Federal and State water quality standards at different points in 2009 and 2010 (Figures 4c and d). In December 2008 and January 2009, chloride concentrations exceeded U.S. drinking water standards (250 mg/L), and in February 2009, values exceeded U.S. CWA criteria for the protection of aquatic life (230 mg/L; Figure 4c). Nitrate concentrations in SW9 exceeded U.S. and State of Washington drinking water standards in June 2009 (Figure 4c). Under premining conditions at SW9, sulfate and pH values were roughly inversely proportional, with the lowest pH values and highest sulfate concentrations occurring during the snowmelt period in the spring, and sulfate concentrations were at or below 100 mg/L (Figure 4d). In April and May 2010, sulfate concentrations in SW9 exceeded U.S. drinking water standards, as shown in Figure 4d.

Figure 4 (a–b). Concentrations of mine-related contaminants and pH values in South Fork Nicholson Creek (SW7) over time.

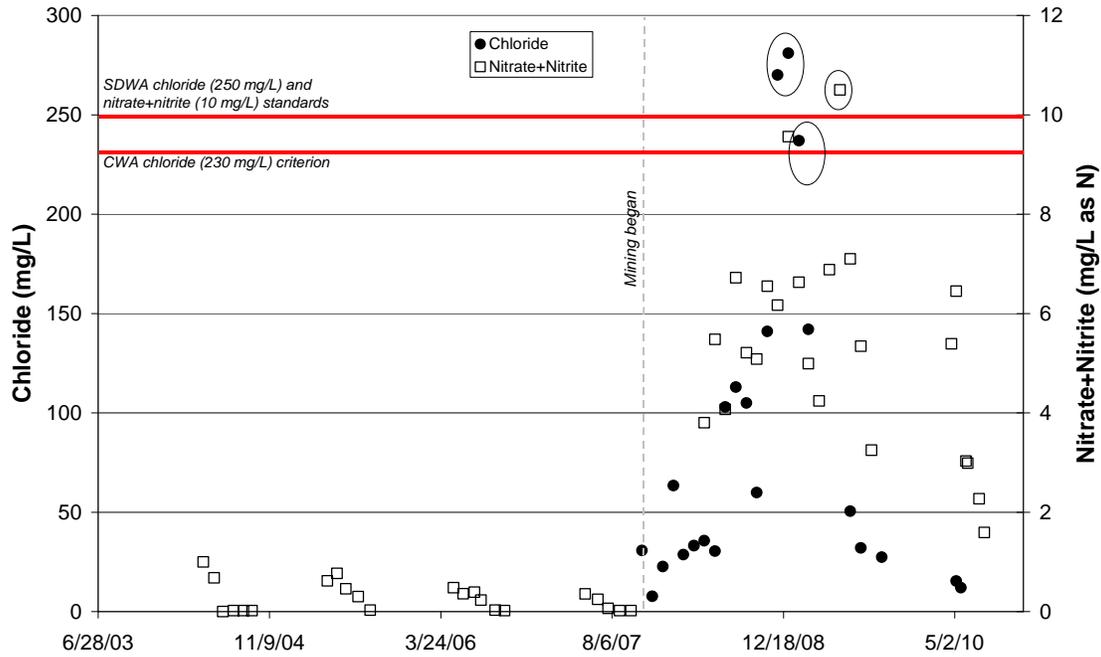
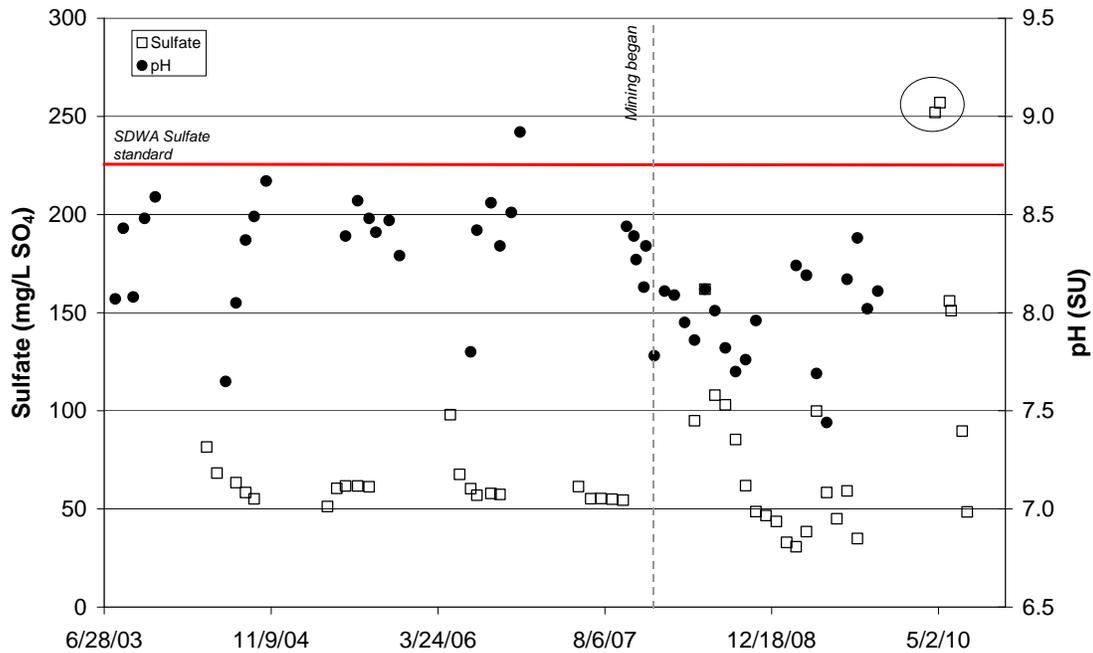
Figure 4 (c–d). Concentrations of mine-related contaminants and pH values in Gold Bowl Creek (SW9) over time. SDWA = Safe Drinking Water Act. Circled points exceed water quality standards.

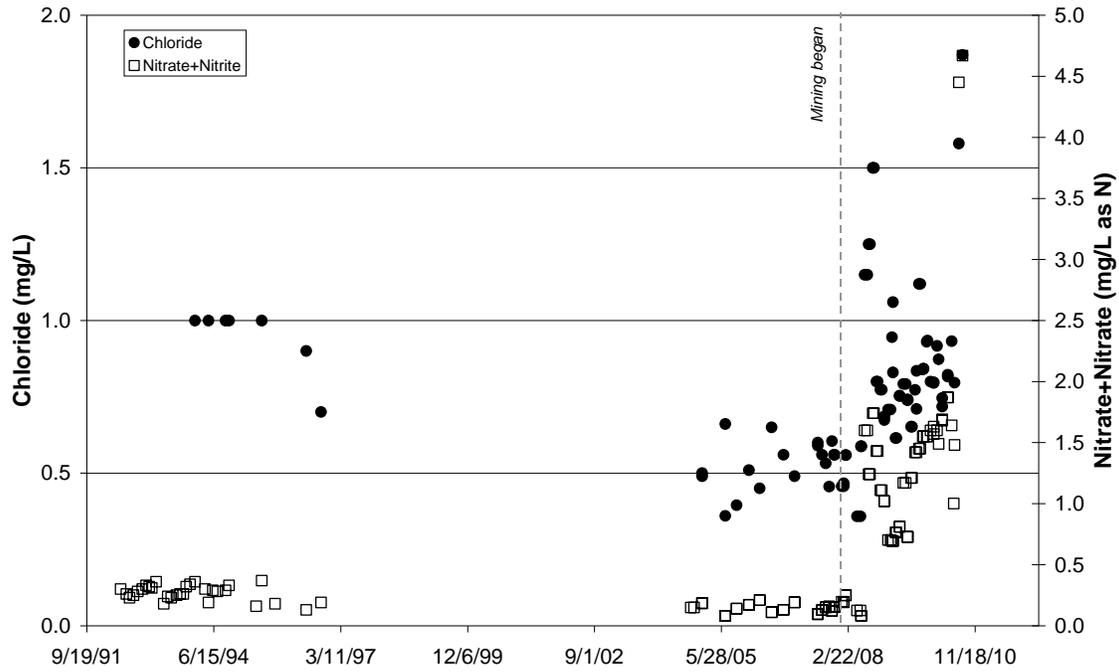
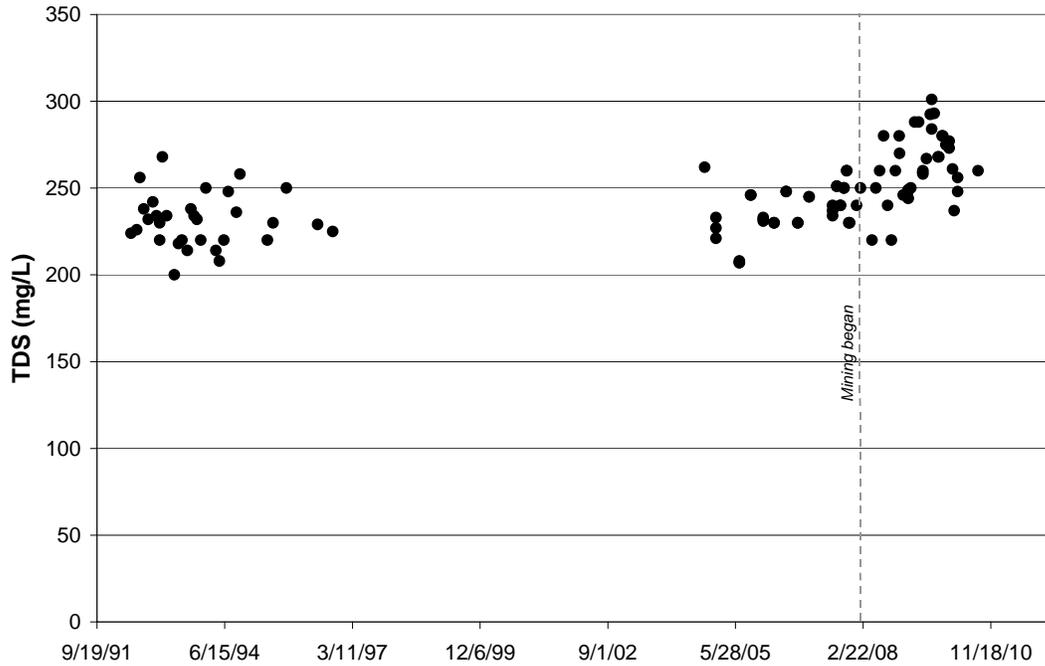
Surface water monitoring point SW14, in Upper South Fork Bolster Creek, is located on the west side of the mine and is not downstream of a treatment plant outfall location. As shown in Figures 4e and 4f, concentrations of mine-related contaminants, including chloride, nitrate, and TDS, that are present in mine water have increased after mining began. Golder Associates (2010b) confirmed that maximum concentrations of TDS, chloride, and nitrate measured in

Figure 4 (e–f). Concentrations of mine-related contaminants in Upper South Fork Bolster Creek (SW14) over time. Note: Early chloride values were above detection but likely reflect higher detection limits at the time.

Water Year⁴ 2009 exceeded baseline values (UTLs developed by Golder Associates and Ecology) at this location. Seepage from the underground mine has traveled along faults or other geologic features and reached South Fork Bolster Creek (Golder Associates, 2010b; also see Figure 3). The investigation of the increasing concentrations in SW14 was ordered by Ecology in April 2009 as part of AO 6674 and as related to penalty 6675. However, as shown in Figures 4e and 4f, concentrations of contaminants are still increasing, even though additional dewatering wells have been installed to capture the mine seepage.

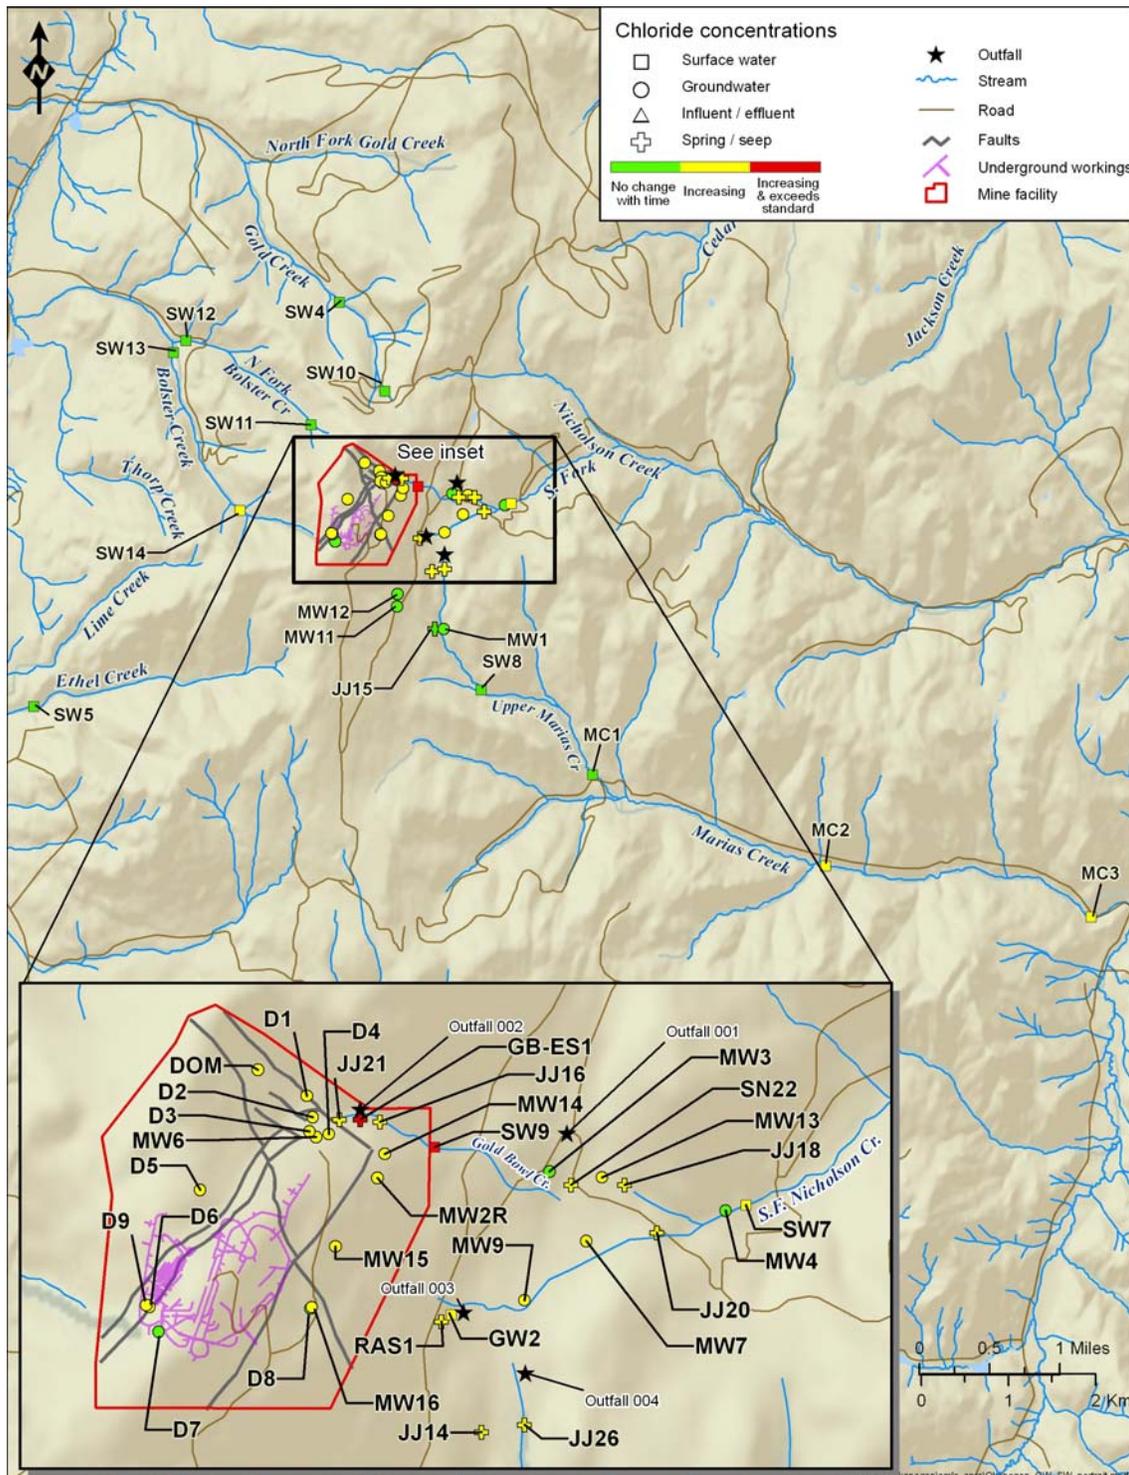
Surface water locations downstream of the outfalls have shown increases in chloride and nitrate concentrations (Figures 5 and 6), but locations to the west of the mine in the Bolster Creek drainage (SW13 and SW14) have also shown increasing concentrations of nitrate and/or chloride. As shown in Figure 5, large faults that intersect the underground workings connect with the upper reaches of the Bolster Creek drainage. As indicated on a map showing the location and capacity of sumps in the underground mine, there are two unlined sumps on the southwestern side of the underground mine with a combined capacity of nearly 860,000 gallons (Kinross, 2010a). Water stored in the underground mine might have leaked into upper Bolster Creek via the faults. As shown in Figure 7, three surface water locations on the east side of the mine, SW9, SW7, and GW2, have shown increasing sulfate concentrations. SW9 and SW7 are downstream

Figure 5. Surface water, groundwater, spring, and seep monitoring points with increasing chloride concentrations.

Chloride concentrations have increased in the same wells, with the exception of MW3, and in MW2R, which is located south of Gold Bowl Creek (Figure 5). As shown in Figure 6, groundwater nitrate or ammonia concentrations have increased in monitoring wells MW3, MW7, MW9, MW13, MW14, MW15, and MW16. These wells are located near the Upper Portal, in the Southwest Zone, and in Upper South Fork Nicholson Creek, which is near the treated water infiltration site. Nitrate values in well MW6, located near the lower portal, exceeded State drinking water standards for nitrate five times after mining began; values decreased after September 2008 but have increased recently, peaking at more than 15 mg/L in July 2010.

- ▶ Evaluate the possible sources of chloride in the underground mine and in downgradient groundwater and surface water.
- ▶ As promised in 2008 by Buckhorn Mountain Mine's previous General Manager, Lauren Roberts, the mine needs to be brought under environmental control before expanding into the Gold Bowl portion of the deposit. Demonstrate that the mine can operate for an extended period of time without significant violations, orders, or AMP triggers.

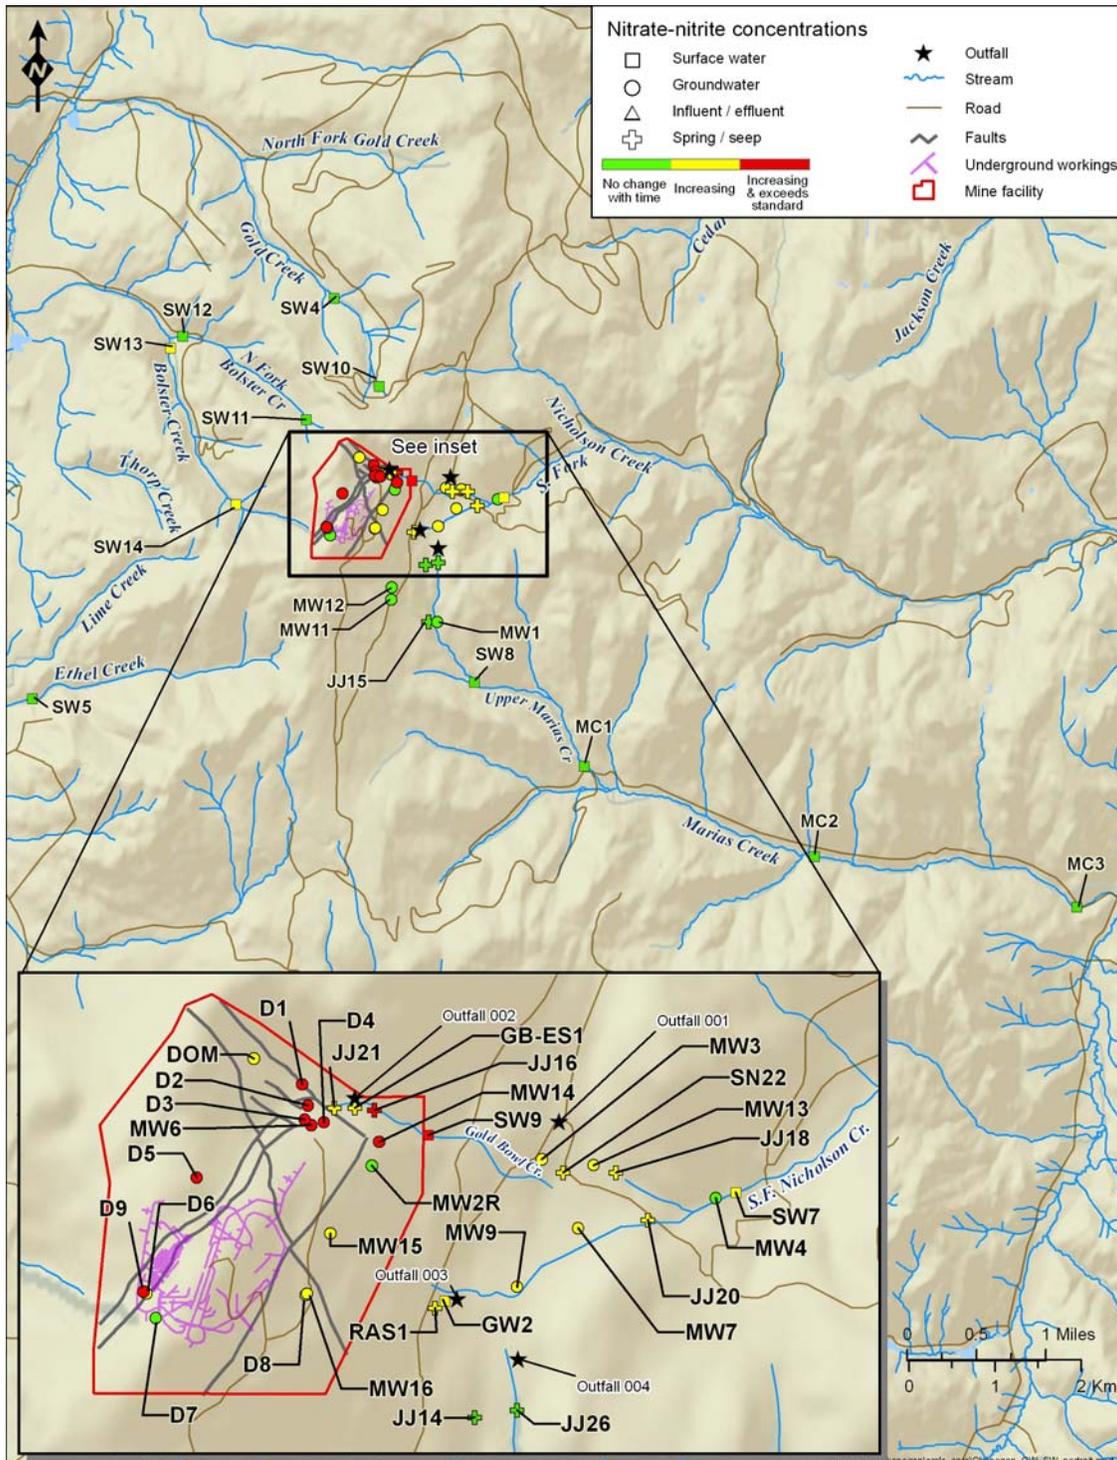
Figure 6. Surface water, groundwater, and spring/seep monitoring locations with increasing nitrate+nitrite or ammonia concentrations.

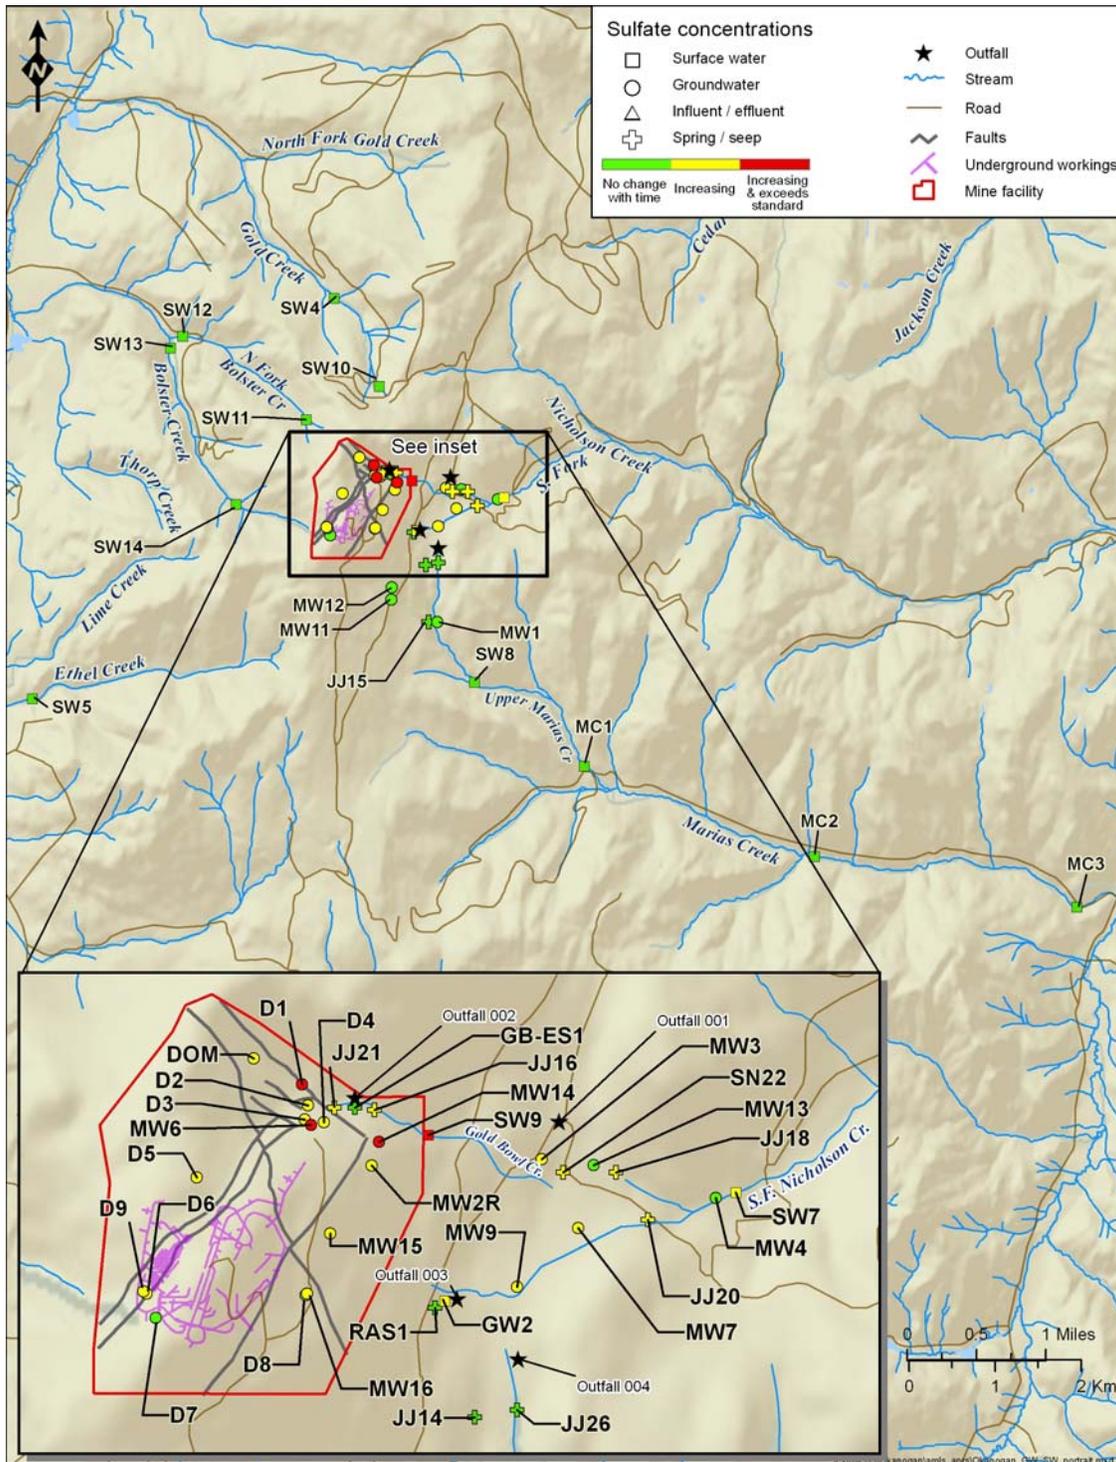
Figure 7. Surface water, groundwater, and spring/seep concentrations with increasing sulfate concentrations.

of Outfall 002, and GW2 (Roosevelt Adit) is the Outfall 3 location. SW9 also has increasing concentrations of copper and aluminum. In addition to the three locations in Marias Creek, SW7 has shown decreasing pH values, which could indicate the beginning of acid drainage.

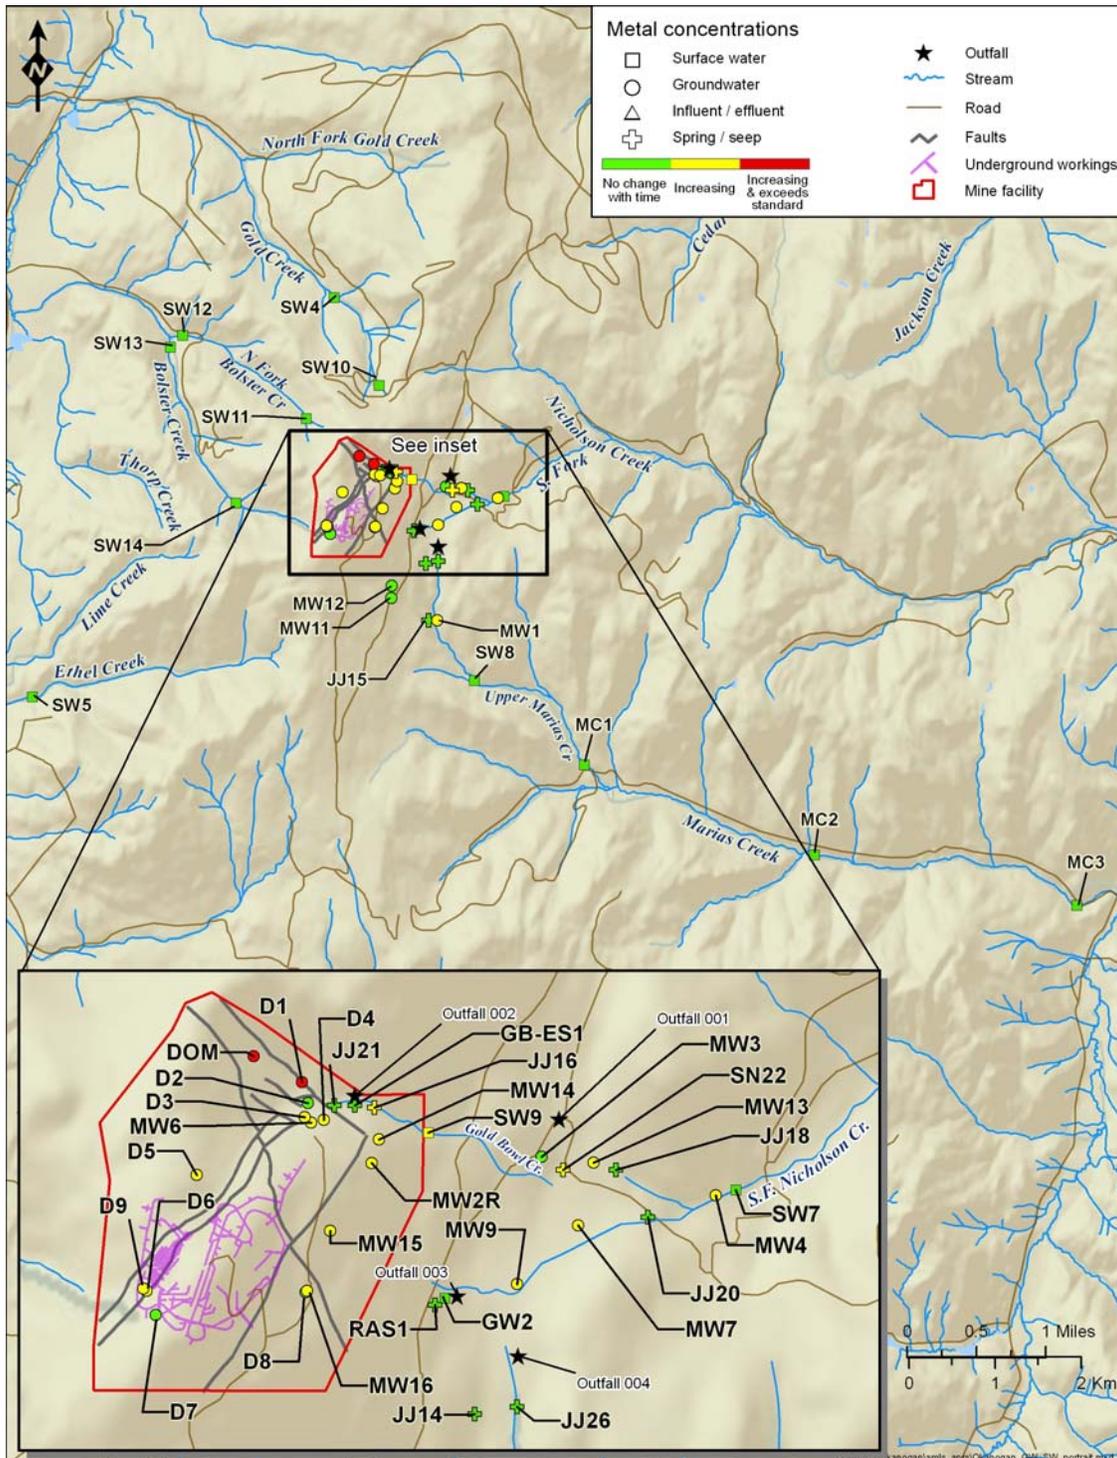
Figure 8. Surface water, groundwater, and spring/seep concentrations with increasing metal concentrations.

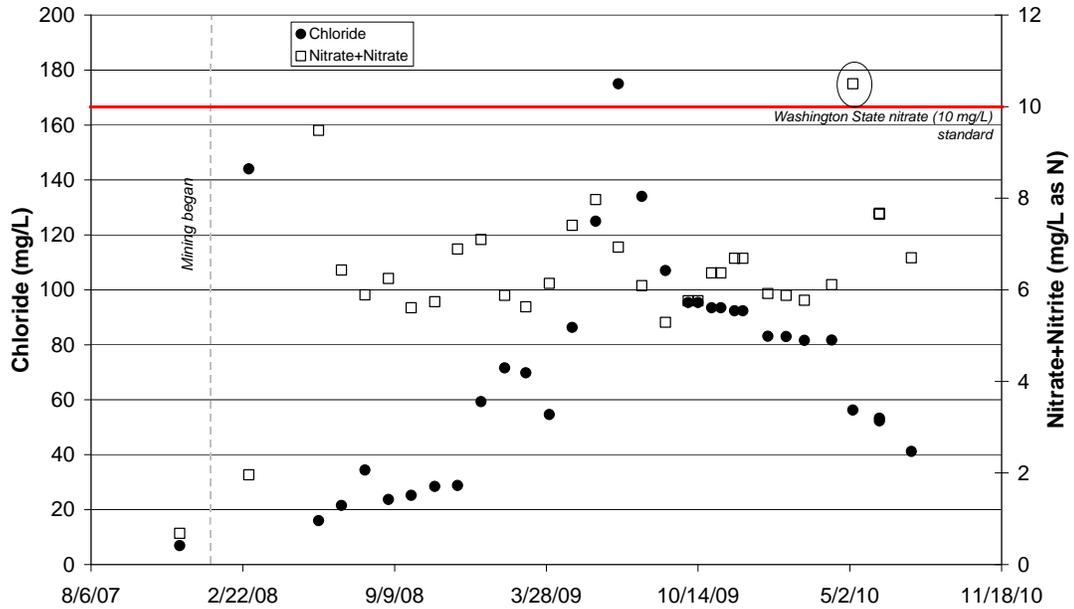
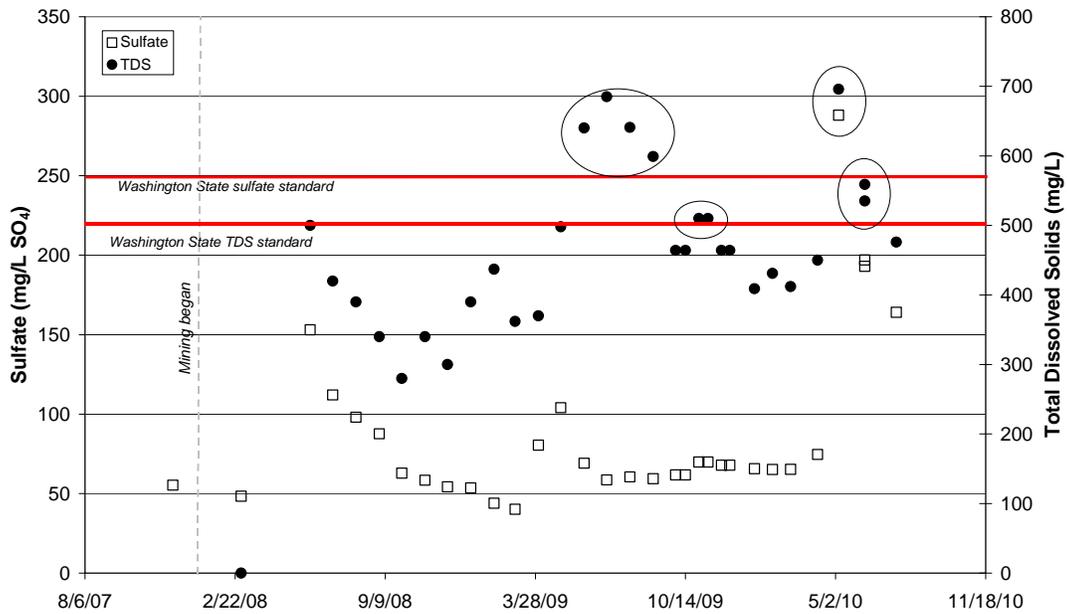
Concentrations of nitrate, chloride, sulfate, and TDS in monitoring well MW14, located in Gold Bowl Creek drainage, are plotted in Figure 9. The trends in MW14 are typical of those in other groundwater wells affected by mining. In MW14, concentrations of nitrate, chloride, sulfate, and TDS increased shortly after mining began in early 2008. Concentrations, which peaked again in mid-2009 and mid-2010, may be related to flushes of contaminants after snowmelt. Baseline data for this location are minimal. MW6, located near the lower portal, has a longer baseline record (beginning in 2003). At this location, concentrations of arsenic decreased after mining began (from ~4 to 1–2 µg/L), but concentrations of nearly all other mining-related constituents have increased, including aluminum, chloride, copper, hardness, manganese, nitrate+nitrite, selenium, sulfate, and TDS.

Figure 9. Concentrations of mine-related contaminants in groundwater well MW-14, located near Gold Bowl Creek: (a) chloride and nitrate+nitrite; (b) sulfate and TDS. Values in excess of Washington State water quality standards are circled.

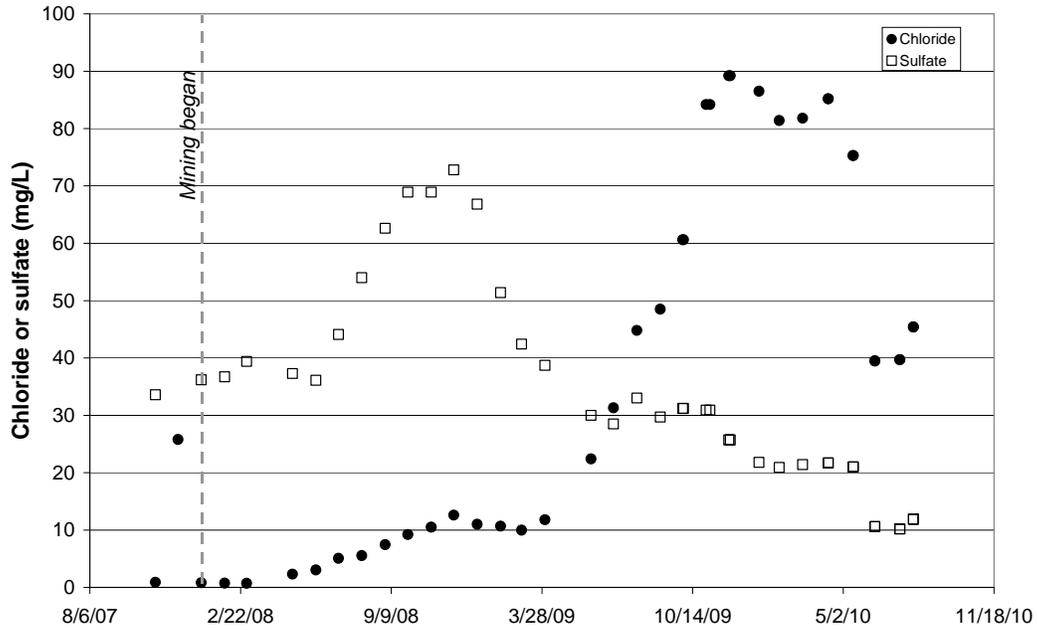
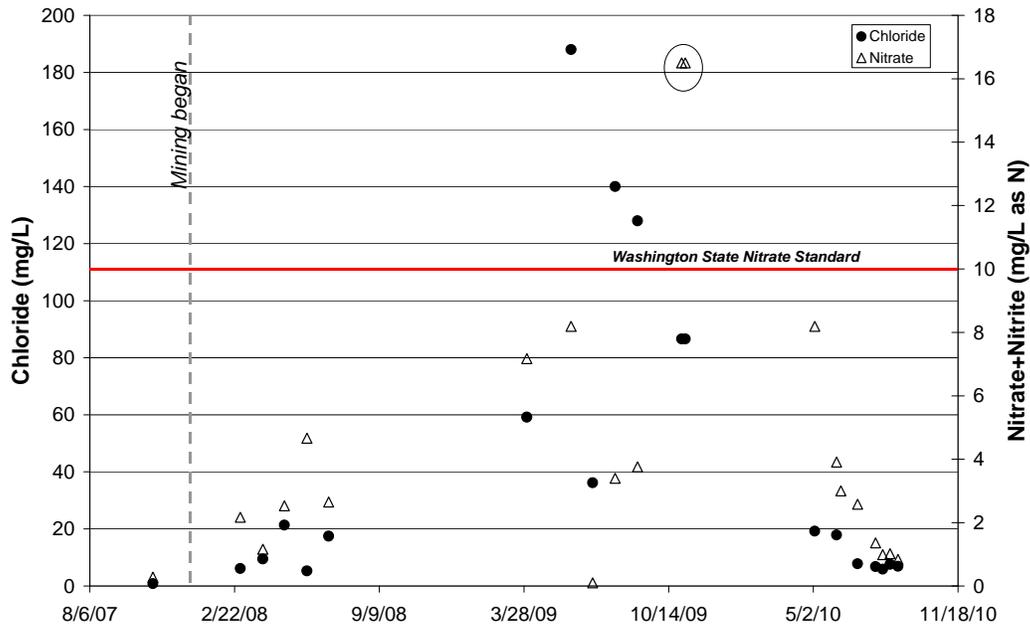
Figure 10. Concentrations of mine-related contaminants in two seeps in South Fork Nicholson Creek: (a) JJ18, chloride and sulfate; (b) JJ16, chloride and nitrate+nitrite. Values in excess of Washington State water quality standards are circled.
