*June 28, 2010*

**Local Government Energy Program  
Energy Audit Report**

***Township of Livingston***  
***Township Garage***  
***235 South Livingston Avenue***  
***Livingston, NJ 07039***

***Project Number: LGEA50***

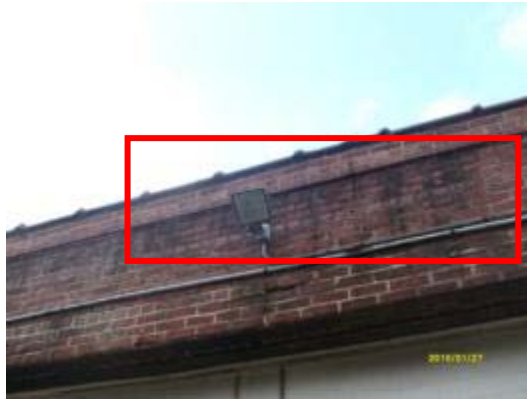
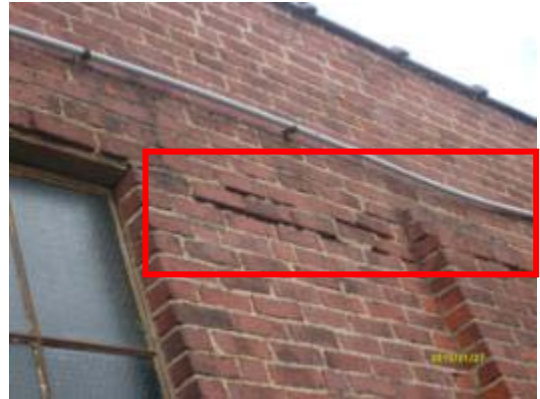
During the field audit exterior and interior wall surfaces were inspected. They were found to be in overall poor/ age appropriate condition with numerous signs of uncontrolled moisture, air-leakage and/ or other energy-compromising issues located mostly at the sides of the building.

Examples of water damage, displaced masonry units and cracked caulking

1. Inspect and replace cracked/ ineffective caulk, realign displaced masonry units
2. Efflorescence coated brick and masonry materials need to dry out and possible cause of water infiltration into wall cavities should be investigated.
3. Replace broken and deteriorated bricks, re-point cracked mortar joints.
4. Insulate original and uninsulated exterior wall sections. SWA suggests applying 2" XPS rigid foam boards to the interior and covering it with gypsum wallboard or other preferred interior finish.
5. Overgrown ground vegetation should be trimmed/ removed to not touch or block exterior wall surfaces from access, ventilation and sunlight.
6. Maintain and inspect all exterior wall surfaces with a focus on the condition of caulking, displaced masonry, and signs of water damage and locations that correspond to areas of known infiltration.

- (Main Building) Exterior wall repair of masonry brick units and cracked caulking - Inspect and replace cracked/ ineffective caulk, realign displaced masonry units. Efflorescence coated brick and masonry materials need to dry out and possible cause of water infiltration into wall cavities should be investigated. Replace broken and deteriorated bricks, re-point cracked mortar joints.

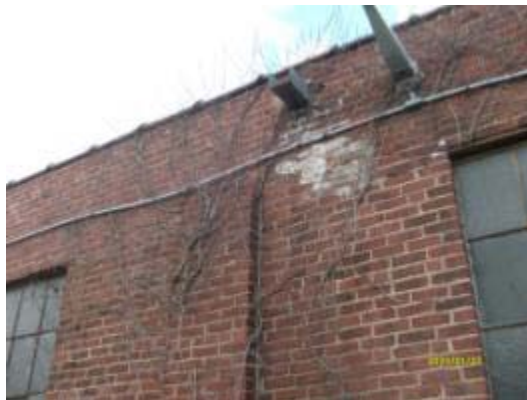
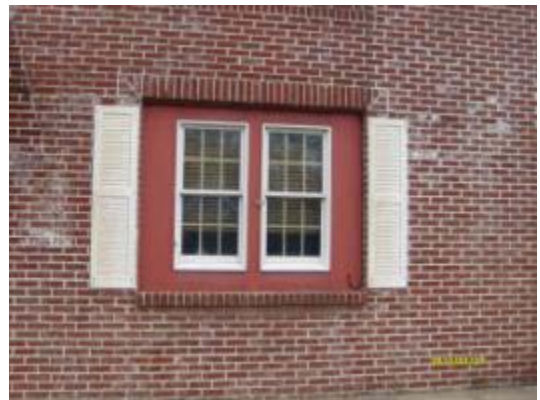
Efflorescence on brick and masonry walls indicate moisture presence within the wall cavity. and signs of plant overgrowth

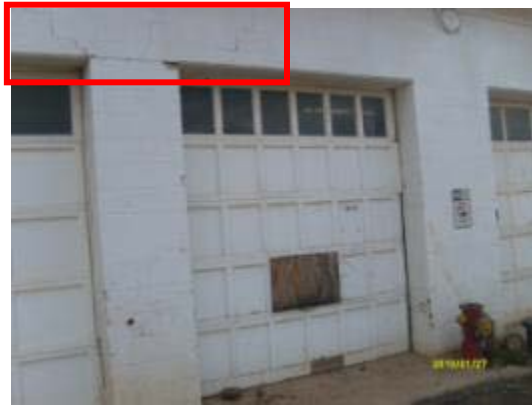
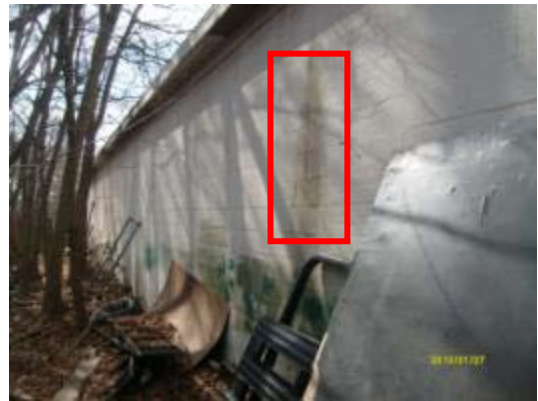
During the field audit exterior and interior wall surfaces were inspected. They were found to be in overall good condition with only a few signs of uncontrolled moisture, air-leakage or other energy-compromising issues located mostly at the sides of the building.

Cracked/ aged caulk, cracked concrete blocks and signs of water damage from roof drainwater run-off.due to defective flashing and gutters.

1. Inspect and replace cracked/ ineffective caulk,
2. Replace broken and deteriorated blocks, re-point cracked mortar joints.
3. Insulate original and uninsulated exterior wall sections. SWA suggests applying 2" XPS rigid foam boards to the interior and covering it with gypsum wallboard or other preferred interior finish.
4. Maintain and inspect all exterior wall surfaces with a focus on the condition of caulking, displaced masonry, and signs of water damage and locations that correspond to areas of known infiltration.

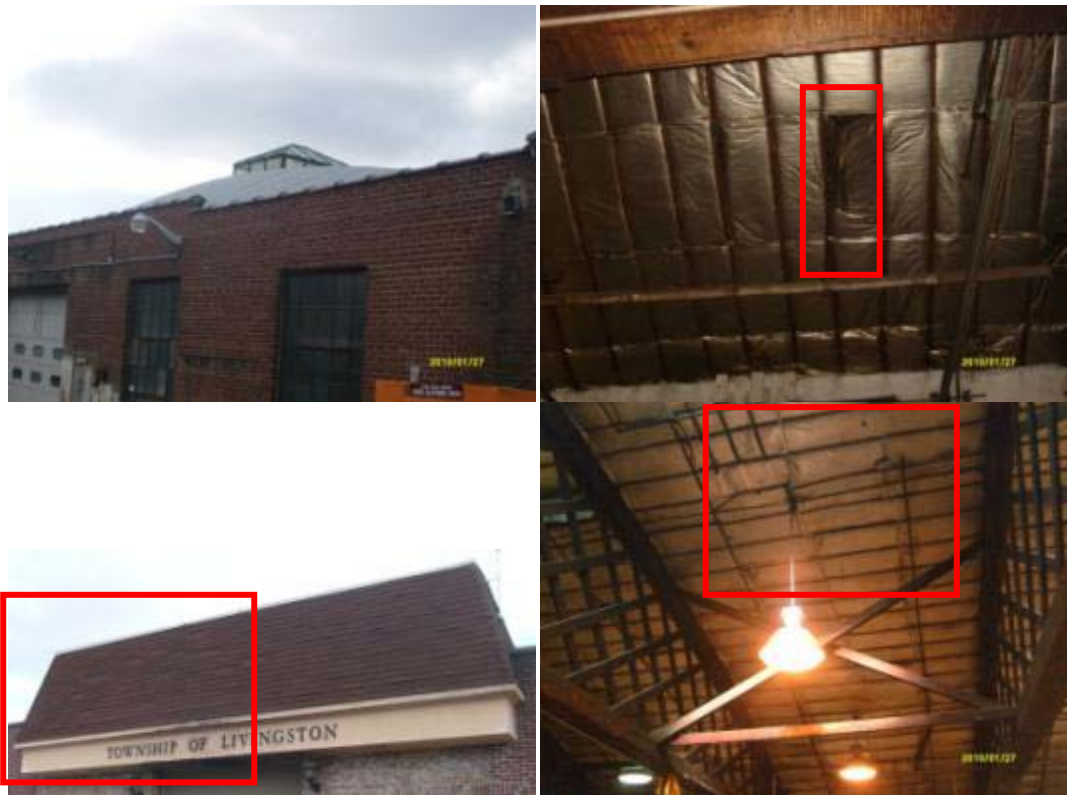
Examples of typical roof surfaces, missing asphalt shingles and damaged roof insulation.

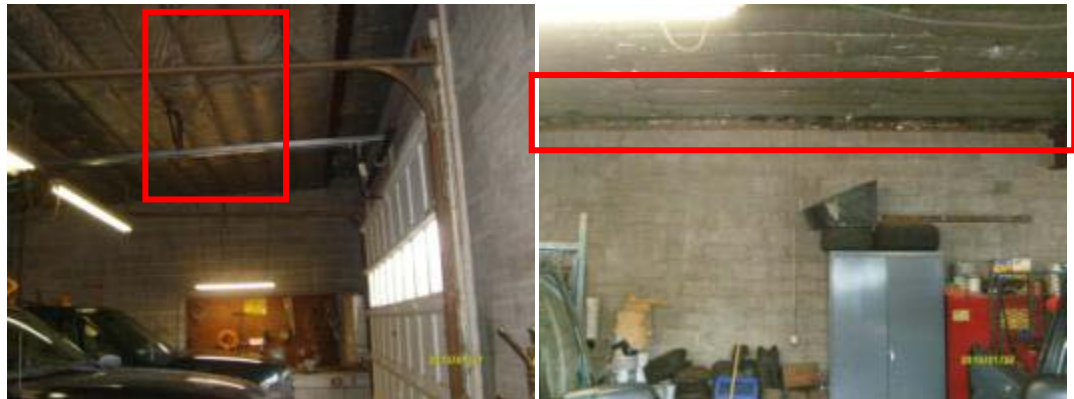
Sagging roof insulation showing signs of water damage

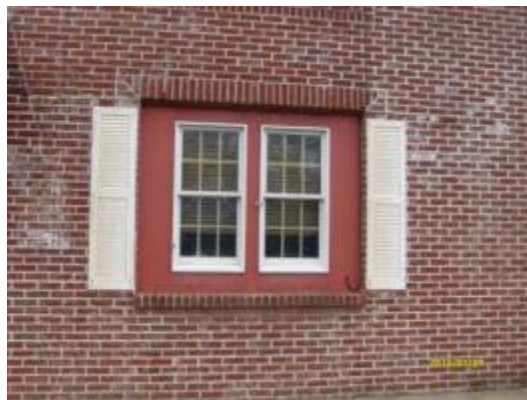
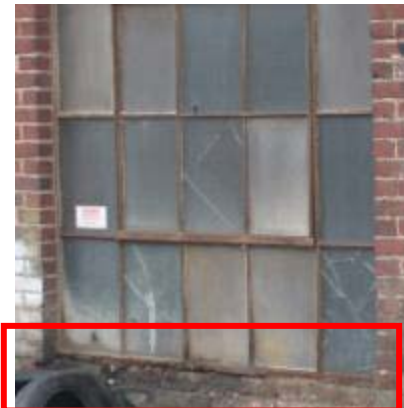
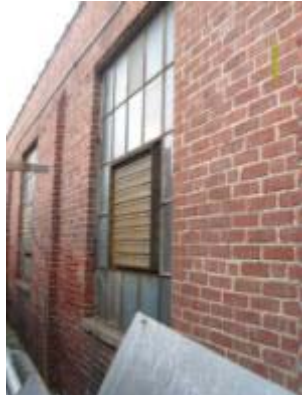
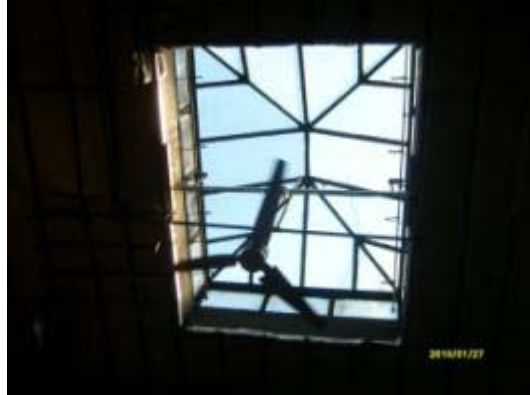
Typical window installations and examples of damaged frames sills and cracked glazing.

1. Install/ repair pan or strip flashing and drip edge detail at window sill.
2. Replace all original/ single glazed windows with a low-E, double glazed type.
3. Replace/ add/ maintain caulk around window frames and sills.
4. Maintain and inspect all exterior windows with a focus on the condition of the frames, properly operating hardware, airtight seal and window sill.

- (Main Building) Window frame, sill and glazing repairs - Install/ repair pan or strip flashing and drip edge detail at window sill. Replace all original/ single glazed windows with a low-E, double glazed type. Replace/ add/ maintain caulk around window frames and sills.

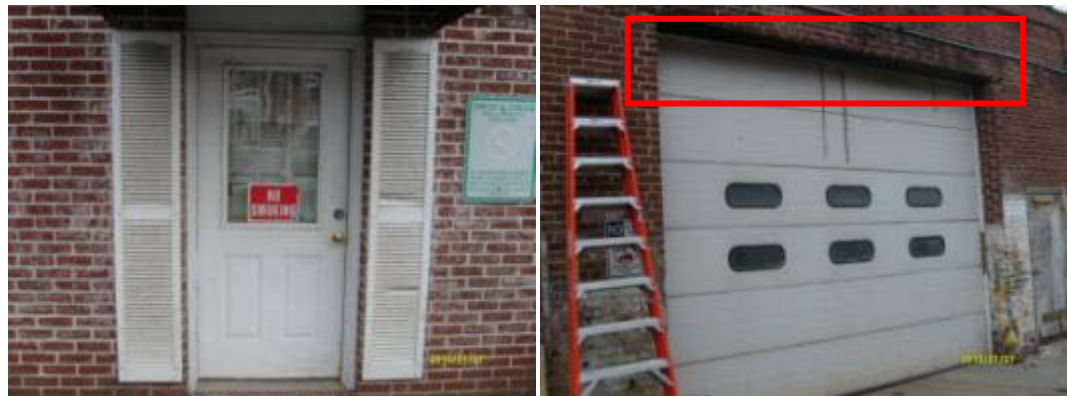
Typical door installations and some signs of water damaged overhead door frames

1. Maintain and inspect all doors with a focus on the condition of the weather-stripping, door frame, air tight seal and signs of water damage and infiltration.

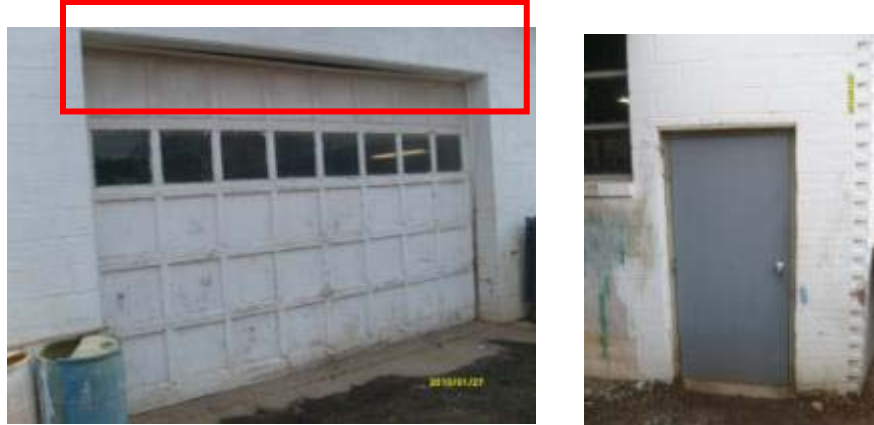
Typical door installations and some signs of exposed and damaged door frames

1. Maintain and inspect all doors with a focus on the condition of the weather-stripping, door frame, air tight seal and signs of water damage and infiltration.
2. Repair and maintain damaged door frames.

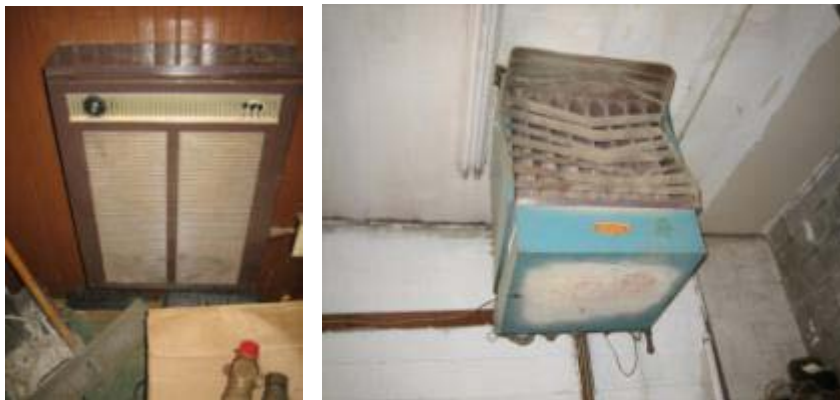
The front offices of the garage are heated by a wall mounted electric unit heater which is estimated to be beyond its expected useful life of thirteen (13) years. SWA recommends that the heater be replaced in kind. The offices are also heated by hot water radiators. The heating hot water for these radiators is provided by a boiler located in an enclosed room in the front garage. The hot water boiler was replaced in 1985 and has 15% remaining of its expected useful life of 30 years. Three gas-fired unit heaters provide heat to the front garage area. The unit heaters are believed to have been installed during the 1980s, or earlier, and are beyond their expected useful life of thirteen (13) years. SWA recommends that these units be replaced in kind. The rear garage is heated by two gas-fired unit heaters. Similar to the unit heaters in the front garage, one of the gas-fired heaters has exceeded its expected useful life and SWA recommends that it be replaced with a new, more energy-efficient model of the same capacity. The second gas-fired unit heater in the rear garage was installed in 2003 and has approximately 45% remaining of its expected useful life of thirteen (13) years.

Electric unit heater in office, gas unit heater in rear garage

- Replace heating terminal units- such as baseboard radiators and electric wall heater in the offices and hydronic and gas-fired unit heaters in the garages. All equipment except one as mentioned above is in fair to poor condition and beyond its expected service life. Age and wear have reduced the heat transfer capacity. This equipment should be replaced with more modern equipment suited for the intended use. These changes cannot be justified based on energy savings alone. However, replacement is strongly recommended to improve the overall efficiency of the heating system. This is a replacement in kind recommendation which offers negligible energy savings.

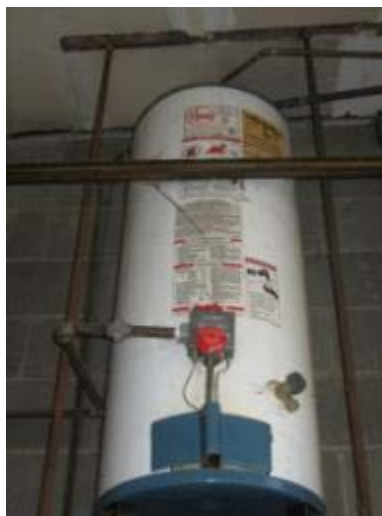
The domestic hot water for the building is provided by a gas-fired, tank-type water heater, located above the entrance doorway in the rear garage. Nameplate information was not accessible, but due to the condition and style of the water heater it is estimated to be approximately 15-20 years old and beyond its expected useful life. SWA recommends that the water heater be replaced with a new higher efficiency unit with the same capacity.

Domestic water heater
