**Local Government Energy Program
Energy Audit Report**

***Township of Livingston
Sewage Treatment Plant and Animal Shelter
81 Naylon Avenue
Livingston, NJ 07039***

Project Number: LGEA50

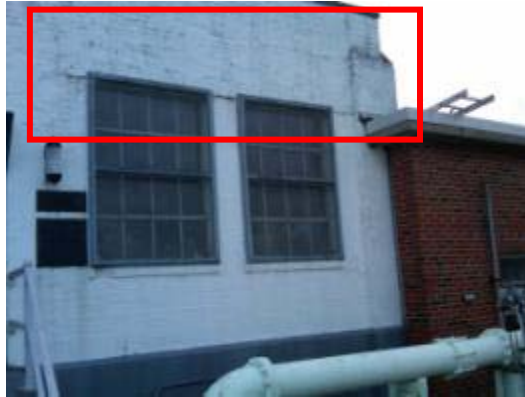
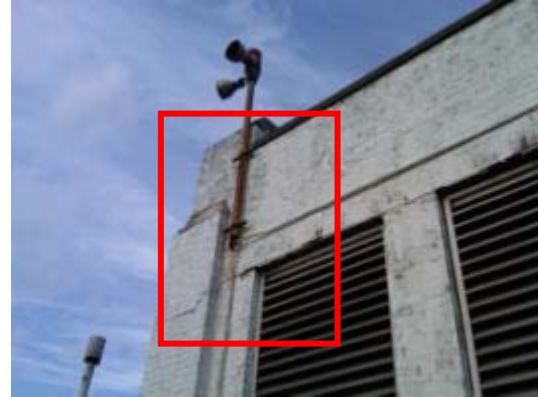
Identified areas of shifted brick, water damage and cracked caulking.

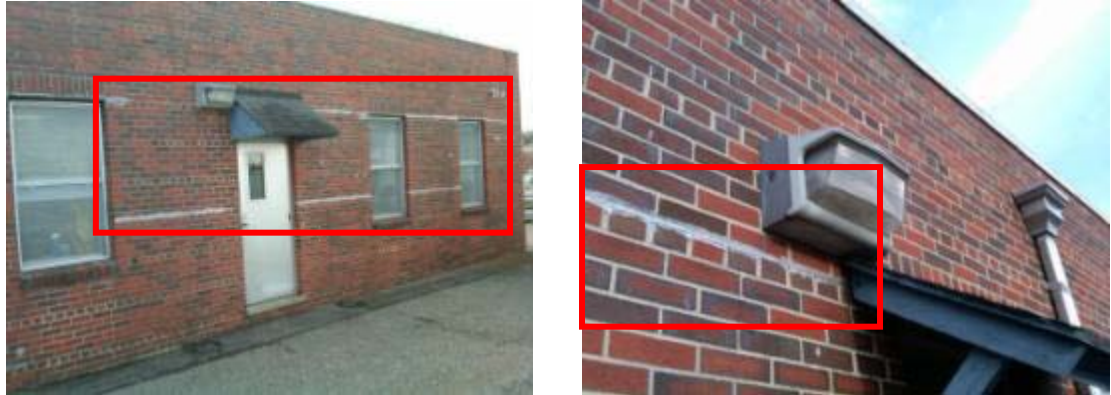
Identified areas of efflorescence crack caulking.

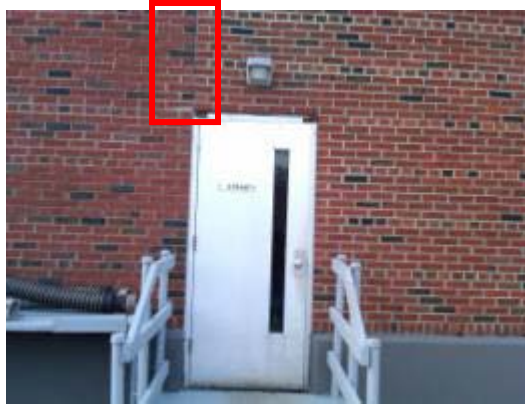
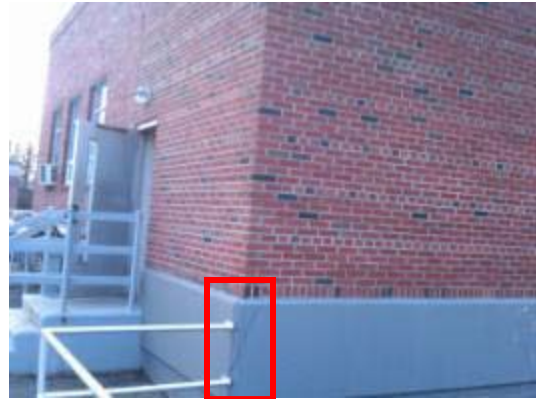
Maintenance building with cracked and missing caulking, and damaged exterior wall finish

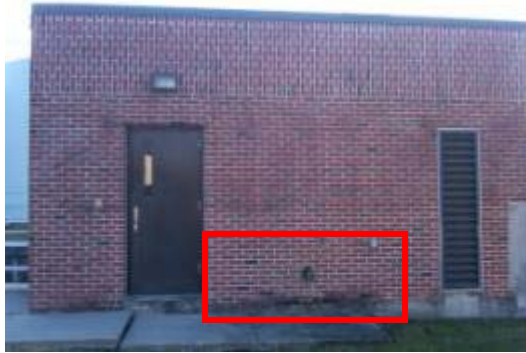
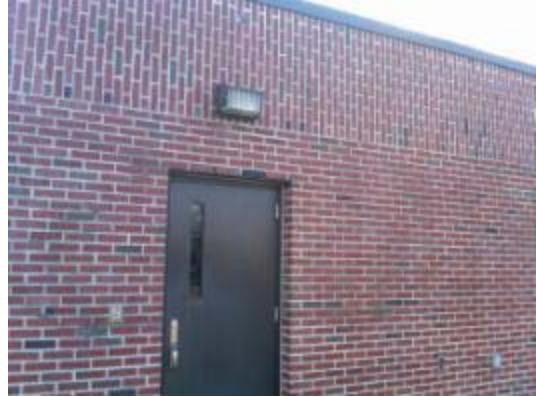
Cracked/ deteriorated bricks and mortar joints, exposed building penetration, and signs of water damage at perimeter walls due to missing/ ineffective site drainage

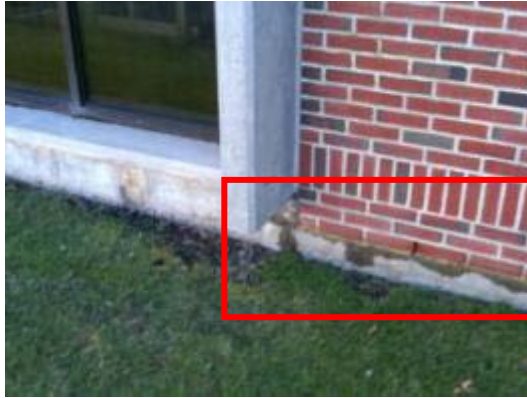
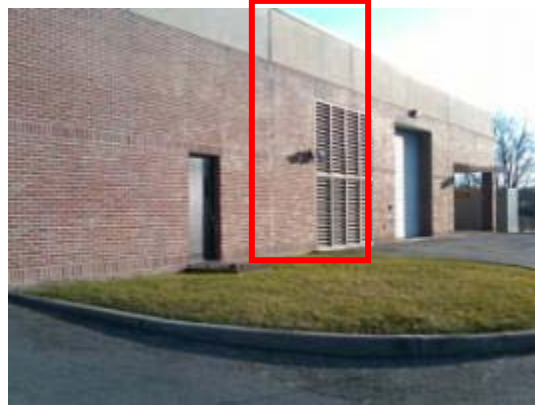
Signs of water damage at perimeter walls due to missing/ ineffective site drainage and cracked/ aged caulk

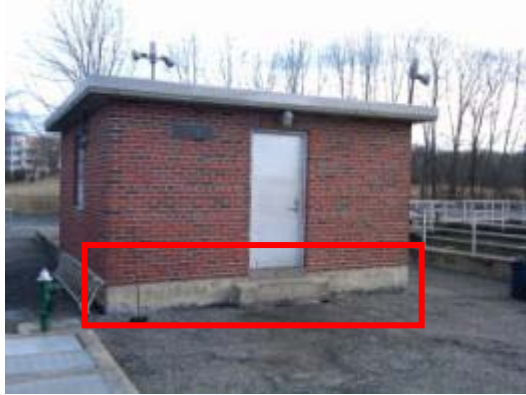
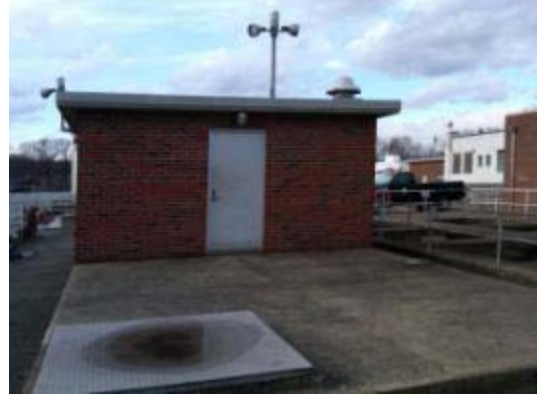
Typical exterior wall finish and signs of water damage at building grade

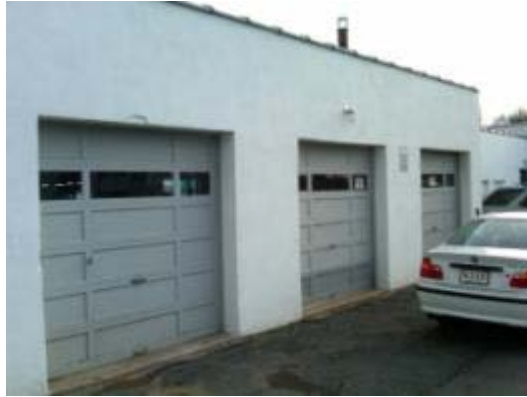
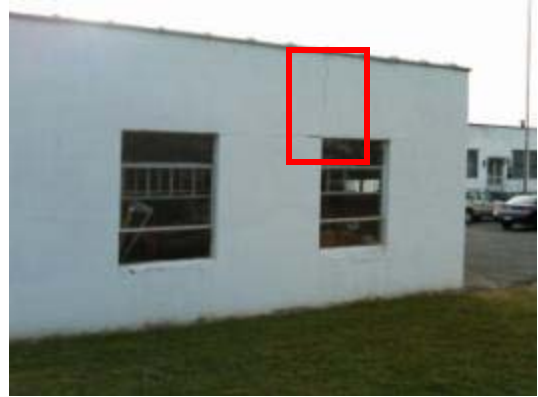
Damaged exterior wall finish

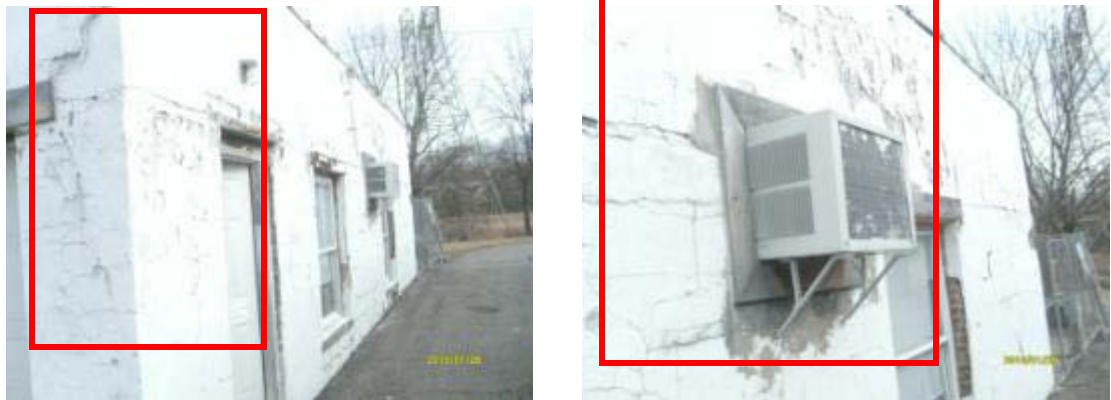
Damaged exterior wall finishes, uncontrolled roof water run-off due to defective/ clogged gutters and downspouts and un-caulked/ un-sealed exterior wall penetrations

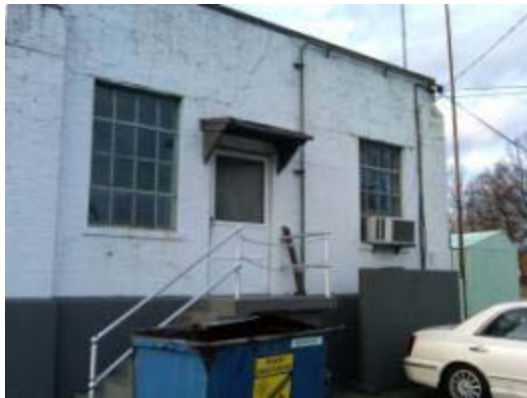
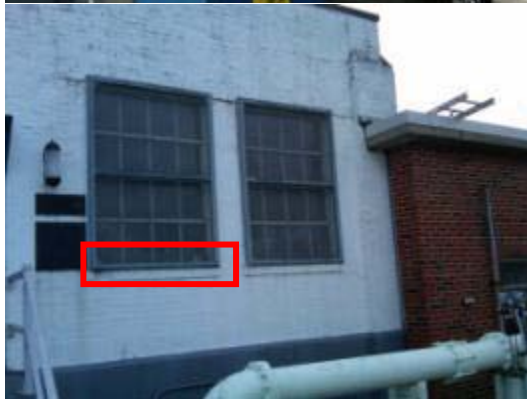
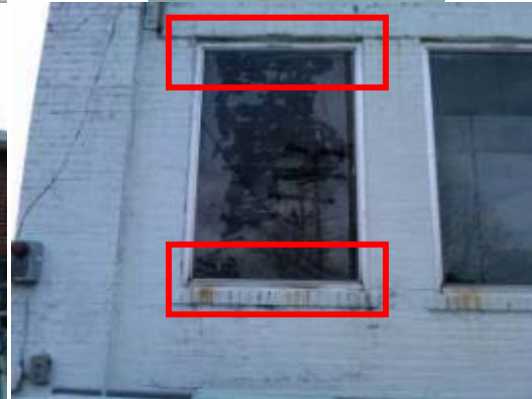
Exterior water damage signs on areas around windows, damaged/aged window frame single-glazed window with ineffective frame, exposed window lintel, missing window sill and drip-edge detail and air-leakage at sleeved window/wall air-conditioning units

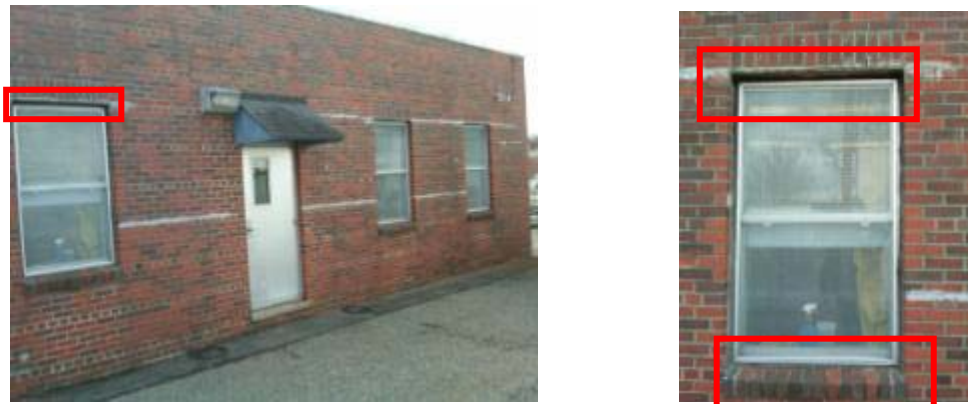
Damaged/old window frame exposed window lintel, missing window sill and drip-edge detail

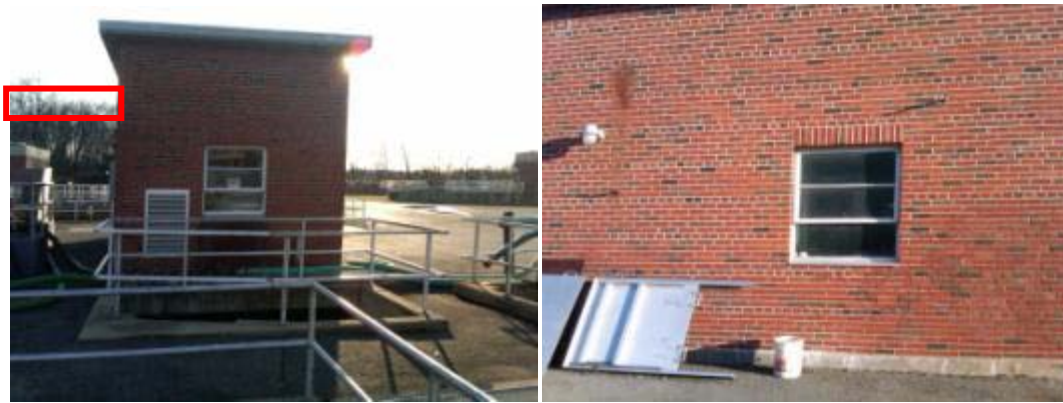
Damaged/aged window frame exposed window lintel, missing window sill and drip-edge detail

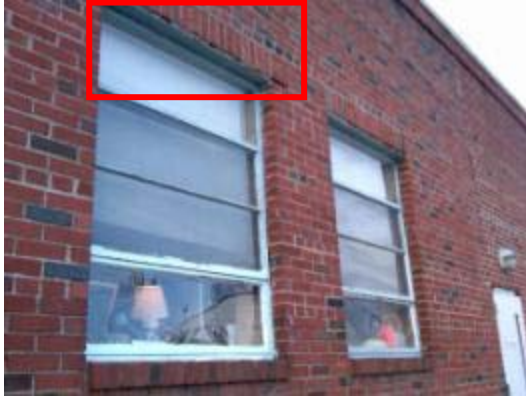
Typical window with exposed window lintel,

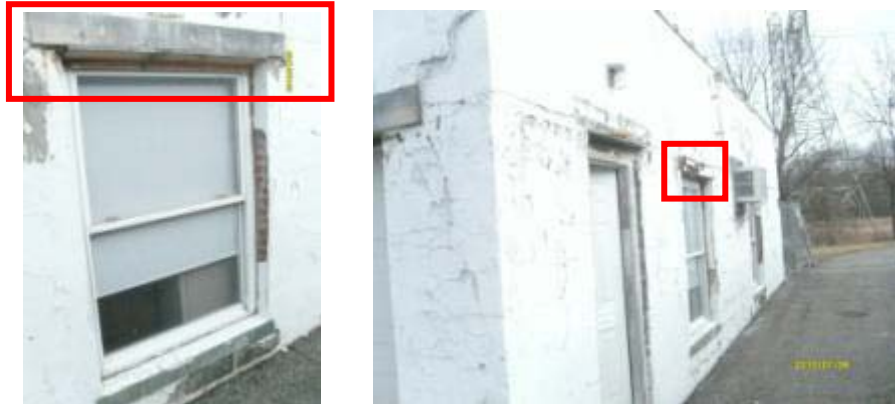
Typical window installation and signs of damaged window frames, infiltration and water damage.

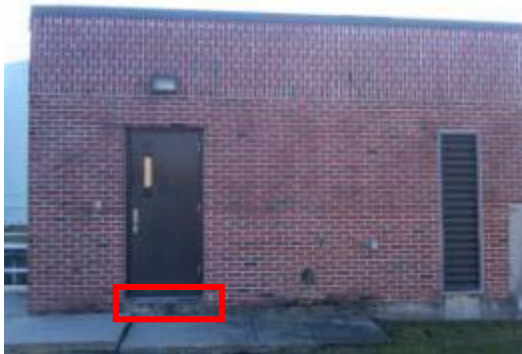
Typical exterior door with damaged lower portion of door frame

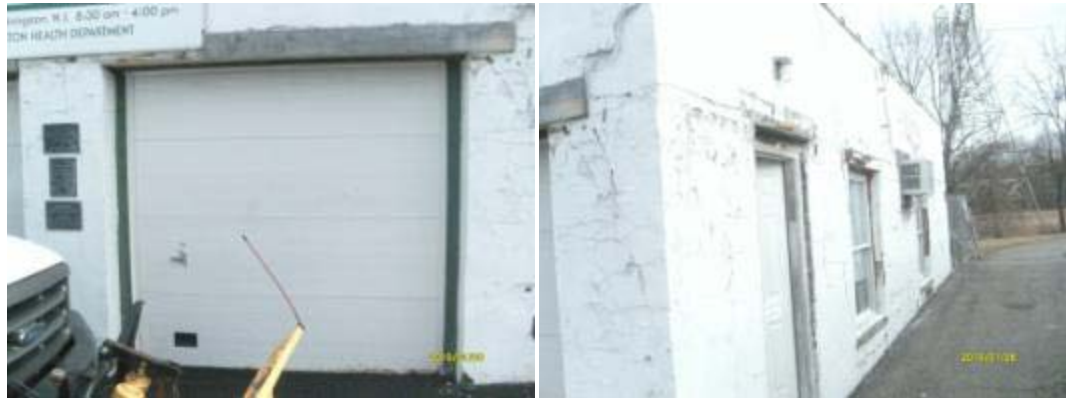
Typical exterior doors with damaged frames

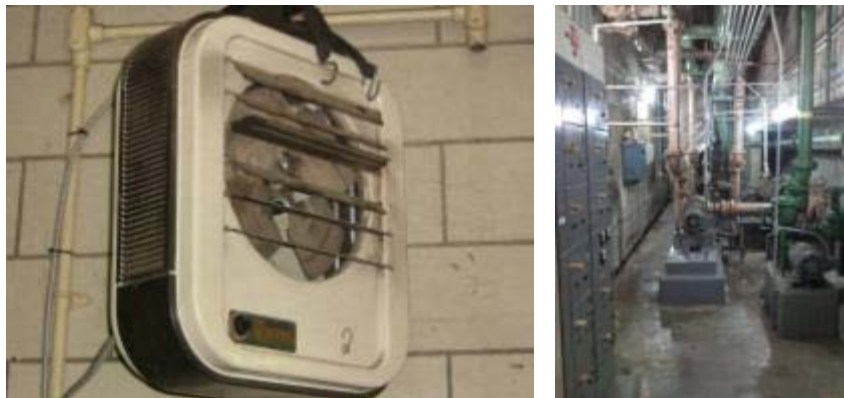
Building 4: Maintenance Building – Three electric unit heaters provide heat to this building. These units were installed within the last 5-10 years and are in fair to good condition. The building also has an underground tunnel which houses some of the facility's treatment pump equipment. No heating was observed in the tunnel space.

Electric unit heater in Maintenance Shop; View of adjoining underground tunnel

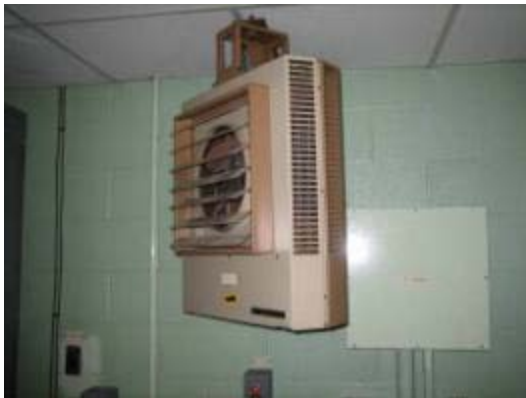
Building 11: Effluent Pump Station – A single electric unit heater mounted at the ceiling provides heat for this space. The unit is beyond its expected useful life of thirteen (13) years and SWA recommends that the unit be replaced with a new unit of the same capacity.

Electric unit heater in Effluent Pump Station
