## Rear Muffler Panel “Rust”

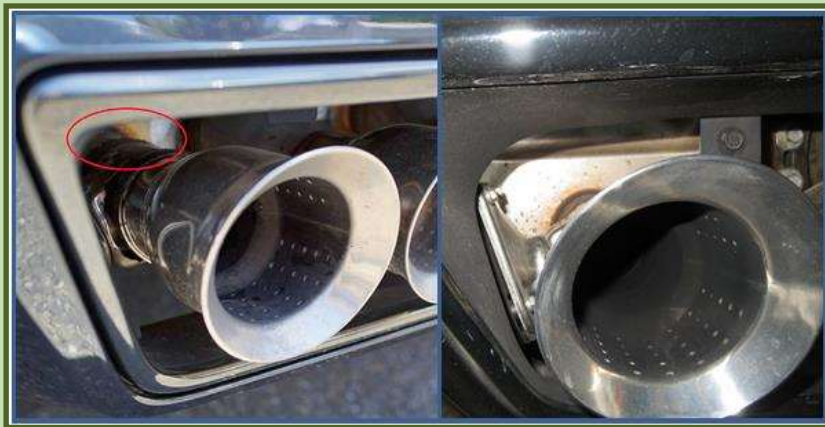
A forum poster asked about the brown stain he observed on the rear panel of his mufflers (red circle picture left.) I recalled seeing the same brown stain in a number of areas on my C7. I responded to his post indicating I used a product called Rust-Olium

Rest Reformer to change the brown, “rust” black (the picture right is a similar area I coated 6 months ago.) These products have been sold for many years. They convert iron oxide (rust) to iron titanate using tannic acid and pH adjusters. This product also contains barium sulfate and a future rust inhibitor.

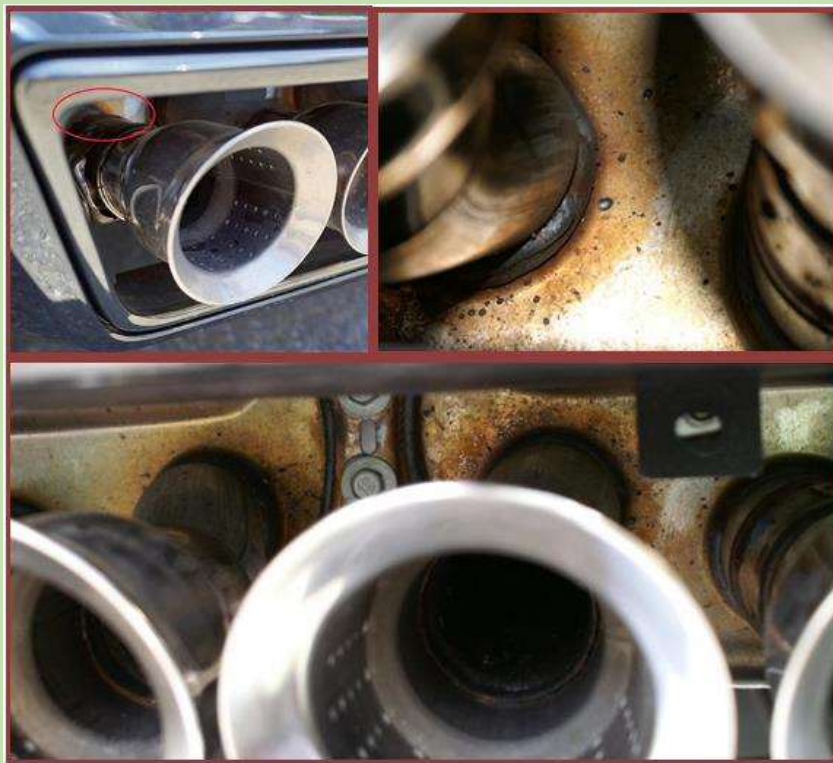
Several others posted even greater amounts of rust and were planning to add a an exhaust cover plate so it wasn't visible. The picture right shows the original posted brown spot and those posted by others. In fact, I recall this issue was brought up when the original fleet of test C7's were observed. I even saw some rust on rear panel on the first C7's I saw, at Laguna Seca in August of 2013. The back panel has a lot of press forming that may thin the aluminized surface. It also has

large pipe welds and weld spatter that no doubt melted the thin aluminized surface exposing uncoated places of 409 stainless that quickly starts to rust.

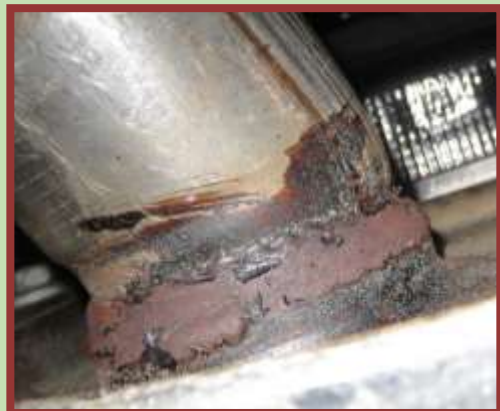
The most heavily rusted areas were the welds and the weld spatter on the back panel. These, of course, are not aluminized. The exhaust supplier probably used a 409 welding wire so the welds will not rust any more than an

Although not readily visible from the rear, when looking under the car I did notice significant rust on the welds attaching the exhaust tip pipes to the back panel. The photo right shows one of these rusted welds on my C7.

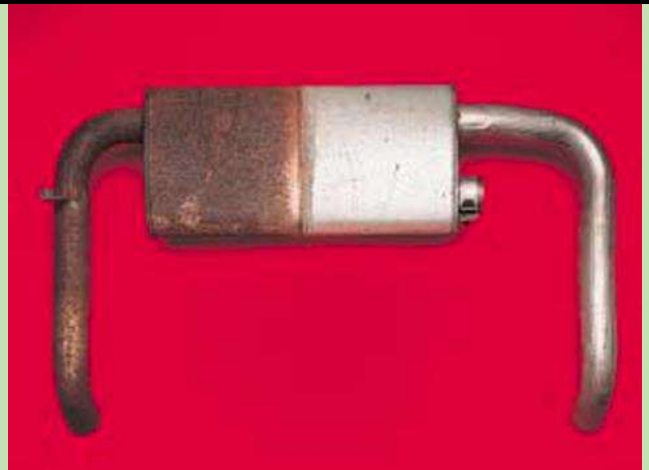
A manufacturer of aluminized 409 stainless made this muffler to show a comparison between aluminized 409 stainless steel (right) and non-aluminized material (left.) The muffler was exposed to accelerated exposure. This appears to be a severe exposure such as a salt water environment, simulating salted roads. The aluminizing process is done on the sheet material, welds, which occur after manufacture, are not coated.

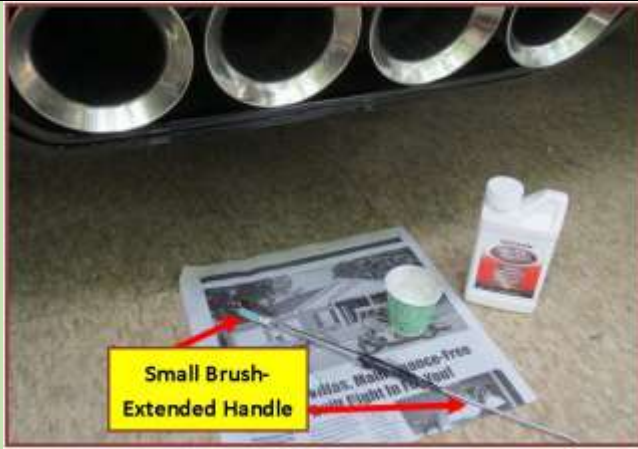
This is a picture of my C7. Note the discoloration on the panel and the rusted welds joining the pipes going to the shiny stainless tips. Since these welds are probably made robotically (*one of our large Gas Saver Systems customers makes OEM exhausts and has 126 MIG robot welders.*) With the two pipe welds probably made one after the other or simultaneously with two robots, the area between them no doubt got very hot, affecting the quality of the aluminized coating. Also note the fine weld spatter that not only rusts but probably melts the aluminized surface it hits.

Perhaps Chevy should consider requiring 307 type welding wire for back panel welds to have more rust free deposits.

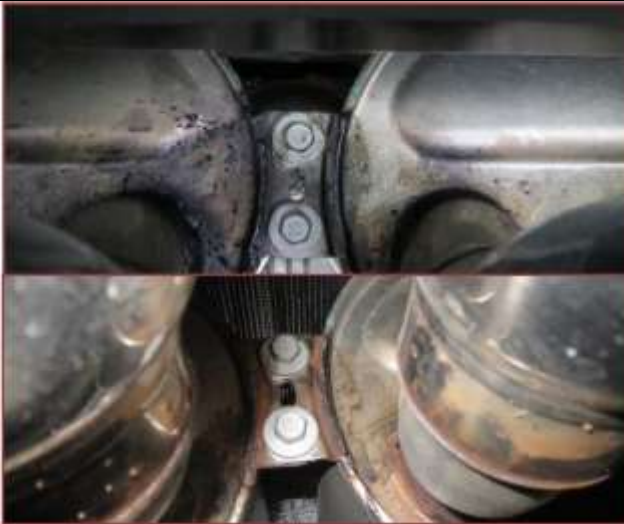
This is a before (lower picture) and after 2 hours of being coated (upper picture.) All rusted areas are now a dull black.

The finished appearance is matt somewhat mottled black. It does not change the aluminized finish on the none rusted materials.

My past experience with this type product indicates it may have to be repeated yearly to coat newly rusted areas. However the process, unlike painting, is very quick.
