FOBAS Bulletin

21st September 2020

Issue of Excessive Cylinder Component Wear on Large Two-Stroke Engines During the Use of 0.50% Sulphur Fuels

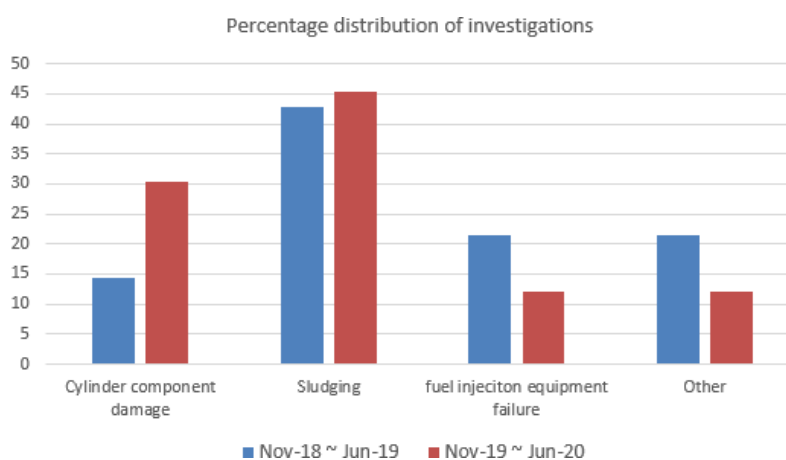
Figure 1: percentage distribution of FOBAS investigations

Figure 1 compares the FOBAS data for eight months (November to June) for last two consecutive periods. The reported failure modes have been divided into four main categories i.e. sludging, fuel injection equipment failure, cylinder component damage and others.

The data indicates that overall incidents related to cylinder component damage almost doubled for the studied period (Nov-19~Jun-20) whilst sludging incidents remain on similar levels though reduction in fuel injection equipment failure incidents have been observed. Moreover, recent cylinder component damage cases seem to have only been reported on large two-stroke main engines during VLSFO consumption. Though since March 2020, FOBAS has observed a downward trend in ships reporting cylinder component damage problems.

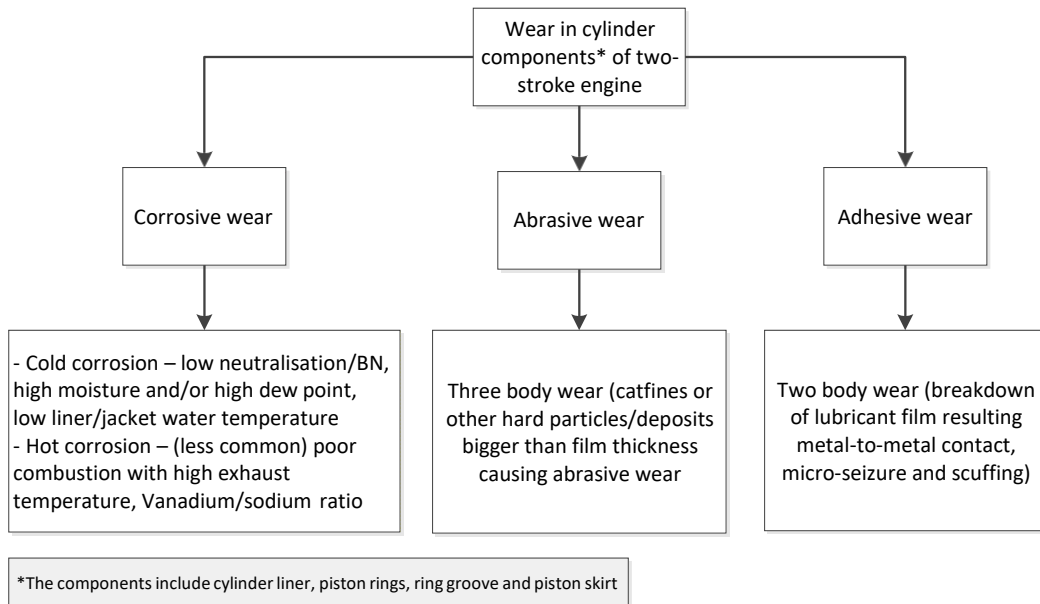
Figure 2: Wear in cylinder component of two-stroke engine

There could be several ways the failure could occur on two-stroke engine cylinder components, but it usually starts off with the excessive wear and then manifest itself into conditions such as blow by, scavenge fire, high liner and exhaust temperatures, low power output, excessive vibration, surging of turbocharger and so forth. The following diagram provides the basic wear types and corresponding key description.

During the high sulphur fuels oil (HSFO) consumption, the two-stroke engines were frequently subjected to corrosive wear also known as 'cold' corrosion. Abrasive wear was also not uncommon due to HSFO containing higher concentration of catfines (Aluminium + Silicon) and other sediments making its way to engine inlet due to unsatisfactory fuel management. Ships switching to lower (0.50%) sulphur fuels which were less likely to cause cold corrosion (low acid-neutralisation requirement) and contain relatively lower concentrations of catfines. Though ships still reported excessive wear which is most likely to be associated with the third type i.e. adhesive wear where metal to metal contact takes place resulting in micro-seizure and scuffing.

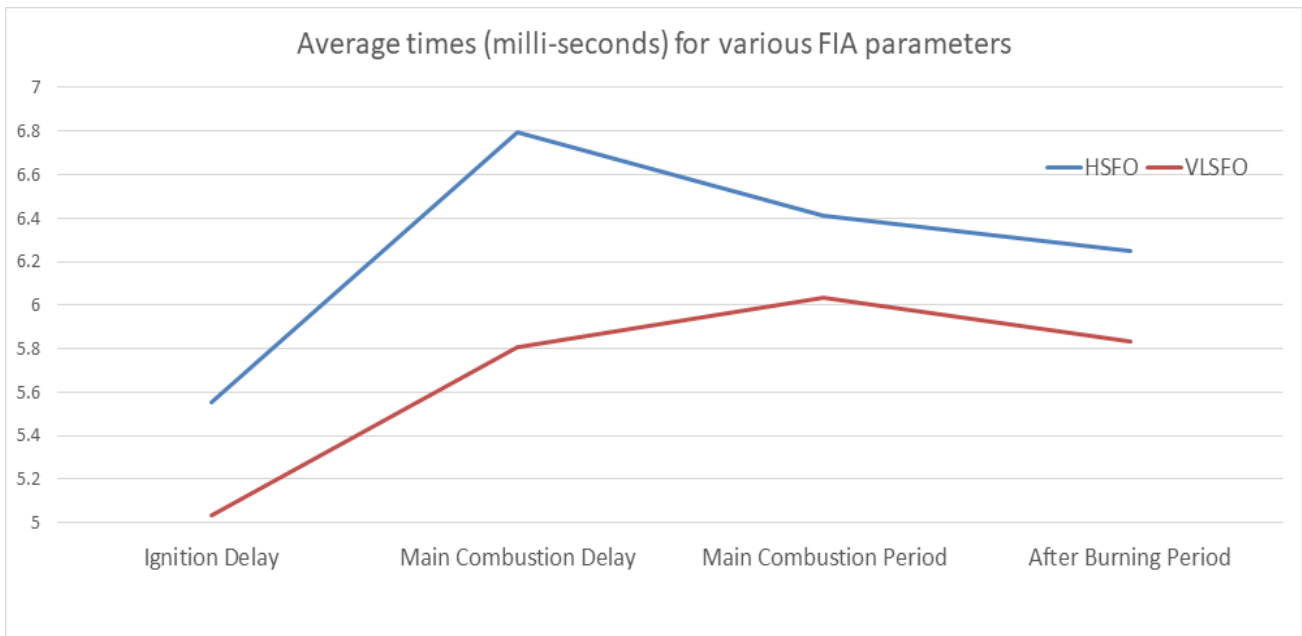
Figure 3: Comparison of key Fuel Ignition Analyser (FIA) results between VLSFO and HSFO samples

FOBAS was asked to investigate those incidents and whether VLSFO quality is a contributory factor. The suspected fuels were tested for standard ISO 8217 (table 2) parameters and results were satisfactory. Further testing options in cases where a ship only reported damages to cylinder components are limited. If standard parameters results are satisfactory then FIA (Fuel Ignition Analyser) test is recommended to evaluate the fuels ignition characteristics. Some of these suspected VLSFO fuels were tested and key parameters are compared against the standard HSFO in figure 3.

Above results from FOBAS data indicate that VLSFO has seen on average around 10% improvement on various ignition parameters compared to the HSFO. Although FOBAS tested a couple samples which showed relatively poor ignition quality one from Santos, Brazil and another one from Houston, USA with estimated cetane number (ECN) of just below 10. The FIA results from Houston seems to be an exception rather than the rule however Santos fuels are known for low ECN in the past. Nevertheless, considering the robustness of large two-stroke engines in burning fuels with varying ignition qualities and in view of CIMAC guidelines, it is not straight forward to link the fuel quality with the reported issues. Further information received from the ships reporting these problems were studied and following observations were made;
