Feb 07, 2022

## **Improved Desiccant Box for Pressure Transducers**

This bulletin is relevant to the following Pressure Transducers:

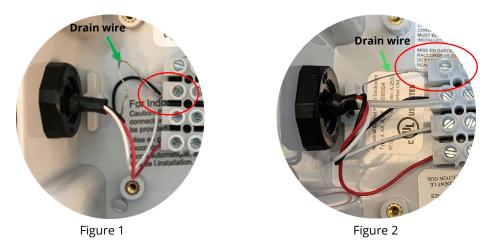
- 1) Open the vent tube enclosure (this should be done under dry conditions to minimize humidity entering the vent tube) and inspect the wiring.
  - a) If your box is wired as in Figure 1 with the silver drain wire sharing a screw on the terminal strip with the black ground wire, follow the steps in paragraph 2.
  - b) If your box is wired as in Figure 2, with the silver drain wire attached to a separate screw in the terminal strip, no action is required.

- 2) If the drain wire from the sensor cable is attached to the same pin as the black wire:
  - a) Disconnect the drain wire from the shared pin with the black ground wire;
  - b) Ensure the black ground wire maintains connection with the terminal strip screw and secure;
  - c) Cut the drain wire close to the terminal point of the sensor cable (see Figure 3);
