Parish Meeting

All Saints' Episcopal Church | Egleston Ministry Center Redevelopment

April 19, 2026

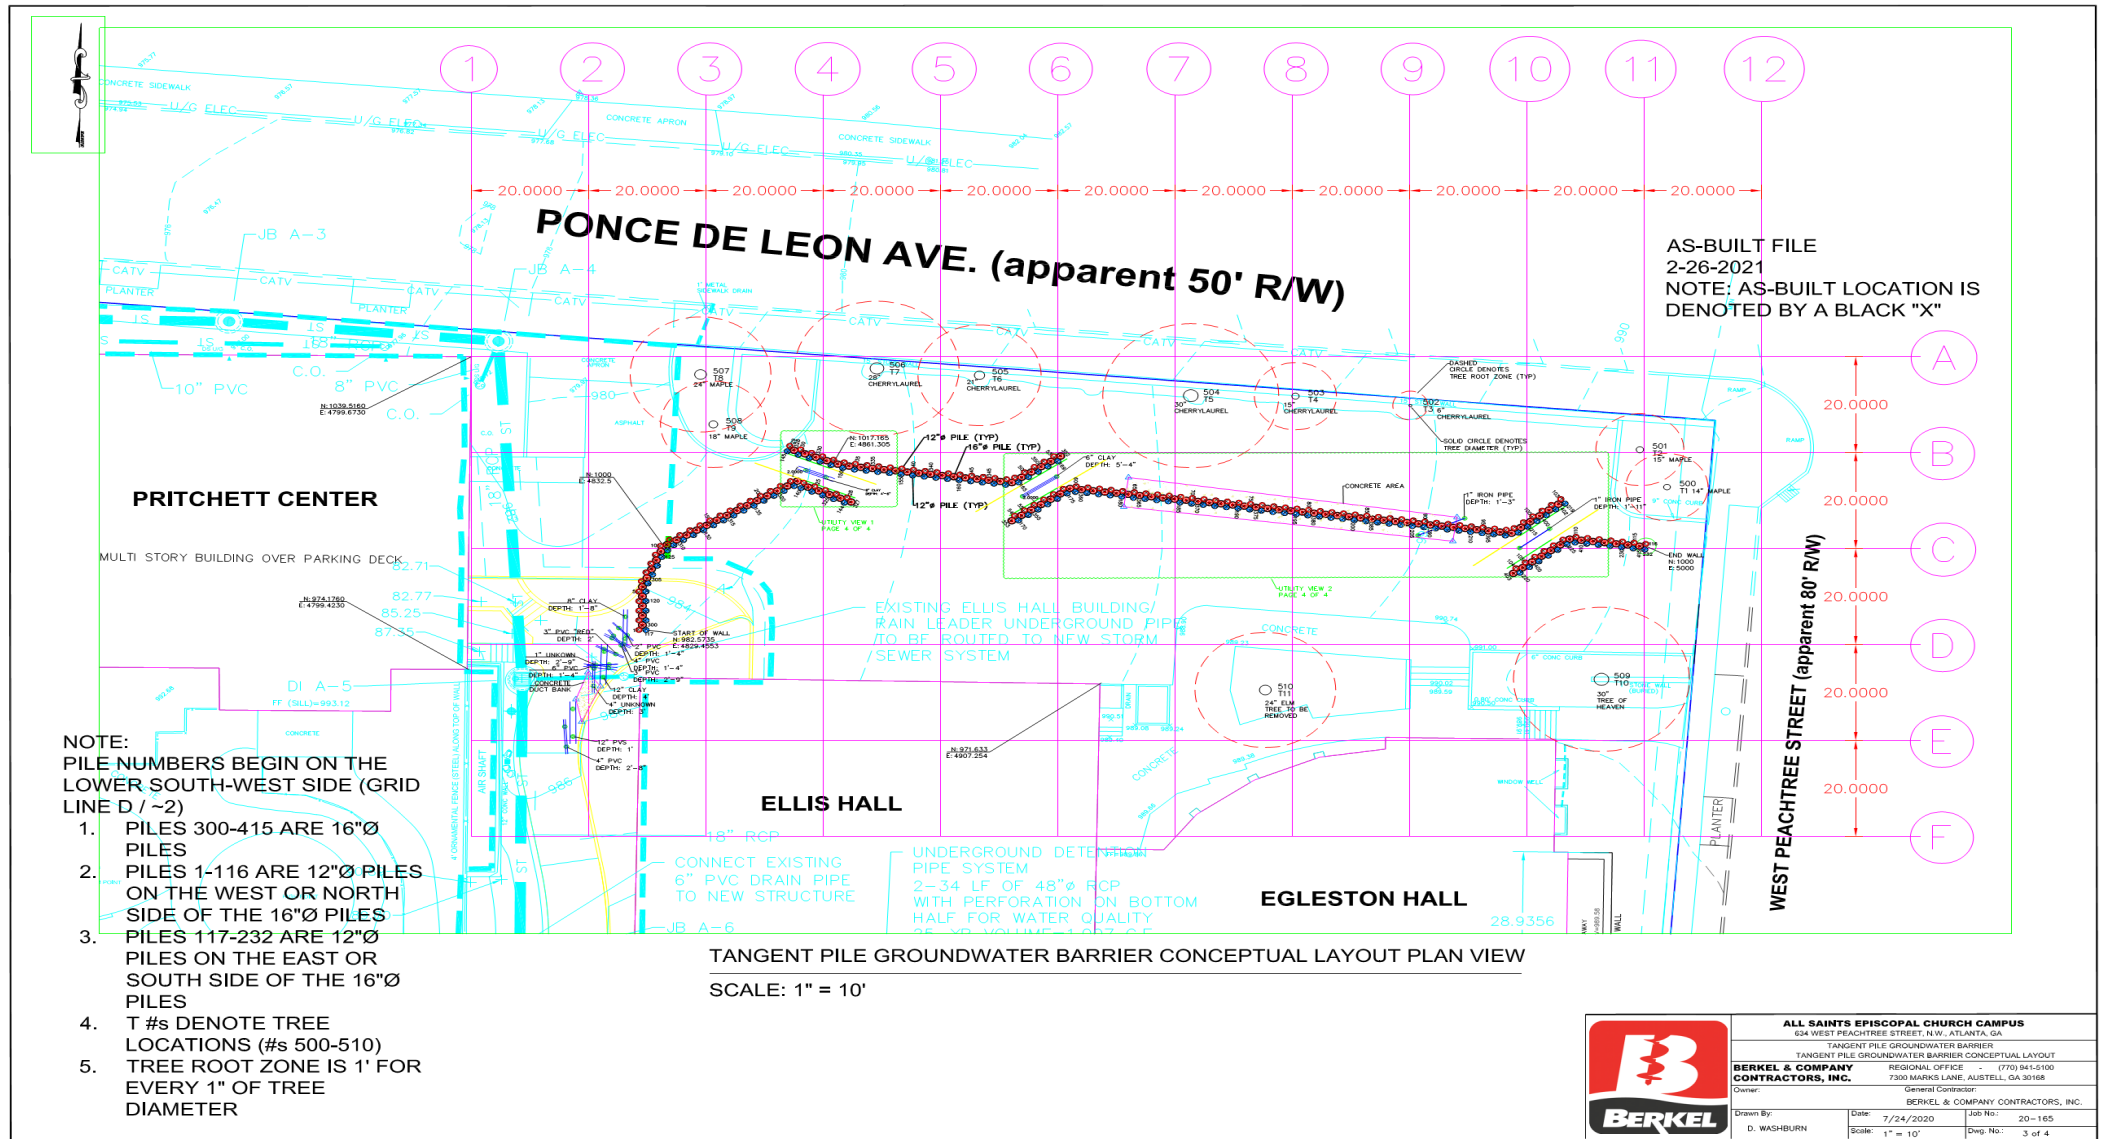
TANGENT PILE GROUNDWATER BARRIER CONCEPTUAL LAYOUT PLAN VIEW
SCALE: 1" = 10'

- NOTE:
PILE NUMBERS BEGIN ON THE LOWER SOUTH-WEST SIDE (GRID LINE D / ~2)
1. PILES 300-415 ARE 16"Ø PILES
 2. PILES 1-116 ARE 12"Ø PILES ON THE WEST OR NORTH SIDE OF THE 16"Ø PILES
 3. PILES 117-232 ARE 12"Ø PILES ON THE EAST OR SOUTH SIDE OF THE 16"Ø PILES
 4. T #s DENOTE TREE LOCATIONS (#s 500-510)
 5. TREE ROOT ZONE IS 1' FOR EVERY 1" OF TREE DIAMETER
