# ALL SAINTS' EPISCOPAL CHURCH

## Building Envelope Assessment and Capital Reserve Study

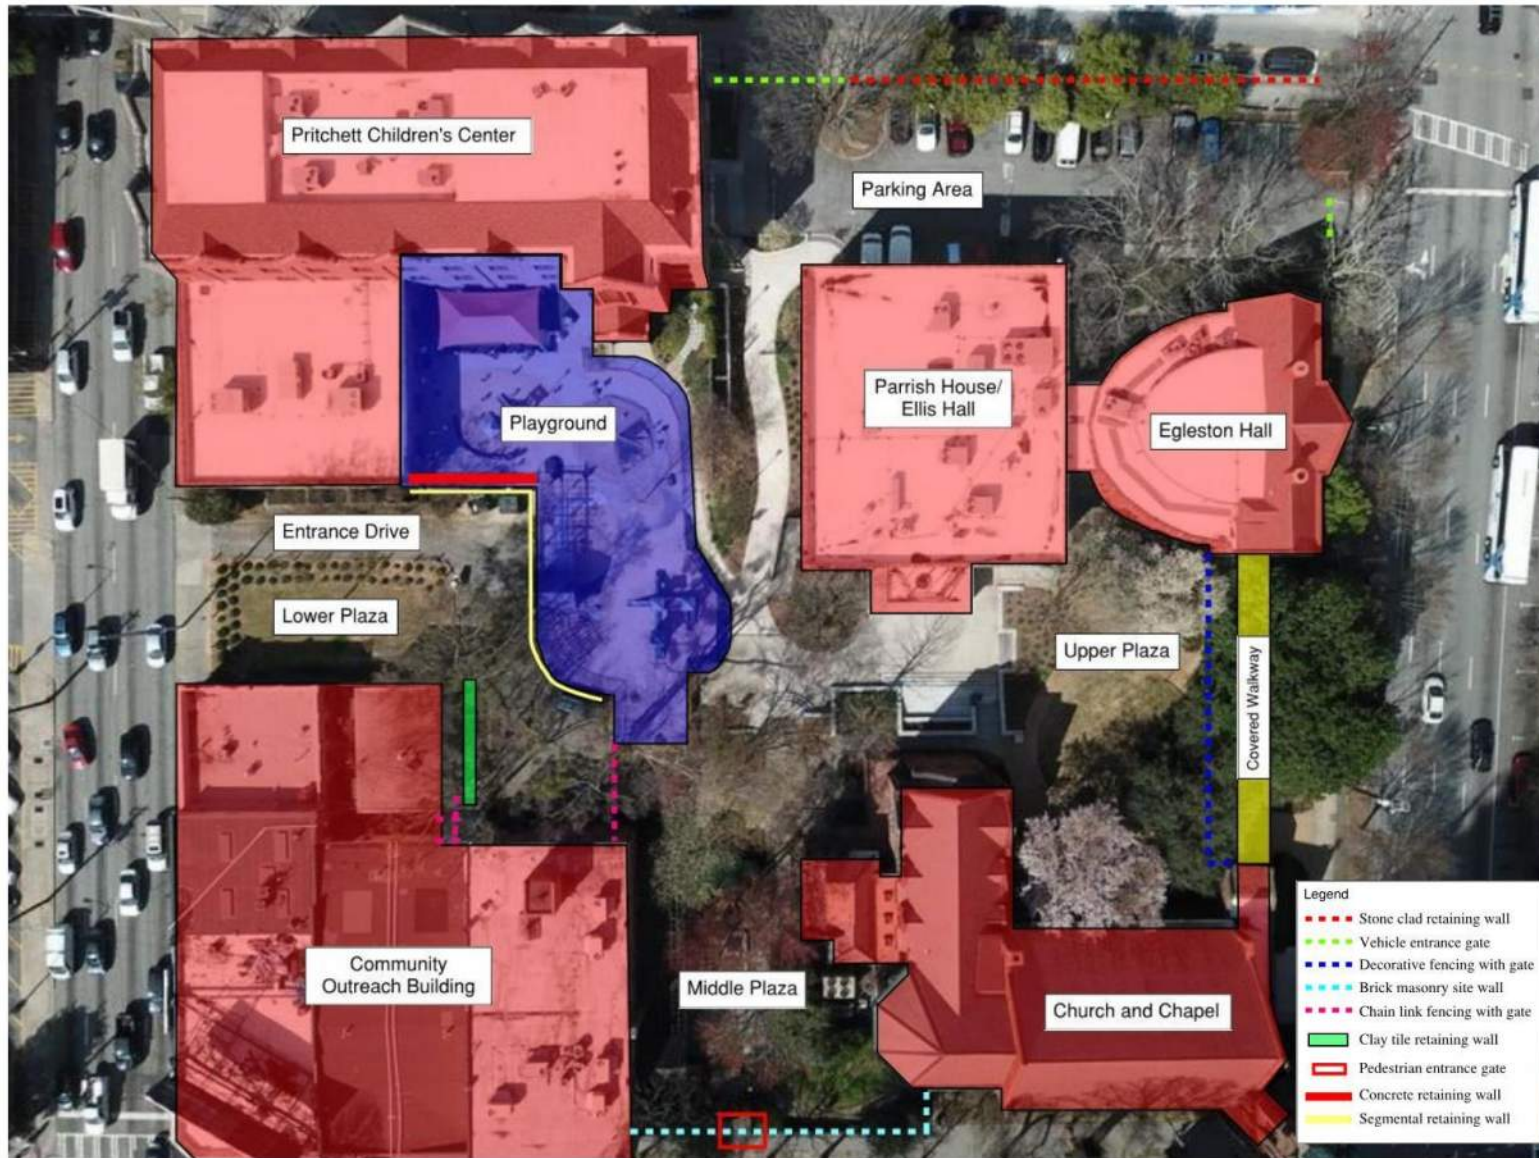
Figure 1. Aerial view of the All Saints' Episcopal Church property.

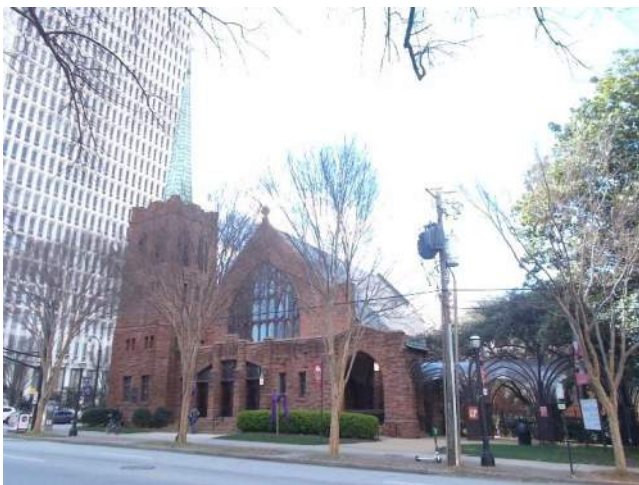
*East facade of the Church and Chapel Building.*

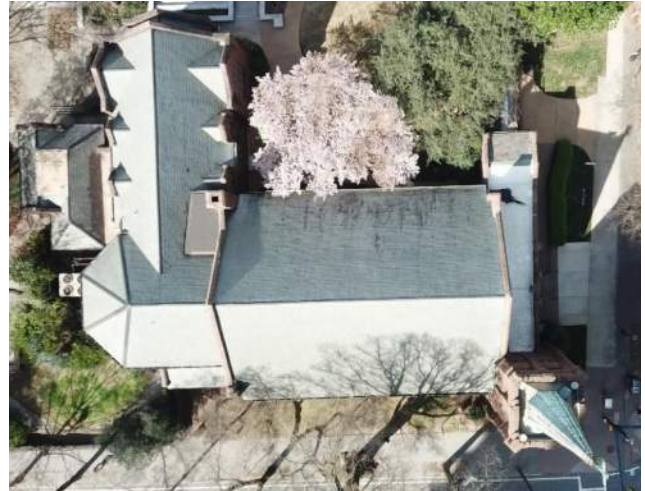
### Summary and Discussion of Observed Conditions:

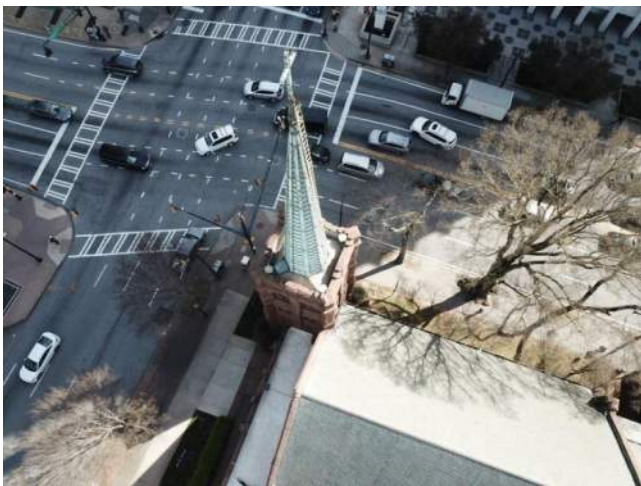
Figure 2.1-1. Partial view of the Church and Steeple roof from our drone survey.

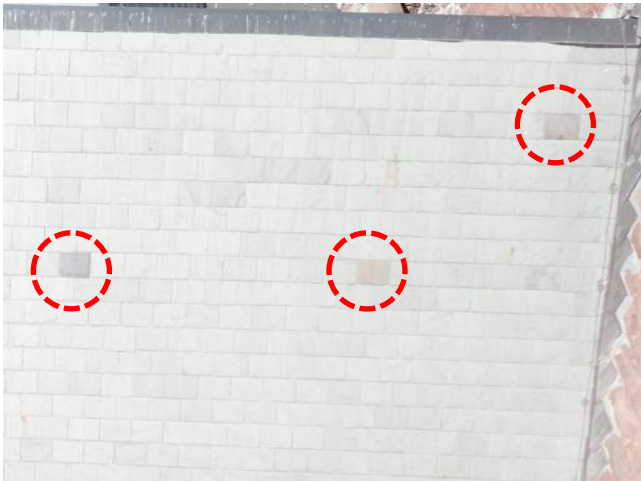
Figure 2.1-11. Slate roofing shingles appear to have been replaced as they are a different color.

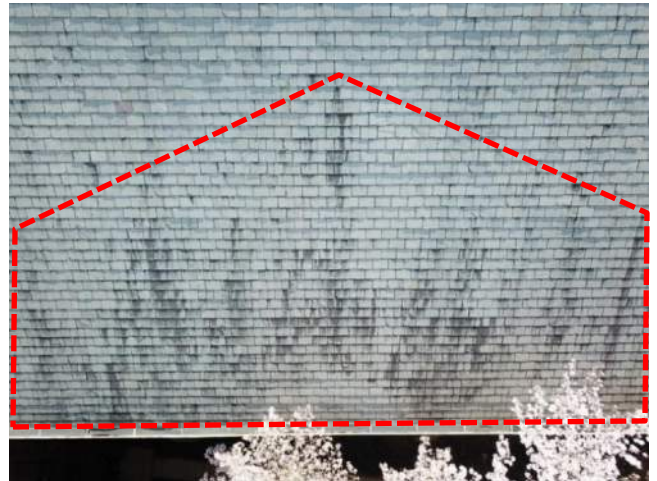
Figure 2.1-12. Dark black staining on many areas of the shingles, mostly located on the north facing slopes.

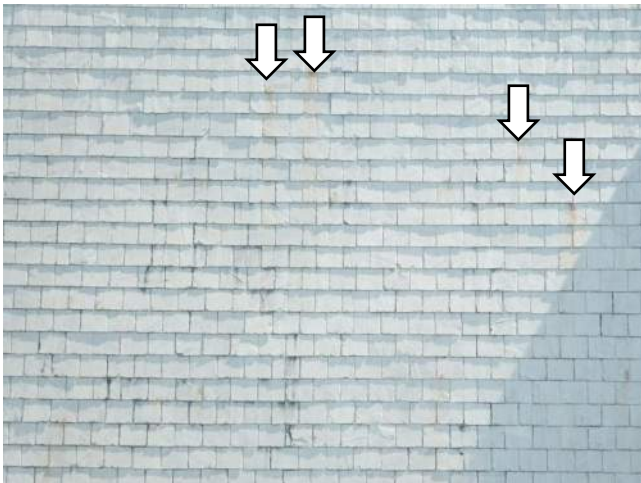
Figure 2.1-13. View of several slate shingles with corrosion colored staining.

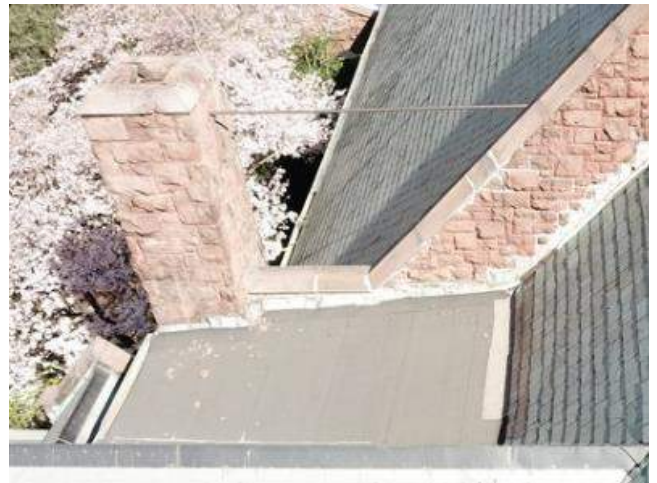
Figure 2.1-22. Coping sealant joints were in poor condition and repair attempts appear to have been implemented.

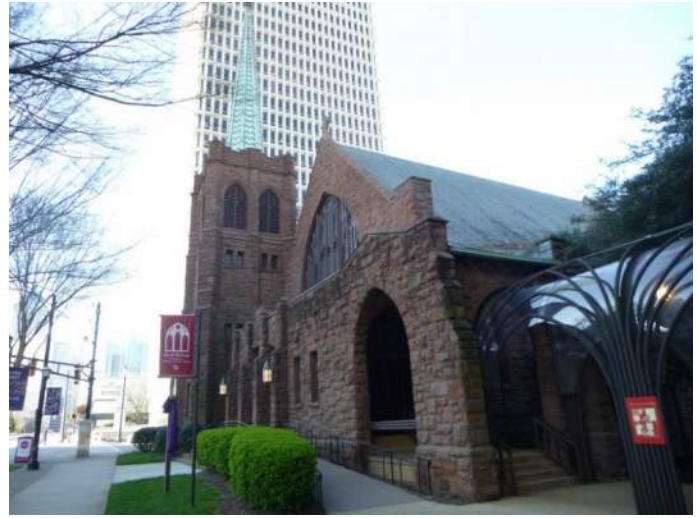
| Condition: | New | Good | <b>Fair</b> | Poor |

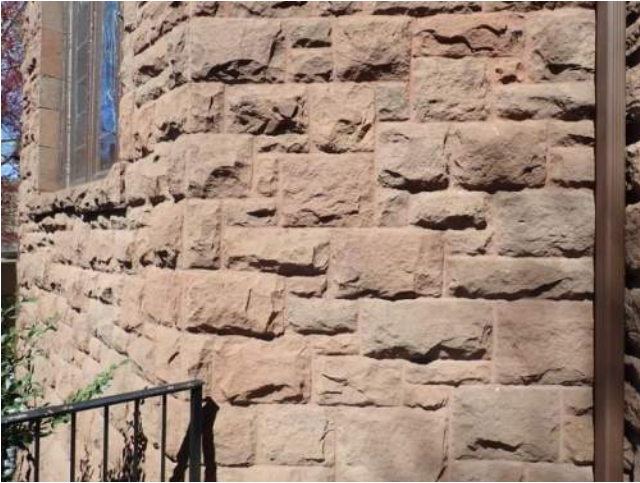
*Figure 2.2-1. The sandstone masonry was observed to be structurally sound.*

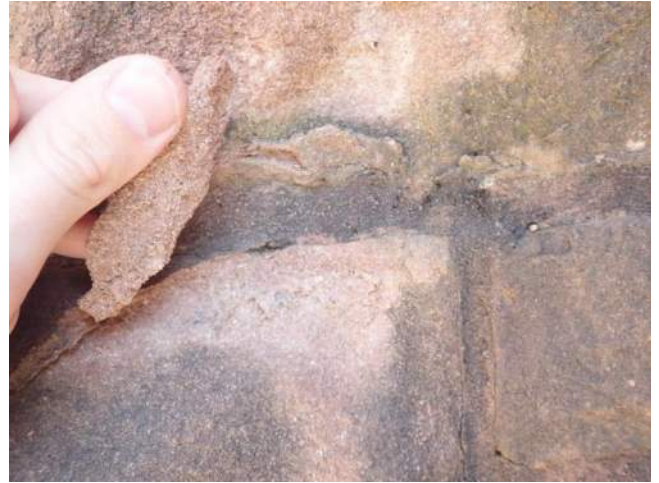
*Figure 2.2-2. Deficiencies within the mortar joints between the sandstone units.*

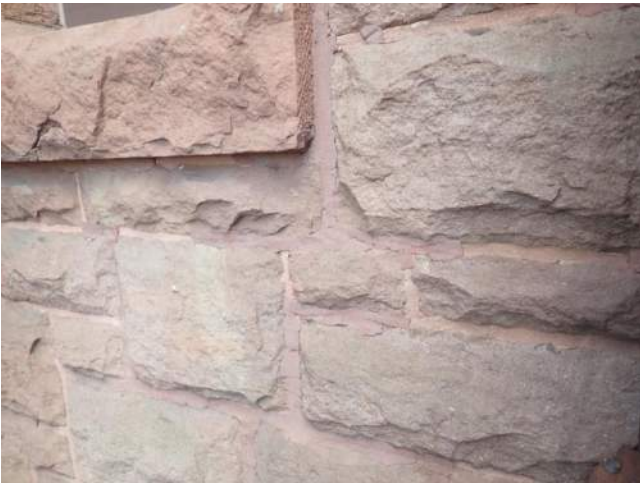
*Figure 2.2-3. Three different mortar colors indicate at least two separate repair efforts during the life of the building.*

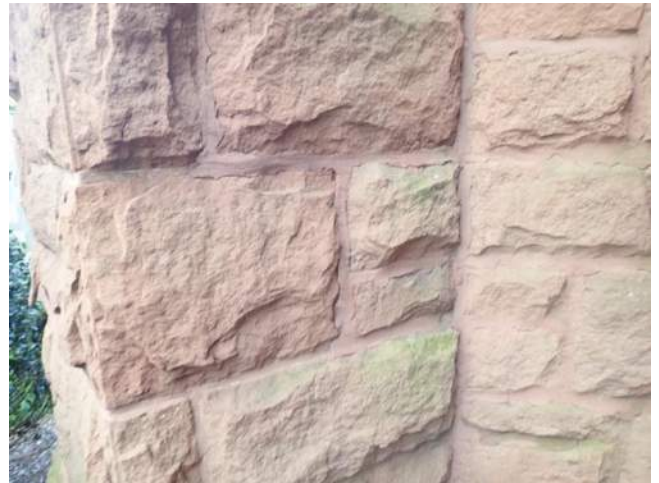
*Figure 2.2-4. Three different mortar colors indicate at least two separate repair efforts during the life of the building.*

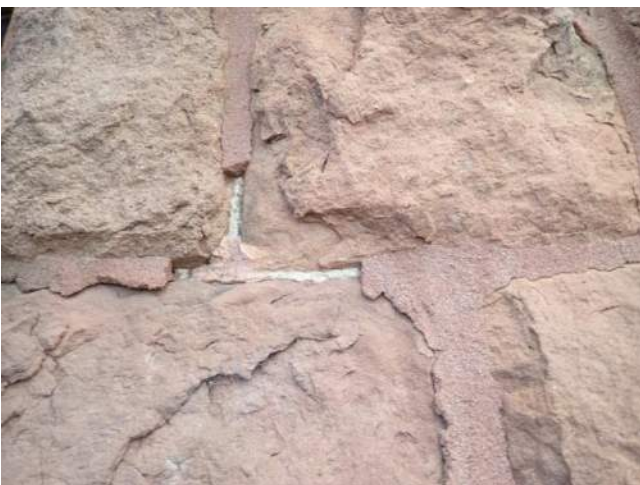
*Figure 2.2-5. Evidence of bag grouting technique to apply new mortar to the face of the masonry.*

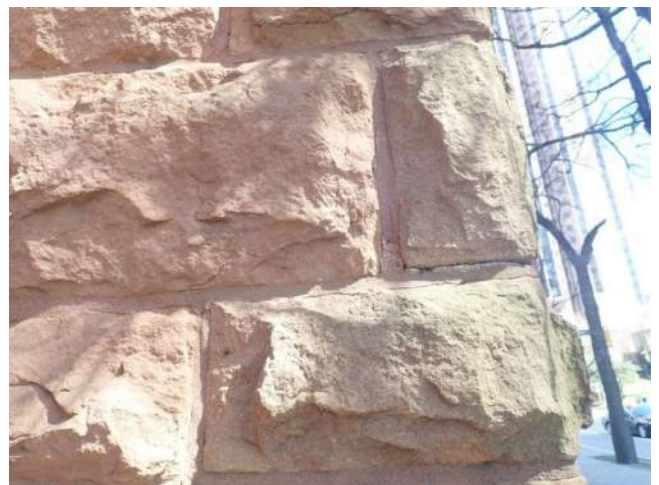
*Figure 2.2-6. Hairline cracks and shallow surface delaminations in the brown sandstone facade.*

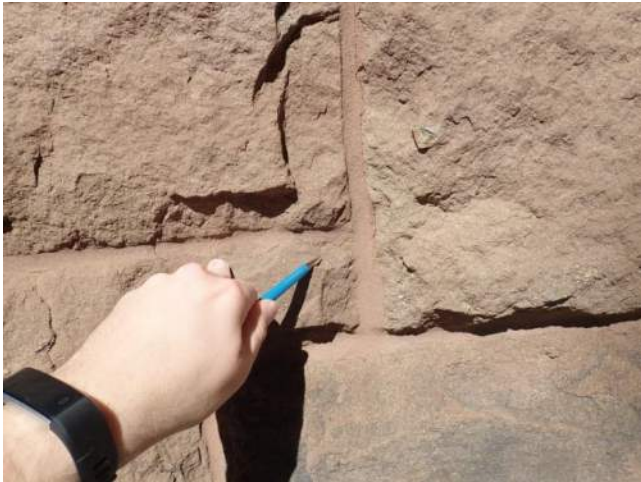
Figure 2.2-7. Hairline cracks and shallow surface delaminations in the brown sandstone facade.

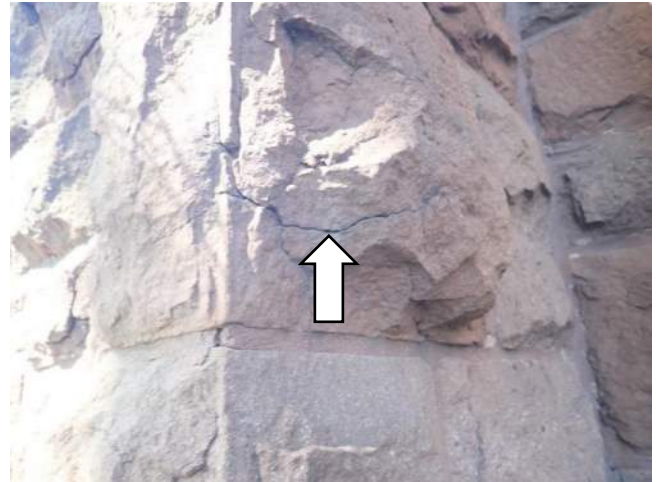
Figure 2.2-8. View of delamination of the face of a sandstone unit.

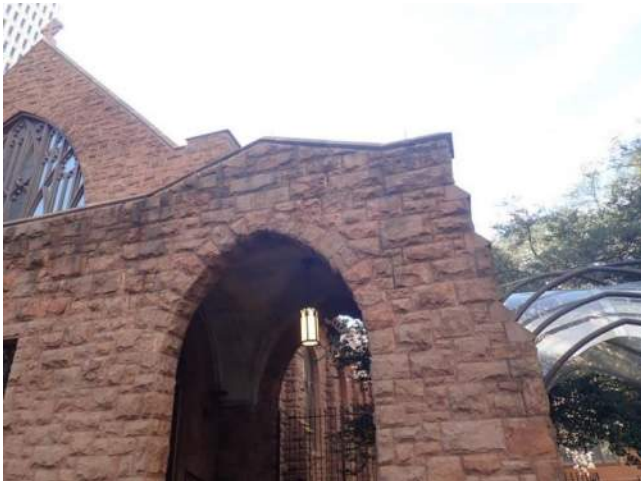
Figure 2.2-9. Face spalls and incipient face spalls located immediately above pedestrian entrance.

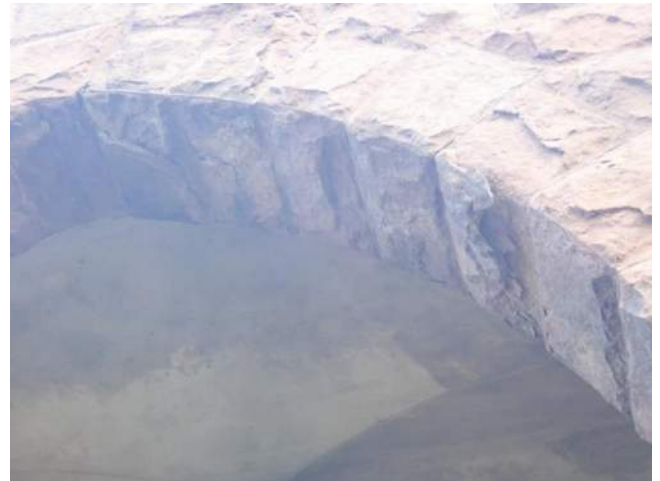
Figure 2.2-10. One incipient spall removed from a stone unit near the top of the arch at the north end of the east elevation

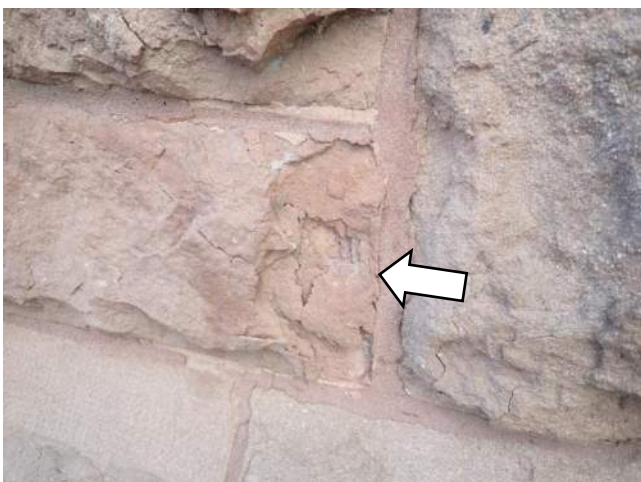
Figure 2.2-11. Exfoliation of a sandstone unit.

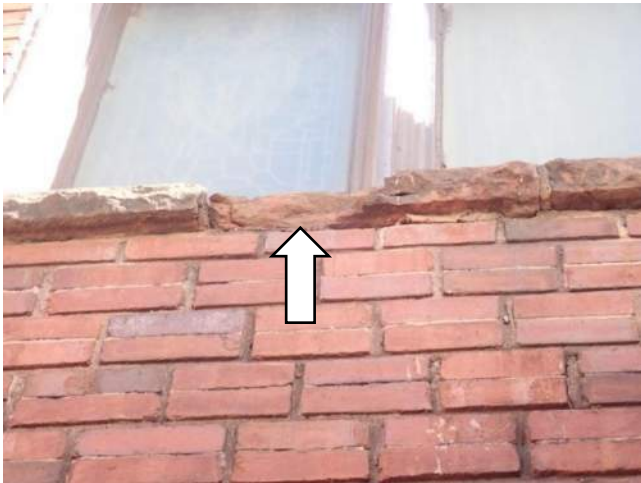
Figure 2.2-15. Spall in the granite unit at sill.

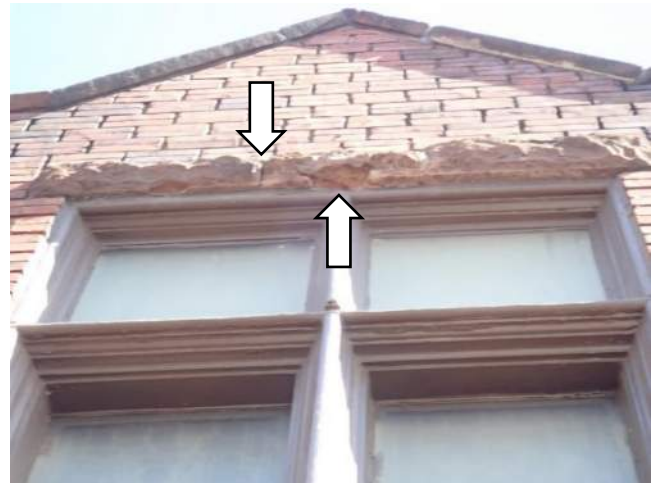
Figure 2.2-16. Cracks and spalls in the granite units at window head.

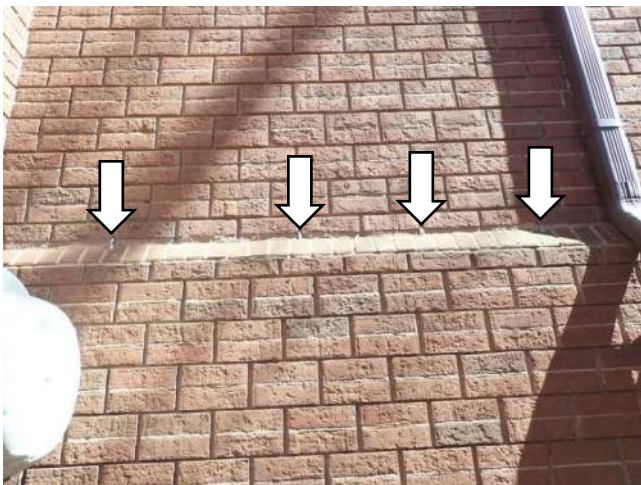
Figure 2.2-17. 1990s era construction is a veneer assembly with weep ropes and concealed flashings at ledges.

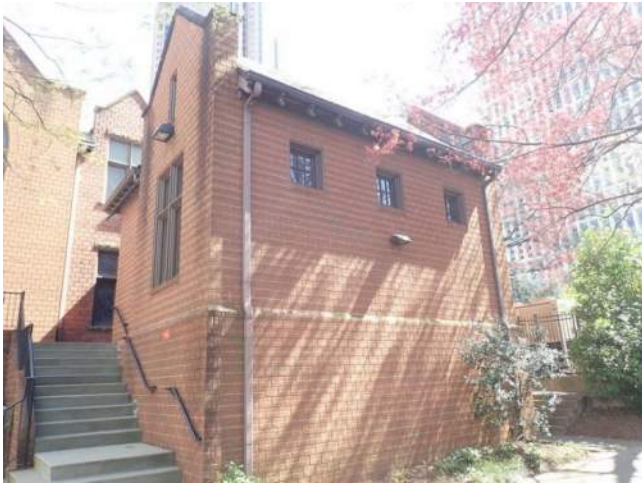
Figure 2.2-19. No deficiencies in the block bond masonry veneer at the Chapel Building.

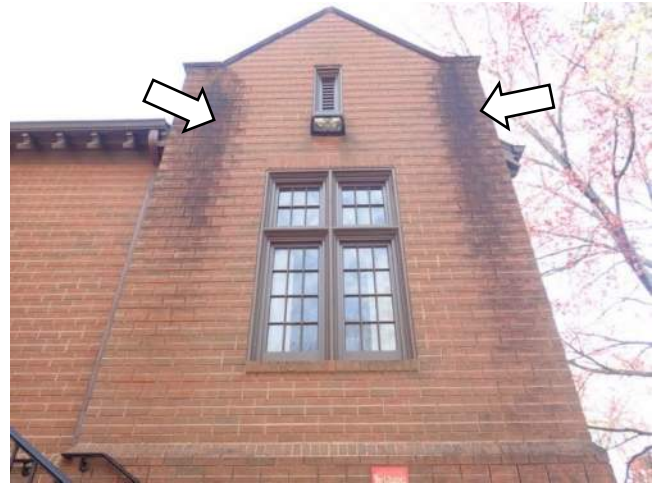
Figure 2.2-20. Accumulation of atmospheric staining and soiling on the brick masonry veneer.

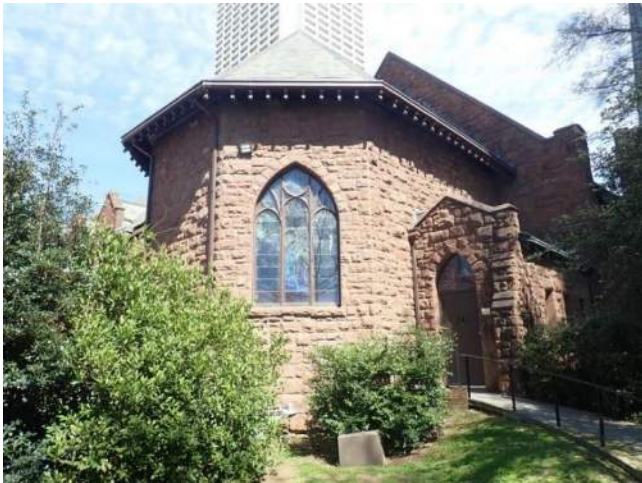
Figure 2.2-21. Stained or leaded glass windows are located throughout the Church and Chapel.

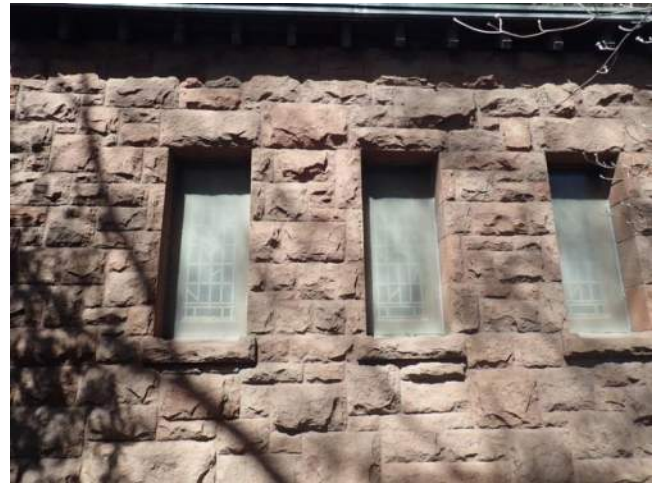
Figure 2.2-22. Stained or leaded glass windows are located throughout the Church and Chapel.

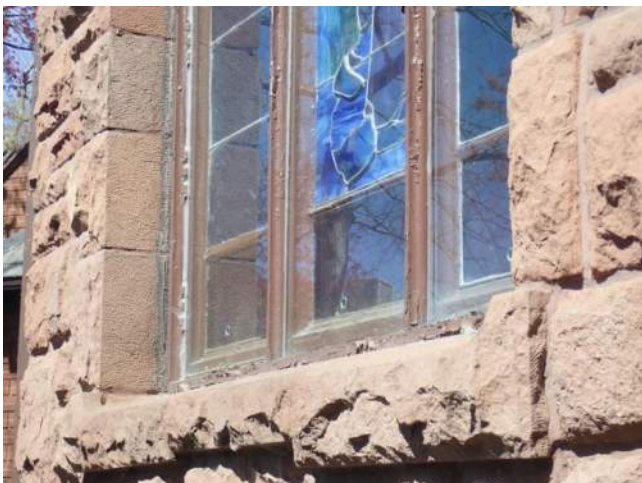
Figure 2.2-23. Deteriorated wood trim with failed coating.

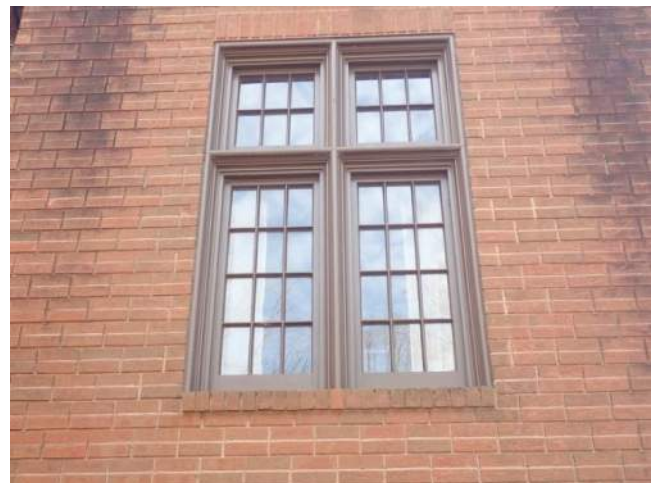
Figure 2.2-24. The wood framed window systems within the Chapel addition were in good condition.

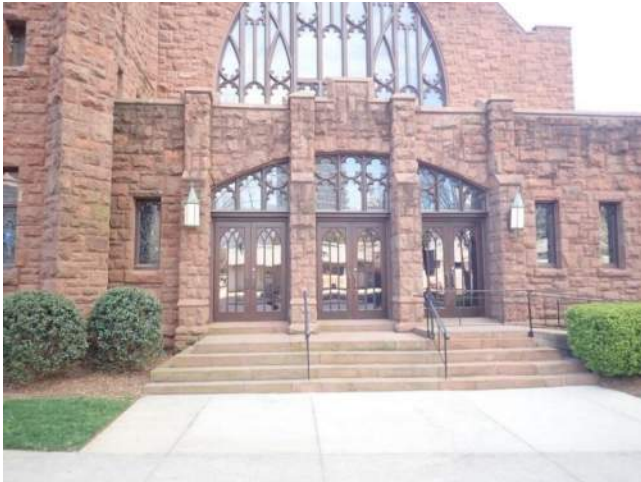
Figure 2.2-25. Wood entrance doors at the east facade of the Church were in good condition.

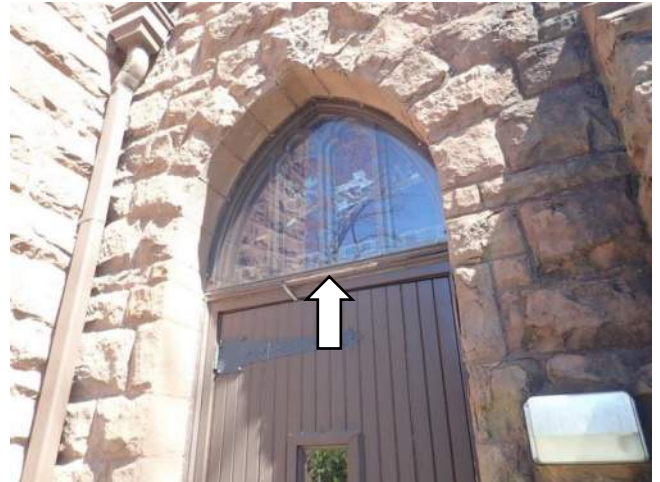
Figure 2.2-26. Wood door at the west facade in good to fair condition; with flaking paint.

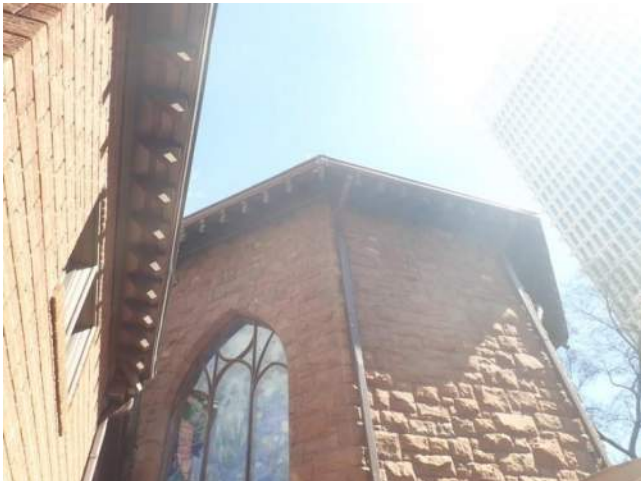
Figure 2.2-27. Decorative wood rafter tails and vented wood soffits beneath the overhanging steep slope slate shingle roof areas.

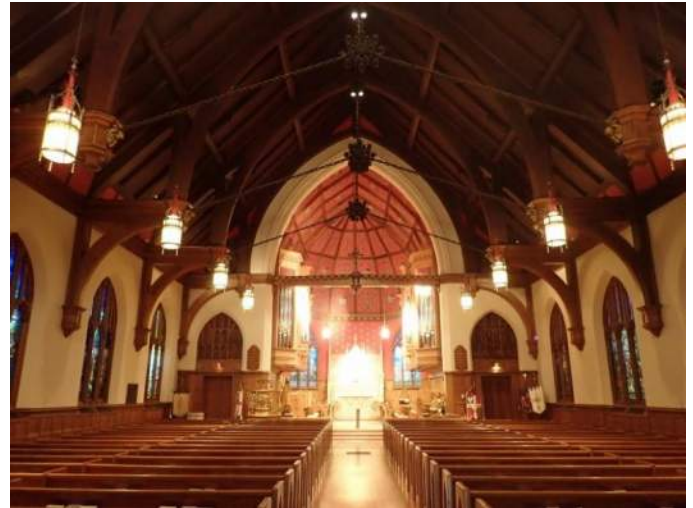
### **Summary and Discussion of Observed Conditions:**

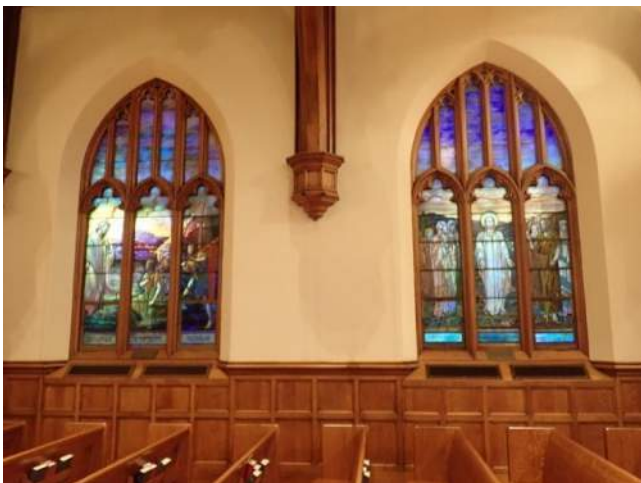
Figure 2.3-9. View of typical stained glass windows at the Nave aisle.

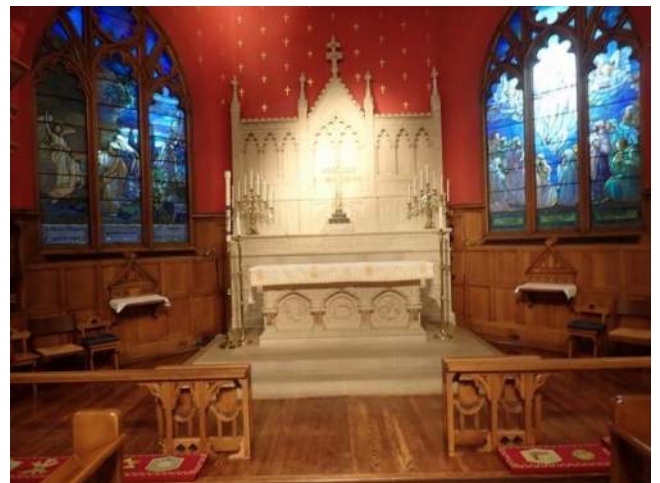
Figure 2.3-10. View of the altar and stained glass windows of the apse.

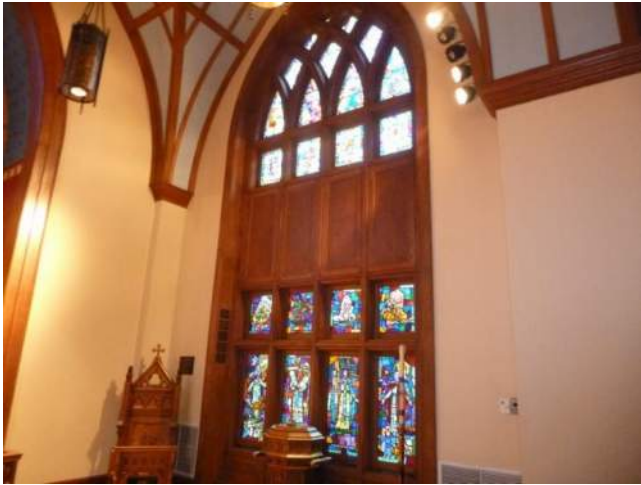
*Figure 2.3-11. View of typical stained glass windows and wood paneling in the Chapel.*

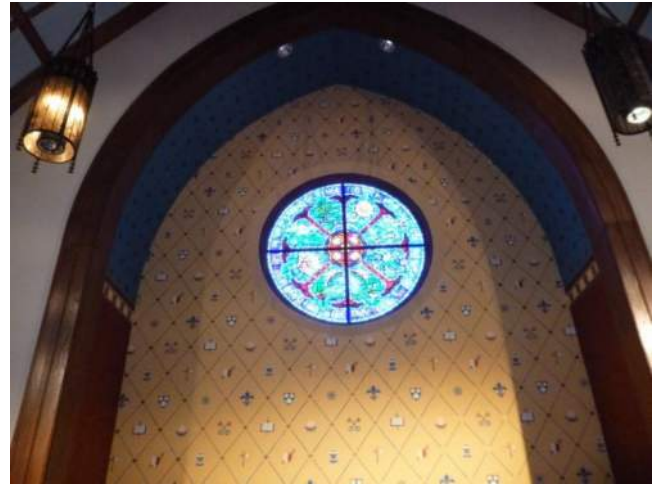
*Figure 2.3-12. View of the rose window on the north wall of the Chapel.*

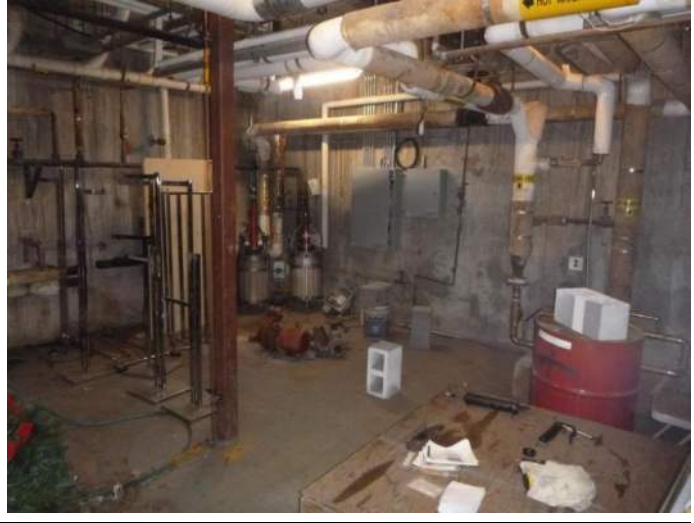
### Summary and Discussion of Observed Conditions:

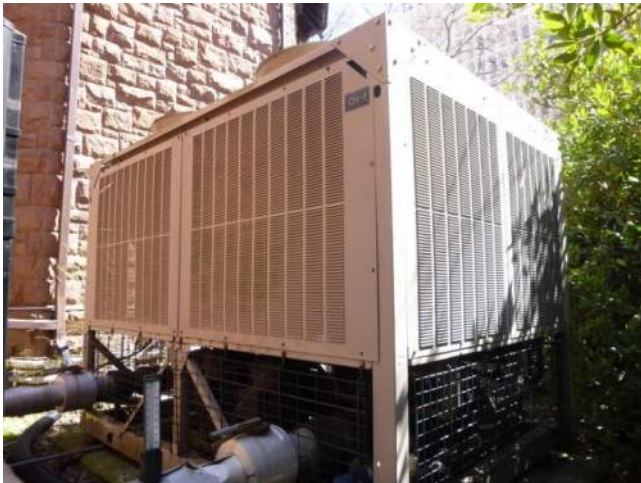
Figure 2.4-1. View of the main chiller for the Church and Chapel.

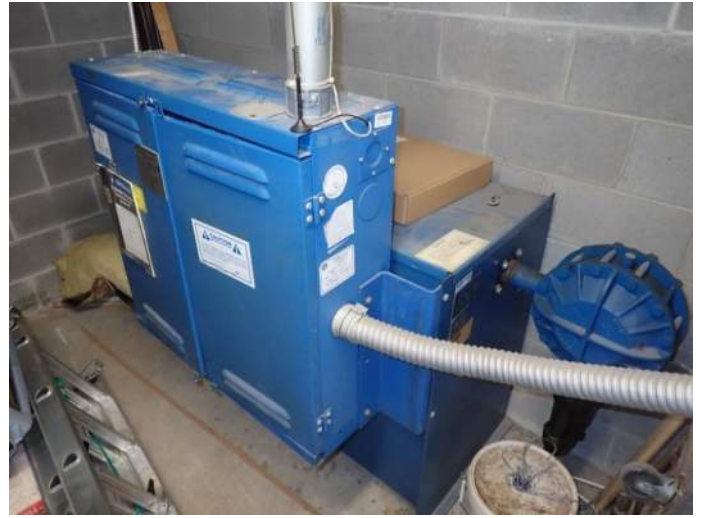
| Condition: | New | <b>Good</b> | Fair | Poor |

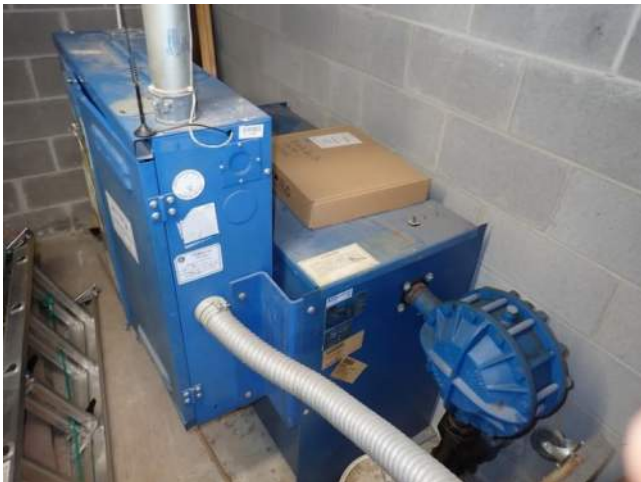
Figure 2.5-1. View of the elevator hydraulics and control system located in the mechanical/storage room.

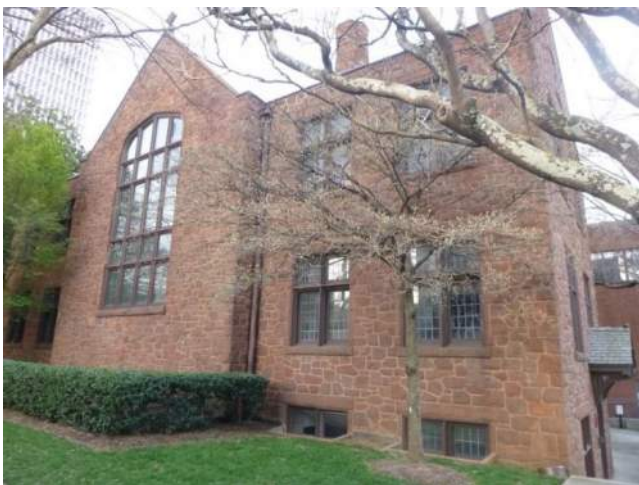
*Partial east facade of Egleston Hall.*

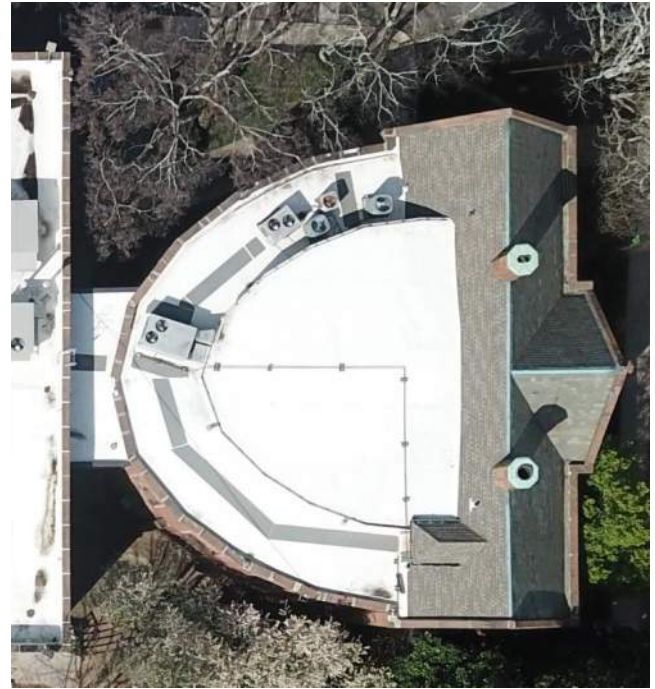
| Condition: | New | <b>Good</b> | Fair | Poor |

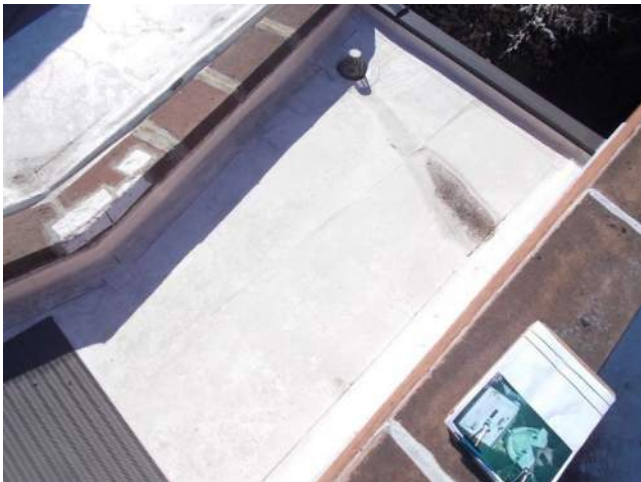
Figure 3.1-1. Overall view of the south end of the lower roof from the top of the east parapet wall of the Parish House roof.

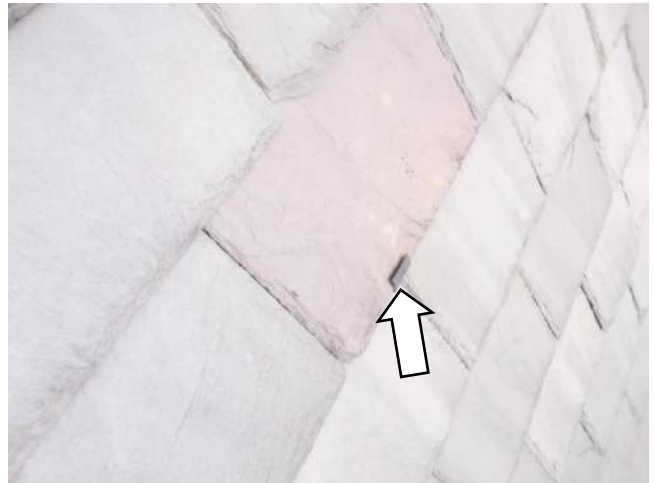
Figure 3.1-6. Copper clips along the bottom edge of a replaced shingle.

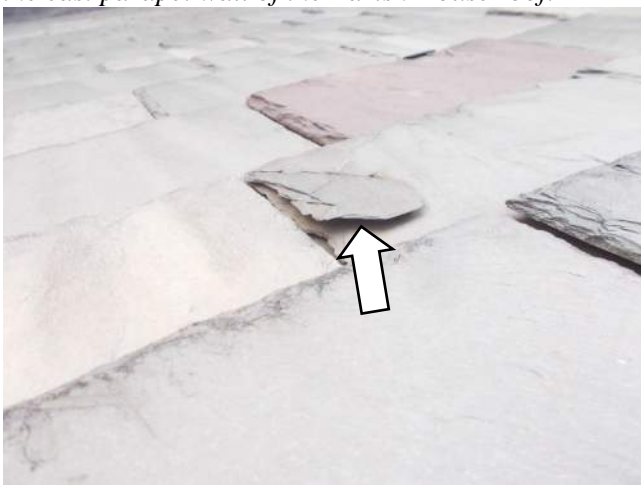
Figure 3.1-7. View of a delaminated roofing slate shingle.

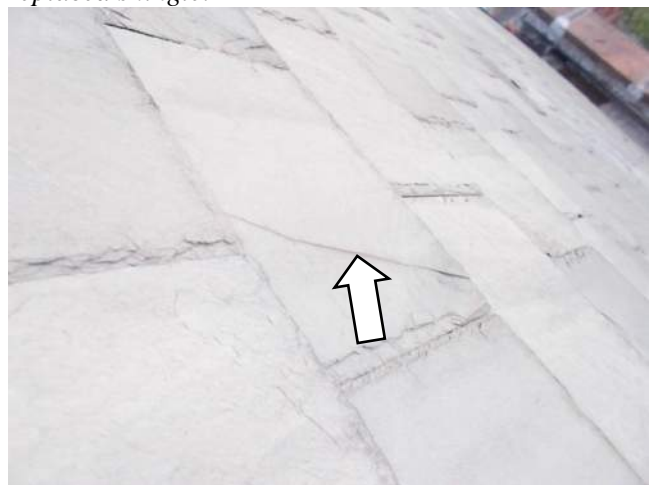
Figure 3.1-8. View of a crack in an isolated slate roofing tile.

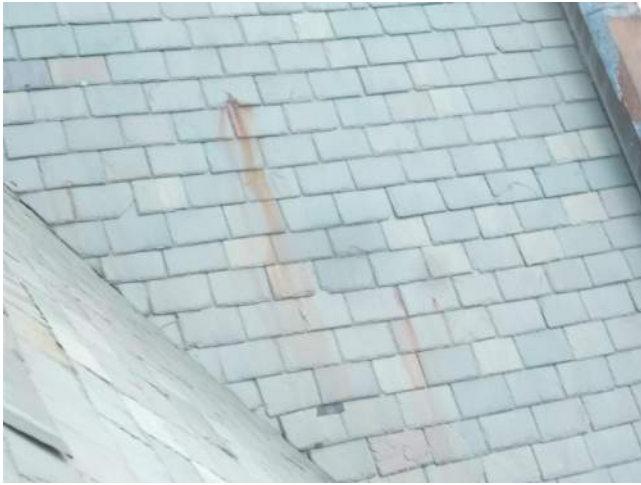
*Figure 3.1-9. View of area of typical staining on the slate tile roof portion of Egleston Hall.*

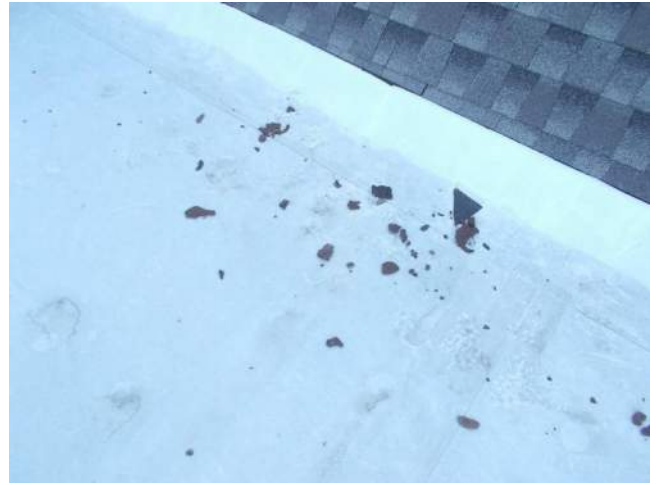
*Figure 3.1-10. View of stone debris on the low slope roof portion of Egleston Hall.*

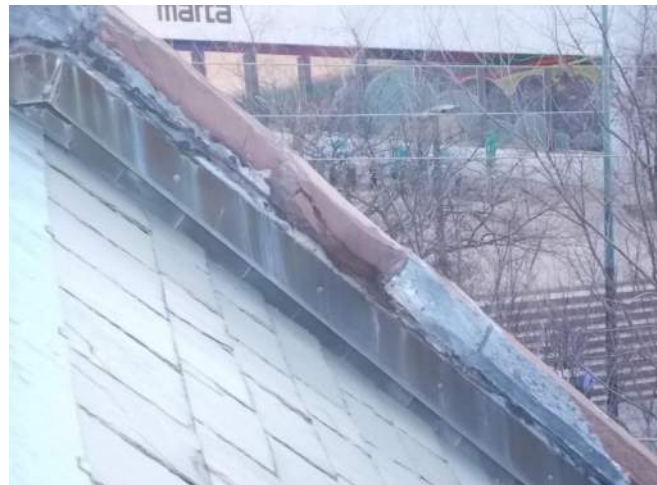
*Figure 3.1-12. View of previous mortar and liquid membrane repairs on the terra cotta coping.*

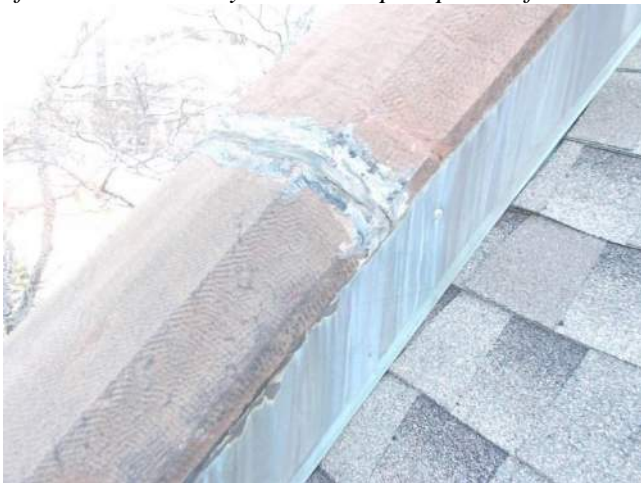
*Figure 3.1-13. View of deteriorated sealant repairs at coping.*

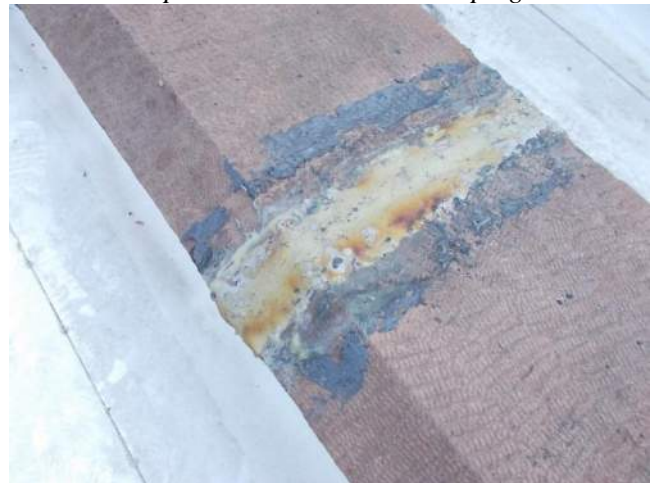
*Figure 3.1-14. View of numerous layers of sealants at a coping joint.*

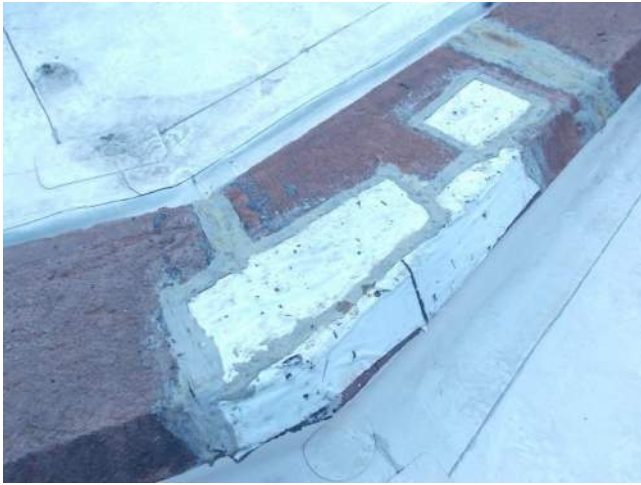
Figure 3.1-15. Self-adhered membrane and sealant repairs on the terra cotta coping units.

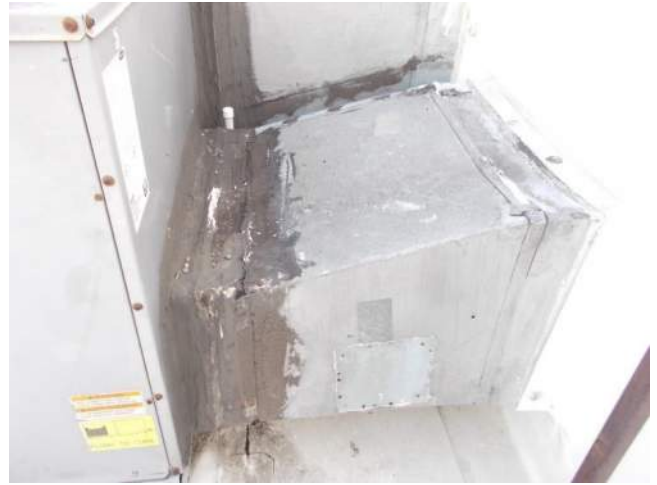
Figure 3.1-16. Failed sealant between the HVAC units and the exposed ductwork.

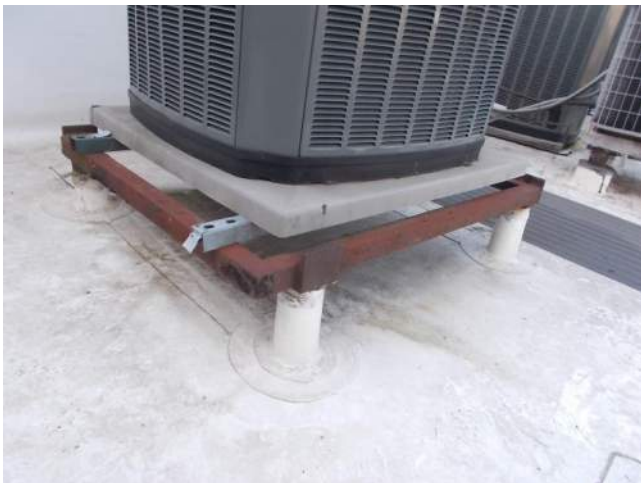
Figure 3.1-17. Equipment supports integrated with the roofing assembly.

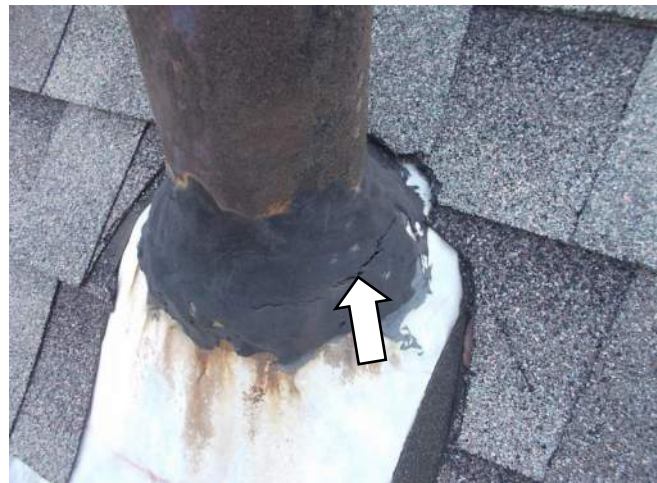
Figure 3.1-18. Weathered and cracked liquid membrane at one of the pipe penetrations.

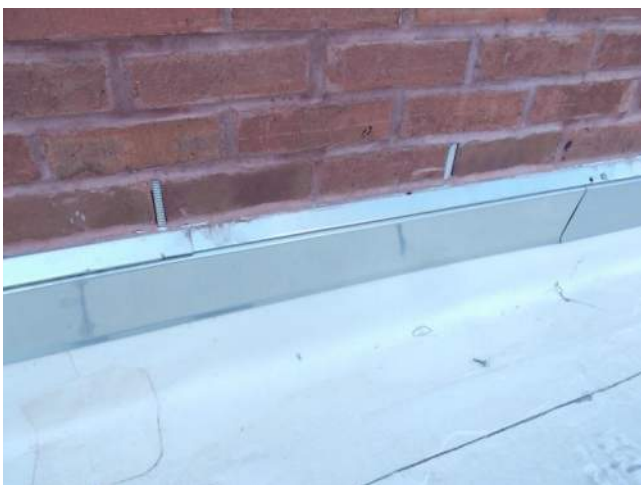
Figure 3.1-19. Roof termination on the connector roof integrated with a through wall flashing and weeps.

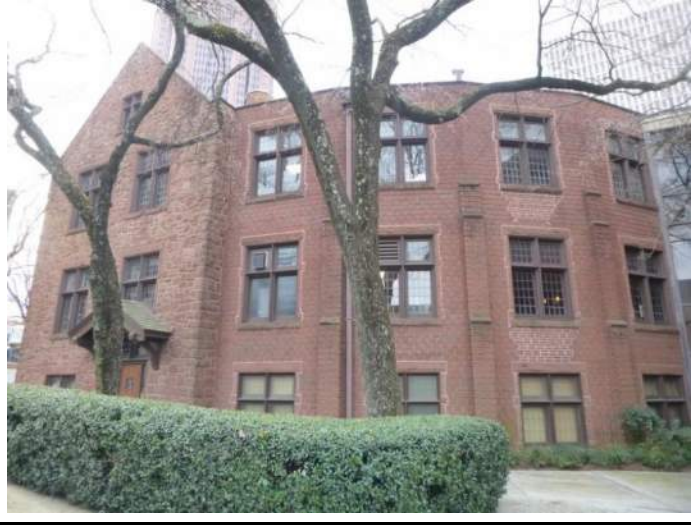
| Condition: | New | Good | <b>Fair</b> | Poor |

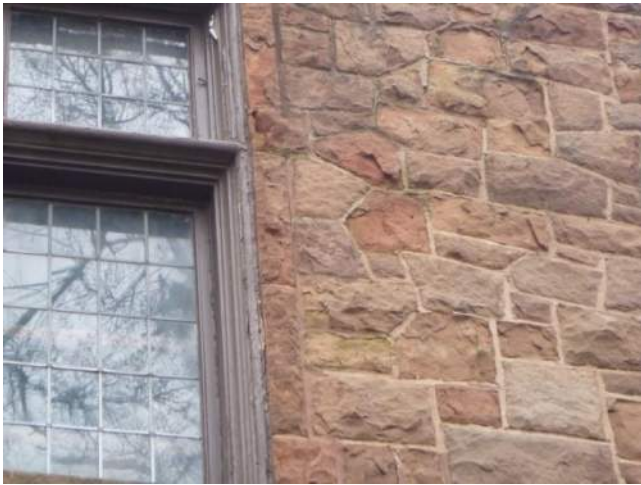
Figure 3.2-1. View of brown sandstone on the exterior of the Egleston building.

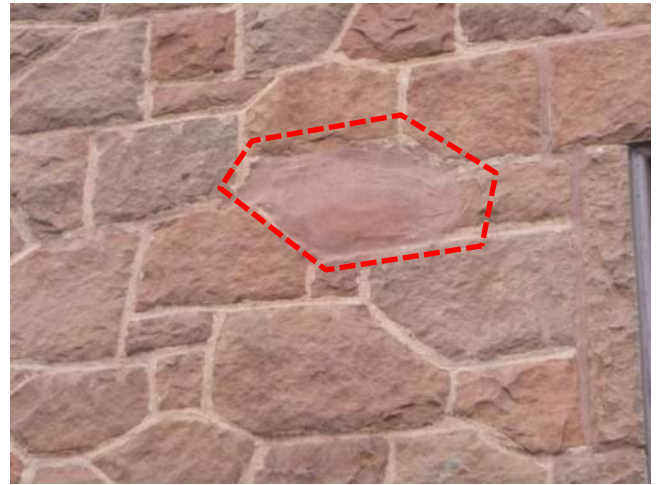
Figure 3.2-2. View of a patch repair at an area of sandstone on the Egleston building.

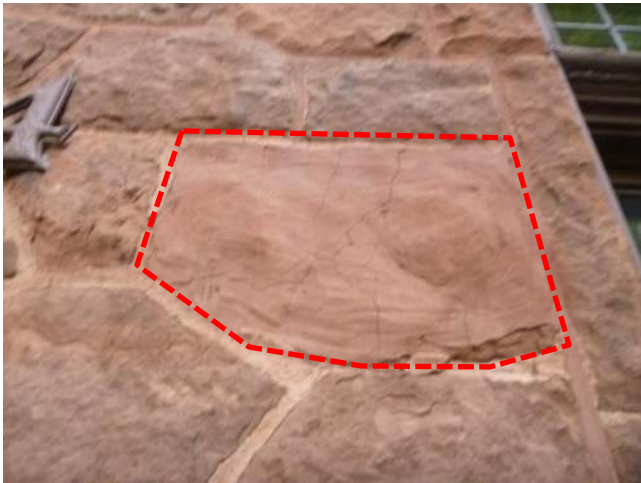
Figure 3.2-3. View of a failed patch repair in the stone masonry on the Egleston building.

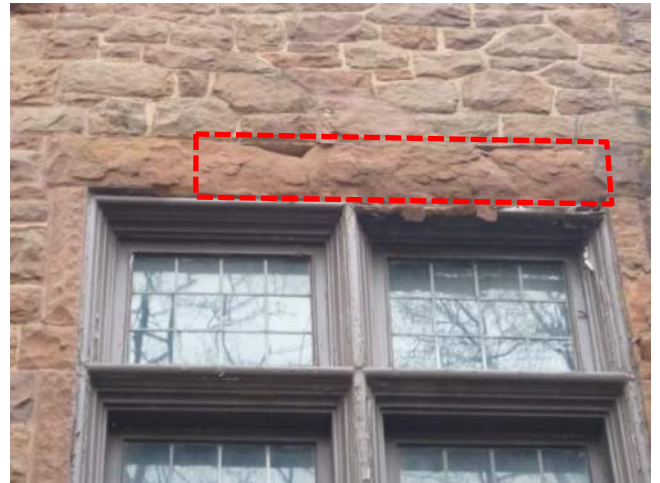
Figure 3.2-4. View of a spall at a lintel above a window on the second floor of the Egleston building.

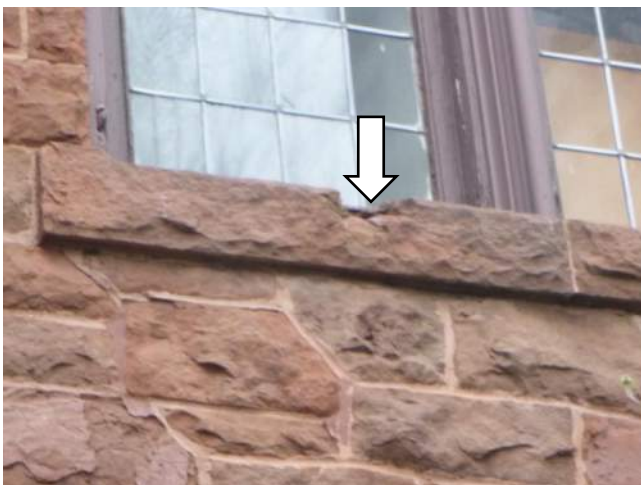
Figure 3.2-5. View of a spall in the stone sill of a window on the Egleston building.
