# ALL SAINTS' EPISCOPAL CHURCH

## Building Envelope Assessment and Capital Reserve Study

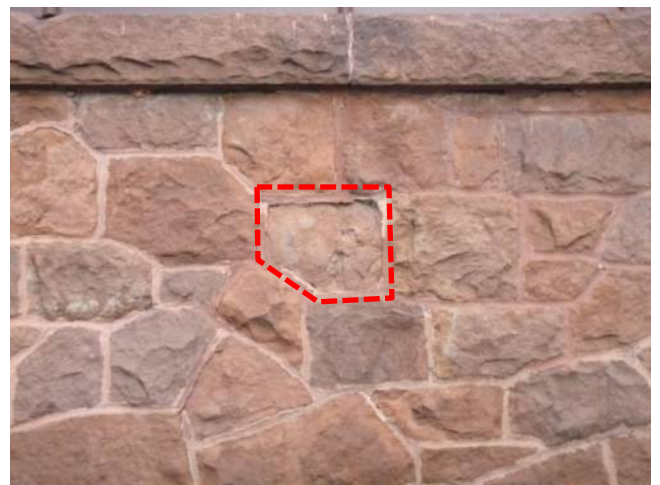
Figure 3.2-6. View of a spalled face of a sandstone unit and previous mortar repairs.

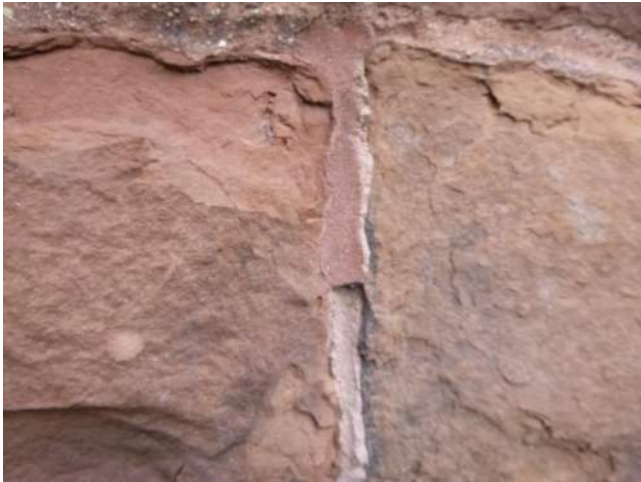
Figure 3.2-7. View of a previous repointing and colored mortar on the Egleston building.

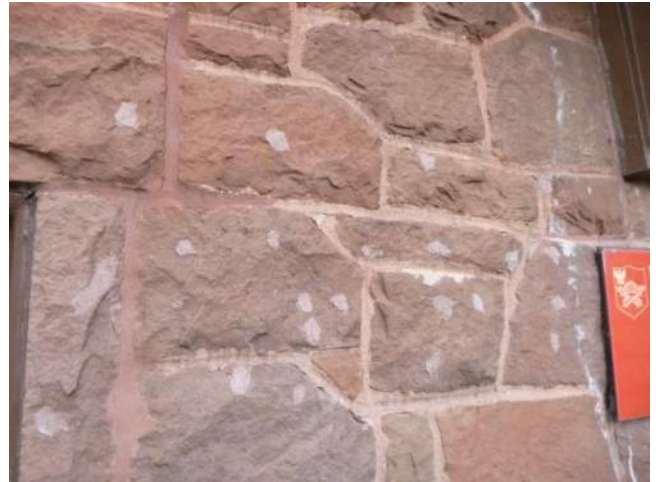
Figure 3.2-8. View of previous bag grouting and remedial spot repair efforts on the Egleston building.

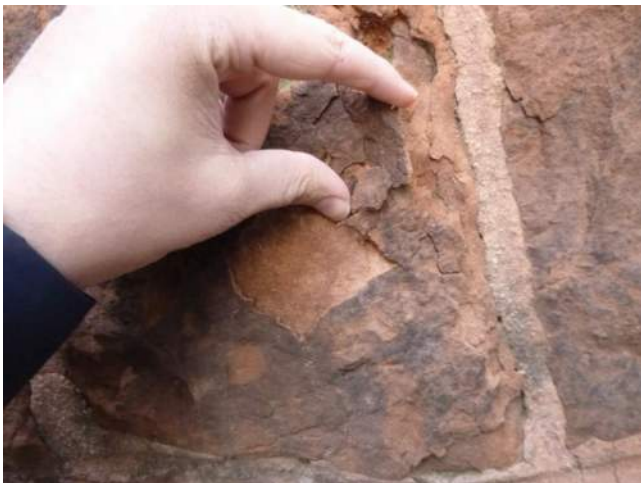
Figure 3.2-9. View of flaking of the exterior face of a sandstone unit on the ground level of the Egleston building.

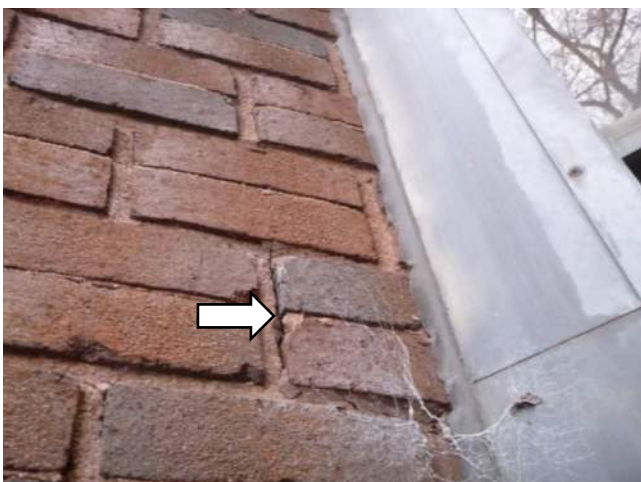
Figure 3.2-11. View of a failed mortar joint in an area of brick masonry on the Egleston building.

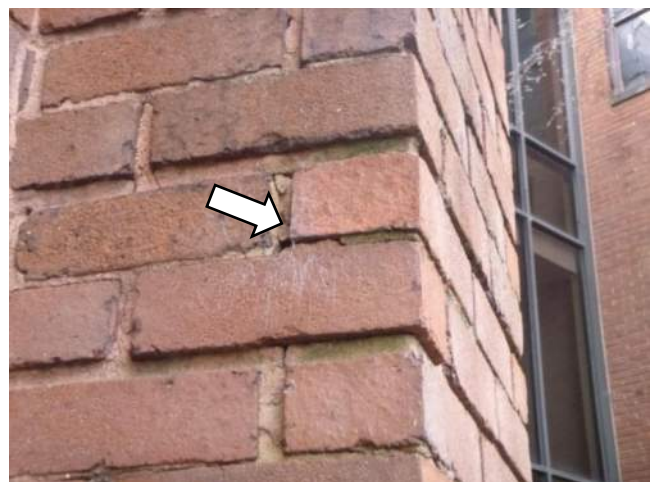
Figure 3.2-12. View of deteriorated mortar joints on the face of a buttress on Egleston Hall.

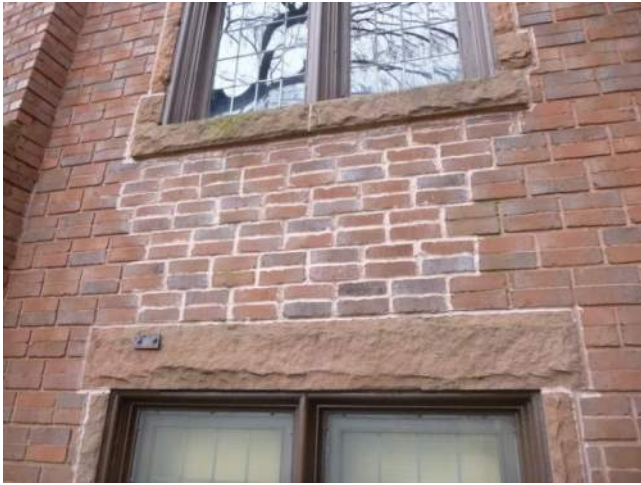
Figure 3.2-13. View of sealant repairs at an area of brick masonry on the south elevation.

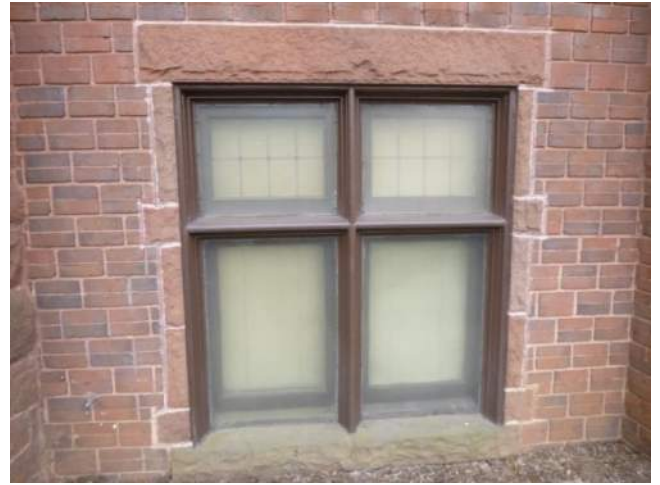
Figure 3.2-14. View of sealant repairs between the brick masonry and stone window surrounds.

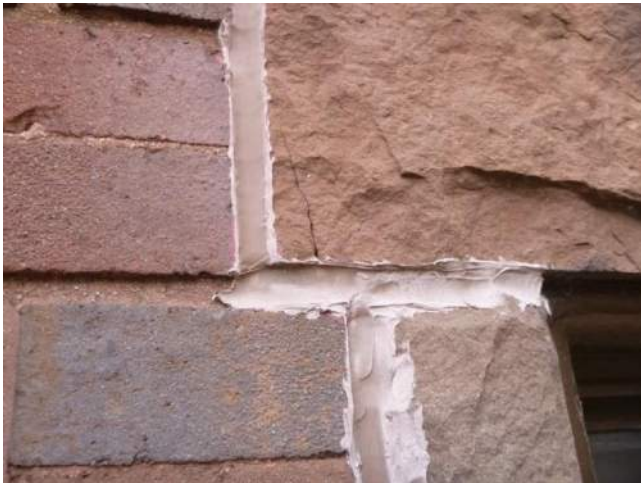
Figure 3.2-15. View of sealant repairs at joints at stone window surrounds.

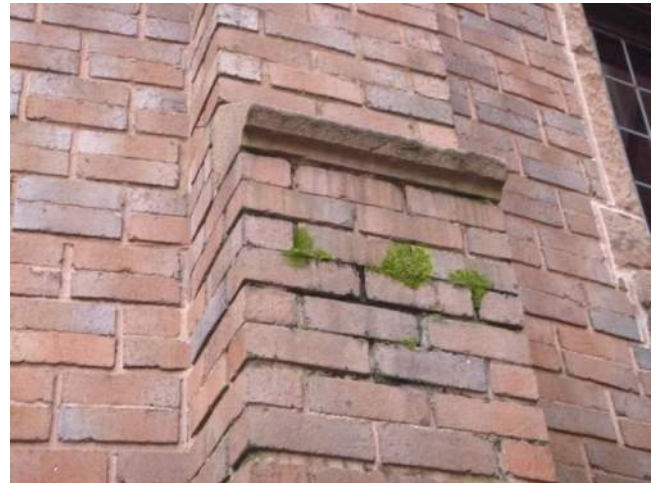
Figure 3.2-16. View of apparent organic growth on a buttress on the Egleston building.

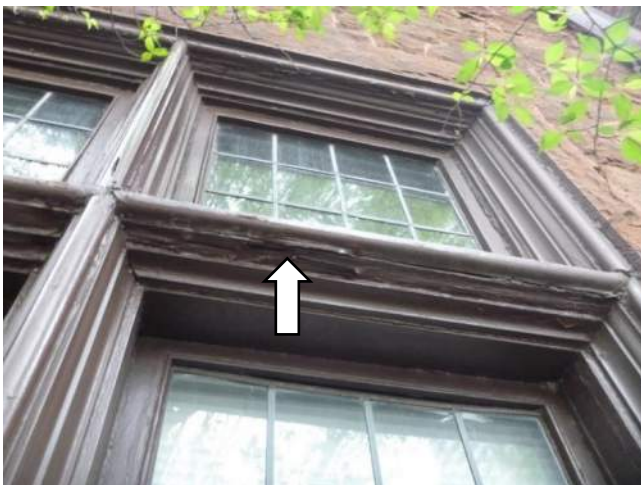
Figure 3.2-17. View of a failing coating on the wood window trim at a typical window on the Egleston building.

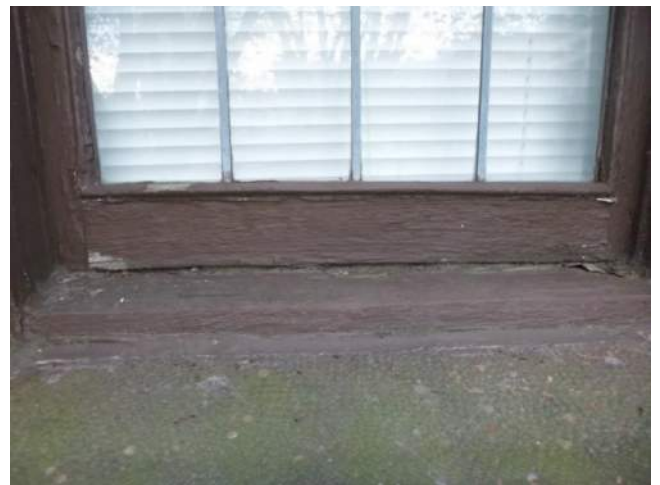
Figure 3.2-18. View of typical condition of wood window surrounds on the Egleston building.

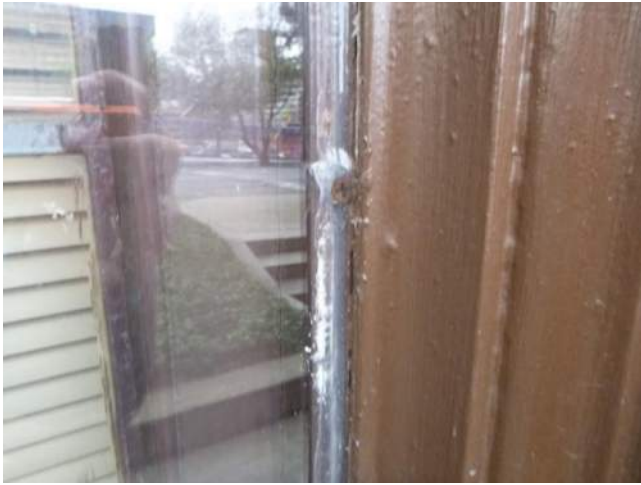
*Figure 3.2-19. View of an acrylic panel fastened over the glass light to the wood window frame.*

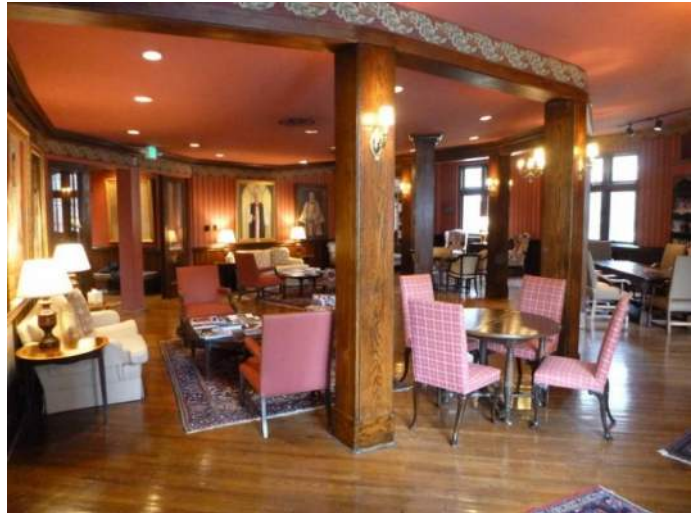
| Condition: | New | <b>Good</b> | Fair | Poor |

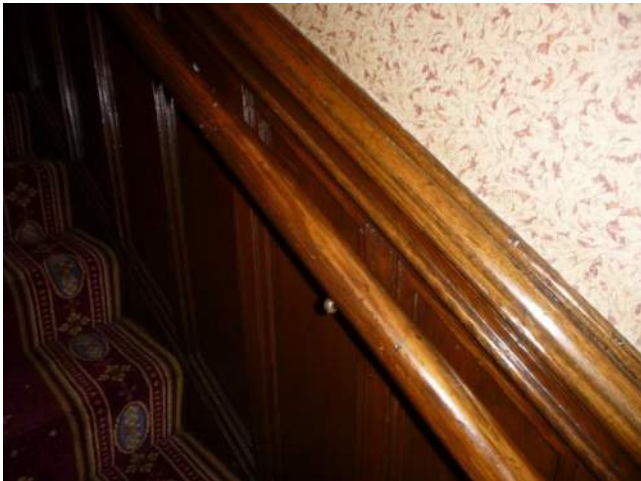
Figure 3.3-9. View of typical condition of wood wainscoting and decorative wall coverings at a second floor stair.

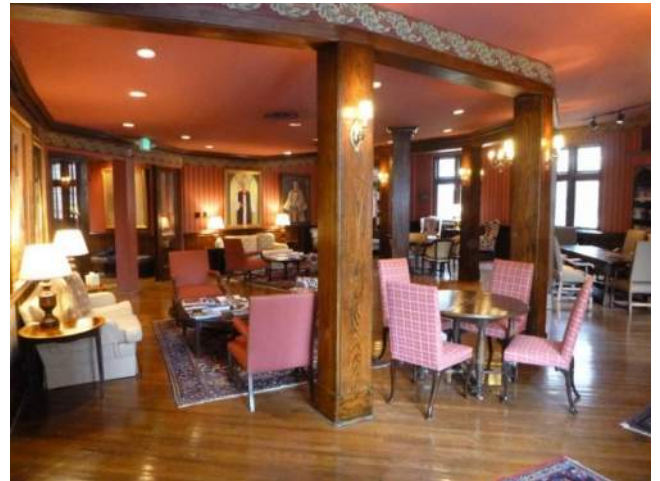
Figure 3.3-10. Overall view of the Library on the second floor of the Egleston building.

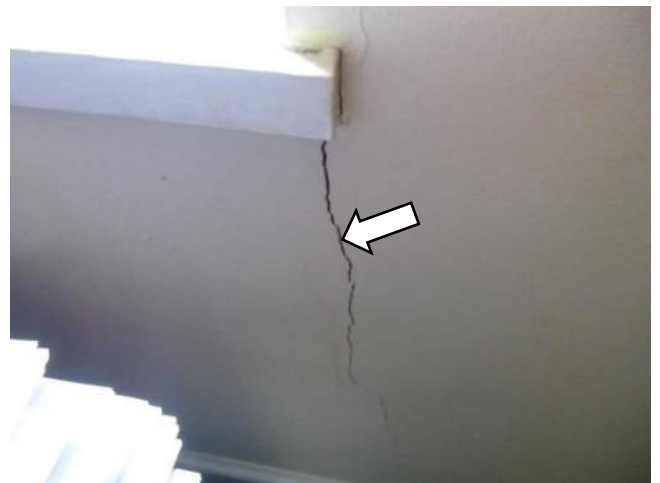
Figure 3.3-30. View of cracked interior gypsum wallboard in a third floor office of the Egleston Building.

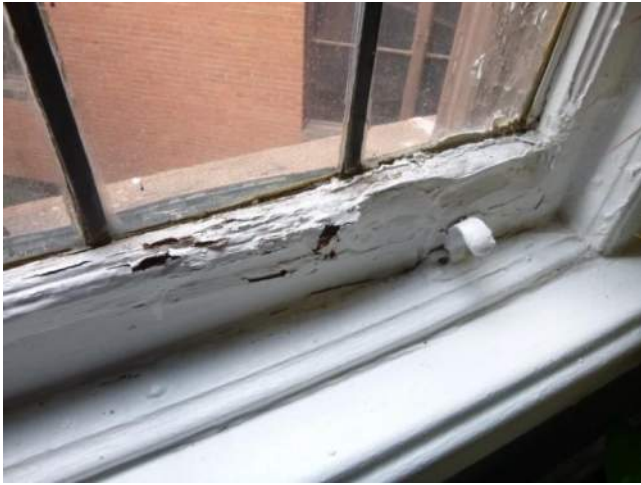
*Figure 3.3-31. View of condition of wood window sash in a third floor office of the Egleston Building.*

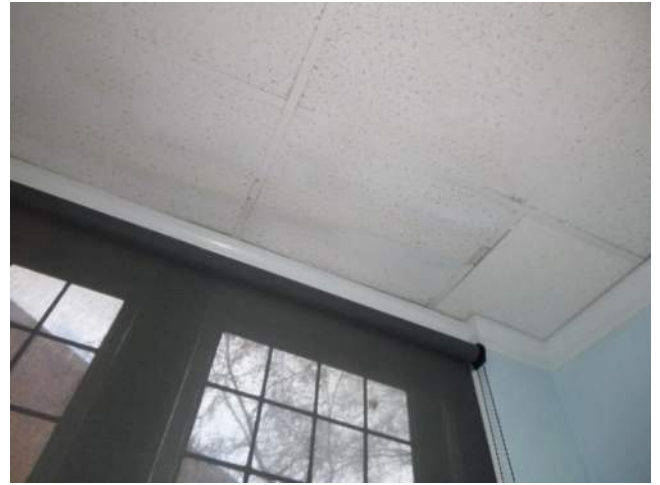
*Figure 3.3-32. View of water damaged ceiling panels in a third floor office of the Egleston Building.*

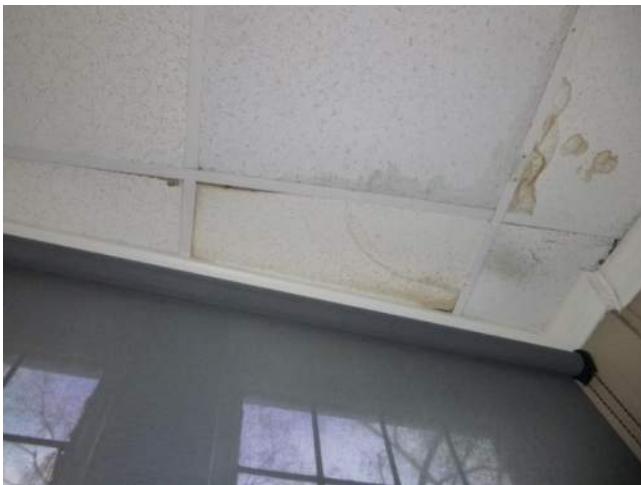
*Figure 3.3-33. View of water damaged ceiling panels in a third floor office of the Egleston Building.*

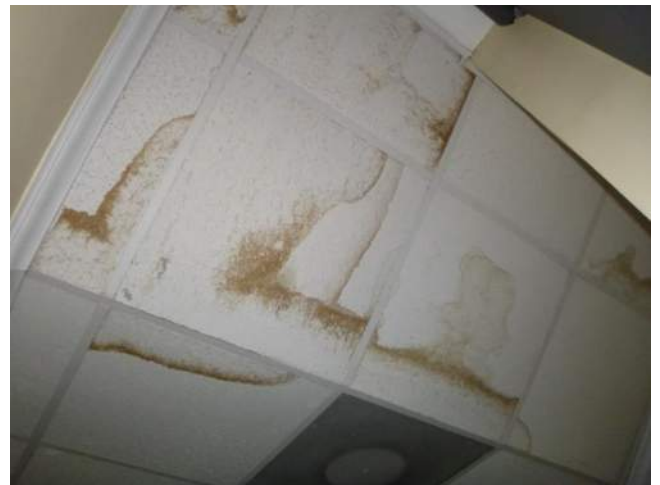
*Figure 3.3-34. View of water damaged ceiling panels in a third floor space of the Egleston Building.*

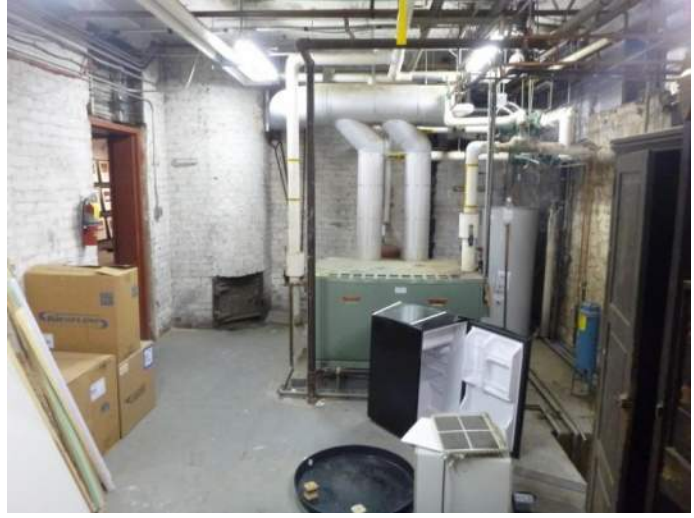
| Condition: | New | Good | <b>Fair</b> | Poor |

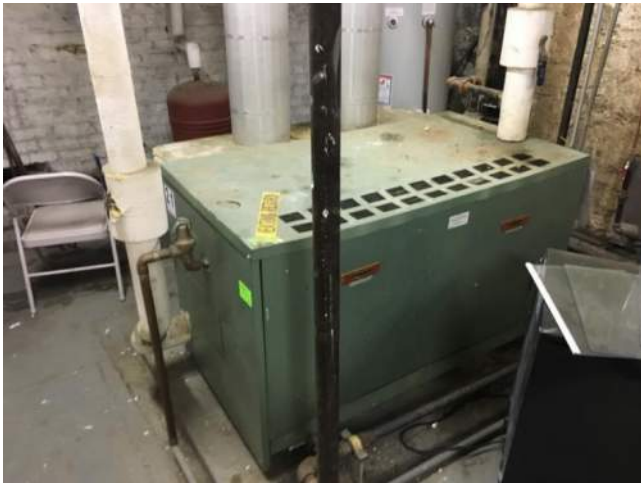
Figure 3.4-1. View of the boiler in the boiler room of Egleston Hall.

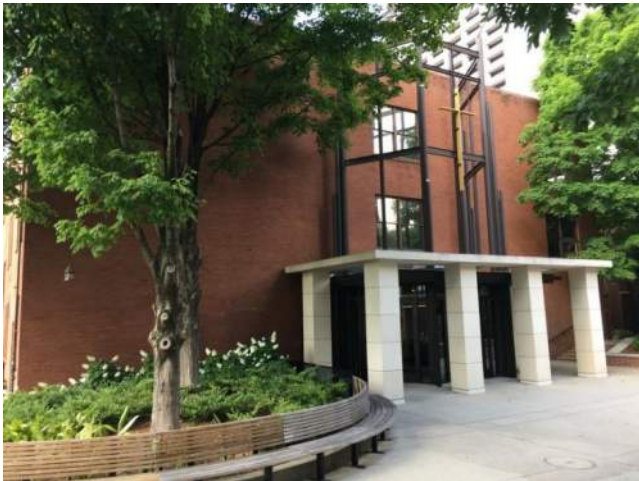
*View of the south facade of the Parish House.*

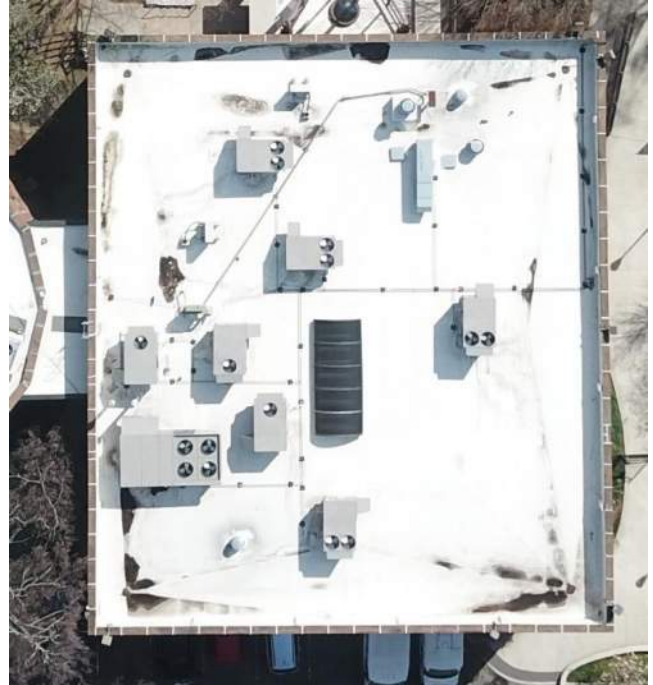
| Condition: | New | <b>Good</b> | Fair | Poor |

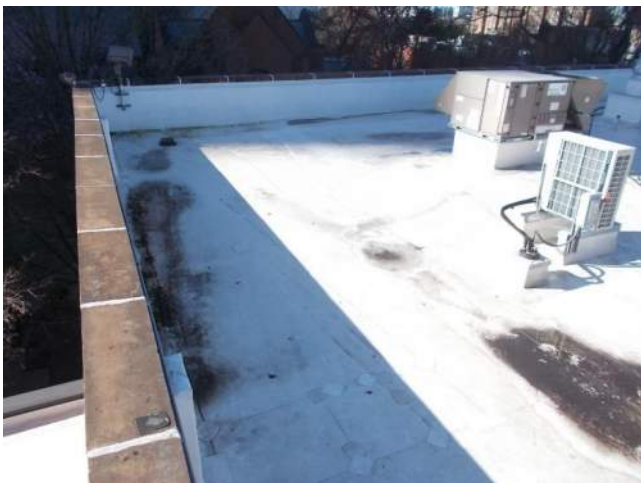
Figure 4.1-1. Overall view of the roof looking from the top of the west parapet wall.

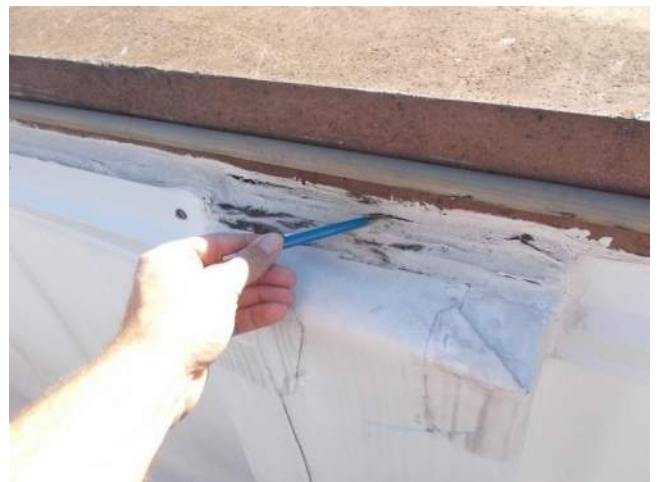
*Figure 4.1-8. View of failed sealant at the top of the piers at the interface of the metal counter flashing.*

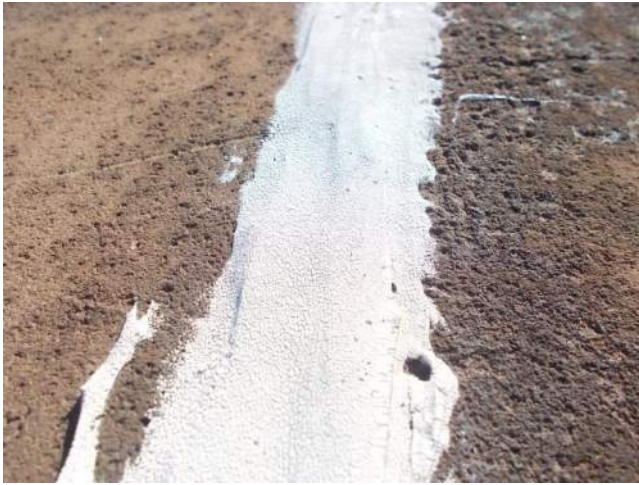
*Figure 4.1-9. Deteriorated sealant between the coping joints.*

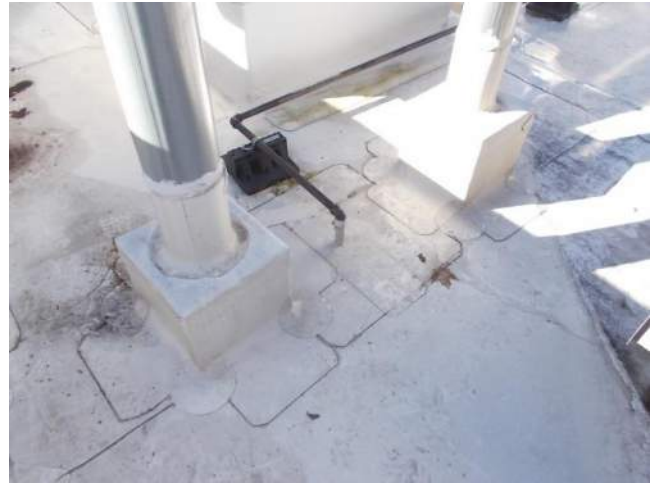
*Figure 4.1-10. Membrane penetration flashings at equipment curbs and pipe penetrations.*

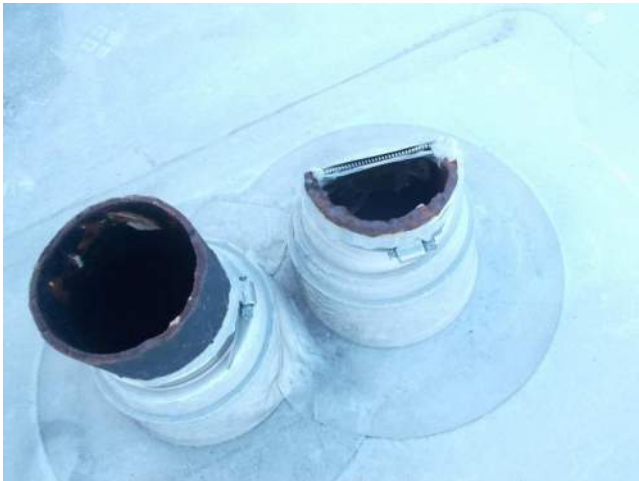
*Figure 4.1-11. Broken cast iron pipe penetration.*

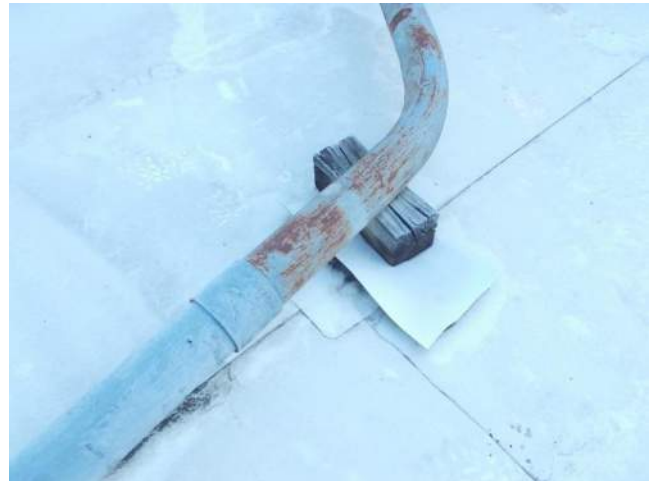
*Figure 4.1-12. Mechanical pipes supported with a wood blocking.*

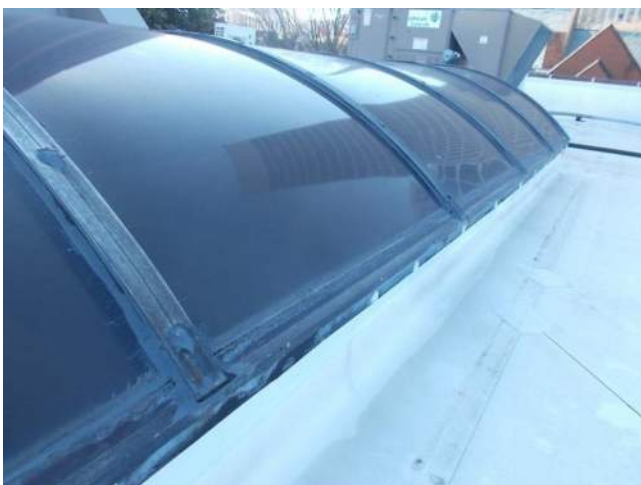
Figure 4.1-19. Sealant at skylight was chalky and generally deteriorated

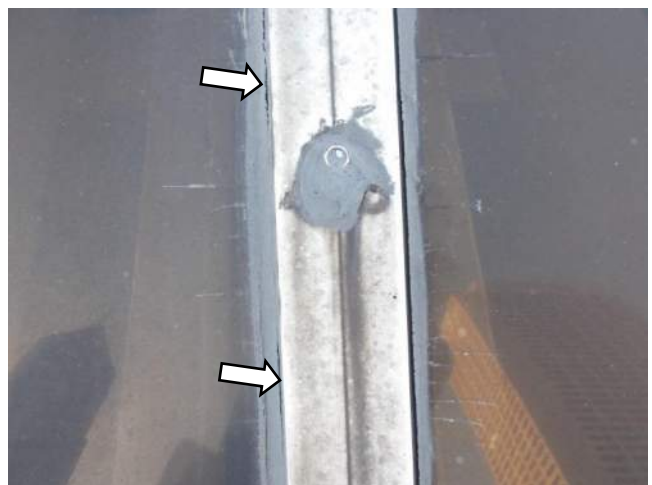
Figure 4.1-20. Adhesive failure of sealant at skylight.

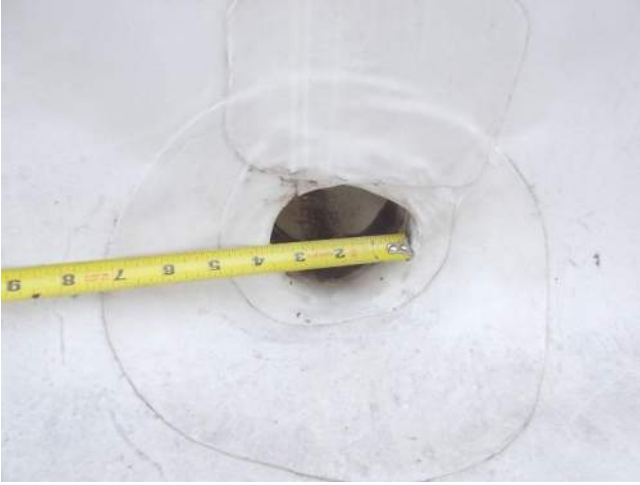
*Figure 4.1-21. View of 3 inch diameter scupper.*

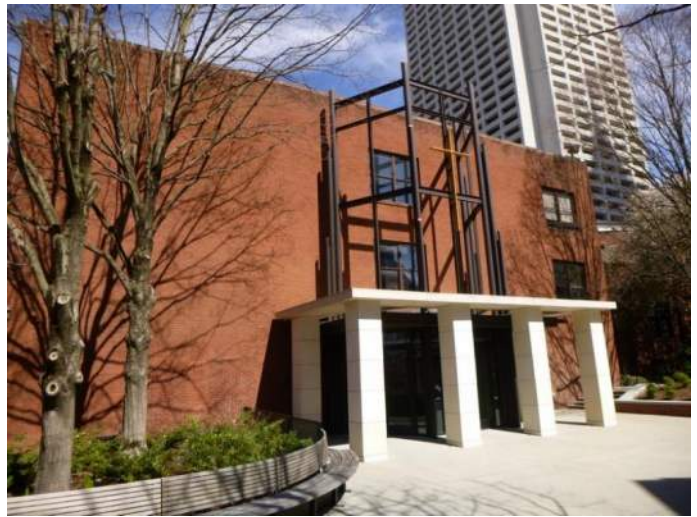
### Summary and Discussion of Observed Conditions:

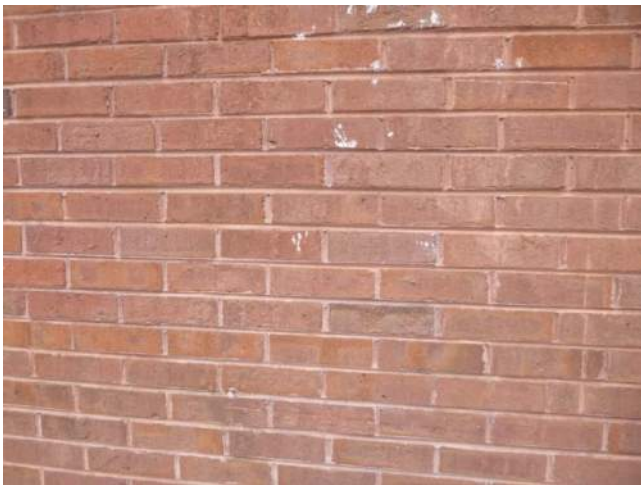
Figure 4.2-1. View of the condition of a typical area of brick masonry facade of the Parish House.

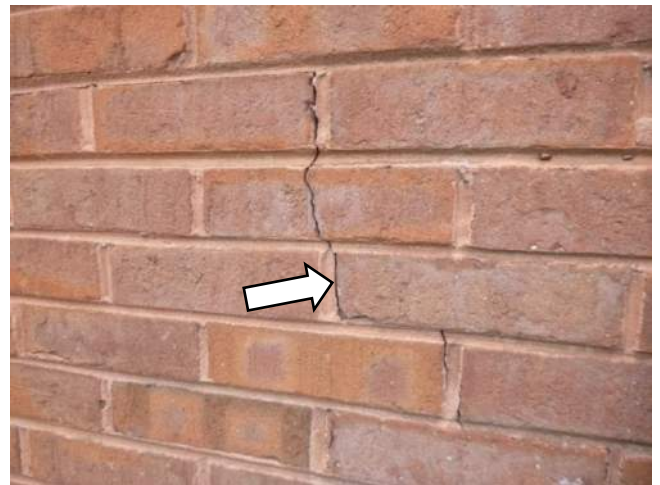
Figure 4.2-2. View of a stepped crack in the brick masonry facade of the Parish House.

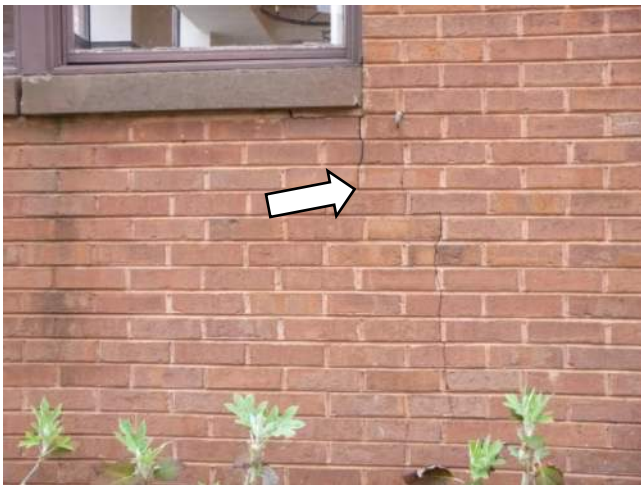
Figure 4.2-3. View of a crack in the brick masonry facade extending from a window corner.

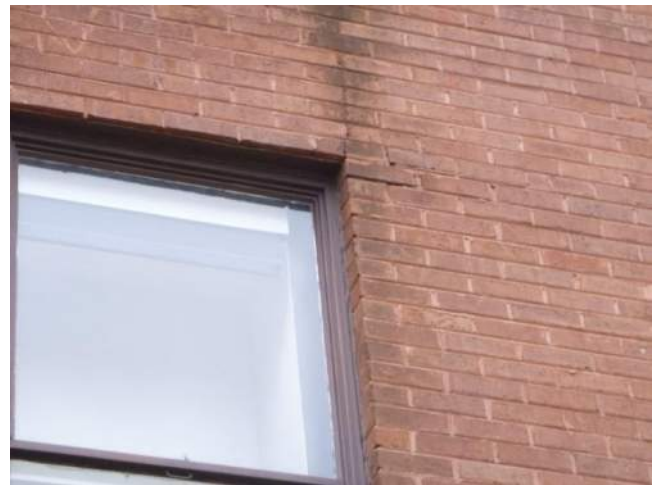
Figure 4.2-4. View of deteriorated mortar at a window corner.

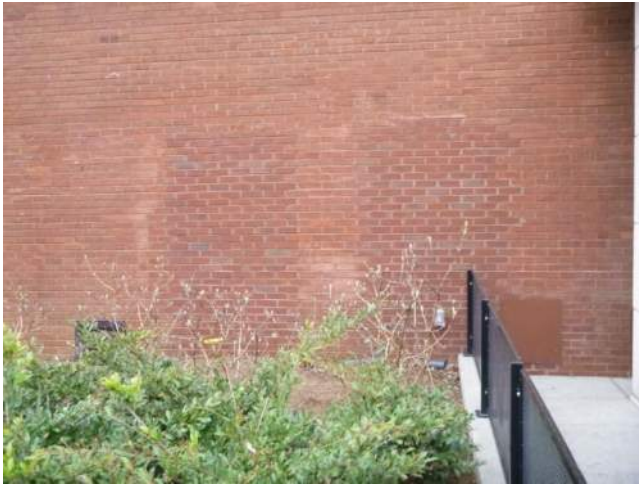
*Figure 4.2-5. View of areas of masonry fill at previous openings on the south facade.*

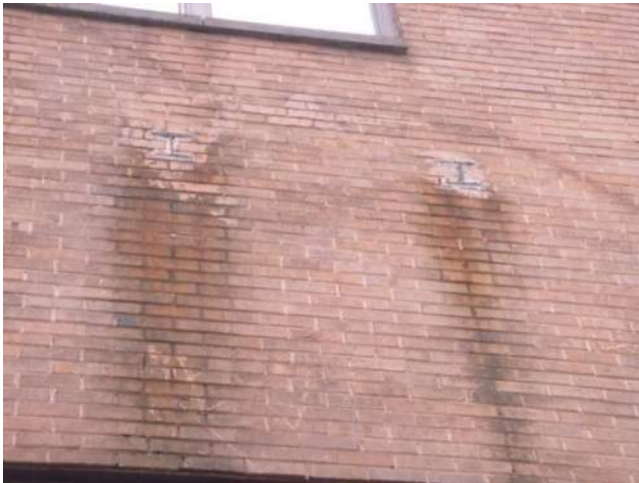
*Figure 4.2-7. View of staining from embedded steel in the masonry facade on the west elevation.*

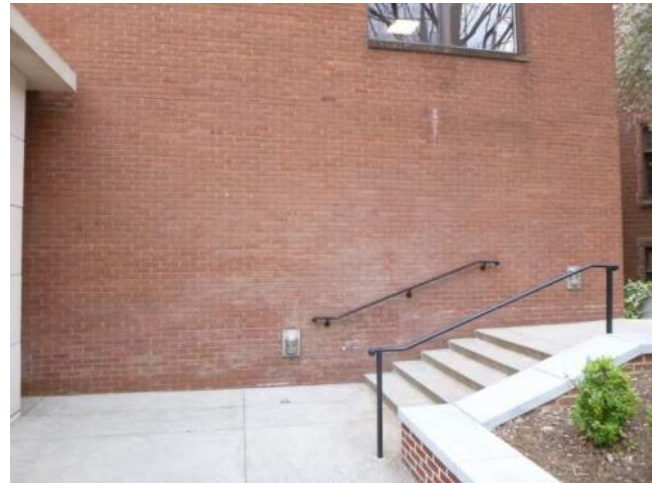
*Figure 4.2-8. View of isolated areas of efflorescence on the south elevation.*

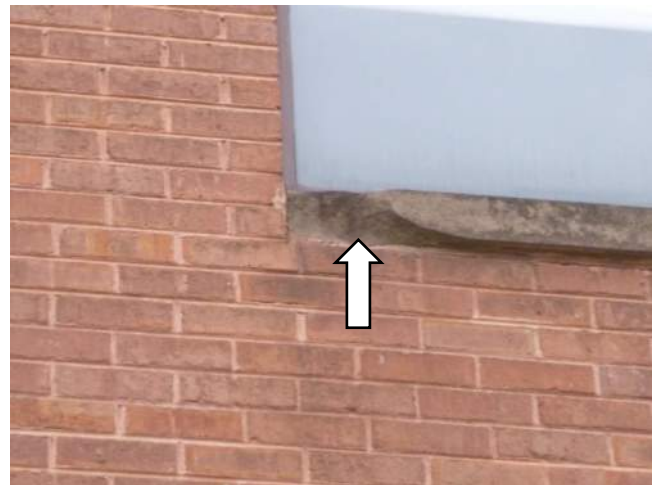
*Figure 4.2-10. View of a spall at a cast stone sill on the third floor.*

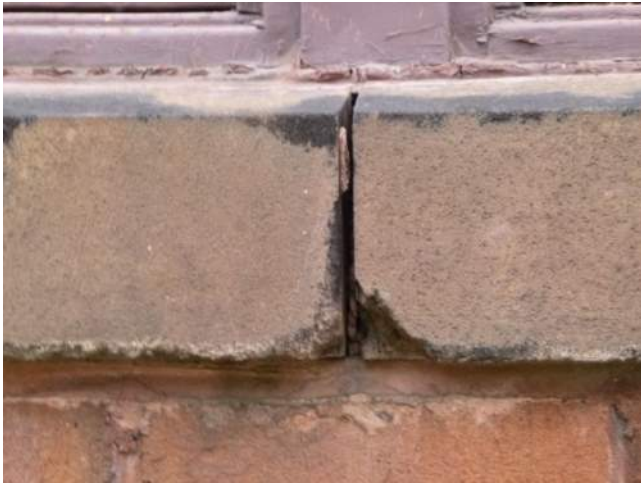
*Figure 4.2-11. View of a minor spall and missing mortar at a cast stone window sill.*

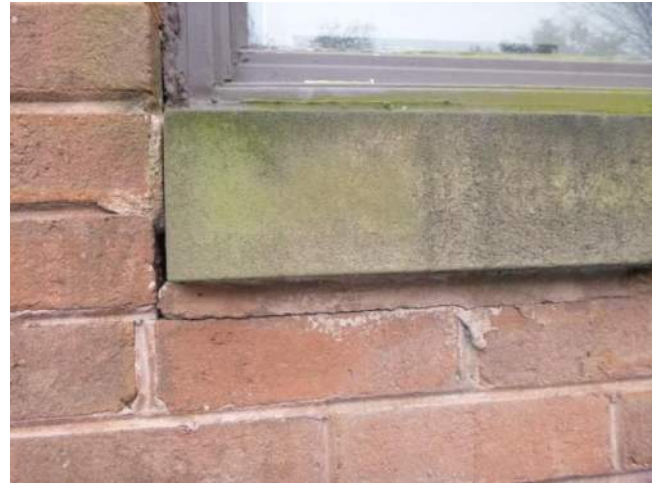
*Figure 4.2-12. View of failed and missing mortar at a typical cast stone sill.*

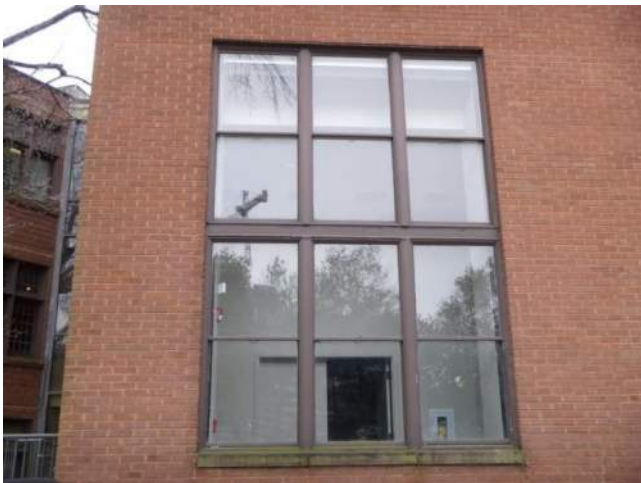
*Figure 4.2-13. View of a double height ganged window on the first floor of the north elevation.*

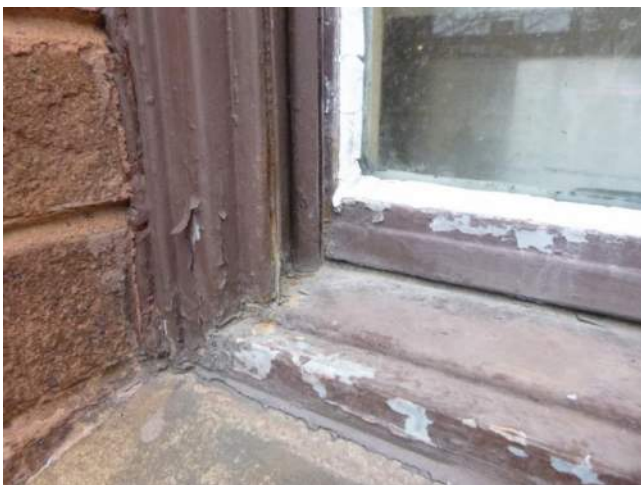
*Figure 4.2-15. View of failed painted coating on a window assembly.*

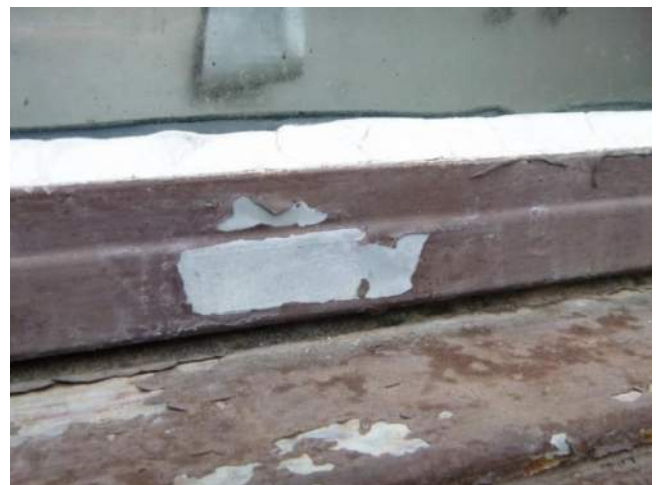
*Figure 4.2-16. View of failed painted coating on a window assembly.*

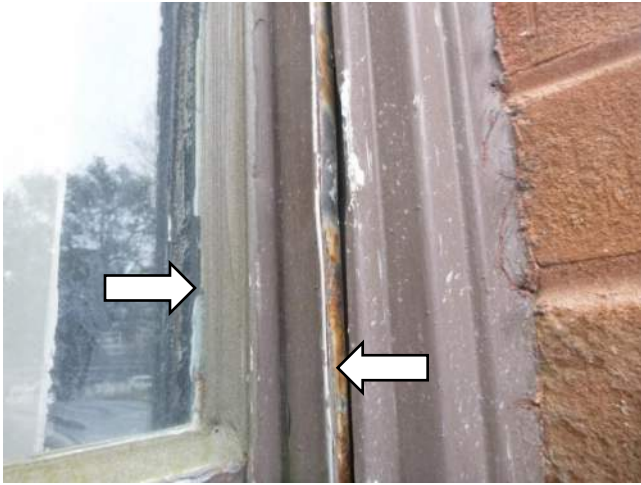
*Figure 4.2-17. View of wet seal repairs and corrosion on an isolated window flashing.*

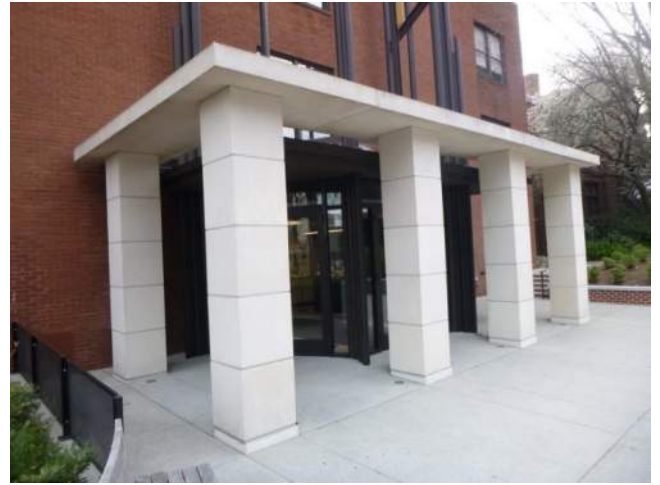
*Figure 4.2-18. View of the cast stone covered entrance portico on the south elevation.*

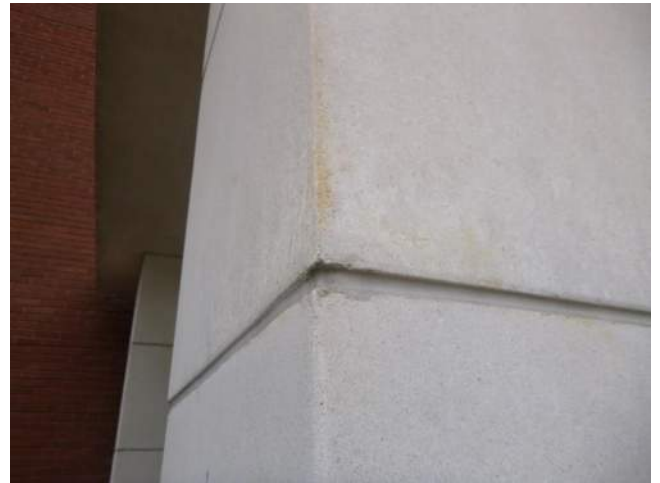
*Figure 4.2-20. View of corrosion at a corner on a cast stone column of the portico.*

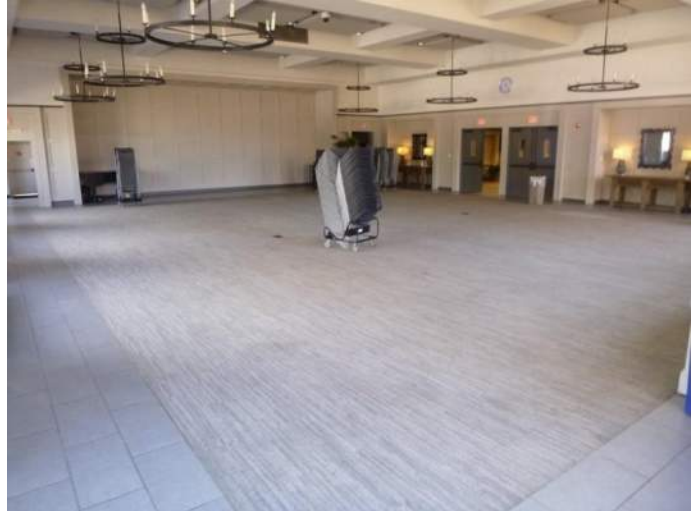
| Condition: | New | Good | Fair | Poor |

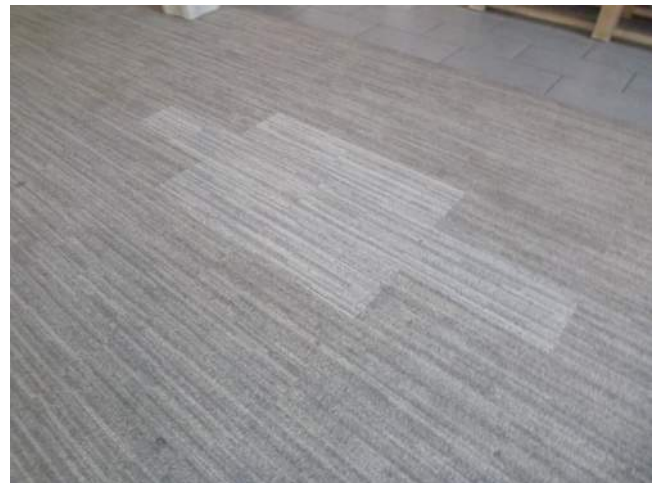
Figure 4.3-6. View of a section of replaced carpet tile in Ellis Hall.

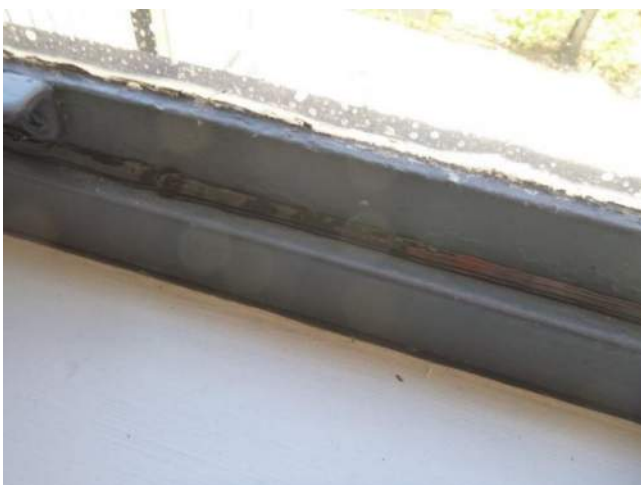
Figure 4.3-7. View of a typical sealed window in Ellis Hall in the Parish House.

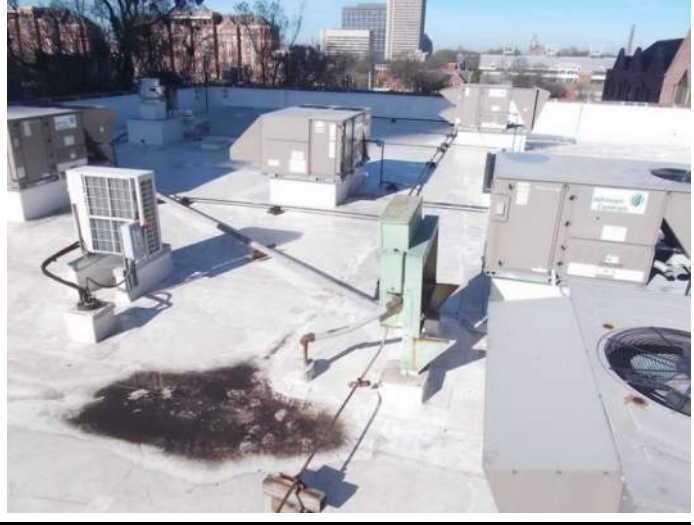
| Condition: | New | <b>Good</b> | Fair | Poor |

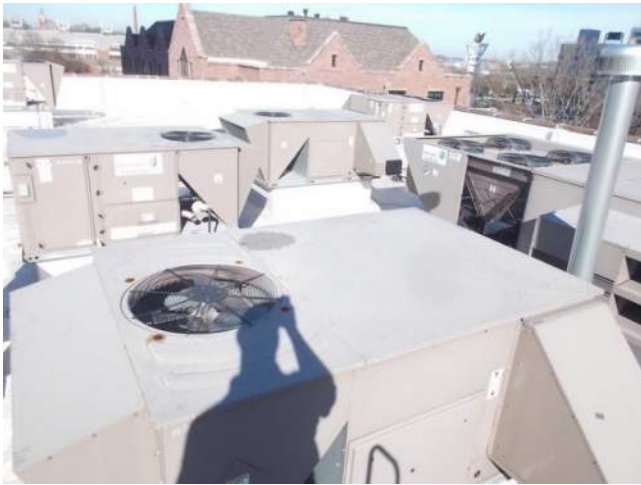
Figure 4.4-1. Partial view of the mechanical equipment on the Parish House roof level.

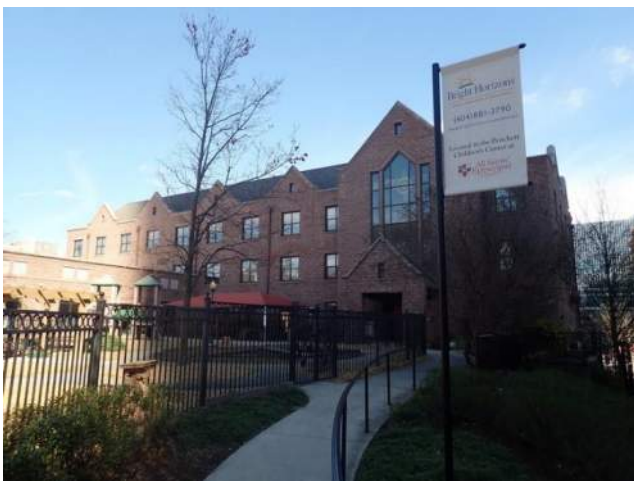
*South facade of the Pritchett Children's Center*

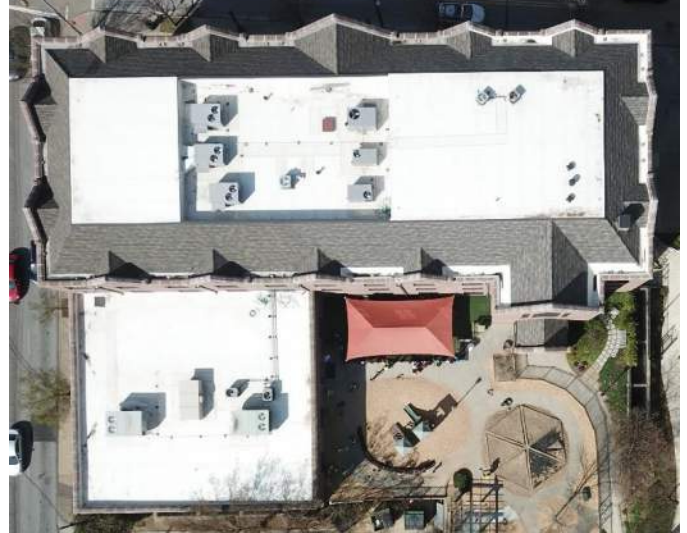
| Condition: | New | <b>Good</b> | Fair | Poor |

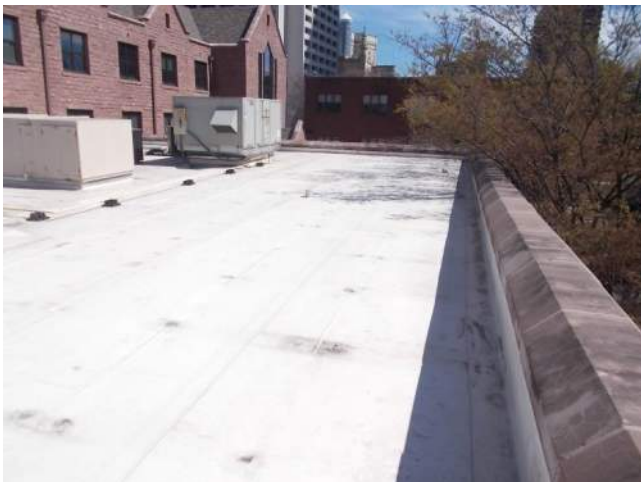
Figure 5.1-1. Overall view of the main lower roof area looking from the southwest corner of the roof.

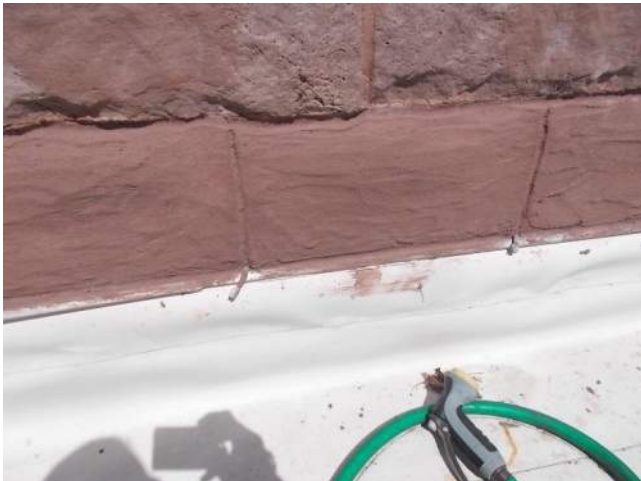
*Figure 5.1-5. Base of wall stone repairs with flashings installed at the interface of the roof membrane.*

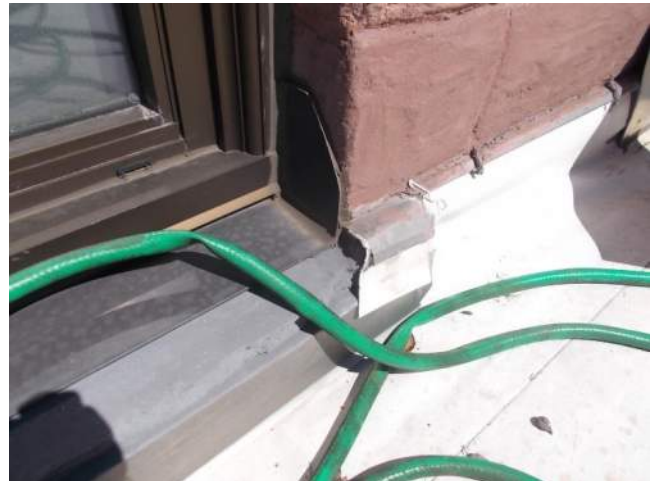
*Figure 5.1-6. Through wall flashing interfaces the window opening and is not well sealed or integrated.*

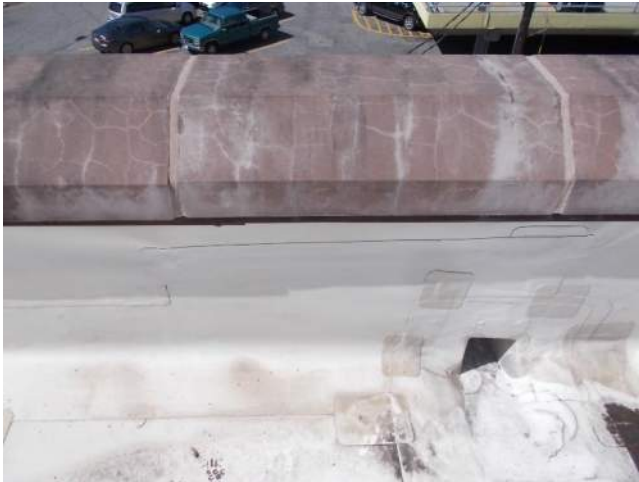
*Figure 5.1-9. Cast stone coping with crazing cracks and deteriorated sealant joints.*

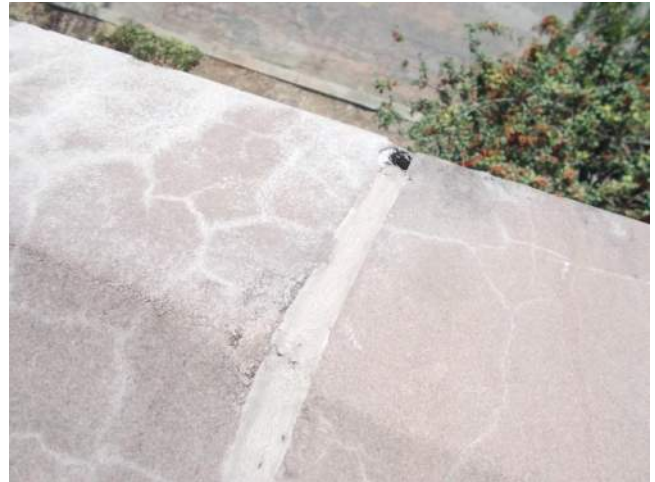
*Figure 5.1-10. Cast stone coping with crazing cracks and deteriorated sealant joints.*

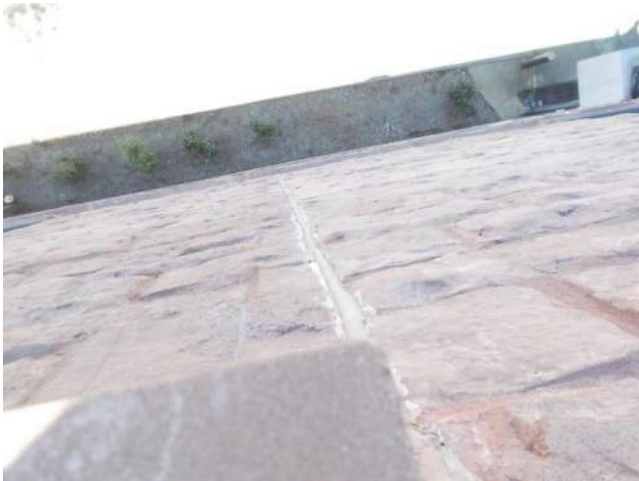
*Figure 5.1-11. Expansion joint in the outer wall at the northwest corner of the roof does not continue up and over the wall to the roof.*

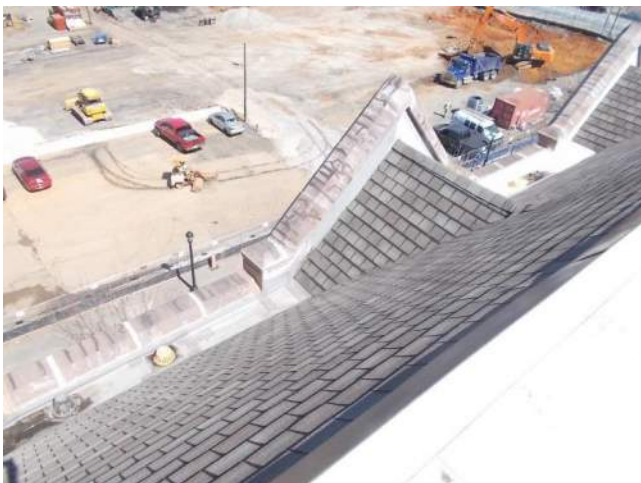
*Figure 5.1-19. Cast stone coping with crazing cracks, many repaired with a liquid applied material.*

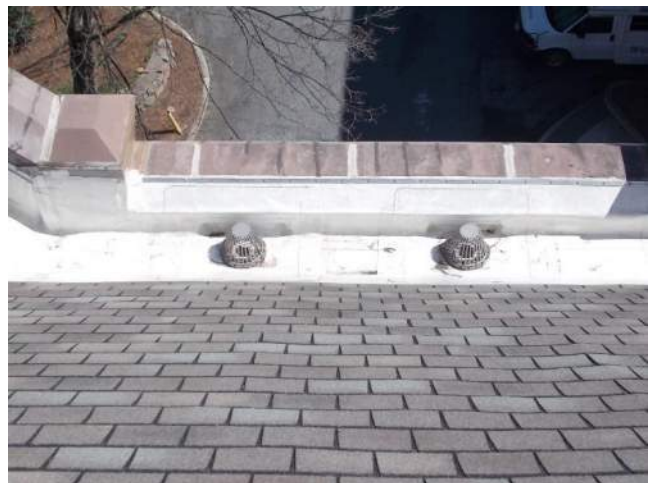
*Figure 5.1-20. TPO roof membrane at internal gutter terminated with mechanically fastened termination bars and sealant.*

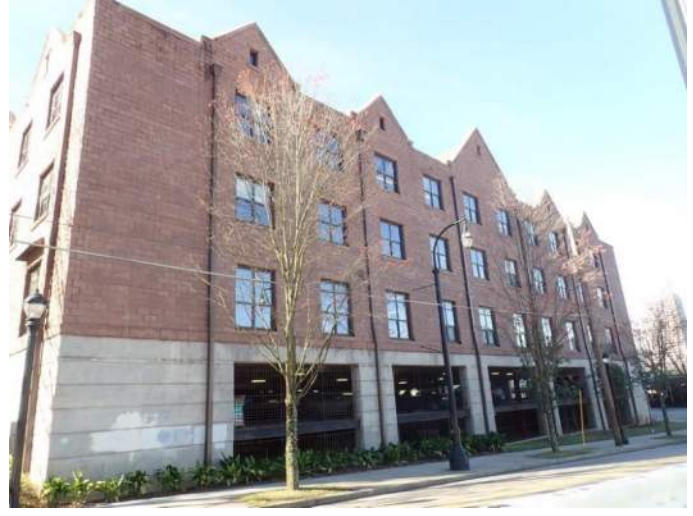
| Condition: | New | <b>Good</b> | Fair | Poor |
