# ALL SAINTS' EPISCOPAL CHURCH

## Building Envelope Assessment and Capital Reserve Study

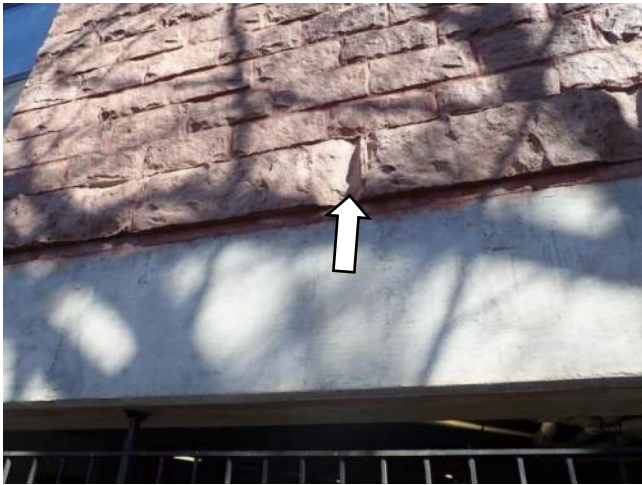
Figure 5.2-1. Isolated spalls at a manufactured stone masonry ledge.

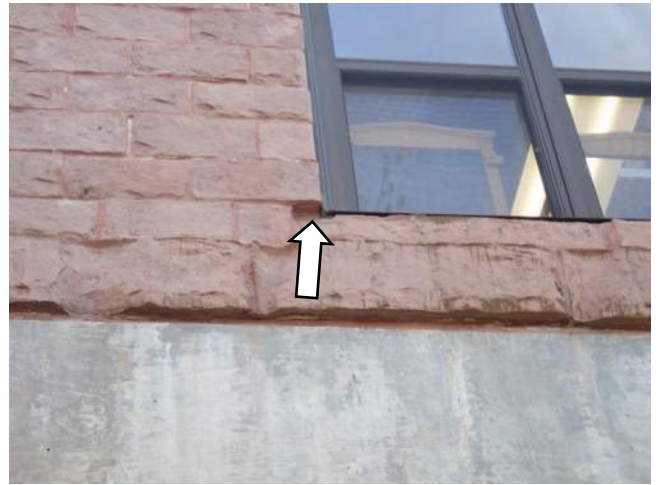
Figure 5.2-2. Isolated spalls at a window sill.

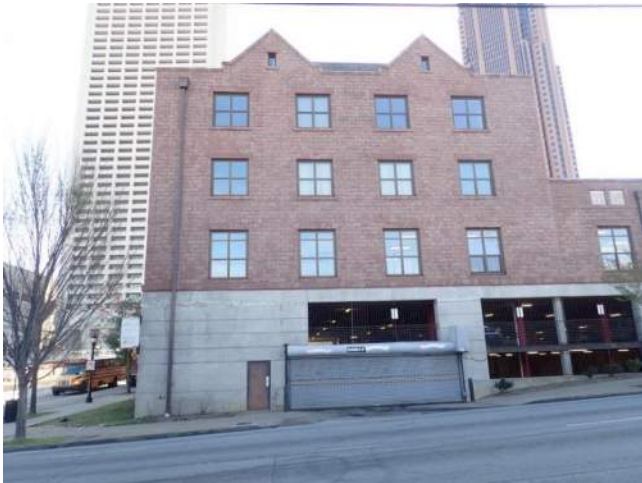
Figure 5.2-3. Overall view of the condition of the manufactured stone masonry facade.

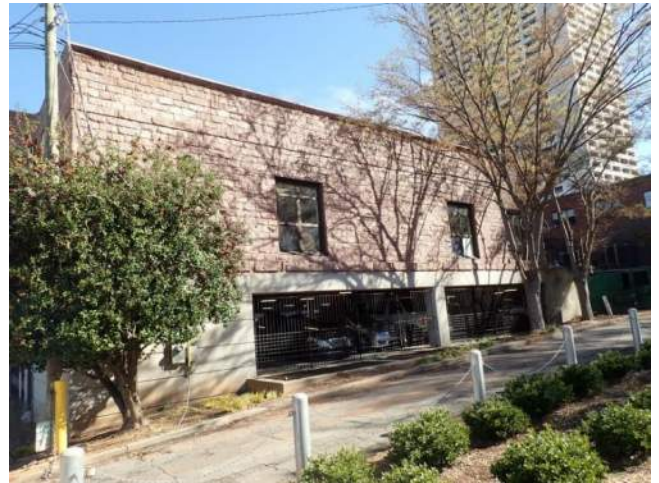
Figure 5.2-4. Overall view of the condition of the manufactured stone masonry facade.

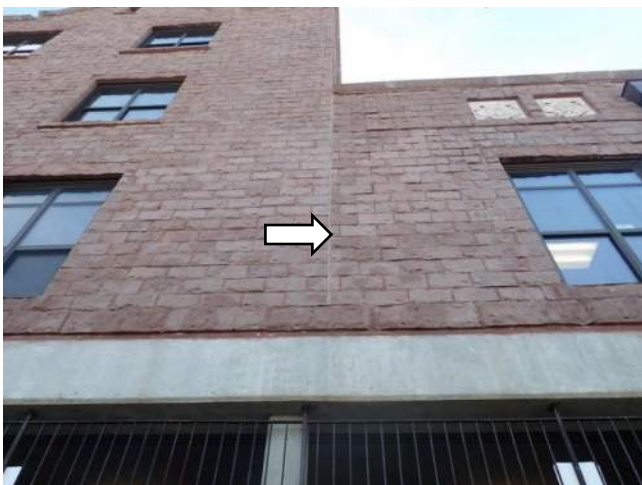
Figure 5.2-5. Vertical expansion joint at the transition between a three story and a one story structure at the west elevation.

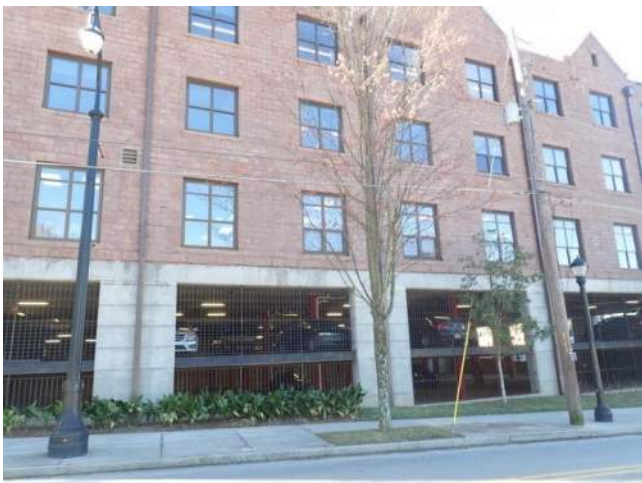
Figure 5.2-11. No deficiencies on exposed cast-in-place concrete elements at the parking garage.

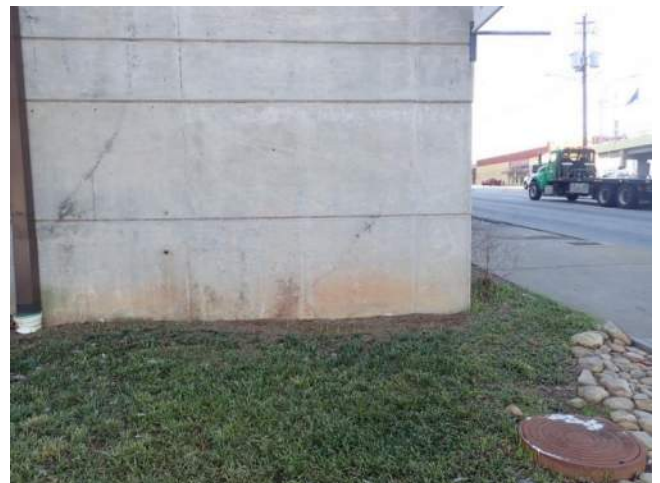
Figure 5.2-12. Isolated cracking at the northwest corner of the parking garage.

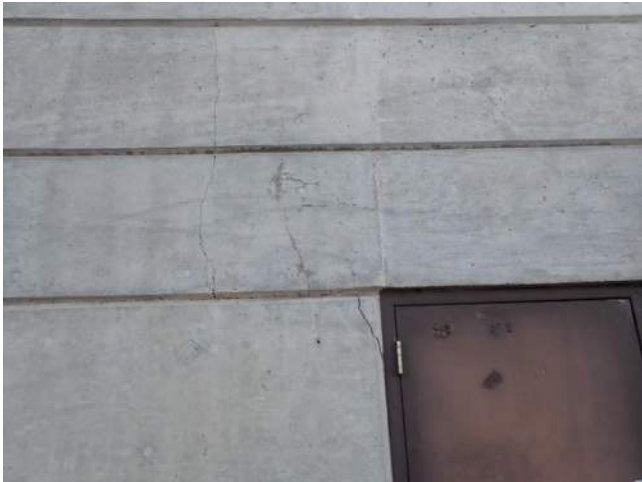
*Figure 5.2-13. A crack and spalled corner of the concrete adjacent to a ground level entrance door.*

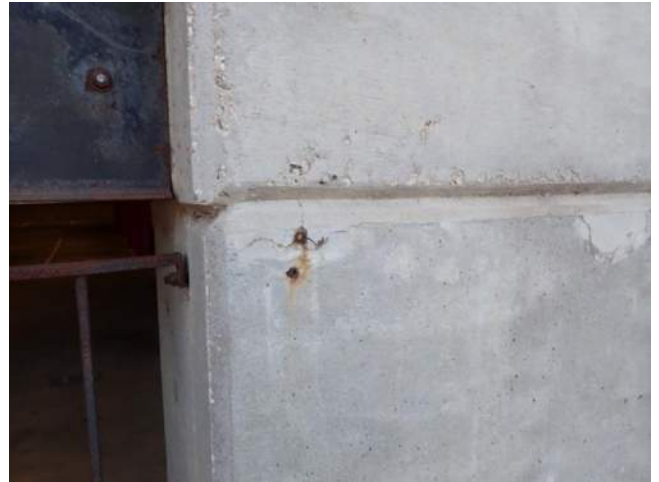
*Figure 5.2-14. Surface cracking and shallow surface spalls at the north elevation.*

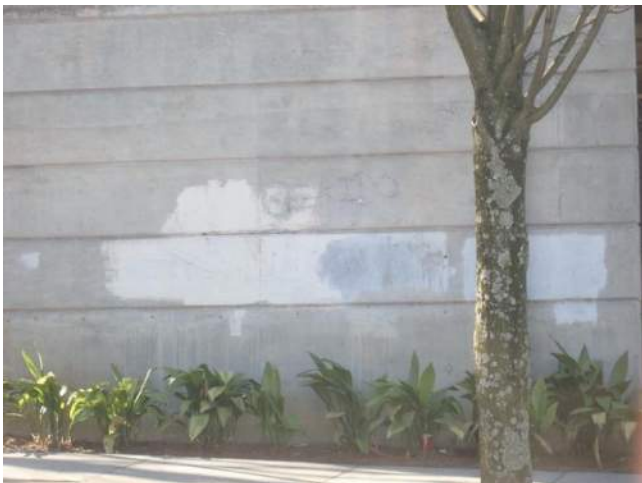
*Figure 5.2-15. Evidence of graffiti at the northeast corner of the parking structure*

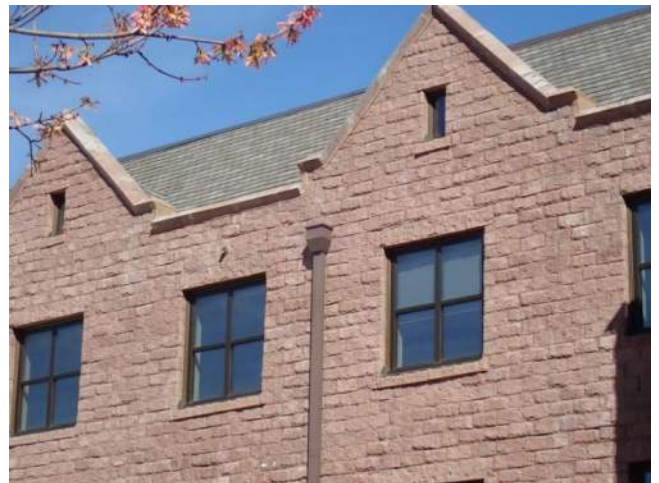
*Figure 5.2-16. Aluminum framed window systems were observed to be in good condition.*

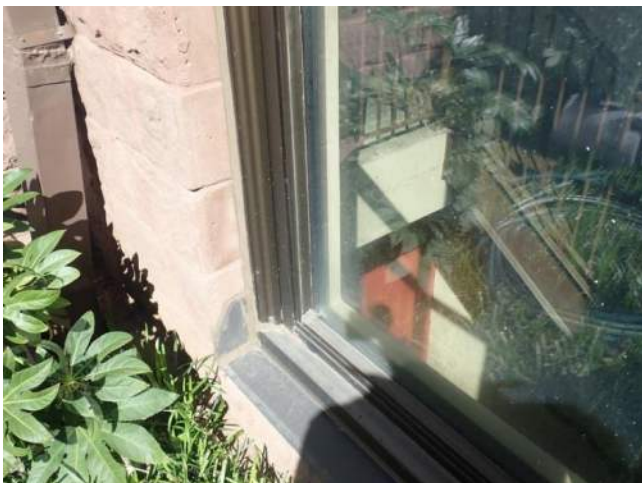
*Figure 5.2-17. The window perimeter sealants were in good condition.*

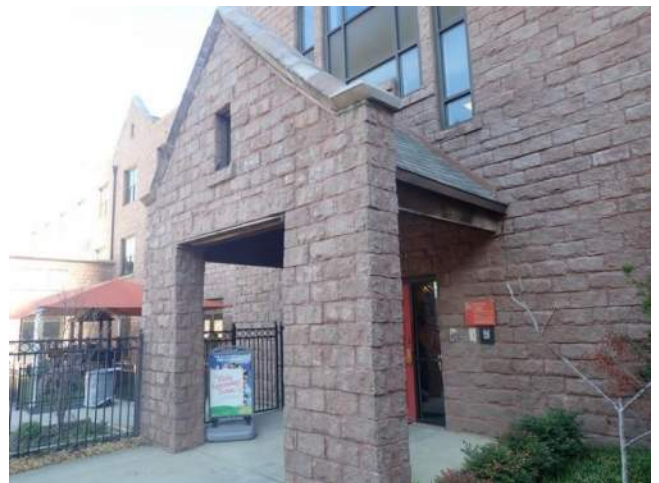
*Figure 5.2-18. Wood trim and soffit at the entrance canopy at the southeast entrance had been removed, exposing the wood structural framing elements.*

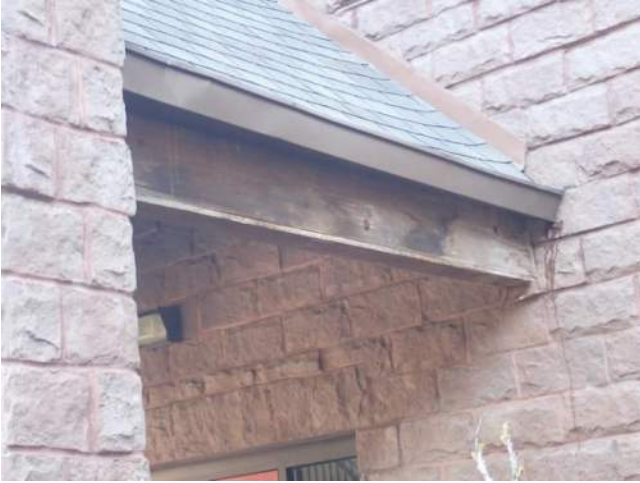
*Figure 5.2-19. Water staining on the exposed structural members.*

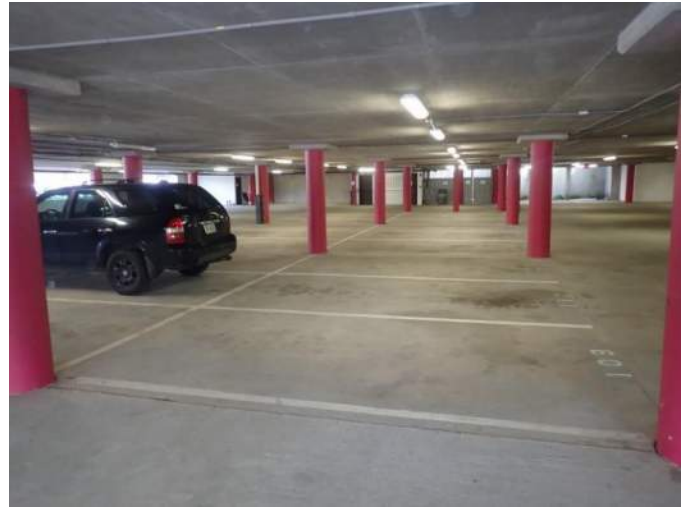
| Condition: | New | <b>Good</b> | Fair | Poor |

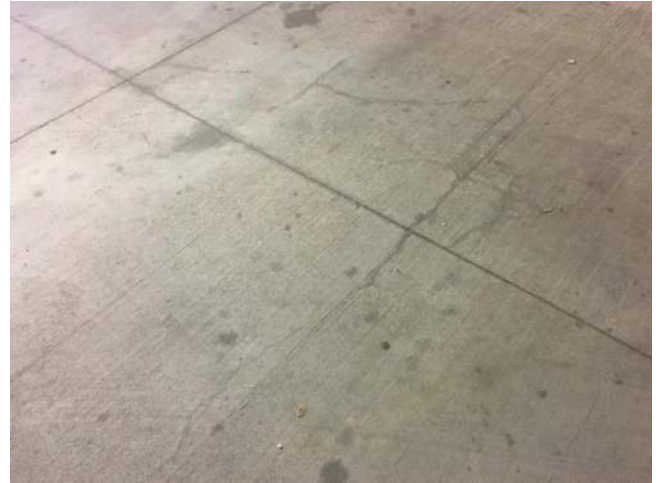
Figure 5.3-2. View of a crack in the bottom level of the parking structure.

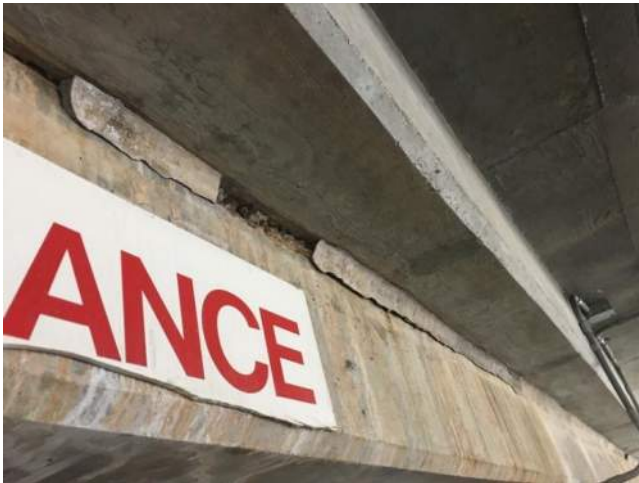
Figure 5.3-3. View of loose overhead concrete in parking garage from original formwork.

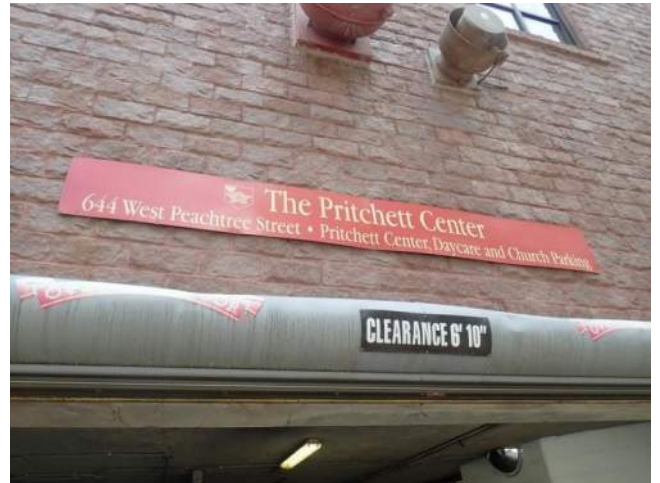
Figure 5.3-4. View of an overhead door at the upper level entrance of the Pritchett center parking structure.

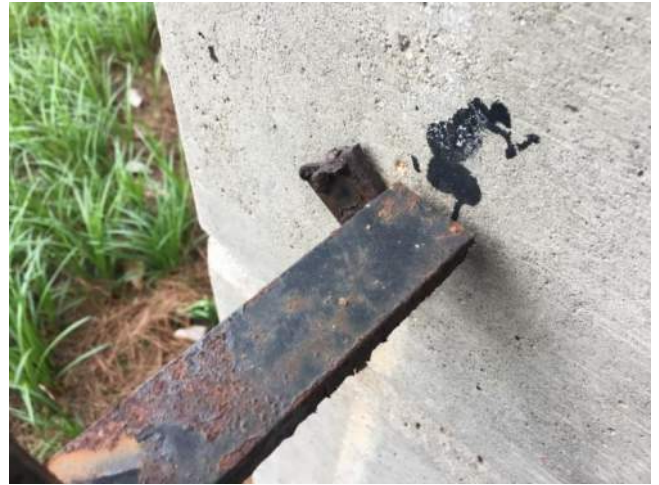
Figure 5.3-8. View of a failed connection in the metal fencing.

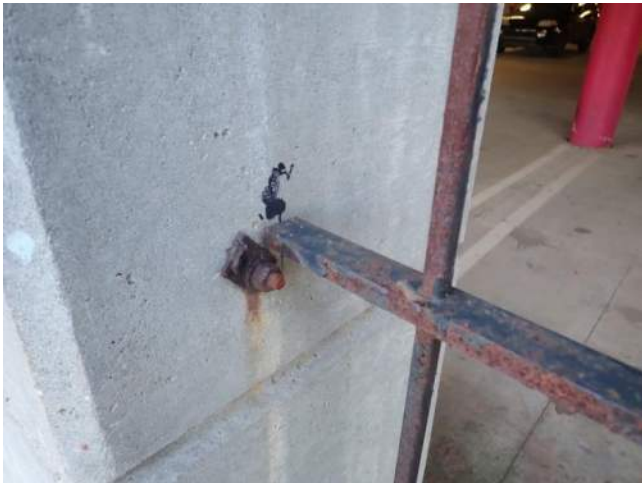
Figure 5.2-9. Failed connections at parking garage fencing.

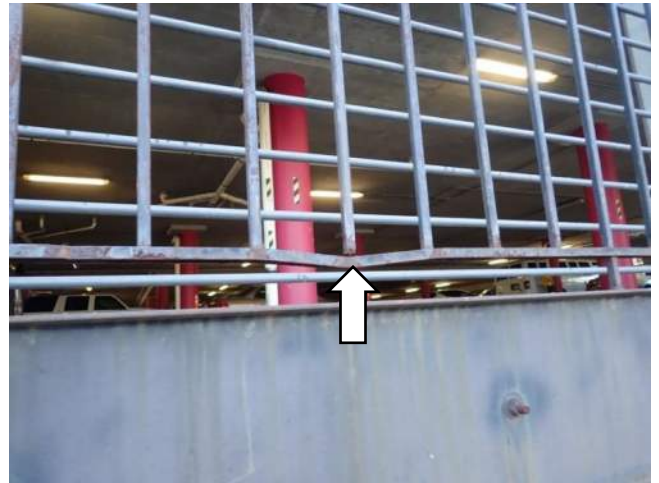
Figure 5.2-10. Failed fence element at parking garage opening.

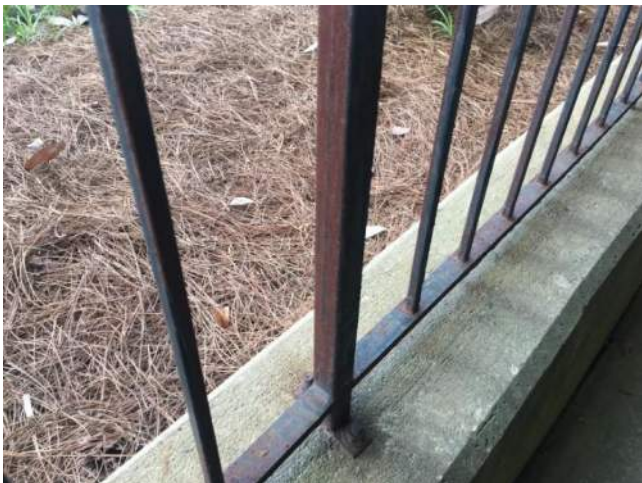
Figure 5.2-11. Fencing is anchored to the concrete structural frame and to a steel slab edge cover.

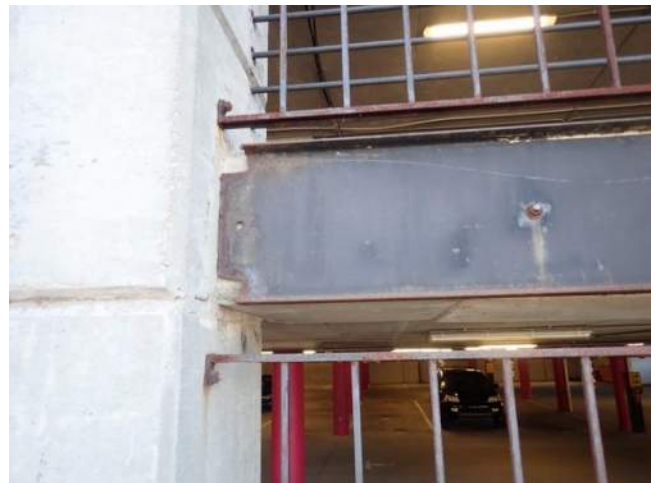
Figure 5.3-12. View of corrosion on metal fencing between openings in the parking structure.

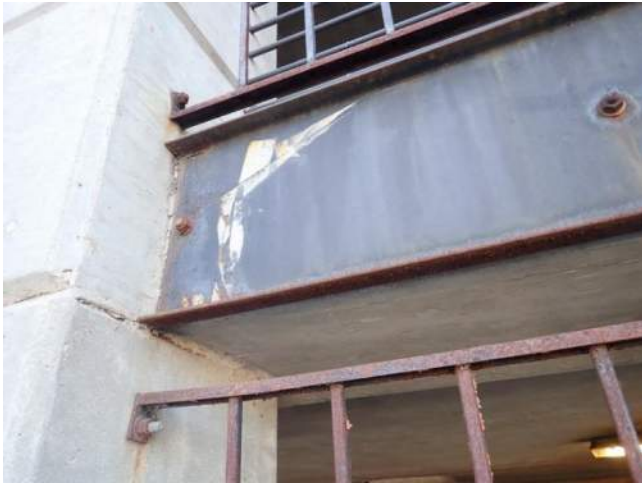
*Figure 5.2-13. The existing coating was failed and flaking and in poor condition on the exposed steel elements.*

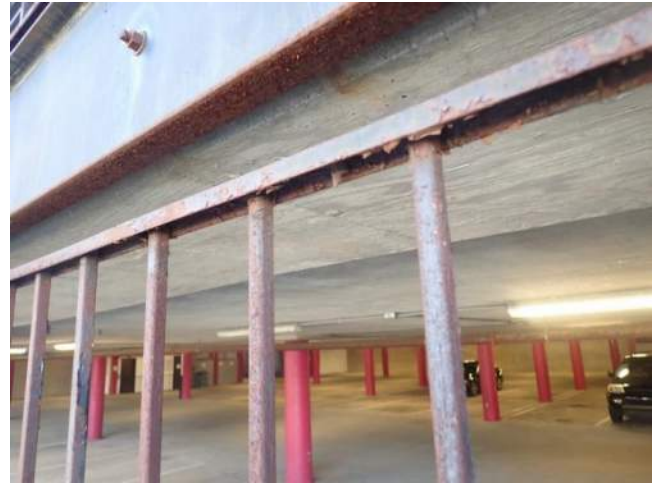
*Figure 5.2-14. Widespread surface corrosion on the steel fencing at the openings in the parking structure.*

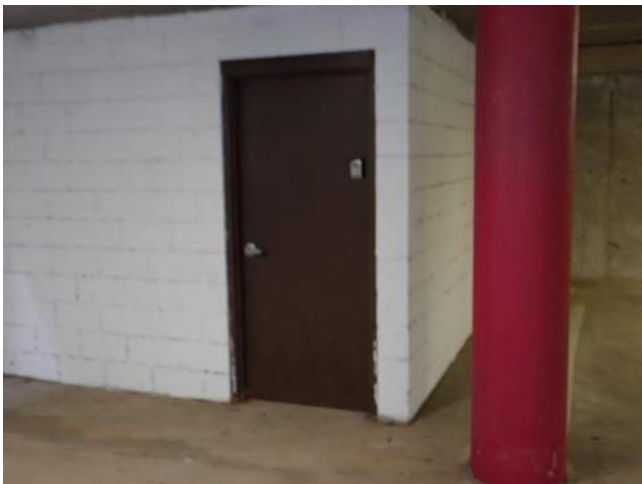
*Figure 5.3-15. View of a typical storage space at the corner of the Pritchett center parking structure.*

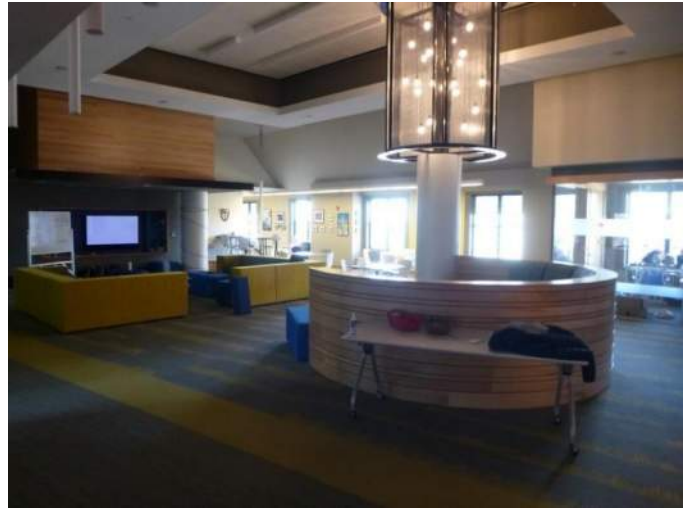
### ***Summary and Discussion of Observed Conditions:***

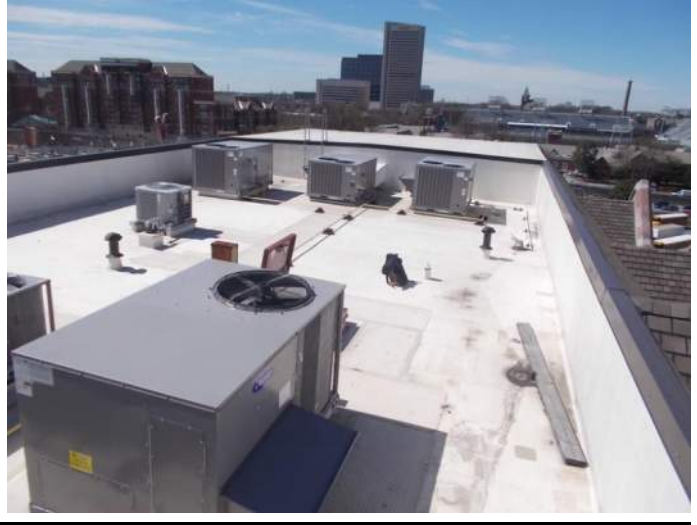
| Condition: | New | <b>Good</b> | Fair | Poor |

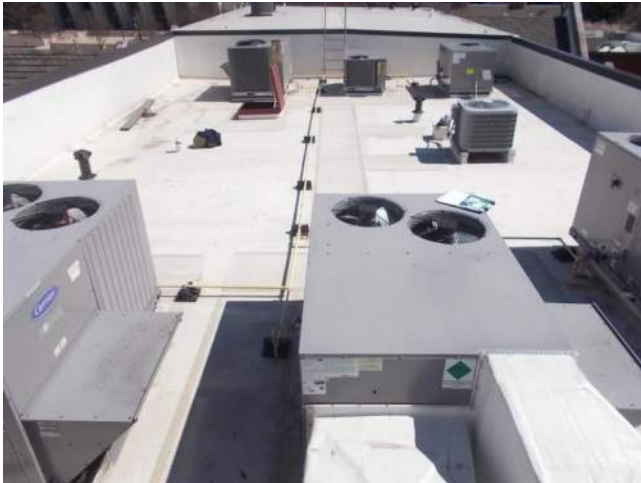
*Figure 5.5-1. View of mechanical equipment on the upper roof of the Pritchett Center.*

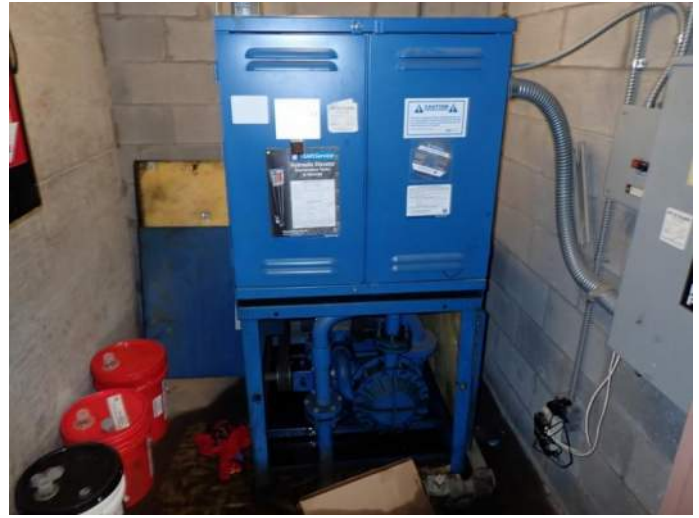
| Condition: | New | Good | Fair | Poor |

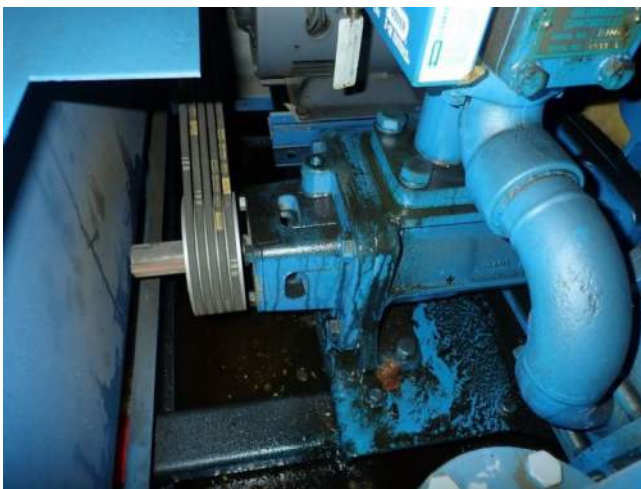
Figure 5.6-1. View of the leaking elevator hydraulics system located in the lower level of the parking structure.

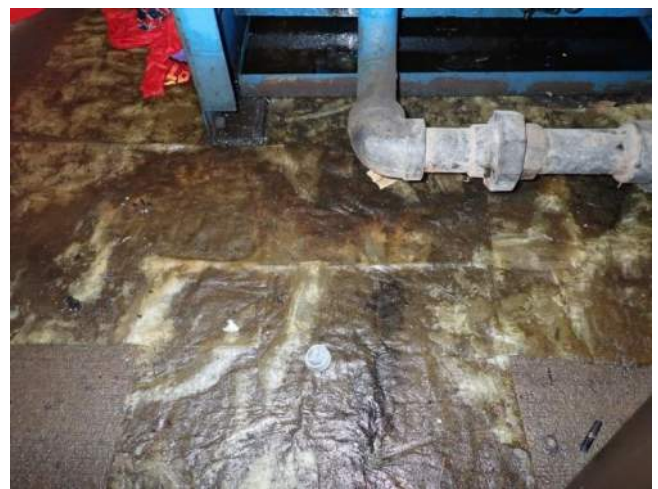
Figure 5.6-2. View of the leak in the elevator hydraulic system.

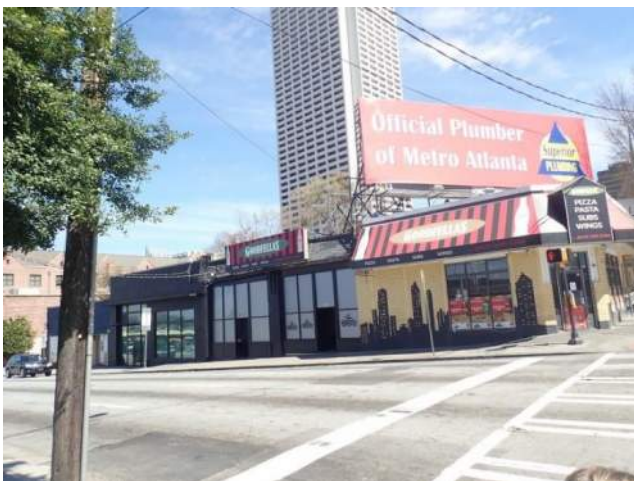
*West facade of the restaurant/retail facade.*

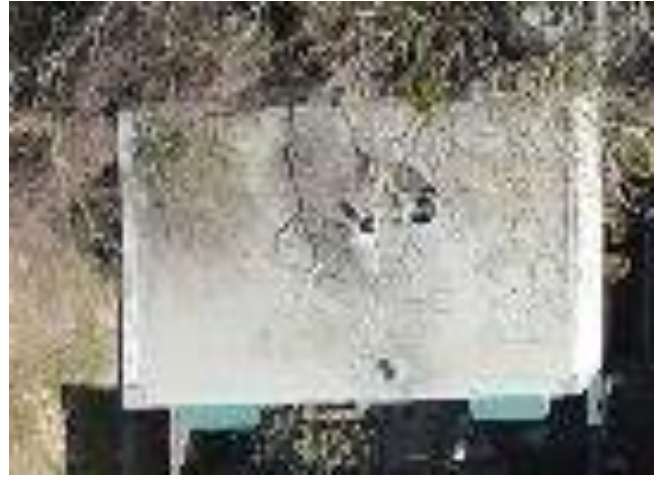
| Condition: | New | Good | <b>Fair</b> | Poor |

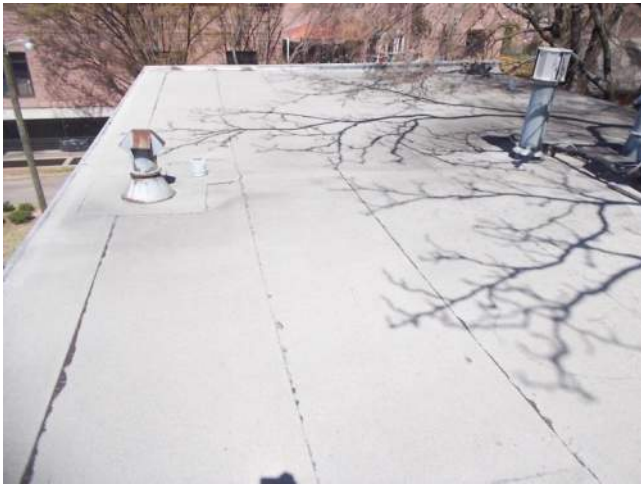
*Figure 6.1-1. Overall view of the roof.*

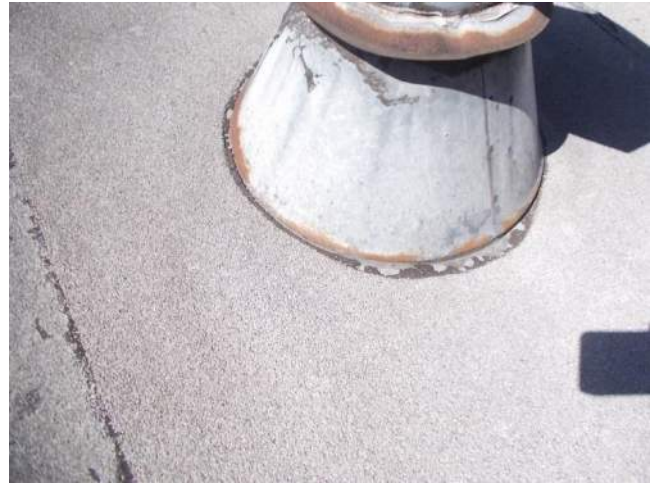
*Figure 6.1-8. Deteriorated liquid membrane and sealant at pipe and vent penetrations.*

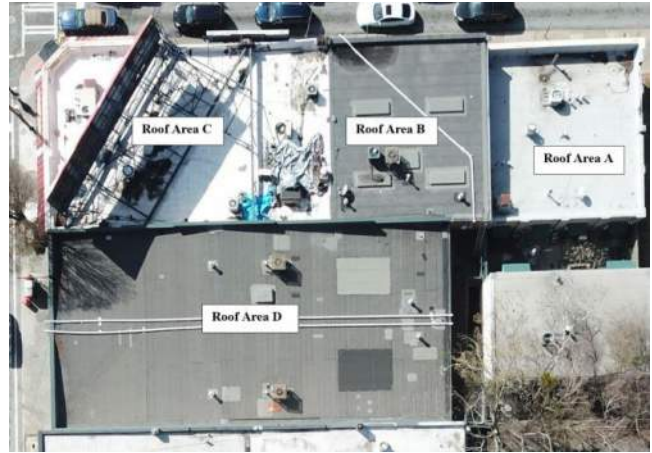
### **Recommendations for Repair and Maintenance**

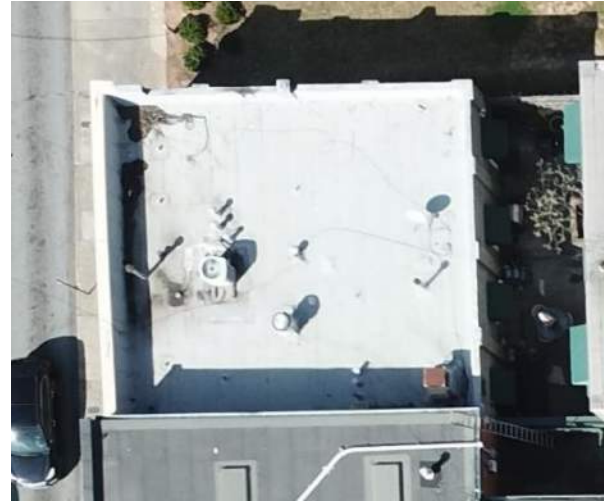
| Condition: | New | Good | <b>Fair</b> | Poor |

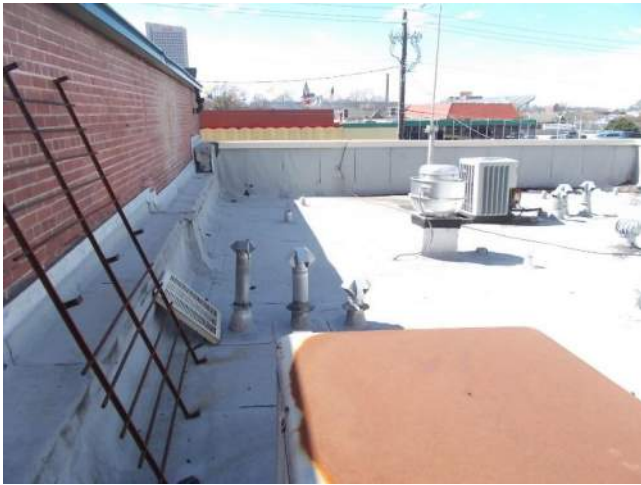
*Figure 6.2A-1. Overall view of the roof area looking from the southeast corner of the roof.*

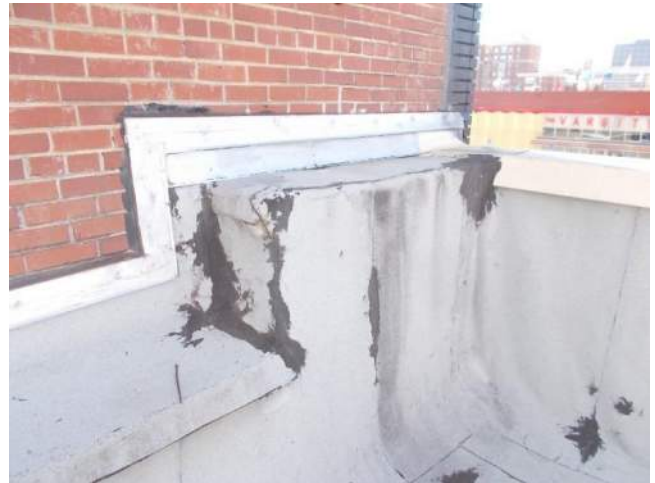
*Figure 6.2A-4. Liquid membrane patches and apparent repair attempts.*

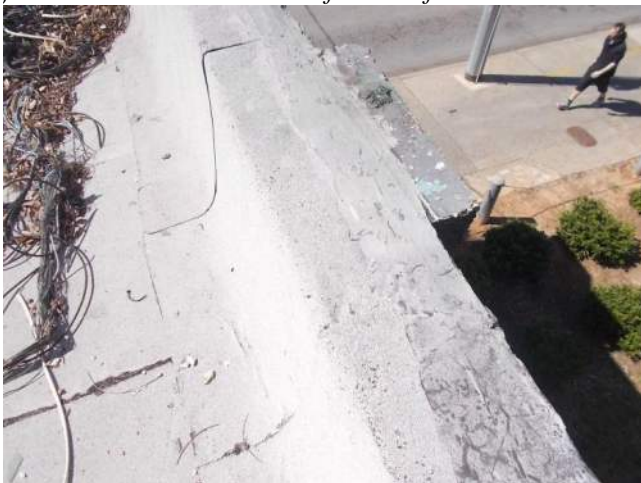
*Figure 6.2A-5. Liquid membrane patches and apparent repair attempts on the terminations on the copings.*

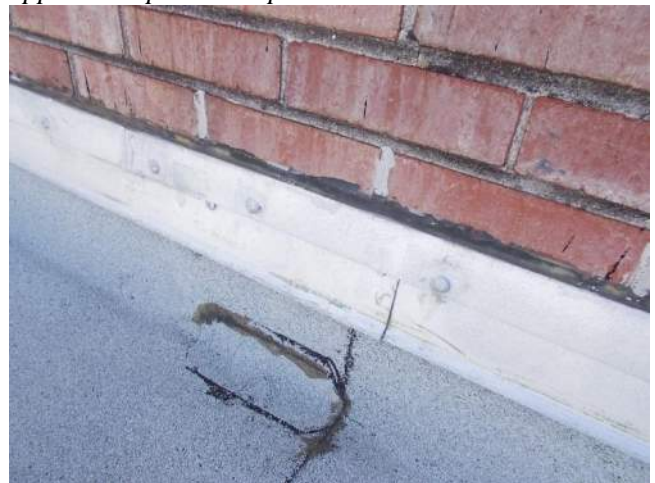
*Figure 6.2A-6. The metal flashing at the south brick masonry wall is surface mounted and sealed to the wall; the sealant is generally deteriorated.*

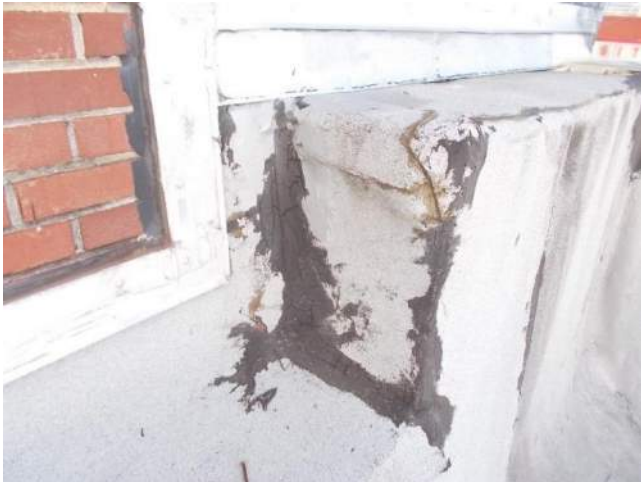
*Figure 6.2A-7. View of cracked liquid membrane patches.*

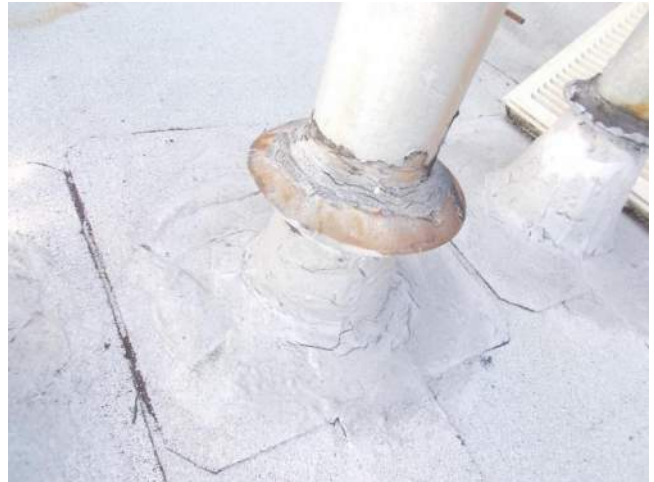
*Figure 6.2A-8. View of deteriorated sealant at a pipe penetration.*

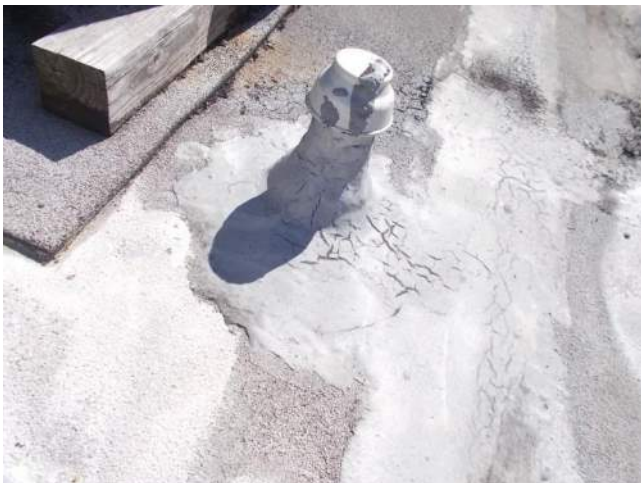
*Figure 6.2A-9. One way vent installed within the roof assembly.*

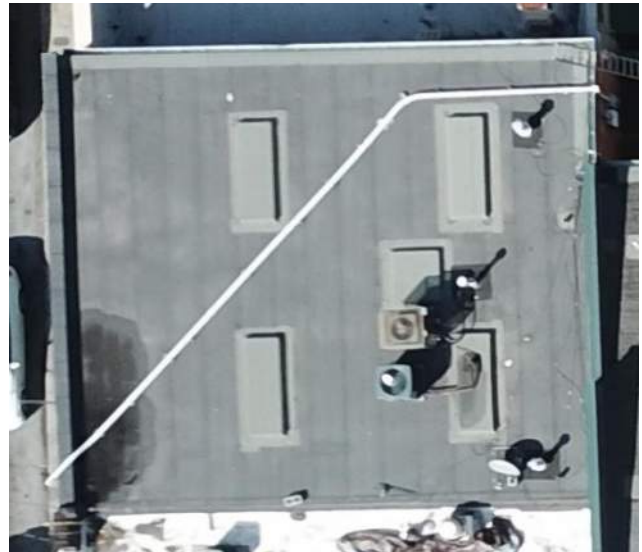
| Condition: | New | <b>Good</b> | Fair | Poor |

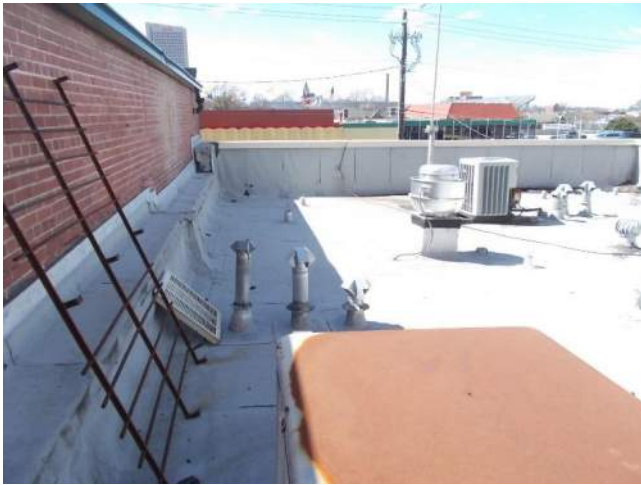
*Figure 6.2B-1. Overall view of the roof area looking from the southeast corner of the roof.*

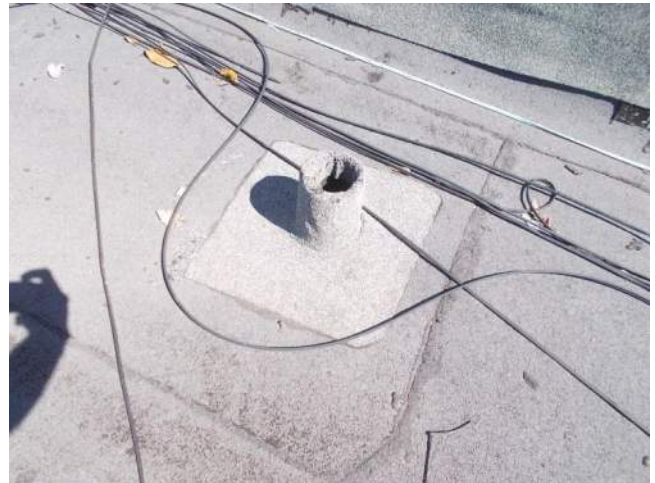
*Figure 6.2B-4. Liquid membrane patch on the roof area in good condition.*

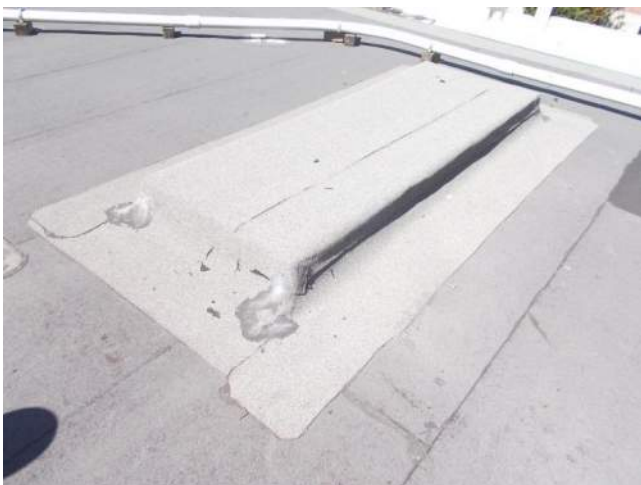
*Figure 6.2B-5. Patch on the roof near an abandoned equipment curb.*

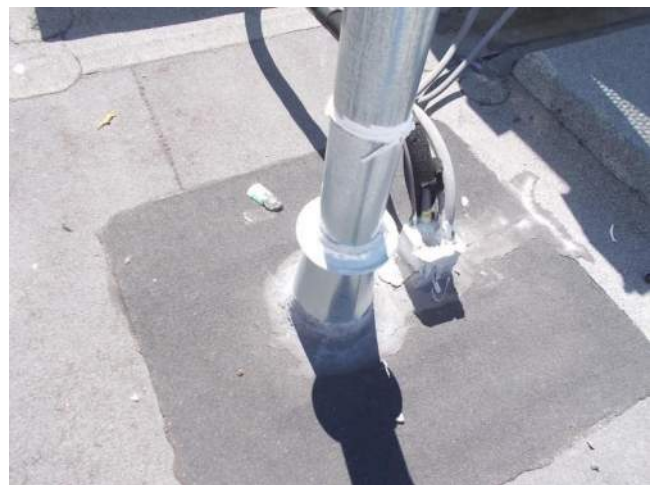
*Figure 6.2B-6. Penetration with liquid membrane seals in good condition.*

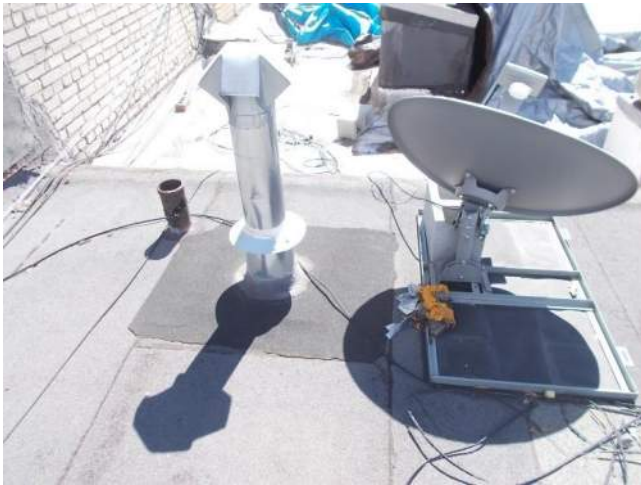
*Figure 6.2B-7. Rooftop equipment resting directly on the roof membrane with no protection pads.*

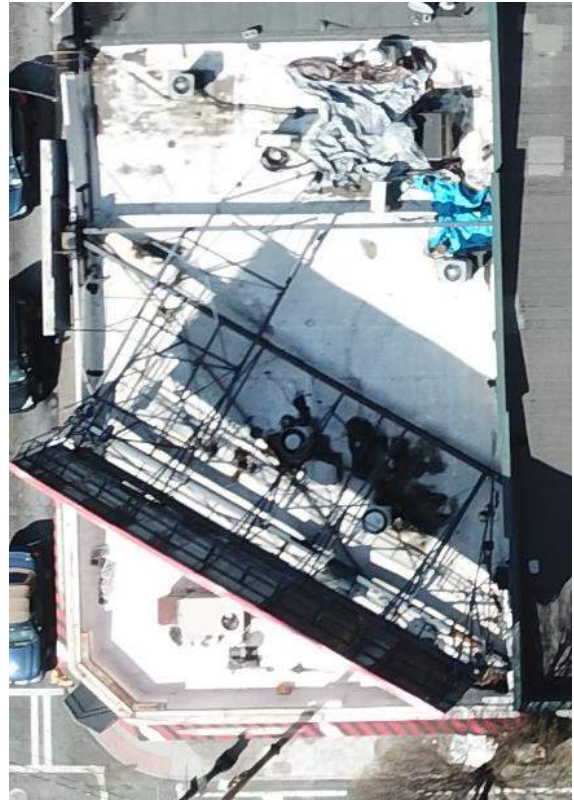
| Condition: | New | Good | Fair | <b>Poor</b> |

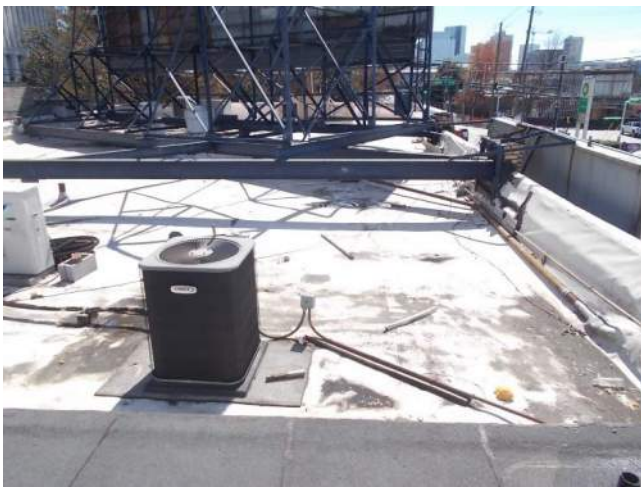
Figure 6.2C-1. Overall view of the Roof Area C.

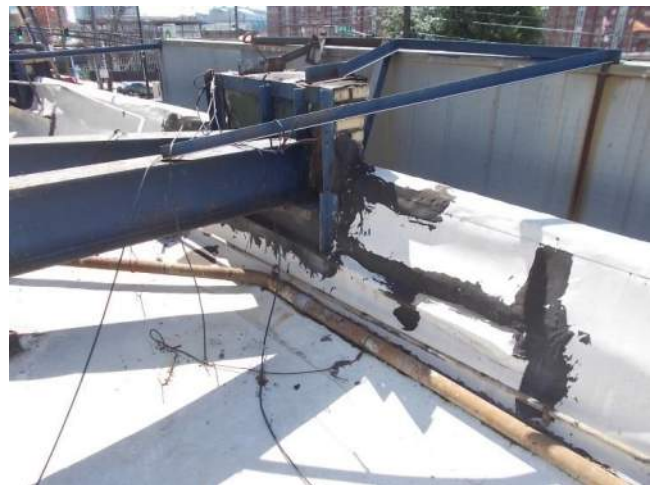
Figure 6.2C-4. Black liquid membrane used to seal the penetration in poor condition.

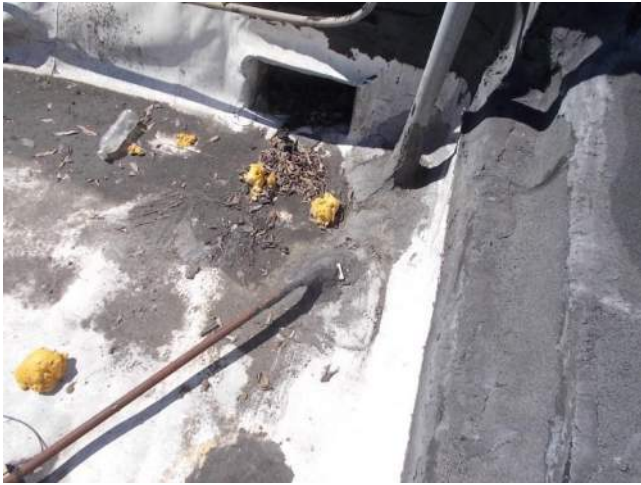
*Figure 6.2C-5. Black liquid membrane used to seal the membrane lap seams in poor condition.*

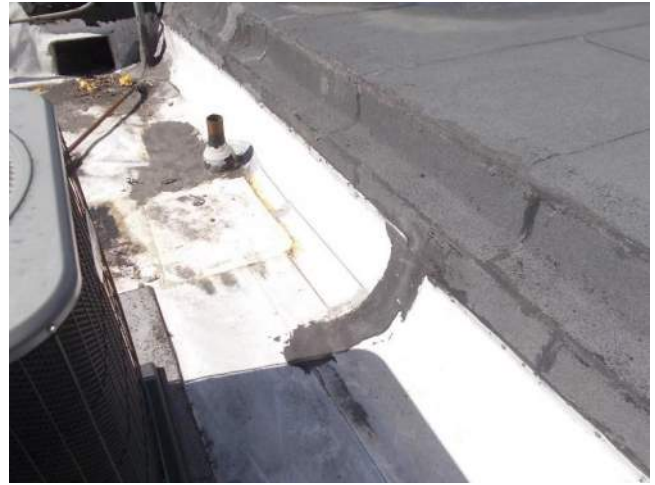
*Figure 6.2C-6. Black liquid membrane used to seal the membrane base flashing lap seams in poor condition.*

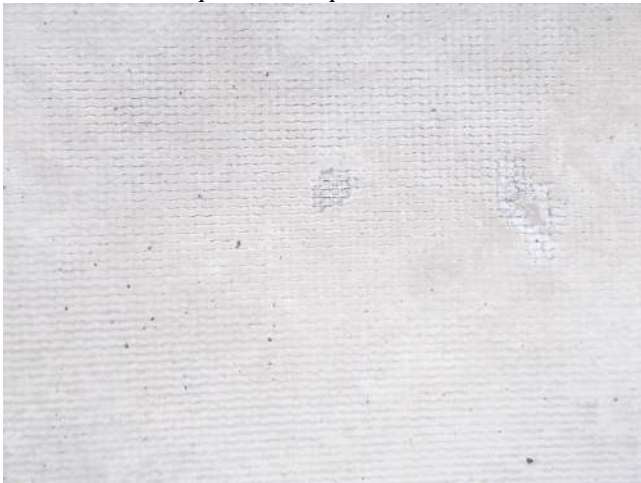
*Figure 6.2C-7. Membrane in poor condition as the top surface of the membrane was worn away exposing the fiberglass scrim.*

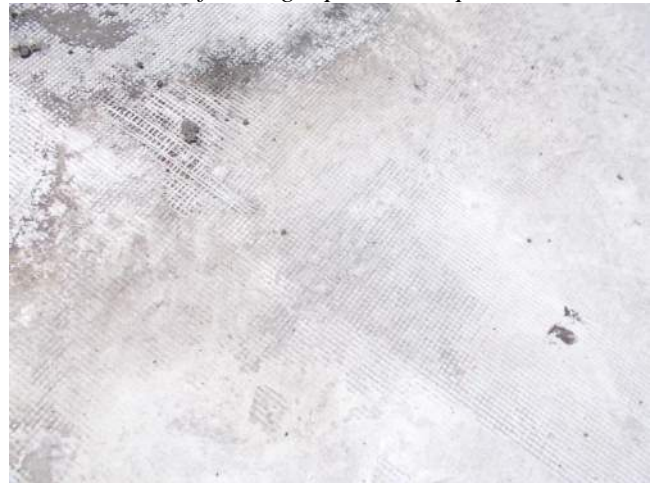
*Figure 6.2C-8. Membrane in poor condition as the top surface of the membrane was worn away exposing the fiberglass scrim.*

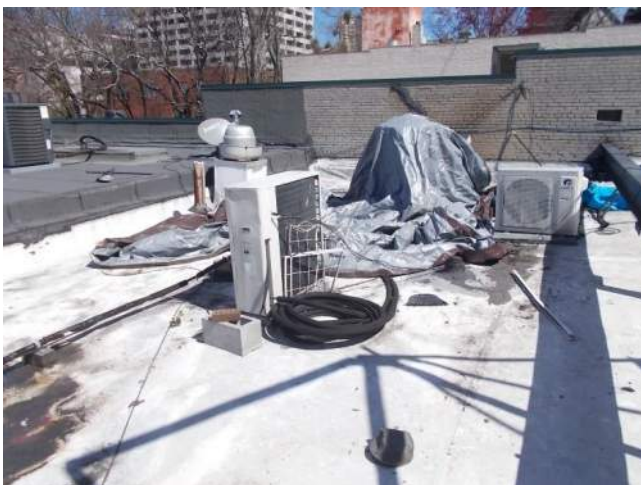
*Figure 6.2C-9. A large tarp covering some equipment and a portion of the roof membrane.*

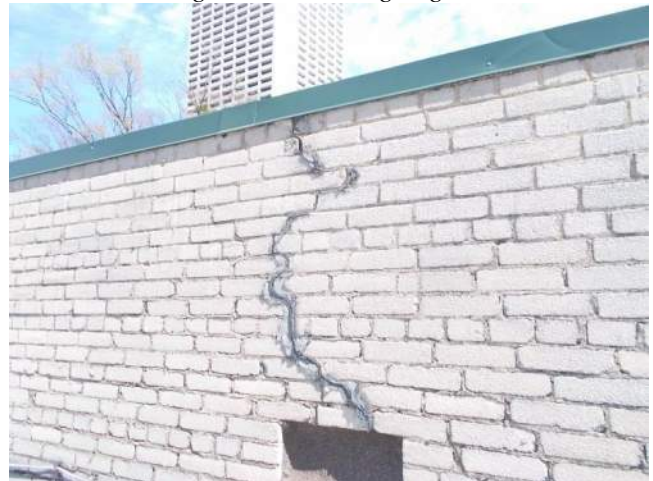
*Figure 6.2C-14. Large cracks in the adjacent brick masonry wall.*

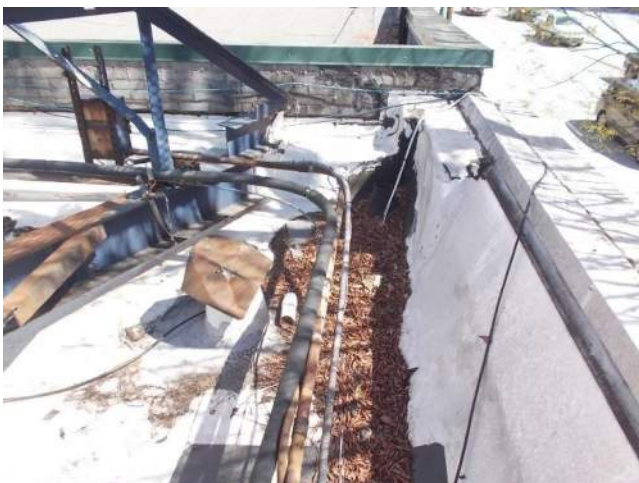
*Figure 6.2C-15. Organic and material debris accumulating near the corners of the roof*

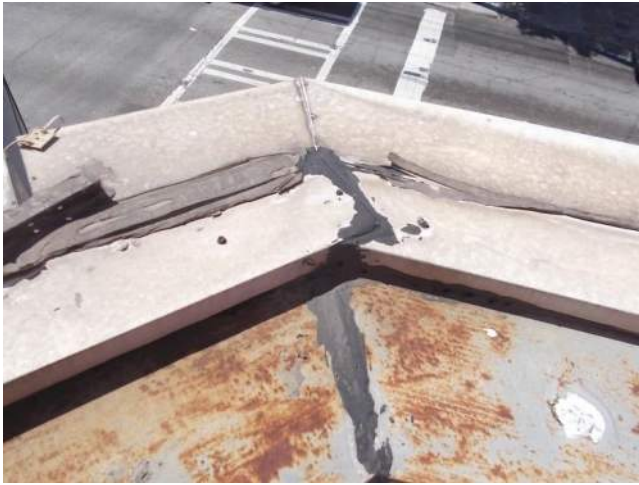
*Figure 6.2C-17. The metal coping is corroded and the splice/lap joint seals are weathered, deteriorated, cracked and failed.*

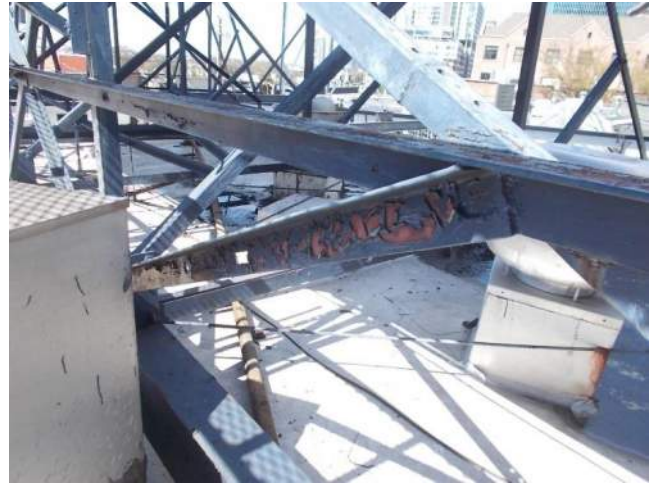
*Figure 6.2C-18. Paint on the steel framing for the billboard is in poor condition and is flaking and peeling off of the substrate.*

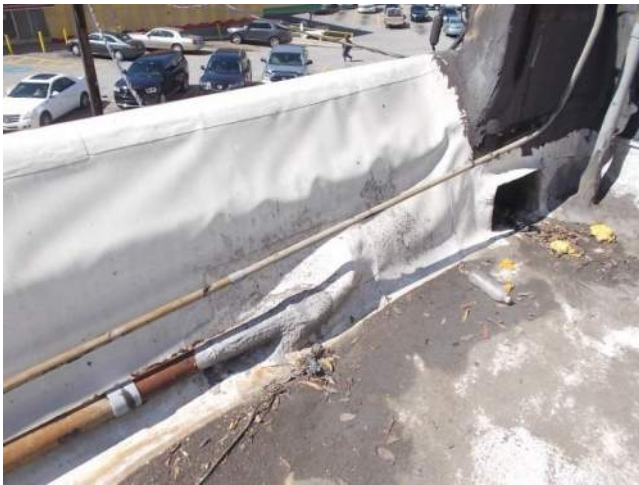
*Figure 6.2C-19. Poorly sealed pipe conduit on the wall penetrating the roof membrane*

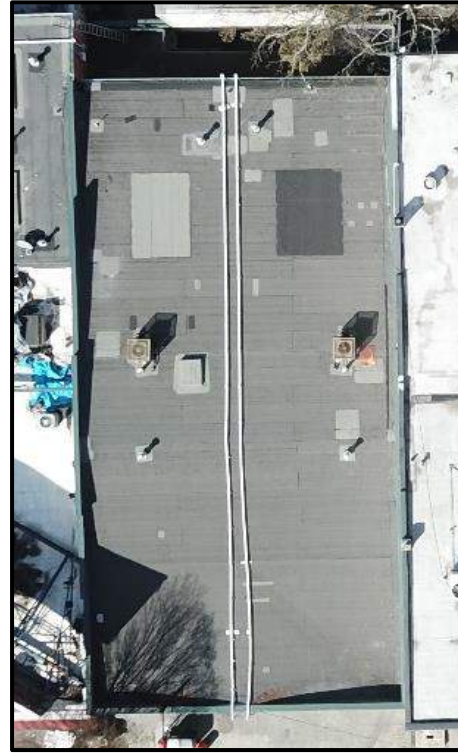
| Condition: | New | Good | <b>Fair</b> | Poor |

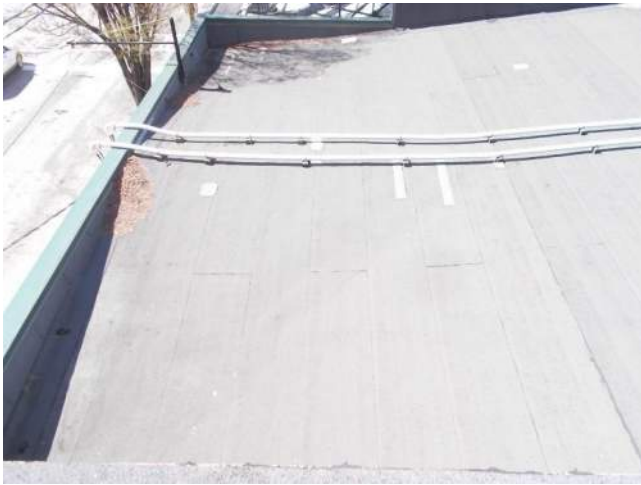
*Figure 6.2D-1. Overall view of the roof area.*

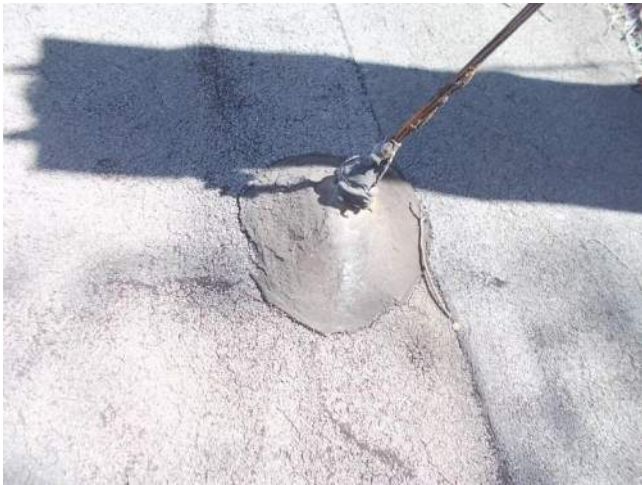
*Figure 6.2D-7. Penetration contained weathered, deteriorated and cracked liquid membrane seals.*

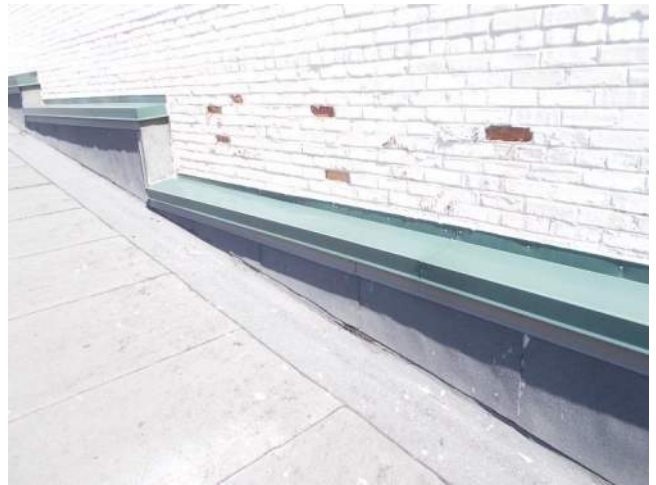
*Figure 6.2D-8. Delaminated outer face of numerous brick masonry units with bubbled and flaking coating.*
