# ALL SAINTS' EPISCOPAL CHURCH

## Building Envelope Assessment and Capital Reserve Study

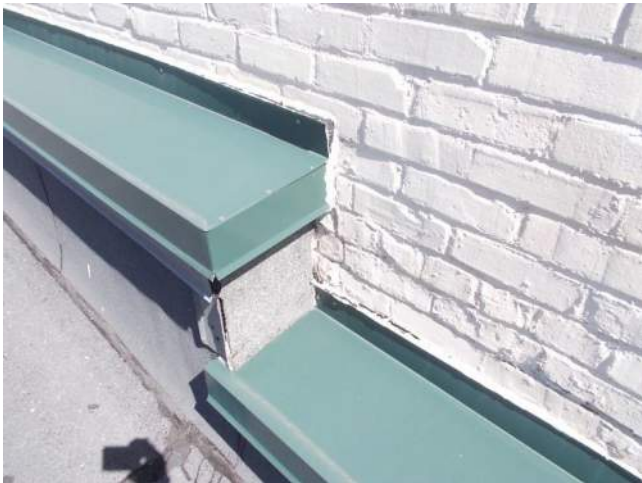
*Figure 6.2D-9. Numerous failures in the sealant at the interface of the metal coping and brick wall.*

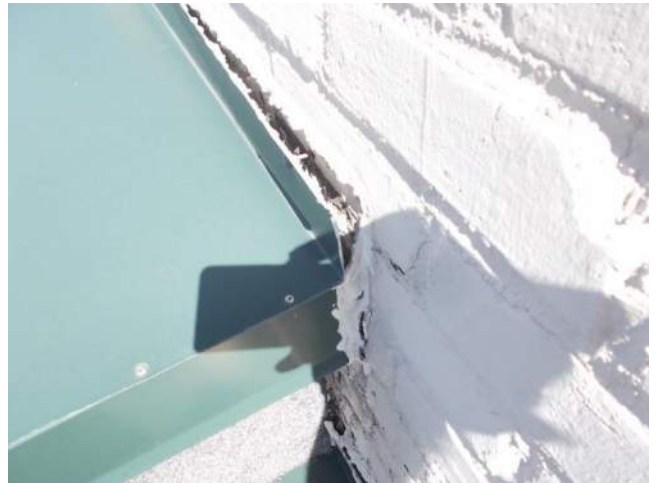
*Figure 6.2D-10. Numerous failures in the sealant at the interface of the metal coping and brick wall.*

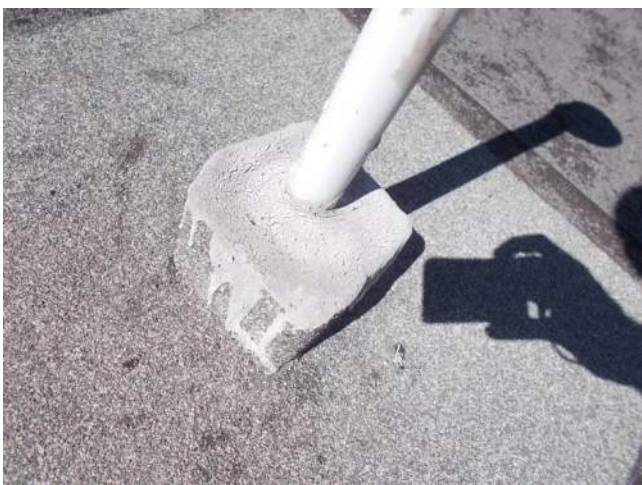
*Figure 6.2D-11. Pitch pocket fillers and liquid membrane seals at penetrations are weathered, deteriorated and cracked.*

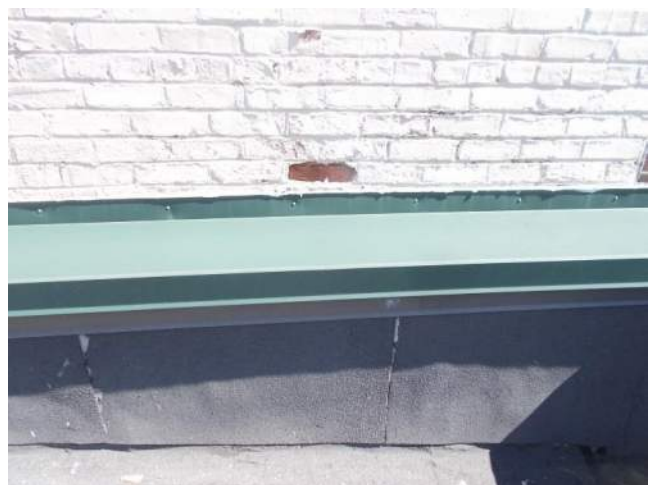
*Figure 6.2D-12. Base membrane flashing lap seams contained additional sealant, most likely as an attempt for repair.*

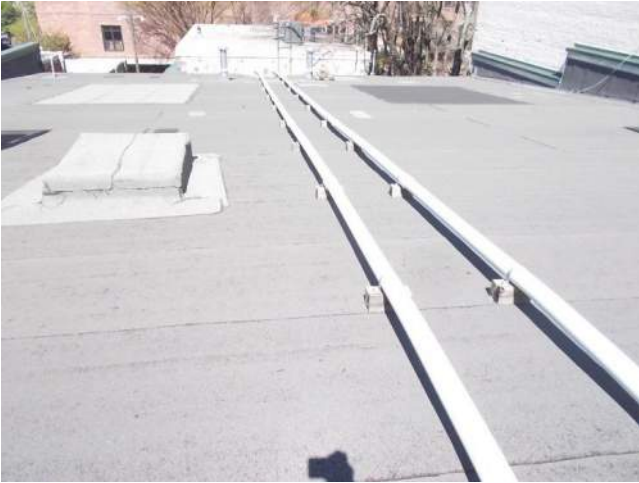
*Figure 6.2D-13. Wood blocking pipe supports resting directly on the roof membrane surface.*

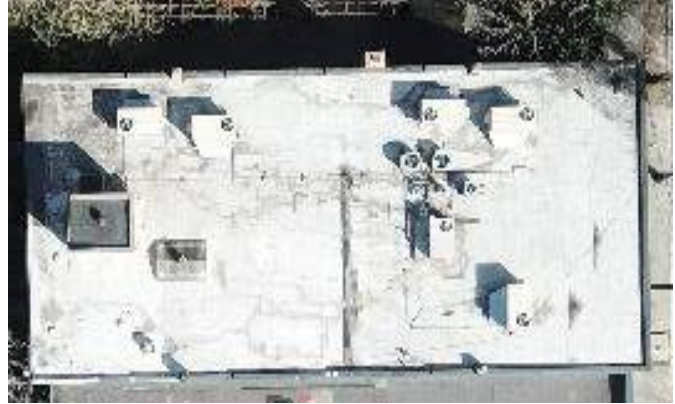
| Condition: | New | Good | Fair | <b>Poor</b> |

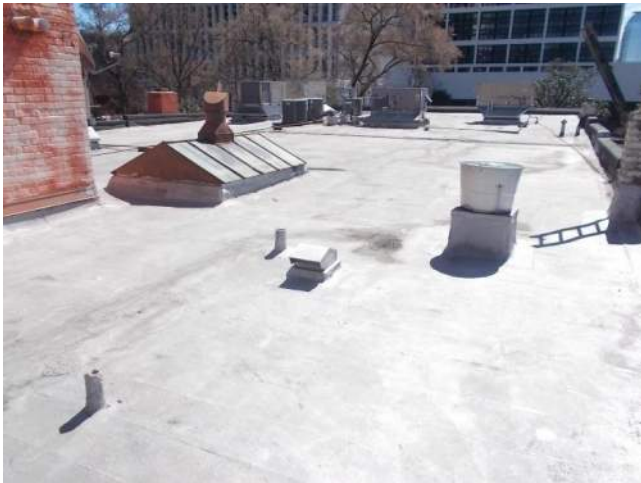
*Figure 6.3-1. View of the main lower roof area from the northwest and southeast corner of the roof.*

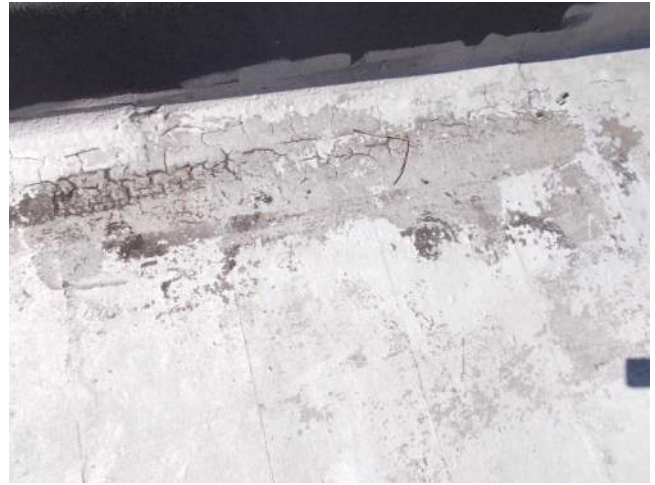
*Figure 6.3-6. Weathered, deteriorated, and faded aluminum coating.*

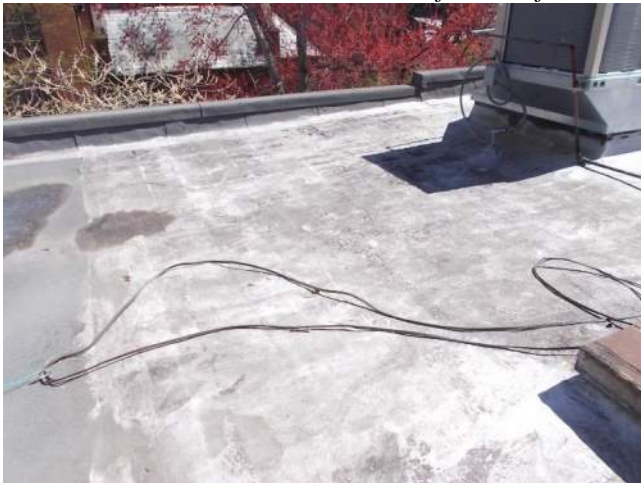
*Figure 6.3-7. Weathered, deteriorated, and faded aluminum coating.*

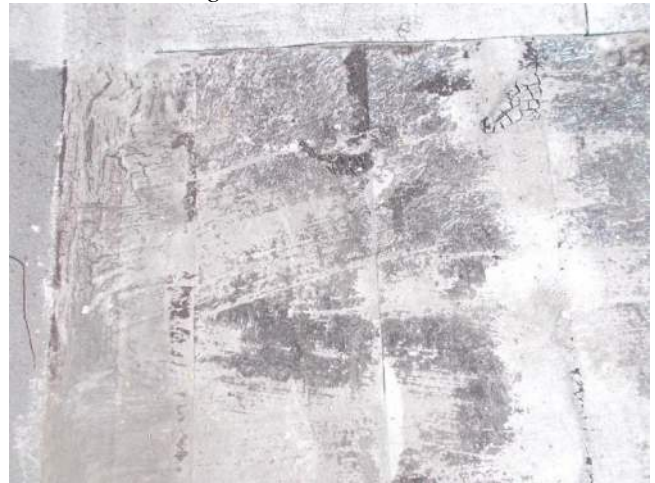
*Figure 6.3-8. Weathered, deteriorated, and faded aluminum coating.*

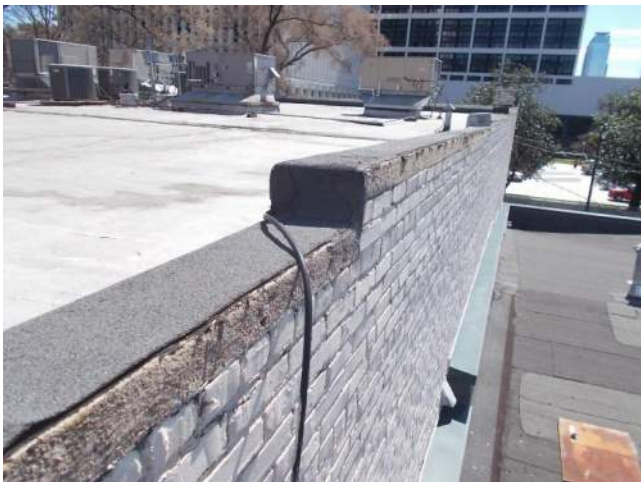
*Figure 6.3-9. GSMB base flashings extend onto the horizontal surface of the stone copings.*

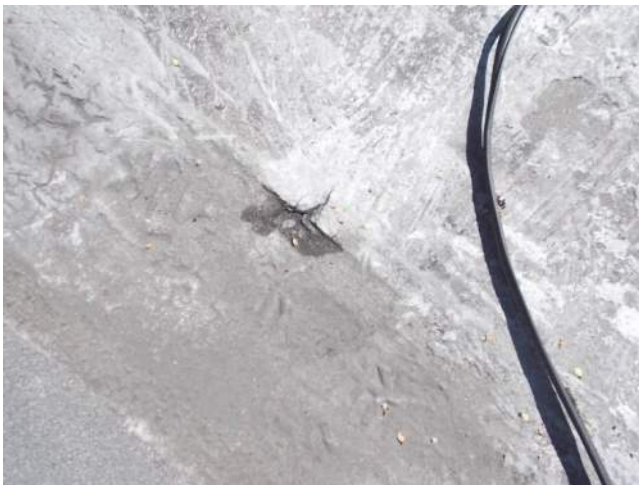
*Figure 6.3-13. Split in the membrane with moisture extending from the split.*

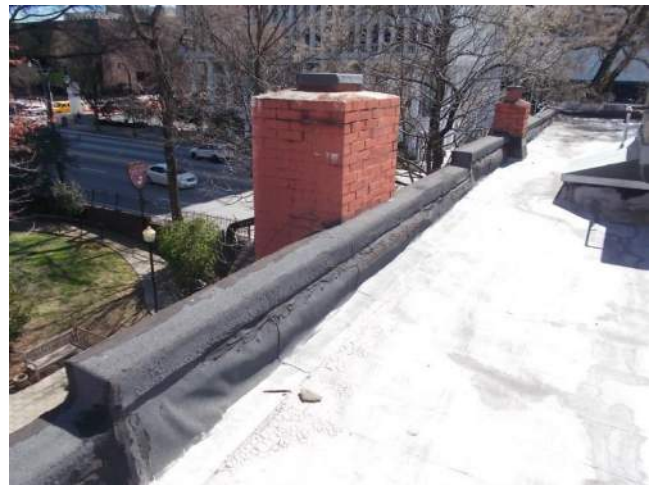
*Figure 6.3-14. Multiple wrinkles and blisters in the GSMB base flashings.*

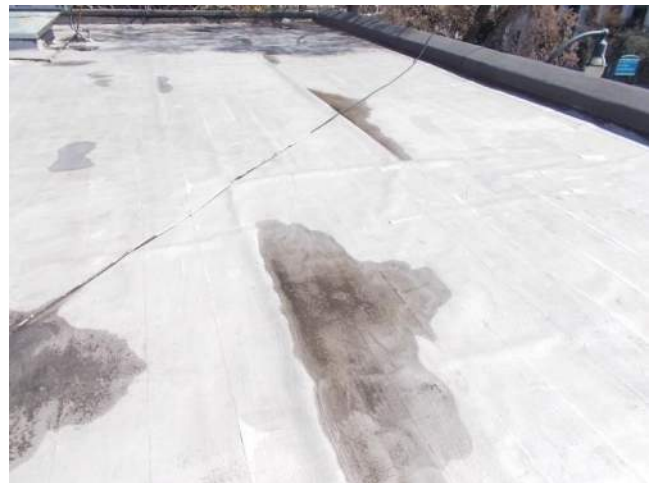
*Figure 6.3-16. Small, localized areas of ponding water were observed on the roof.*

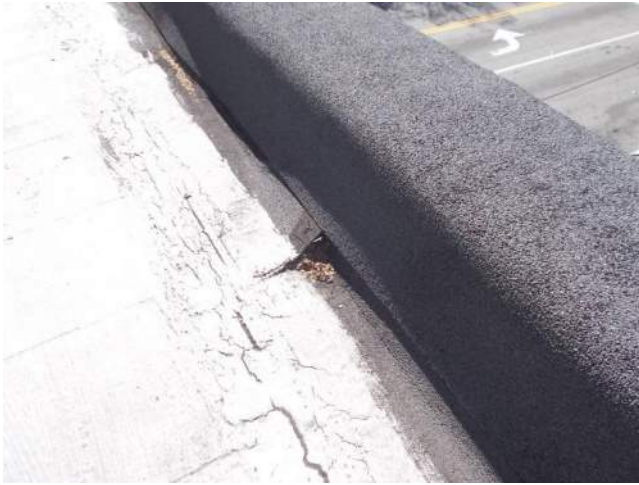
*Figure 6.3-17. Open lap seams in the GSMB base flashings.*

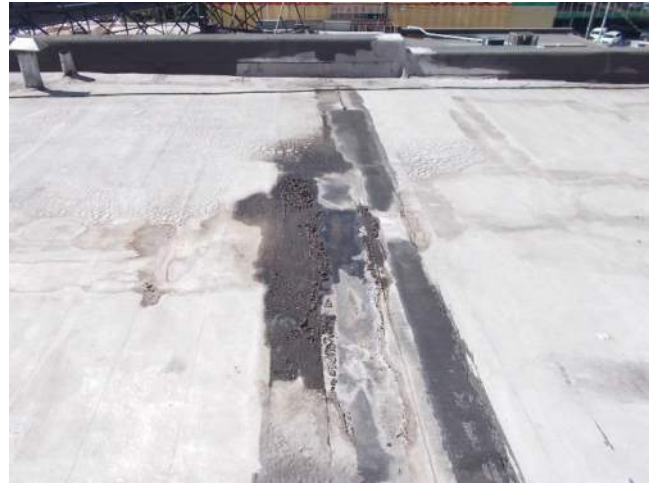
*Figure 6.3-18. Cracked patch in the liquid membrane installed along the edges creating an area of ponding water.*

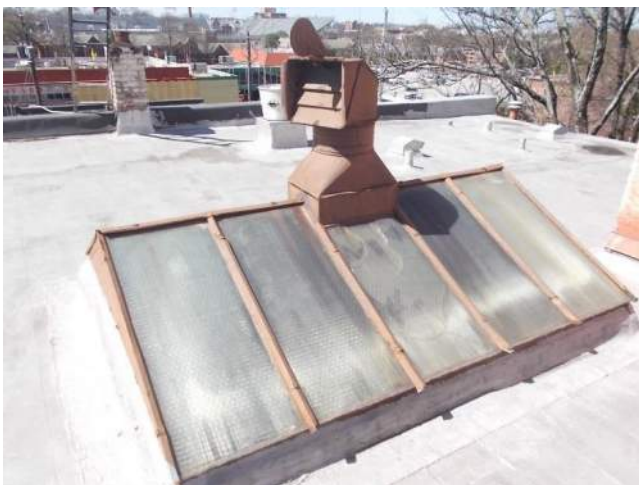
*Figure 6.3-19. Weathered, deteriorated and cracked sealants on the skylight with a cracked glass pane.*

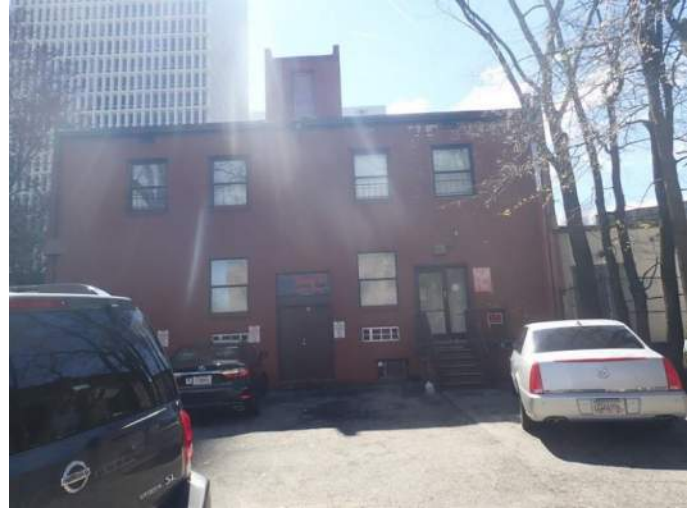
| Condition: | New | Good | Fair | Poor |

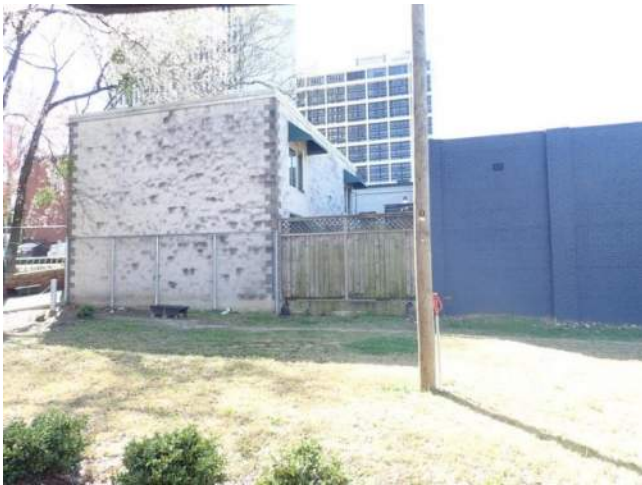
Figure 6.4-1. The facade of the Covenant Community building consists of split face CMU with vinyl window units and wood trim.

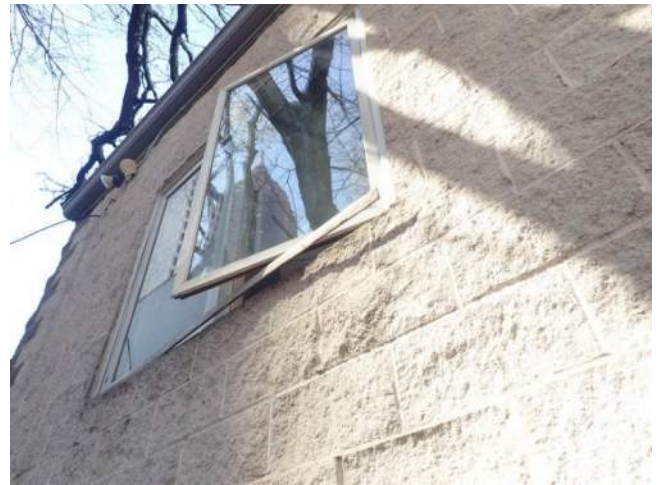
Figure 6.4-2. Isolated damage or displacement in the window trim elements

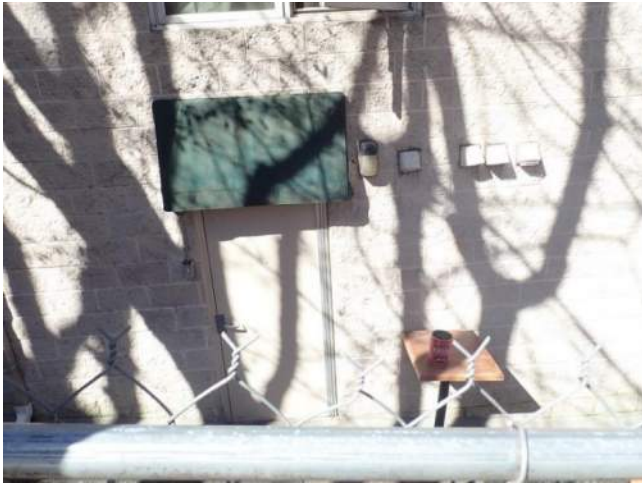
Figure 6.4-3. Surface mounted awnings were installed over entrance doors at the first floor of the building.

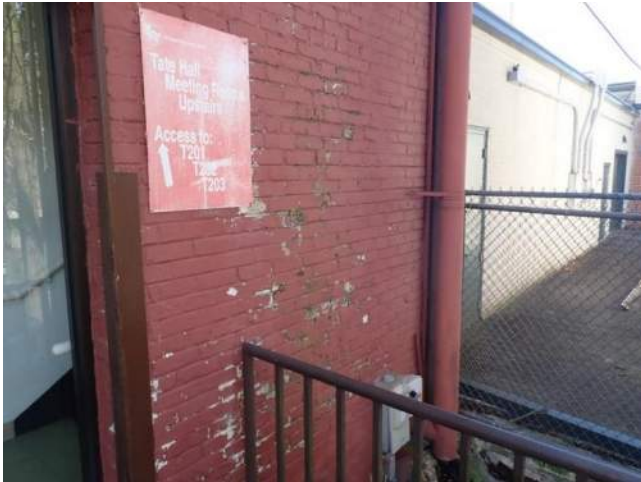
*Figure 6.4-9. The paint on the masonry was flaking and had failed throughout each elevation.*

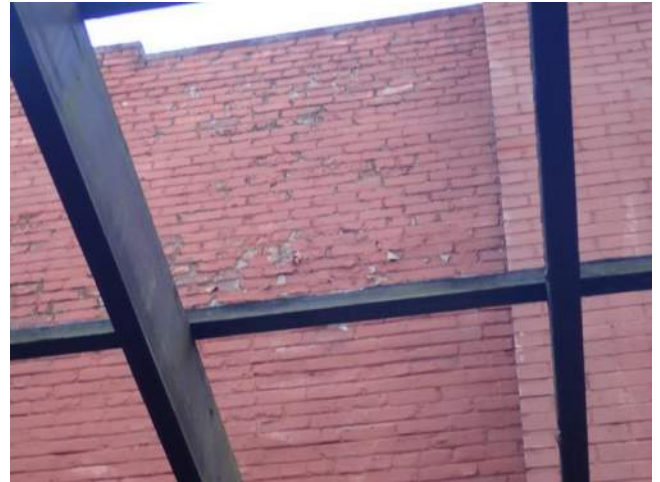
*Figure 6.4-10. The paint on the masonry was flaking and had failed throughout each elevation.*

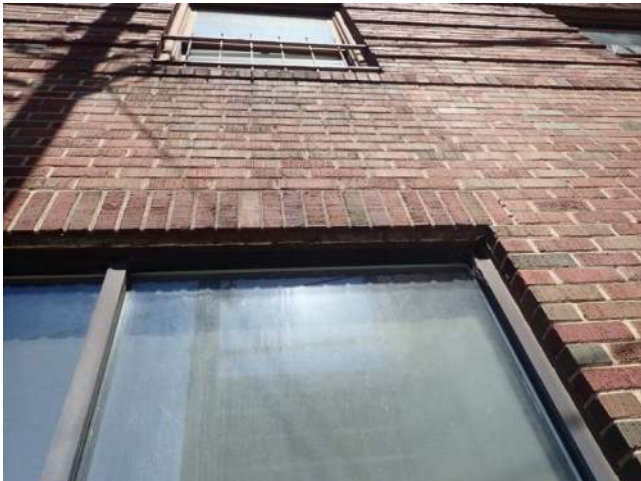
*Figure 6.4-11. Light surface corrosion on the steel lintels at openings throughout the building.*

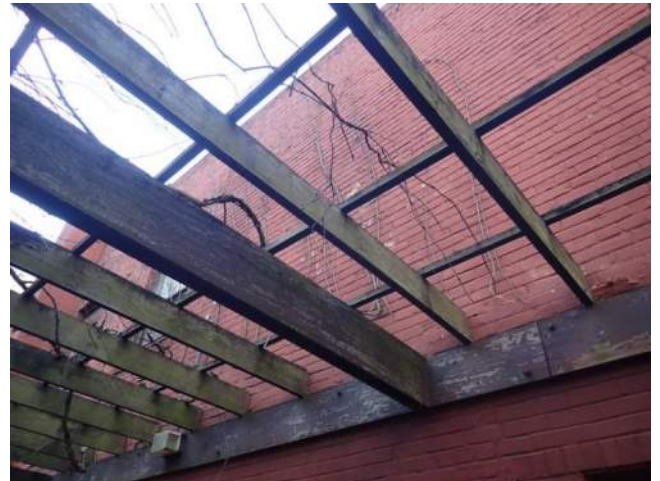
*Figure 6.4-12. Vegetation growing on the surface of the facade at the east facade.*

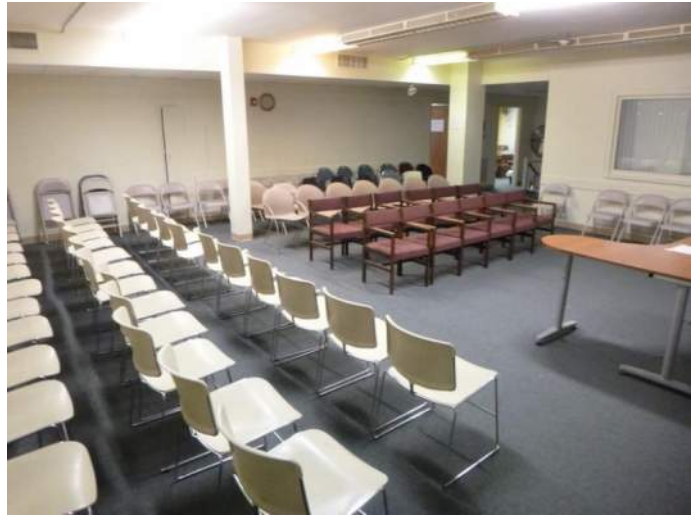
| Condition: | New | Good | <b>Fair</b> | Poor |

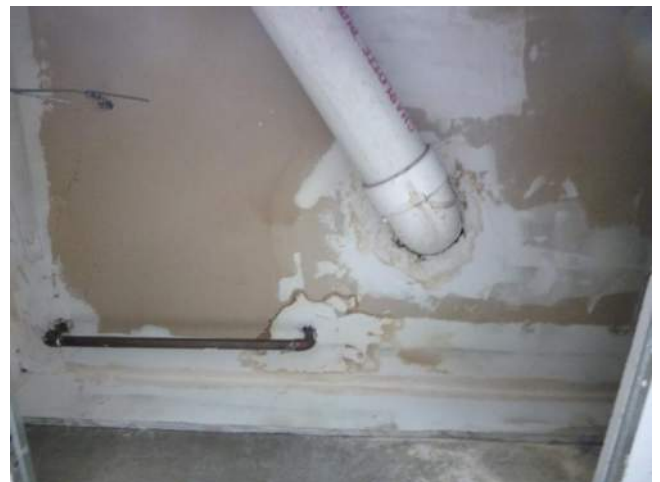
Figure 6.5-6. View of damages to the interior finishes of Tate Hall.

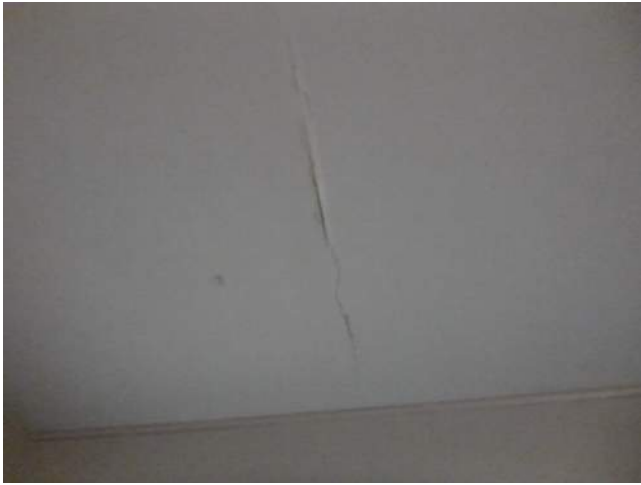
*Figure 6.5-7. View of typical condition of finishes on the interior of Tate Hall.*

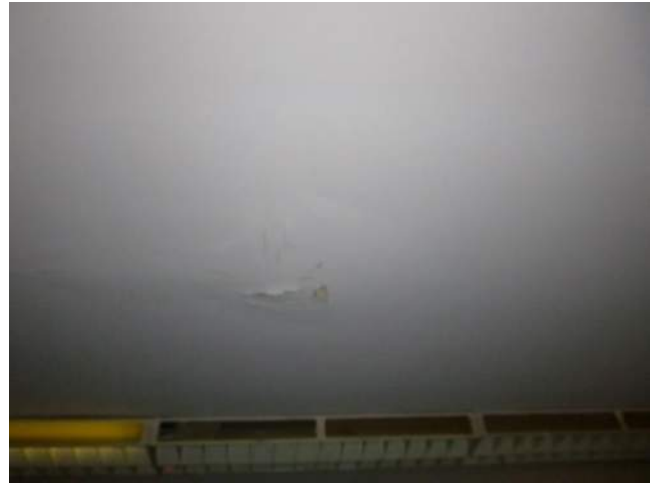
*Figure 6.5-8. View of water damage to a ceiling finish in Tate Hall.*

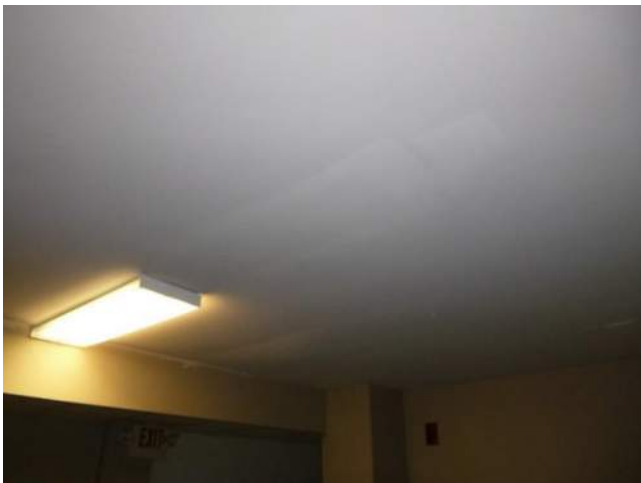
*Figure 6.5-9. View of previous repairs to an area of ceiling on the second floor of Tate Hall.*

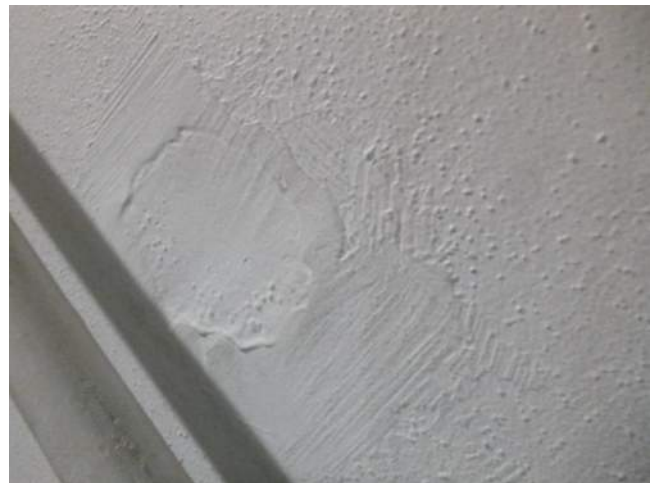
*Figure 6.5-10. View of patch repair on a wall in Tate Hall.*

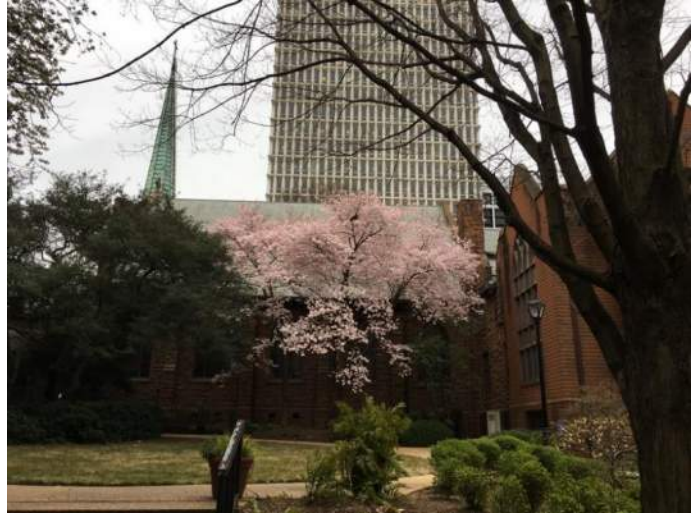
| Condition: | New | Good | Fair | Poor |

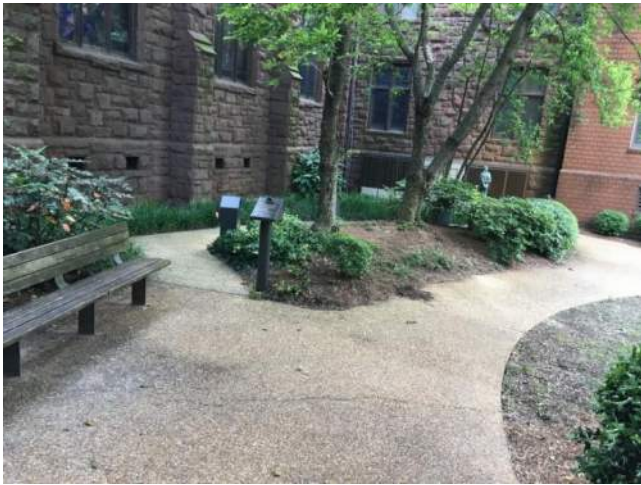
*Figure 7.1-1. View of the courtyard between the Church and Egleston Hall.*

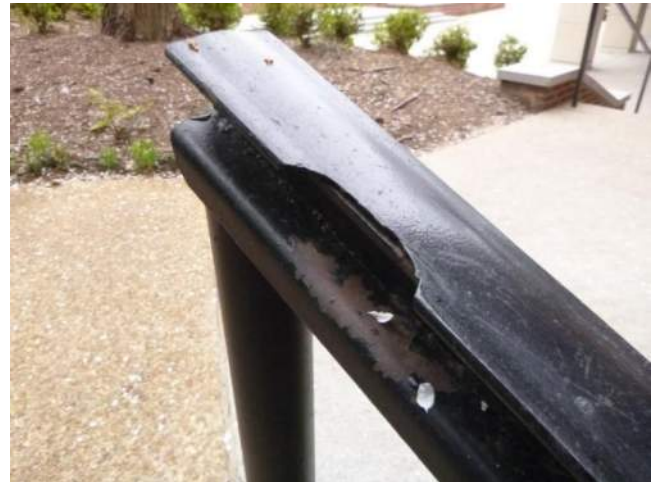
*Figure 7.1-4. View of damaged guardrail at a courtyard site stair.*

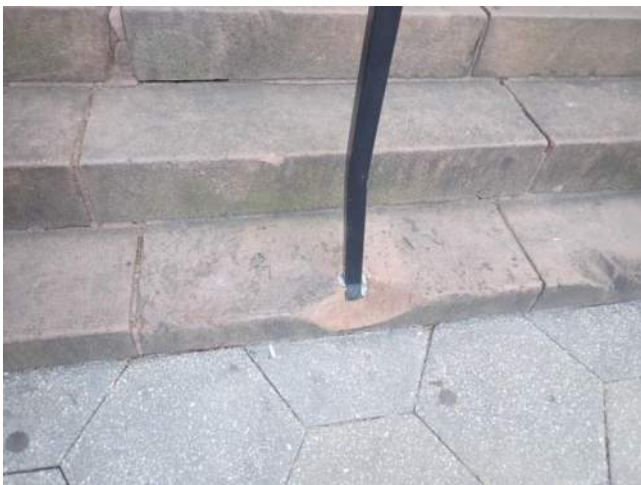
*Figure 7.1-5. View of a damaged handrail at the main Church building.*

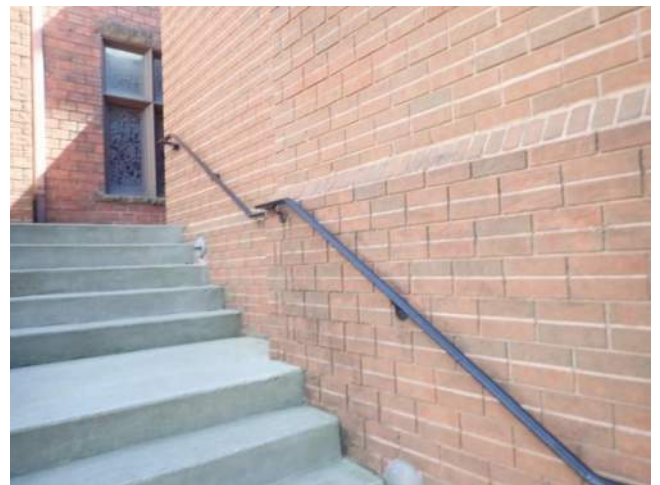
*Figure 7.1-6. View of the handrail at the stairs to the west of the Chapel.*

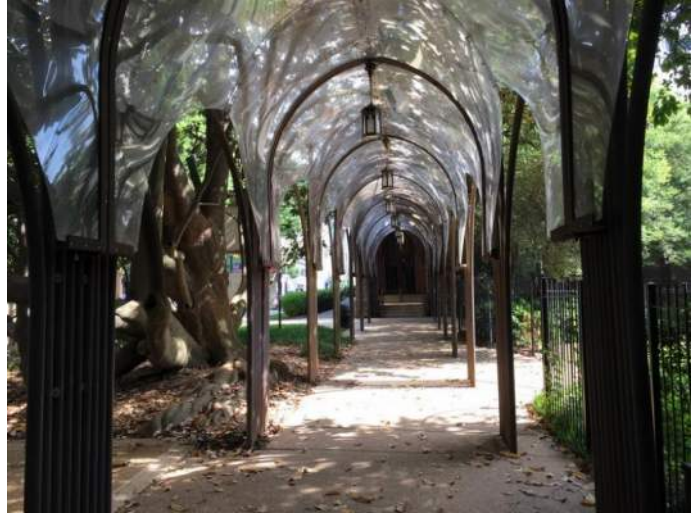
| Condition: | New | Good | <b>Fair</b> | Poor |

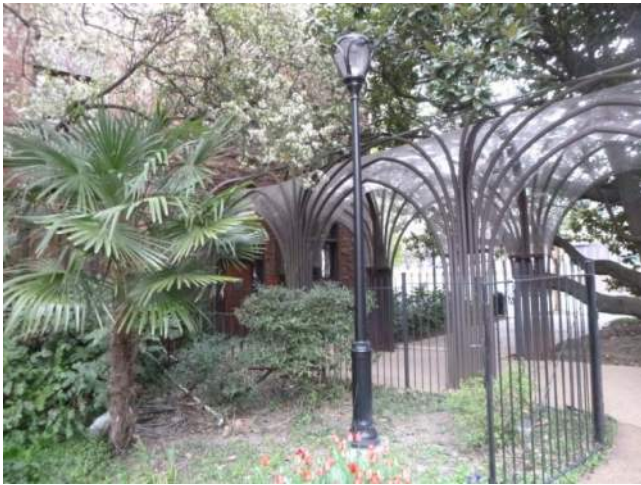
*Figure 7.2-1. Partial view of the covered walkway and canopy structure.*

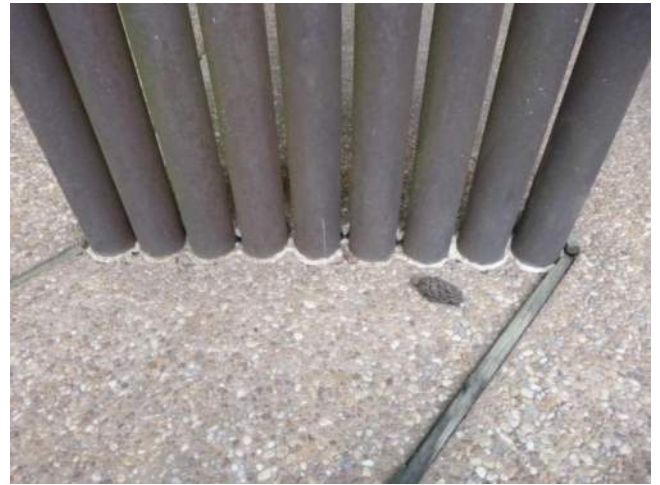
*Figure 7.2-2. View of deteriorated sealant at the support post bases on the canopy structure.*

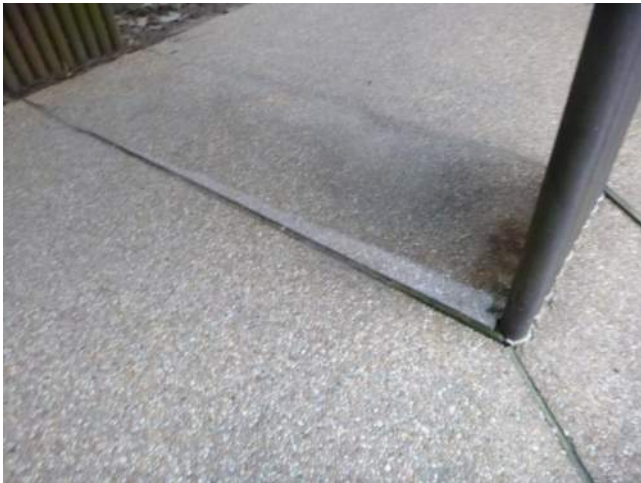
*Figure 7.2-33. View of vertical displacement of a section of cast walkway near Egleston Hall.*

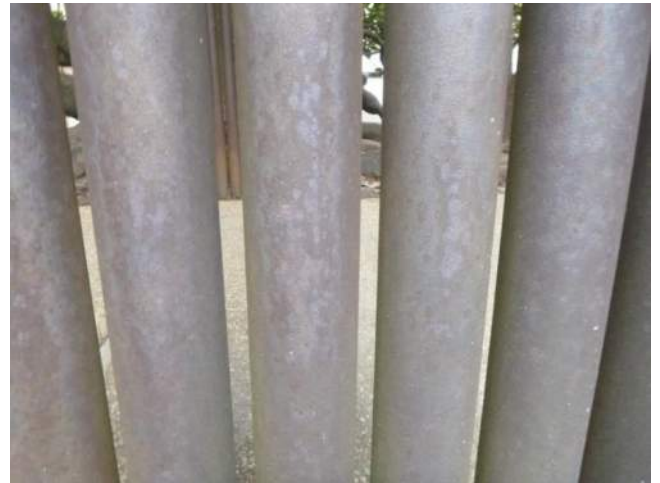
*Figure 7.2-4. View of atmospheric soiling on the coating and light surface corrosion of the steel tubing.*

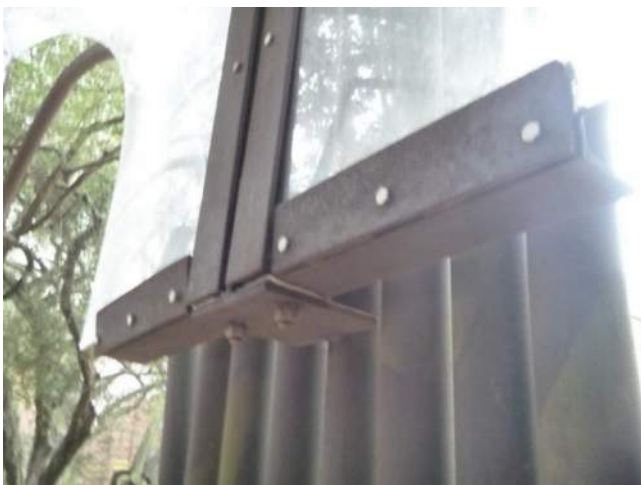
*Figure 7.2-5. View of light surface corrosion and soiling on the canopy structure.*

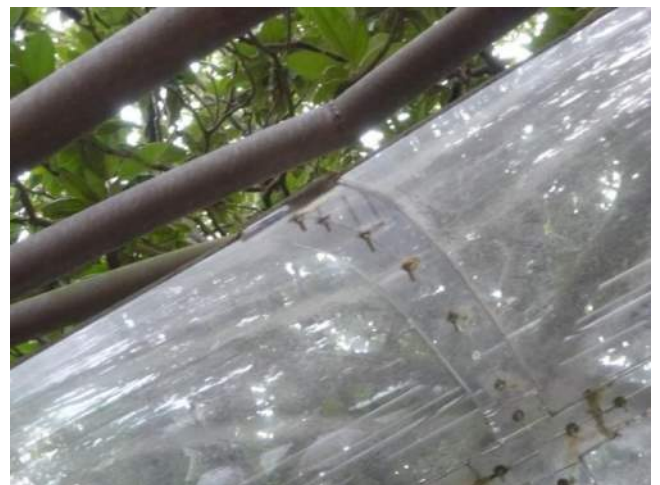
*Figure 7.2-64. View of a typical joint in the polycarbonate sheathing of the canopy structure.*

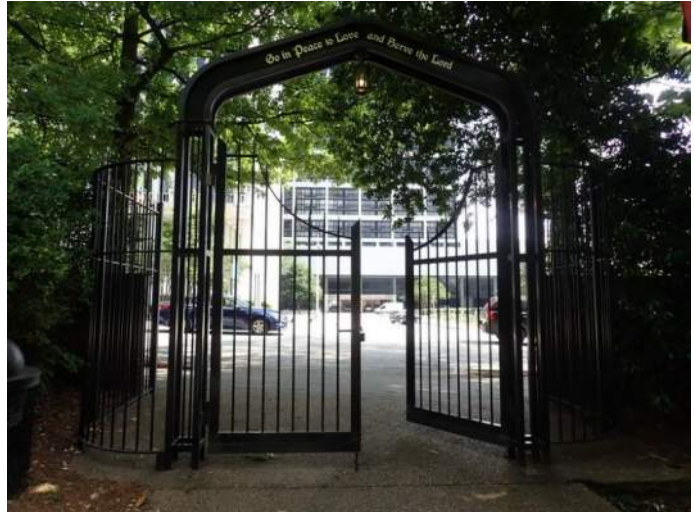
| Condition: | New | Good | Fair | Poor |

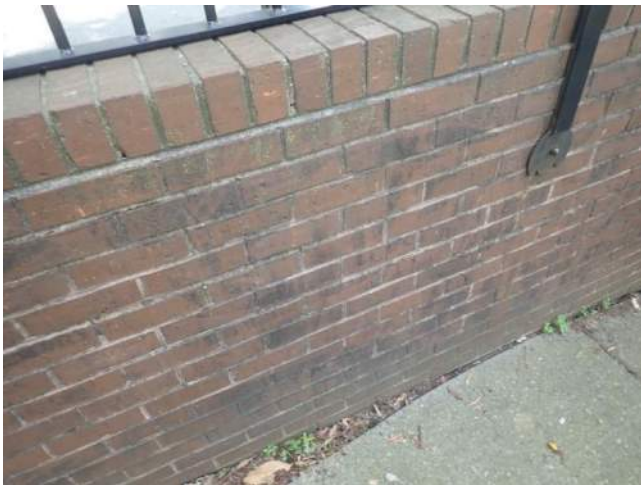
Figure 7.3-1. View of a brick masonry site wall and fencing.

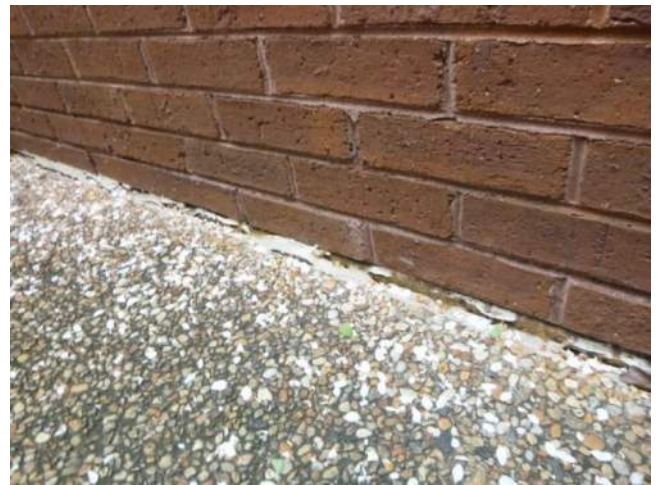
Figure 7.3-2. View of failed sealant at the base of a brick masonry site wall.

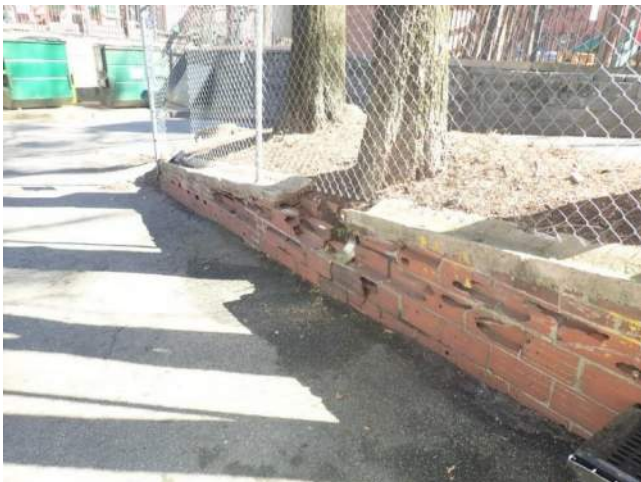
Figure 7.3-35. View of the hollow brick masonry tile retaining wall at the rear entrance drive.

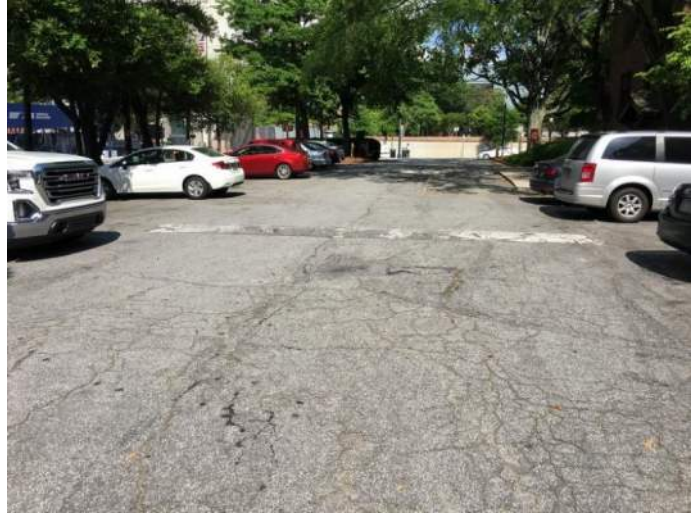
| Condition: | New | Good | <b>Fair</b> | Poor |

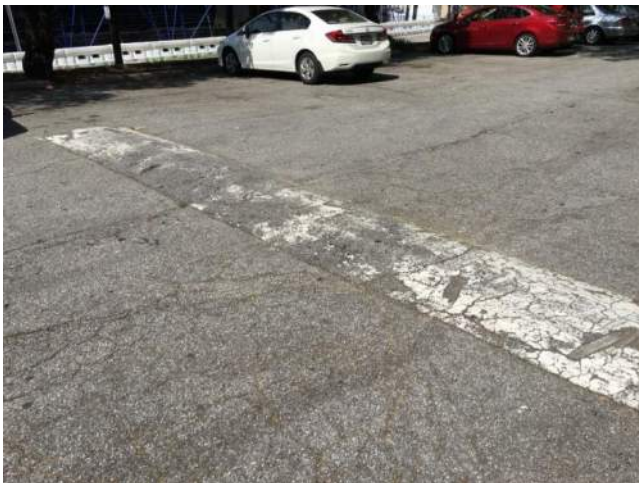
*Figure 7.4-3. View of the condition of the asphalt paving of the parking area.*

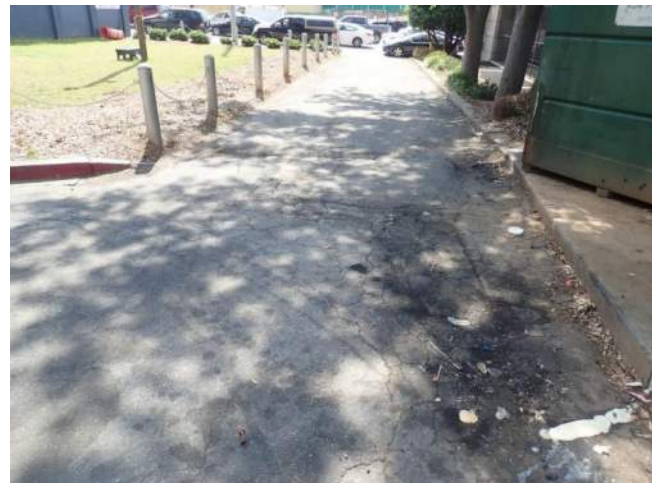
*Figure 7.4-410. View of the rear entrance drive near the covenant community church.*

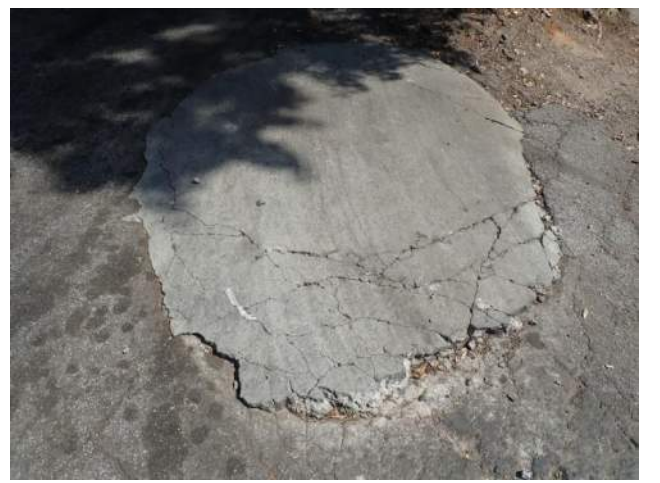
*Figure 7.4-611. View of a failed patch repair at the rear entrance drive.*

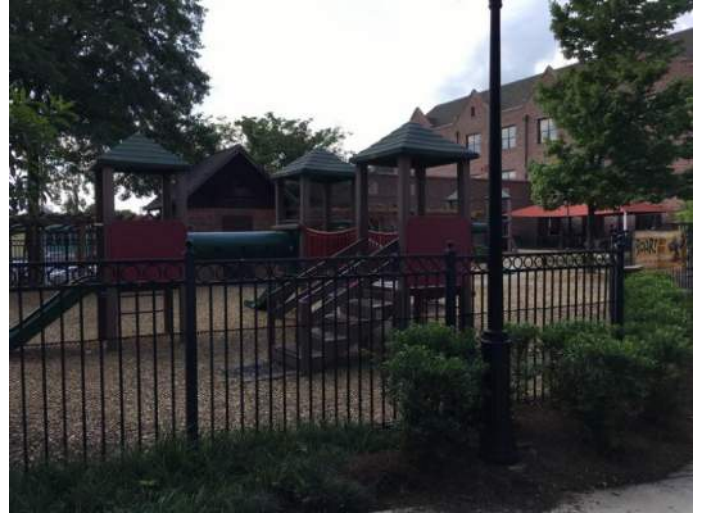
| Condition: | New | <b>Good</b> | Fair | Poor |

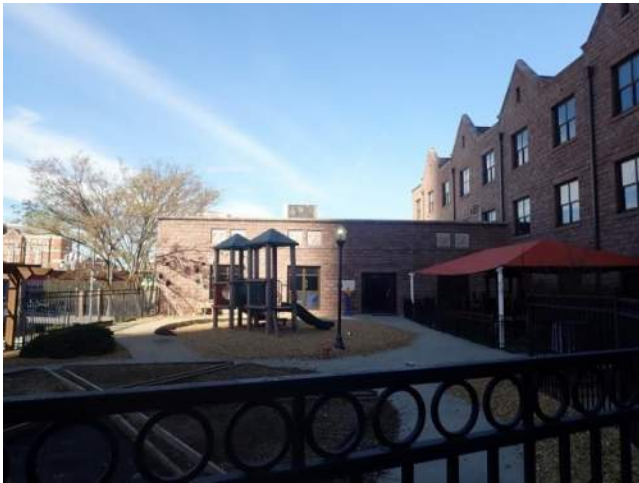
*Figure 7.5-1. Overall view of the playground area.*

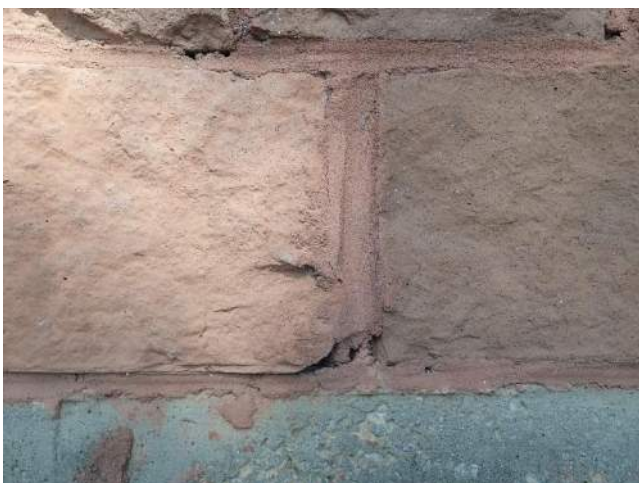
*Figure 7.5-5. View of deteriorated mortar joints in the stone masonry of the storage shed.*

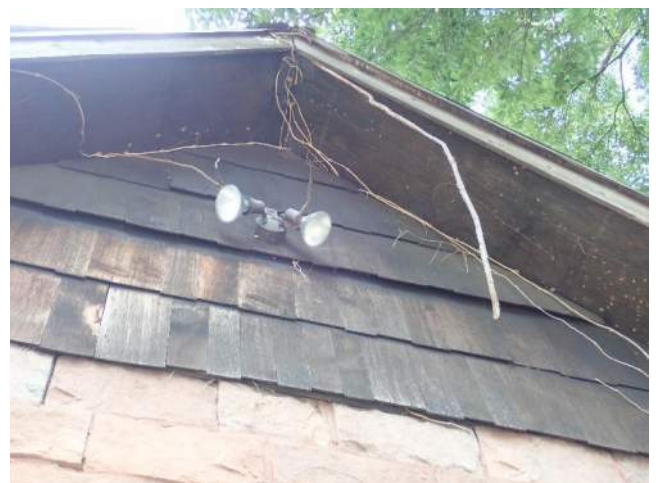
*Figure 7.5-6. View of the wood eaves and shake cladding of the storage shed.*
