REPAIR REQUEST LIST

1000 Central Boulevard
11/12/2018 12:45 pm

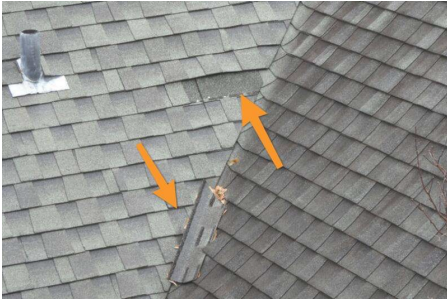
Over garage

3.1.2 - Roof: Coverings

SLIPPED SHINGLE(S)

Repair requested.

Repair needed.

Contact a qualified roofing professional.

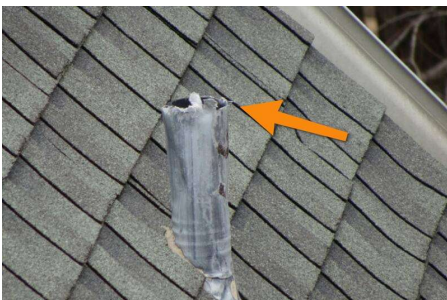
East side upper roof

3.3.1 - Roof: Flashings

DAMAGED FLASHING

Repair requested.

Repair needed.

Contact a qualified roofing professional.

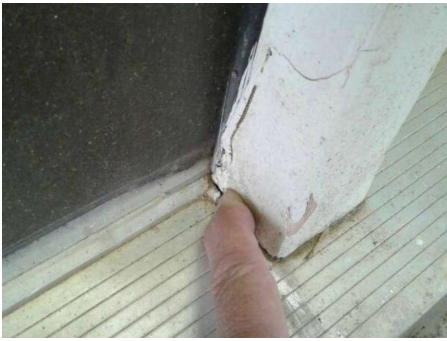
Lower level kitchen door

4.1.1 - Building Exterior & Immediate Grounds: Siding, Flashing & Trim

DECAY

Decay was noted. Recommend having contractor thoroughly check all wood components for less visible decay when repairs are made.

Repair requested.

Contact a qualified handyman.

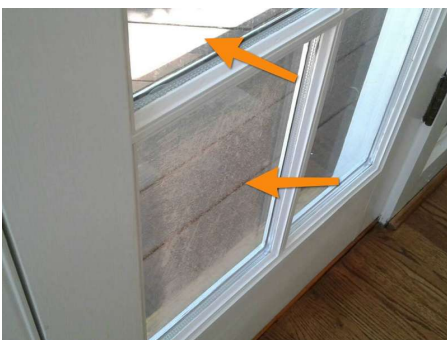
Deck french doors

4.2.1 - Building Exterior & Immediate Grounds: Exterior Doors

FAILED WINDOW SEAL

\$200 credit requested

Replacement of affected panes needed.

Contact a qualified professional.

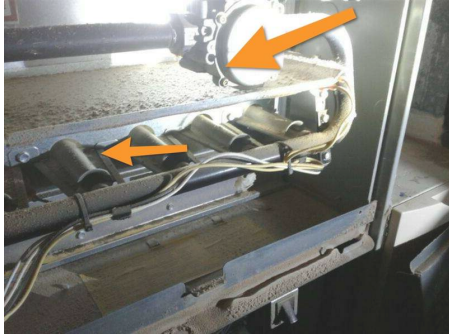
Right side basement unit

6.1.2 - Heating: Equipment

NEEDS SERVICING/CLEANING

Debris / dust buildup was noted and does not appear to have received regular servicing. Furnace should be cleaned and serviced annually. Recommend a qualified HVAC contractor clean, service and verify furnace functioning.

Have serviced and technician report on overall condition.

Contact a qualified HVAC professional.

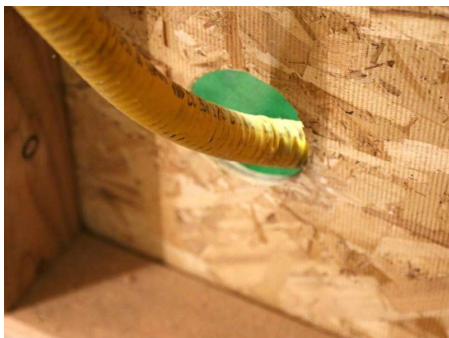
Behind basement furnace

8.6.1 - Plumbing: Fuel Storage & Distribution Systems

CSST PIPE THROUGH WALL

Corrugated Stainless Steel Tubing was run through wall without protection. This is not generally permitted since this type of piping is easily damaged and may leak natural gas. Recommend this be reworked to avoid unintended damage.

Repair requested.

Contact a qualified plumbing contractor.

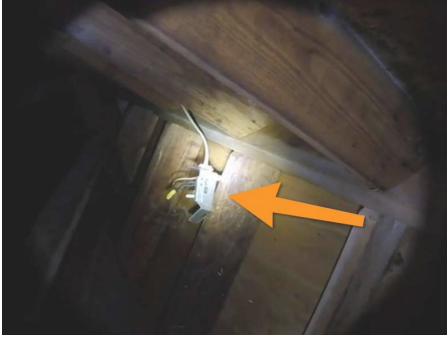
Attic over northwest BR

9.3.1 - Electrical: Branch Wiring Circuits, Breakers & Fuses

MISSING JUNCTION BOX COVER

Repair requested.

Recommend all junction boxes be covered for safety and to meet current standards.

Contact a qualified handyman.

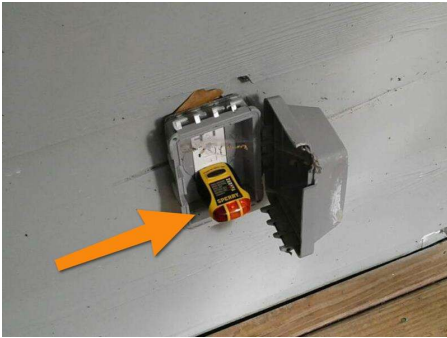
Pool pump house

9.5.1 - Electrical: GFCI & AFCI

DID NOT TRIP

No shock protection provided. Replacement needed

Contact a qualified handyman.

Repair requested.

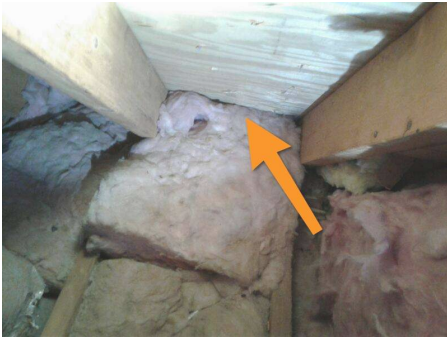
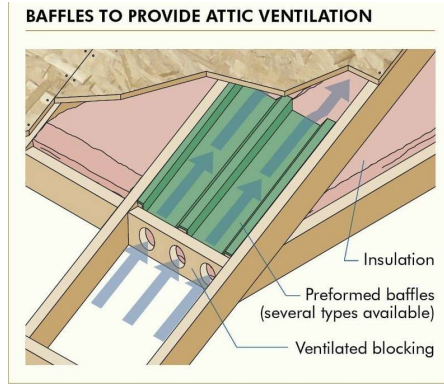
Various locations

10.3.1 - Attic, Insulation & Ventilation: Ventilation

INSULATION BAFFLES MISSING

Recommend installing between insulation and roof sheathing. Insulation Baffles allow for proper air flow to reduce heat buildup in attic, which can shorten the lifespan of the roof covering materials.

Contact a qualified handyman.

\$500 credit requested

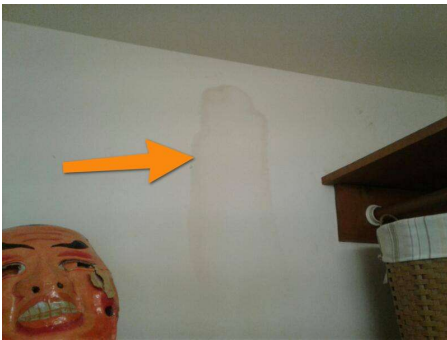
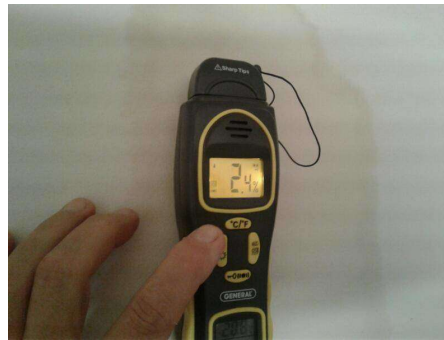
2nd floor NE bedroom closet

11.4.1 - Doors, Windows & Interior: Walls

STAIN(S) - TESTED DRY

There is a stain in need of repair / paint. Tested dry. Recommend consulting owner to verify the leak has been repaired.

Verify leak repaired.

Recommendation
Recommend monitoring.

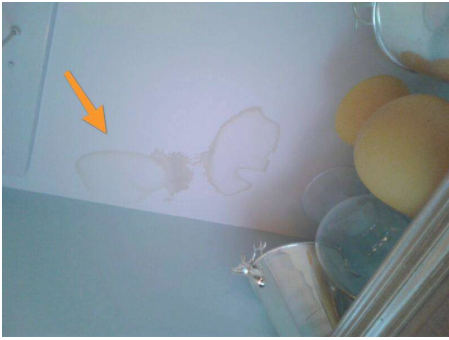
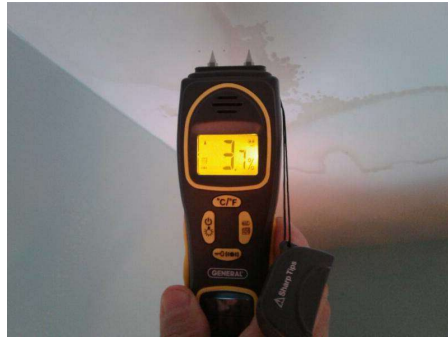
1st floor laundry

11.5.1 - Doors, Windows & Interior: Ceilings

STAIN(S) - TESTED DRY

There is a stain in need of repair / paint. Tested dry. Recommend consulting owner to verify the leak has been repaired.

Verify leak repaired.

Recommendation
Recommend monitoring.

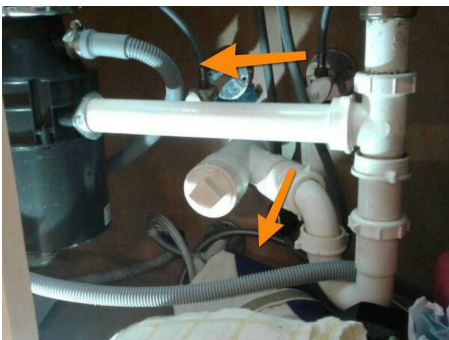
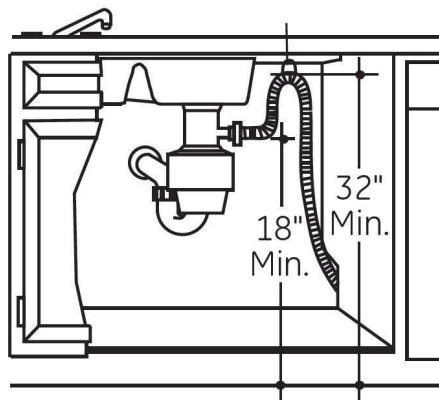
1st floor kitchen

12.3.1 - Appliances: Dishwasher

MISSING HIGH DRAIN LOOP

The backflow of wastewater into the dishwasher is possible with this configuration, and can result in the contamination of dishes during the rinse cycle.

Repair requested.

Position drain line as close to the underside of the counter as possible to create a high loop and ensuring the highest point of the drain line is above the entry point of the drain entrance.

Contact a qualified handyman.

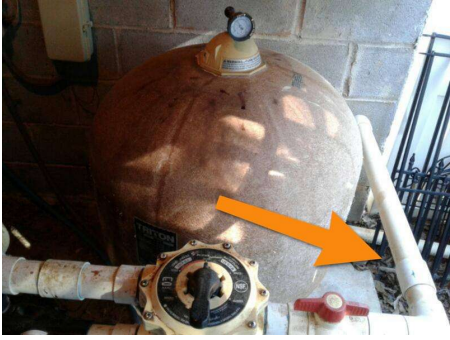
13.7.1 - Pool: Plumbing

LEAK NOTED

Repair requested.

Repair needed.

Contact a qualified professional.
