# Sidewalk Inventory Findings The Big Picture

# Sidewalks Inventory Findings The Nitty Gritty

# Crossing Treatment Findings

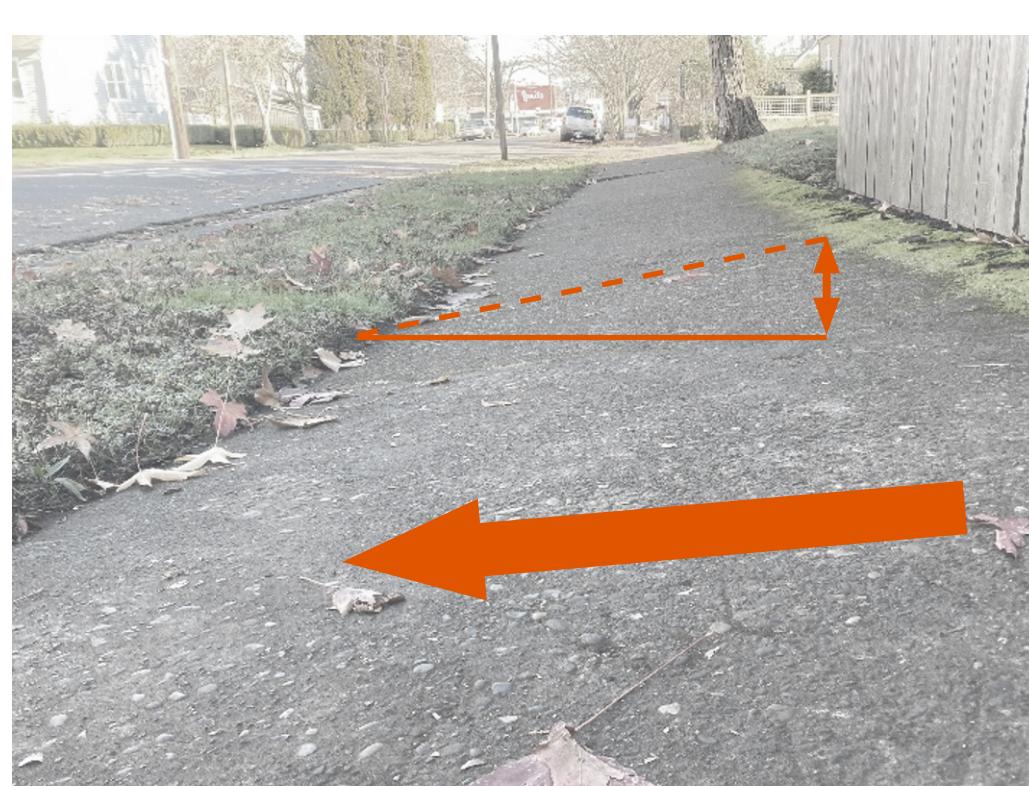
**Cross Slope** is perpendicular to direction of travel.

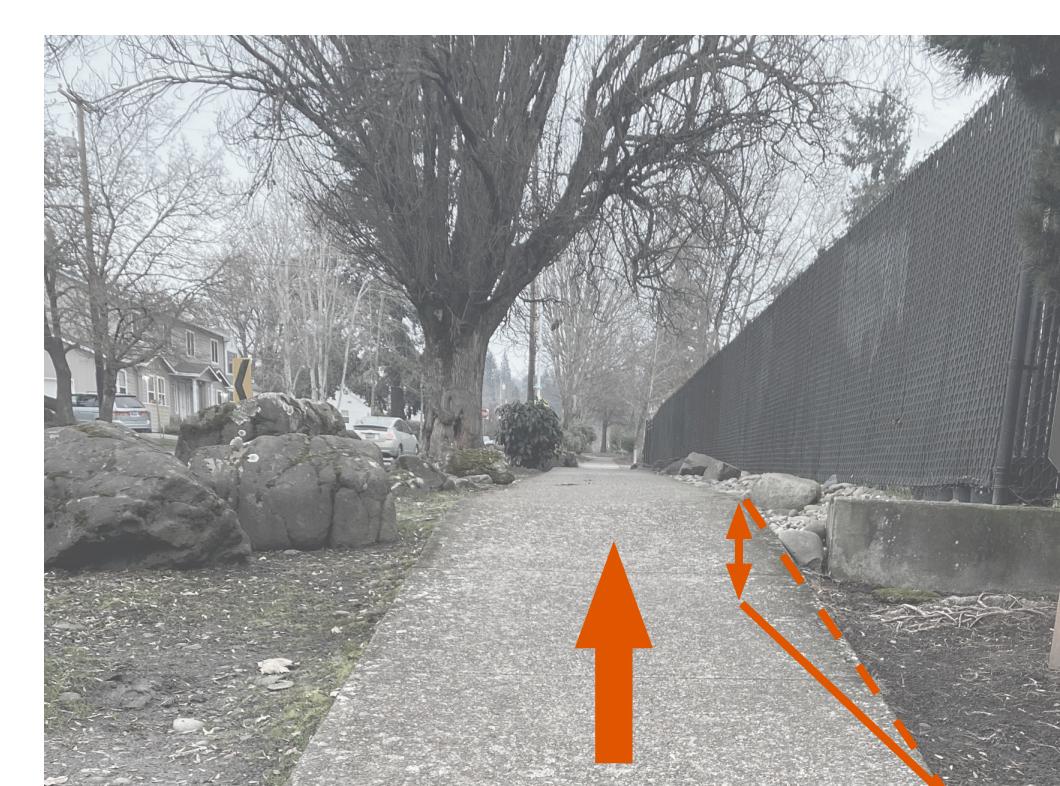
**Running Slope**, or grade, is in the direction of travel.

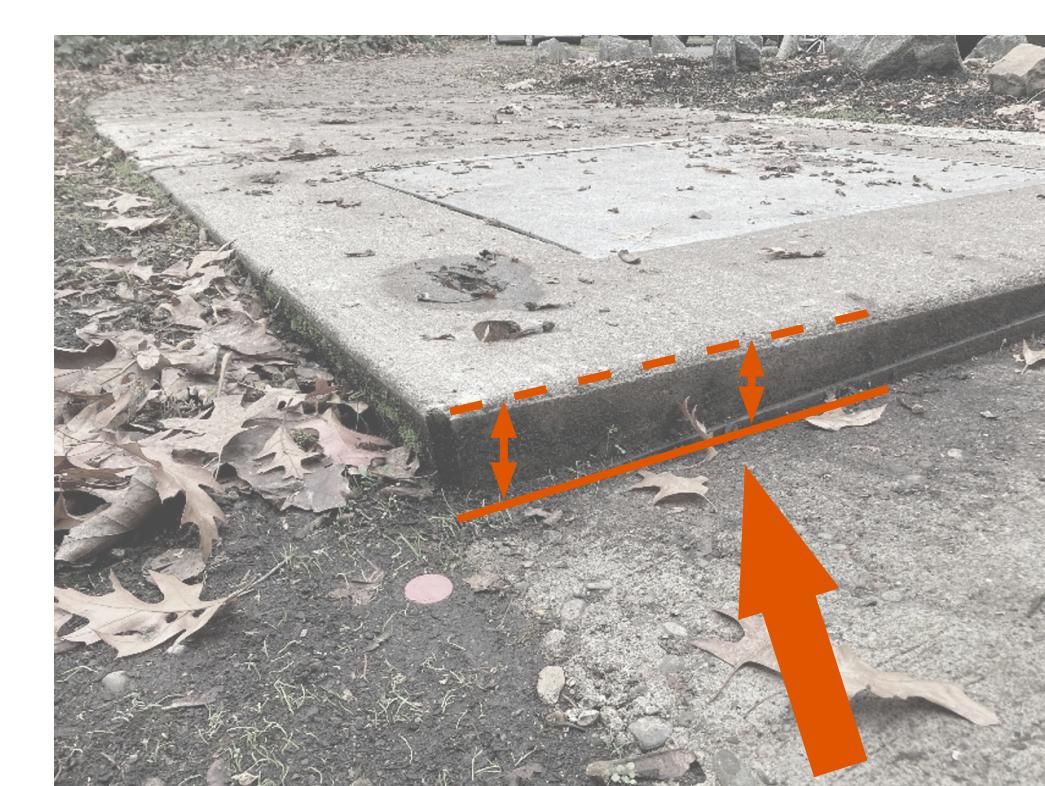
**Uplift** is a height difference where two pavers meet.

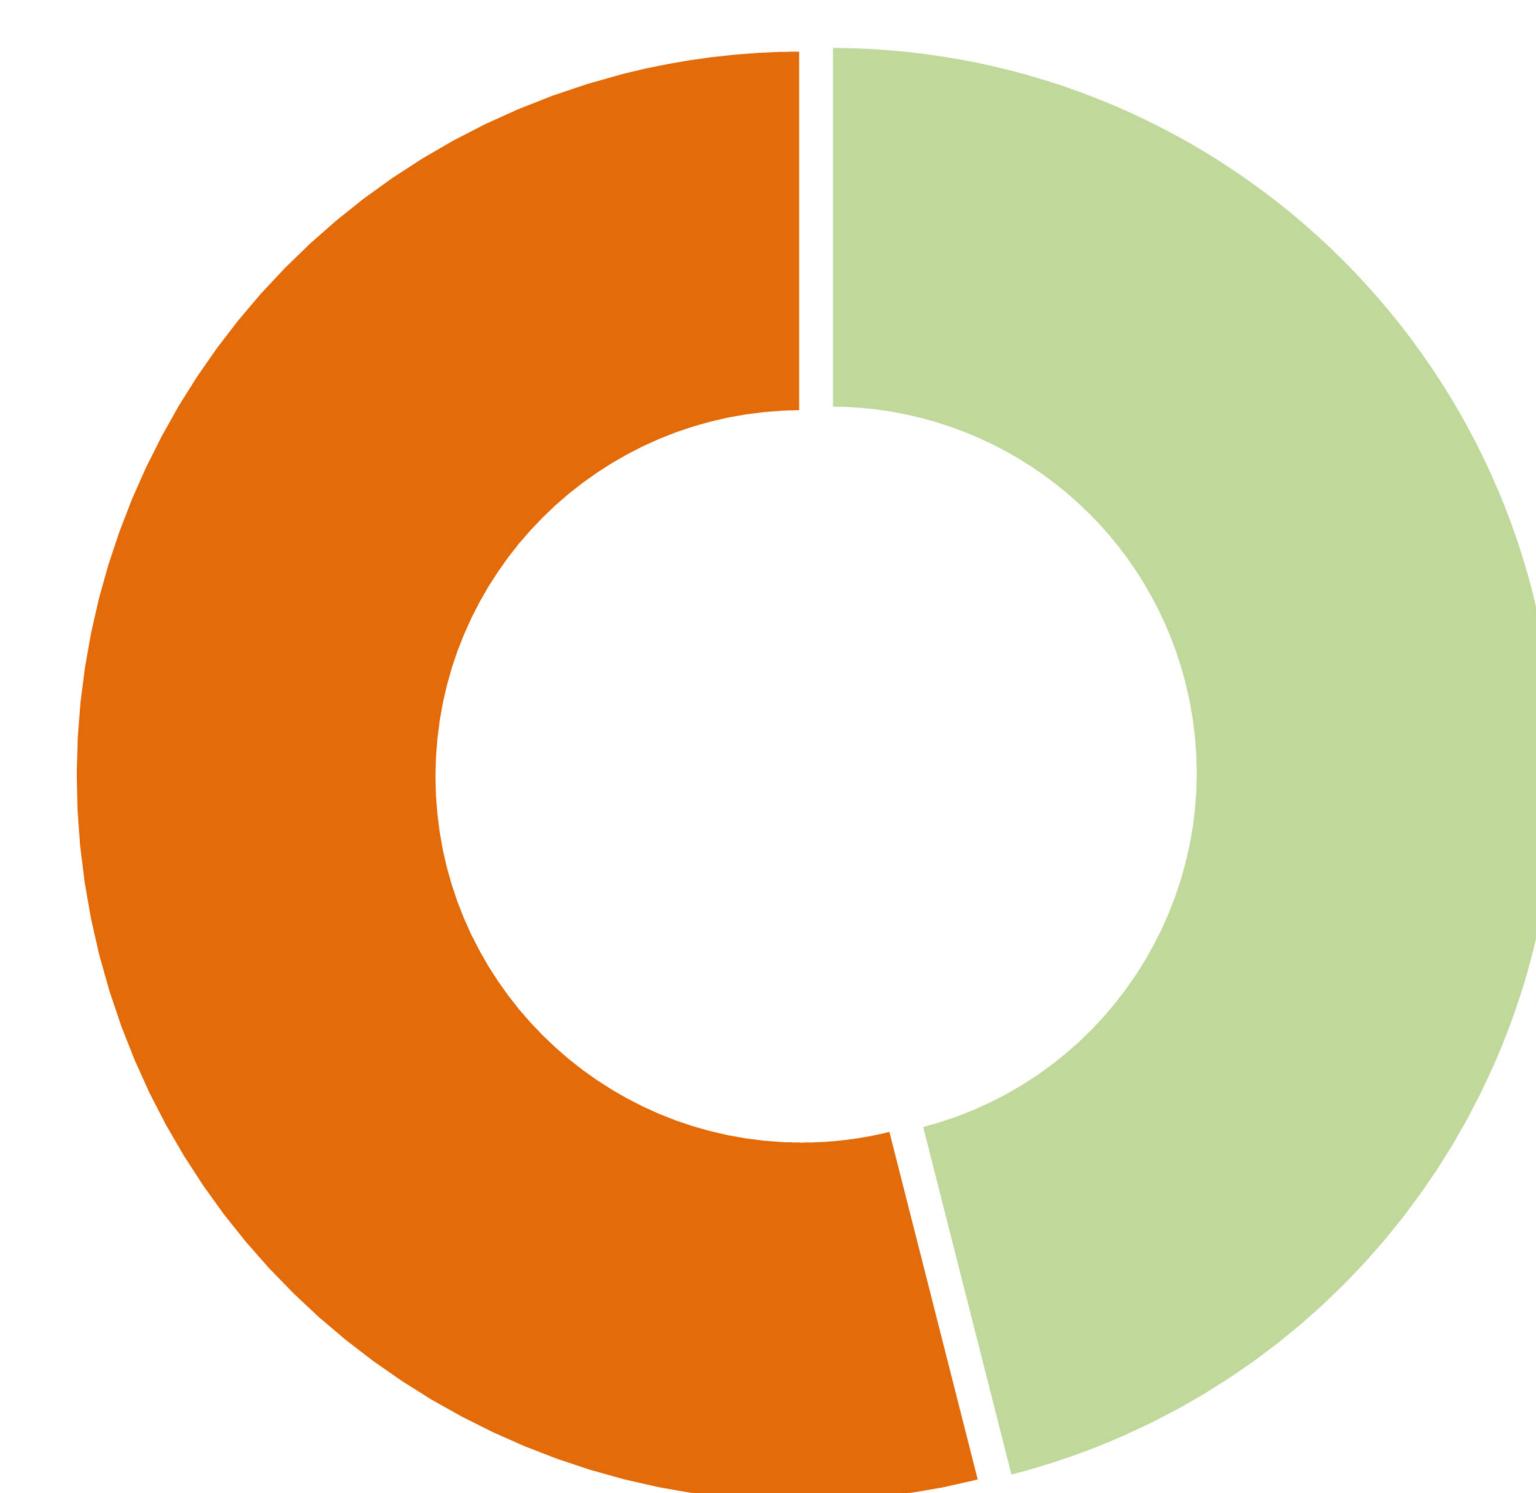
Over **50%** of the sidewalks surveyed were **ADA Non-Compliant** in some way

The green bar above represent square footage that is "Perfect/Very Good," "Good," or "Moderate" and is otherwise ADA compliant.

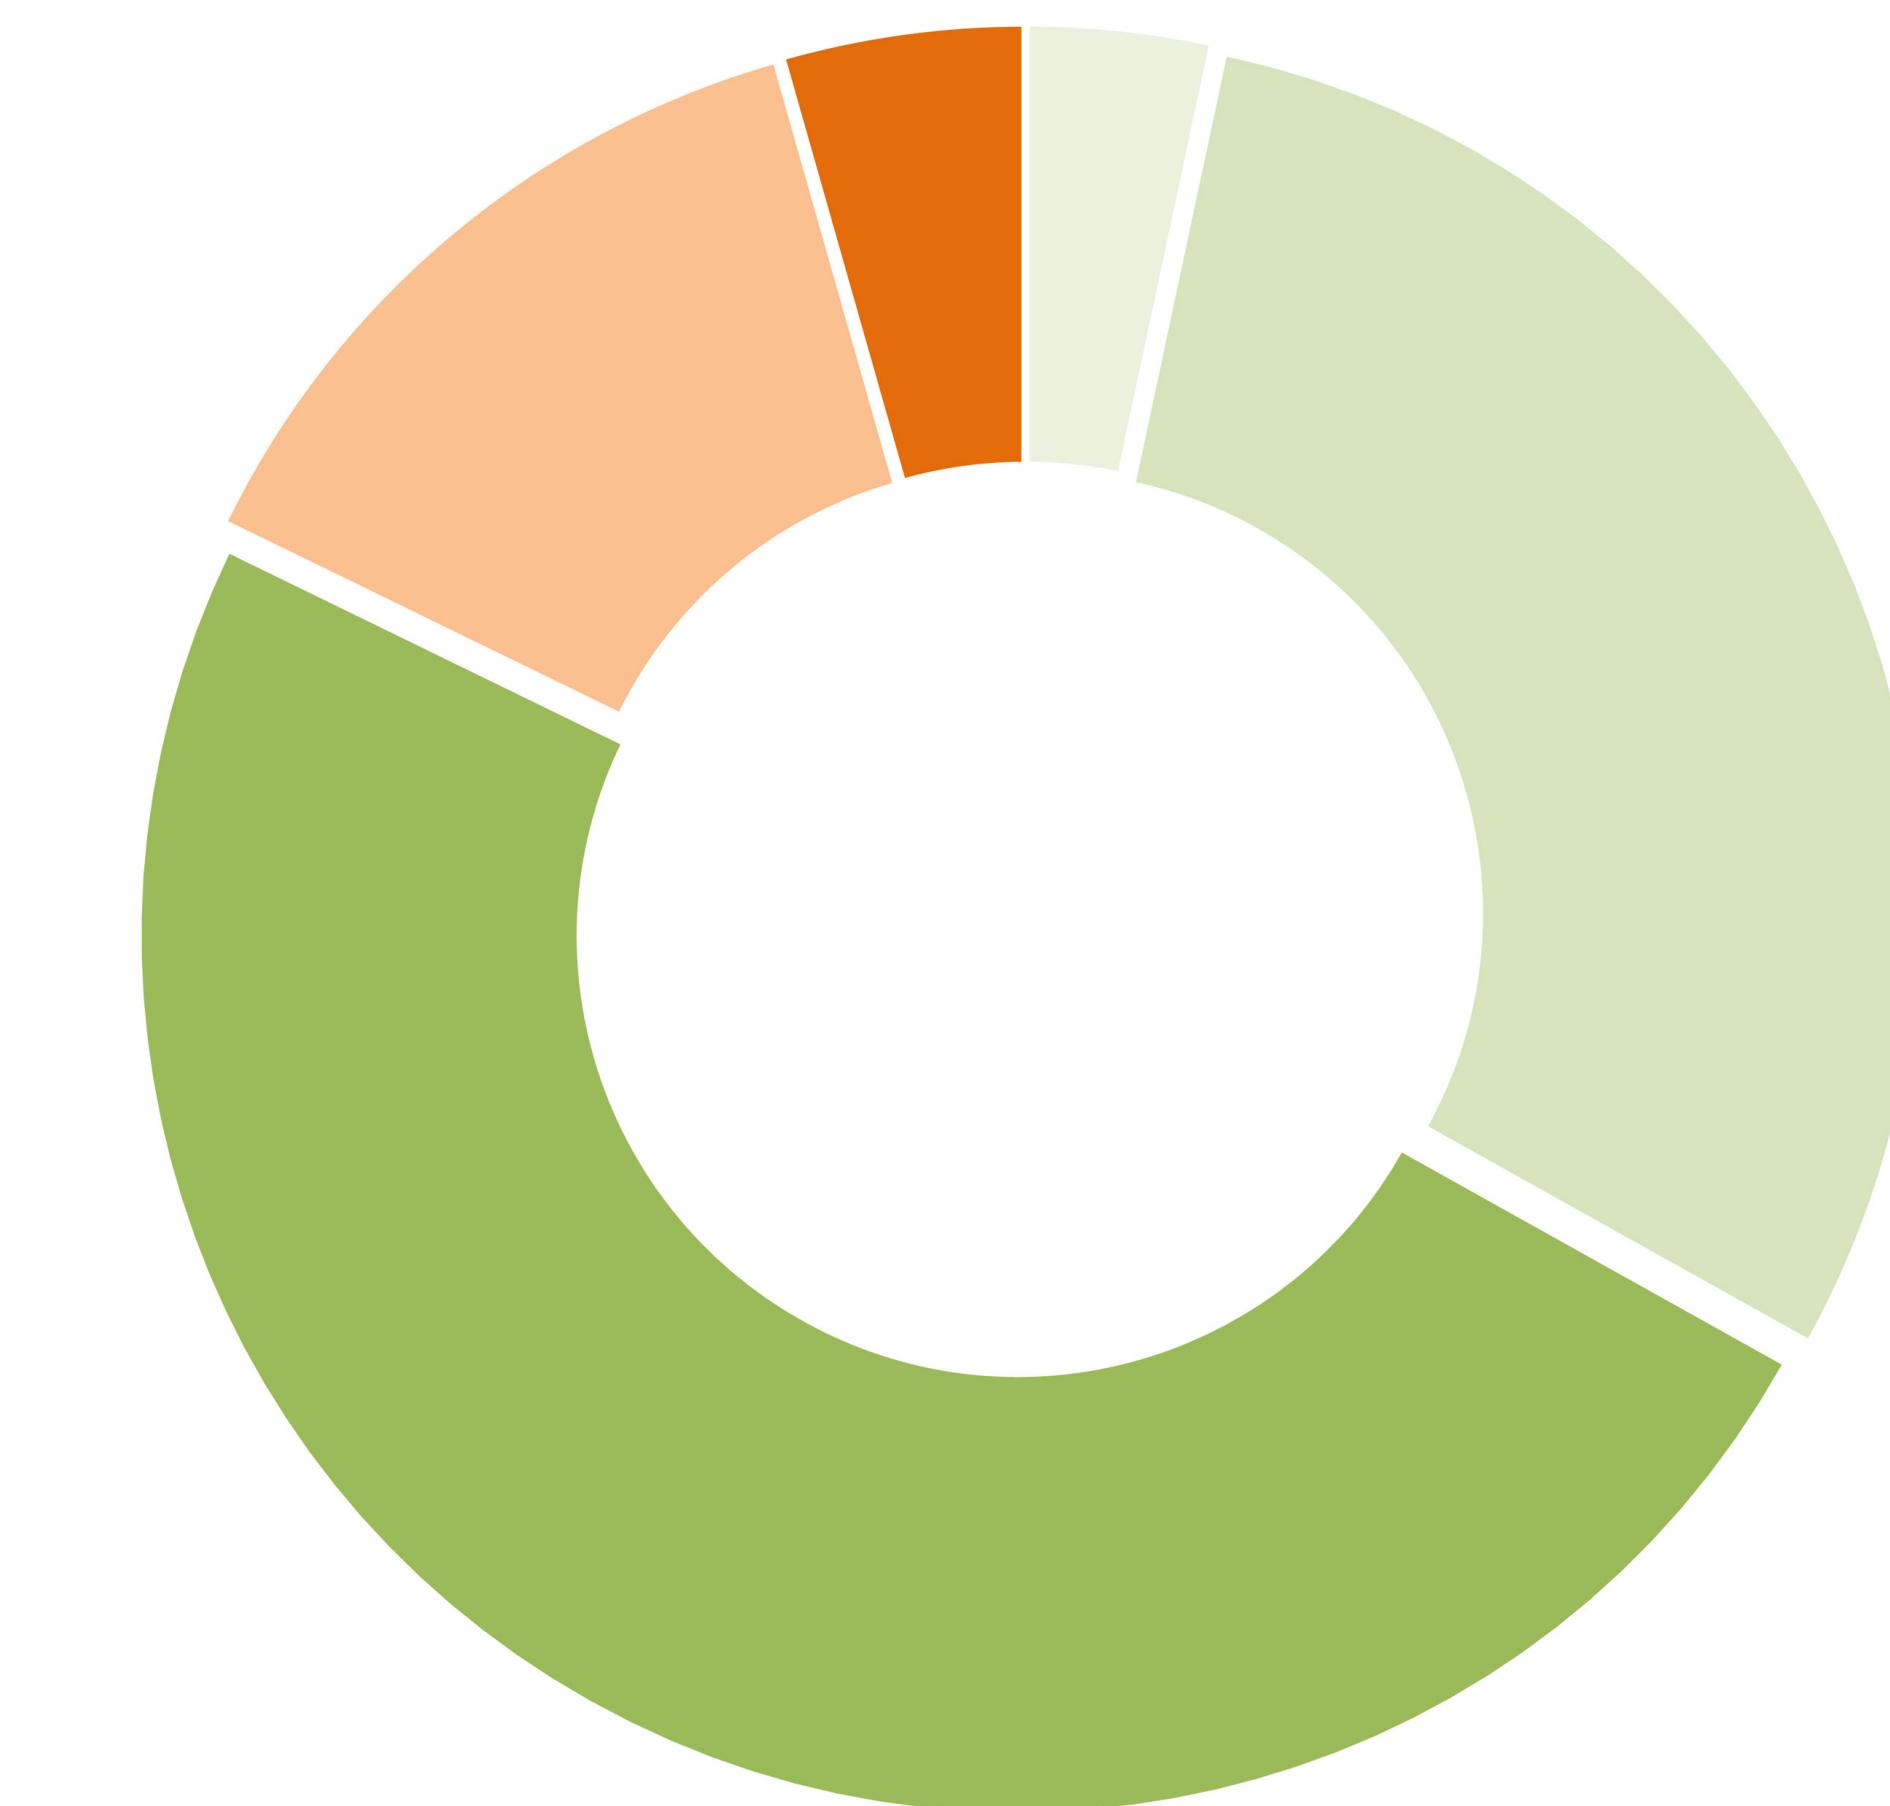
Approximately **50%** of recorded Square Footage was assessed as '**Moderate**'

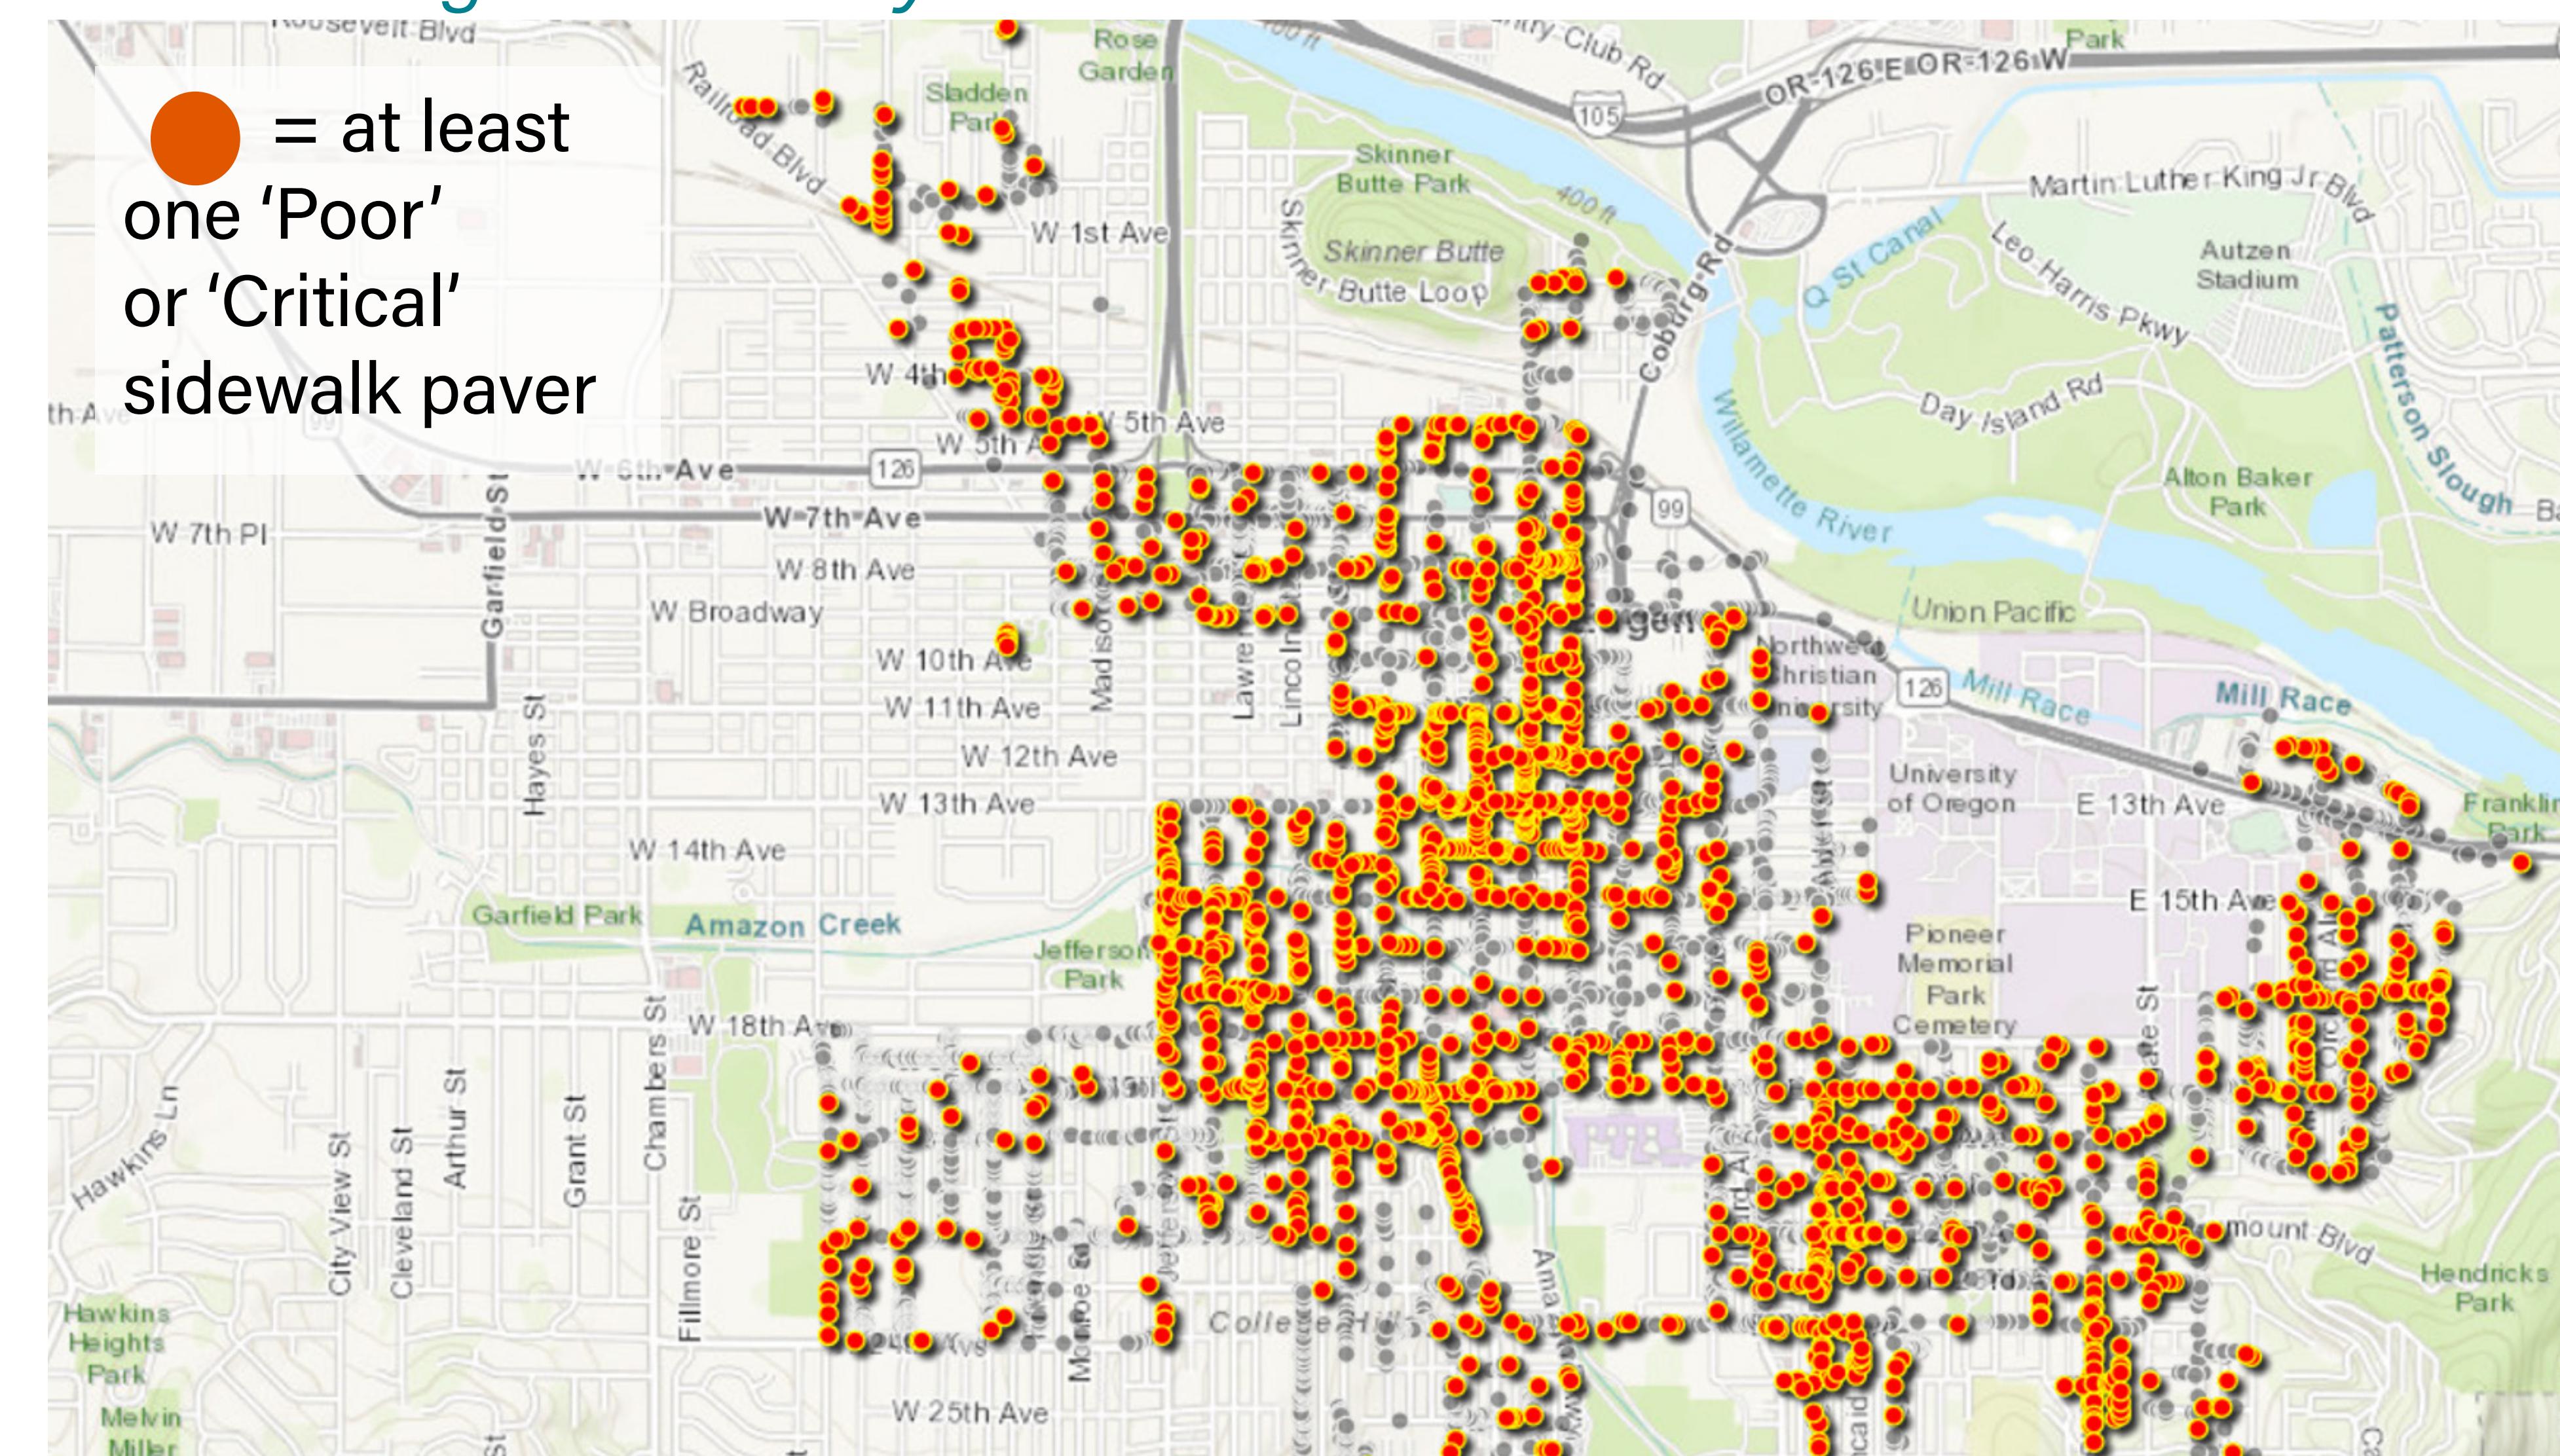
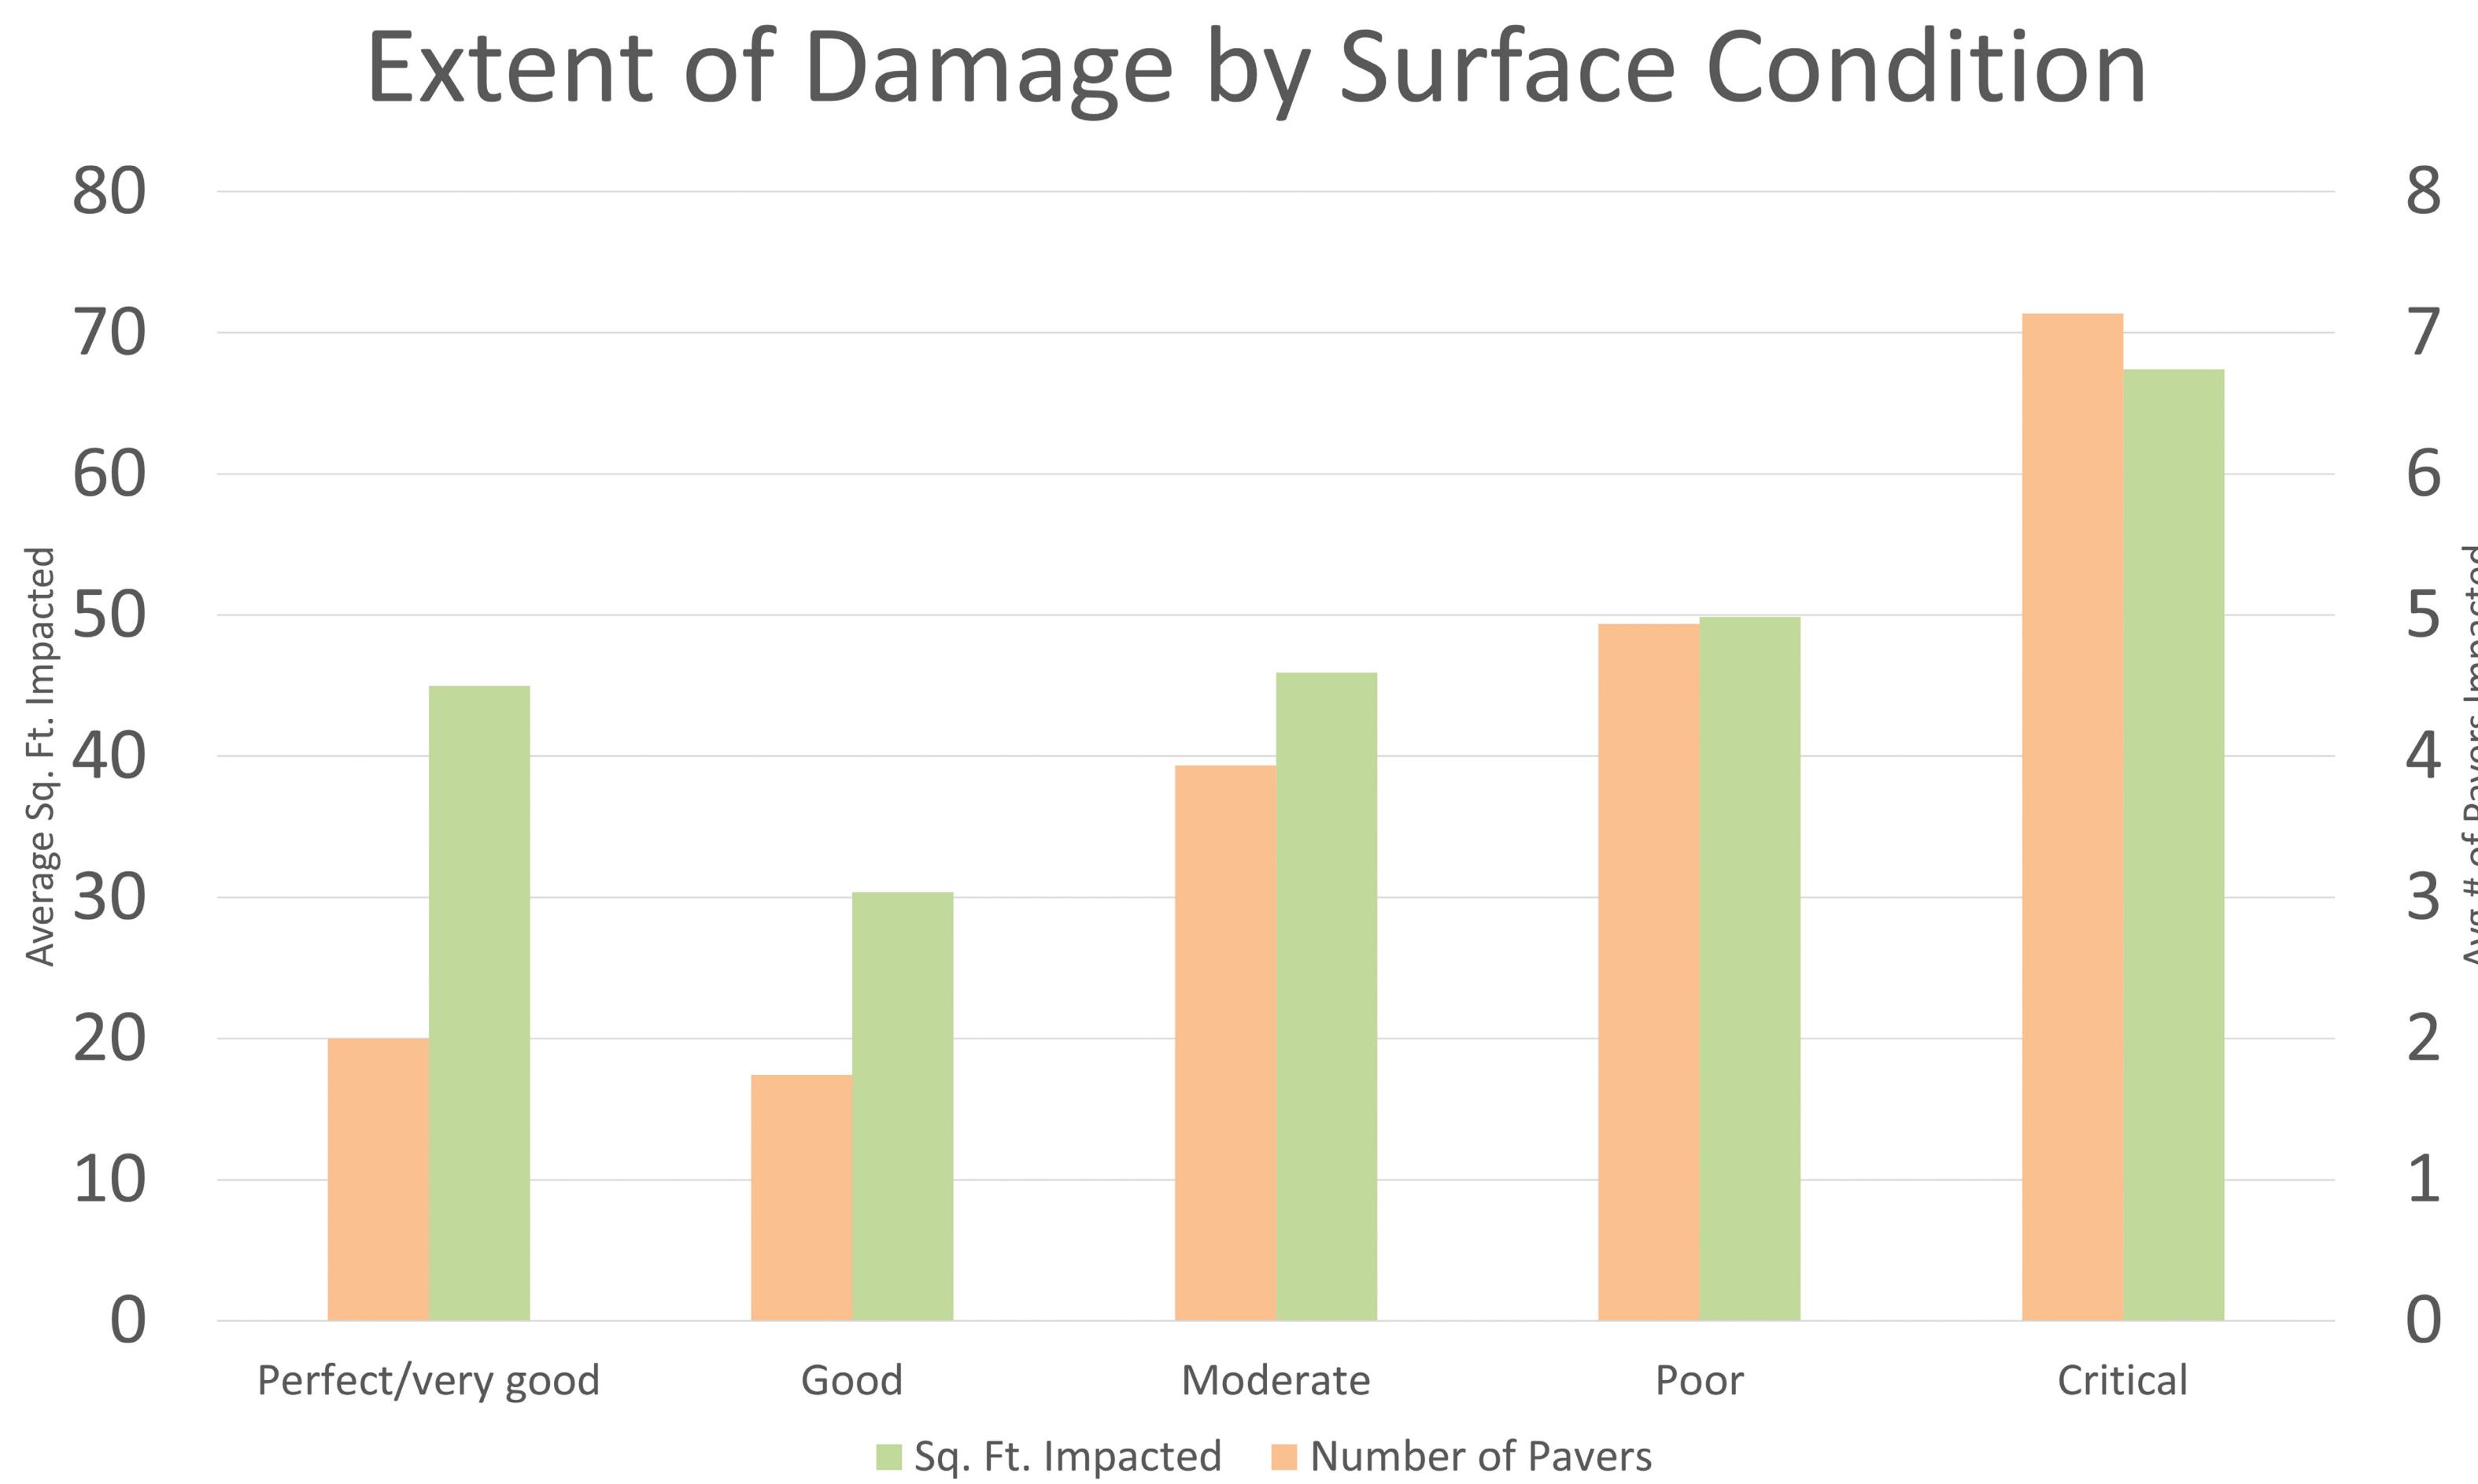
...But '**Poor**' and '**Critical**' pavers, some indicating severe damage, can be found **throughout** the city.

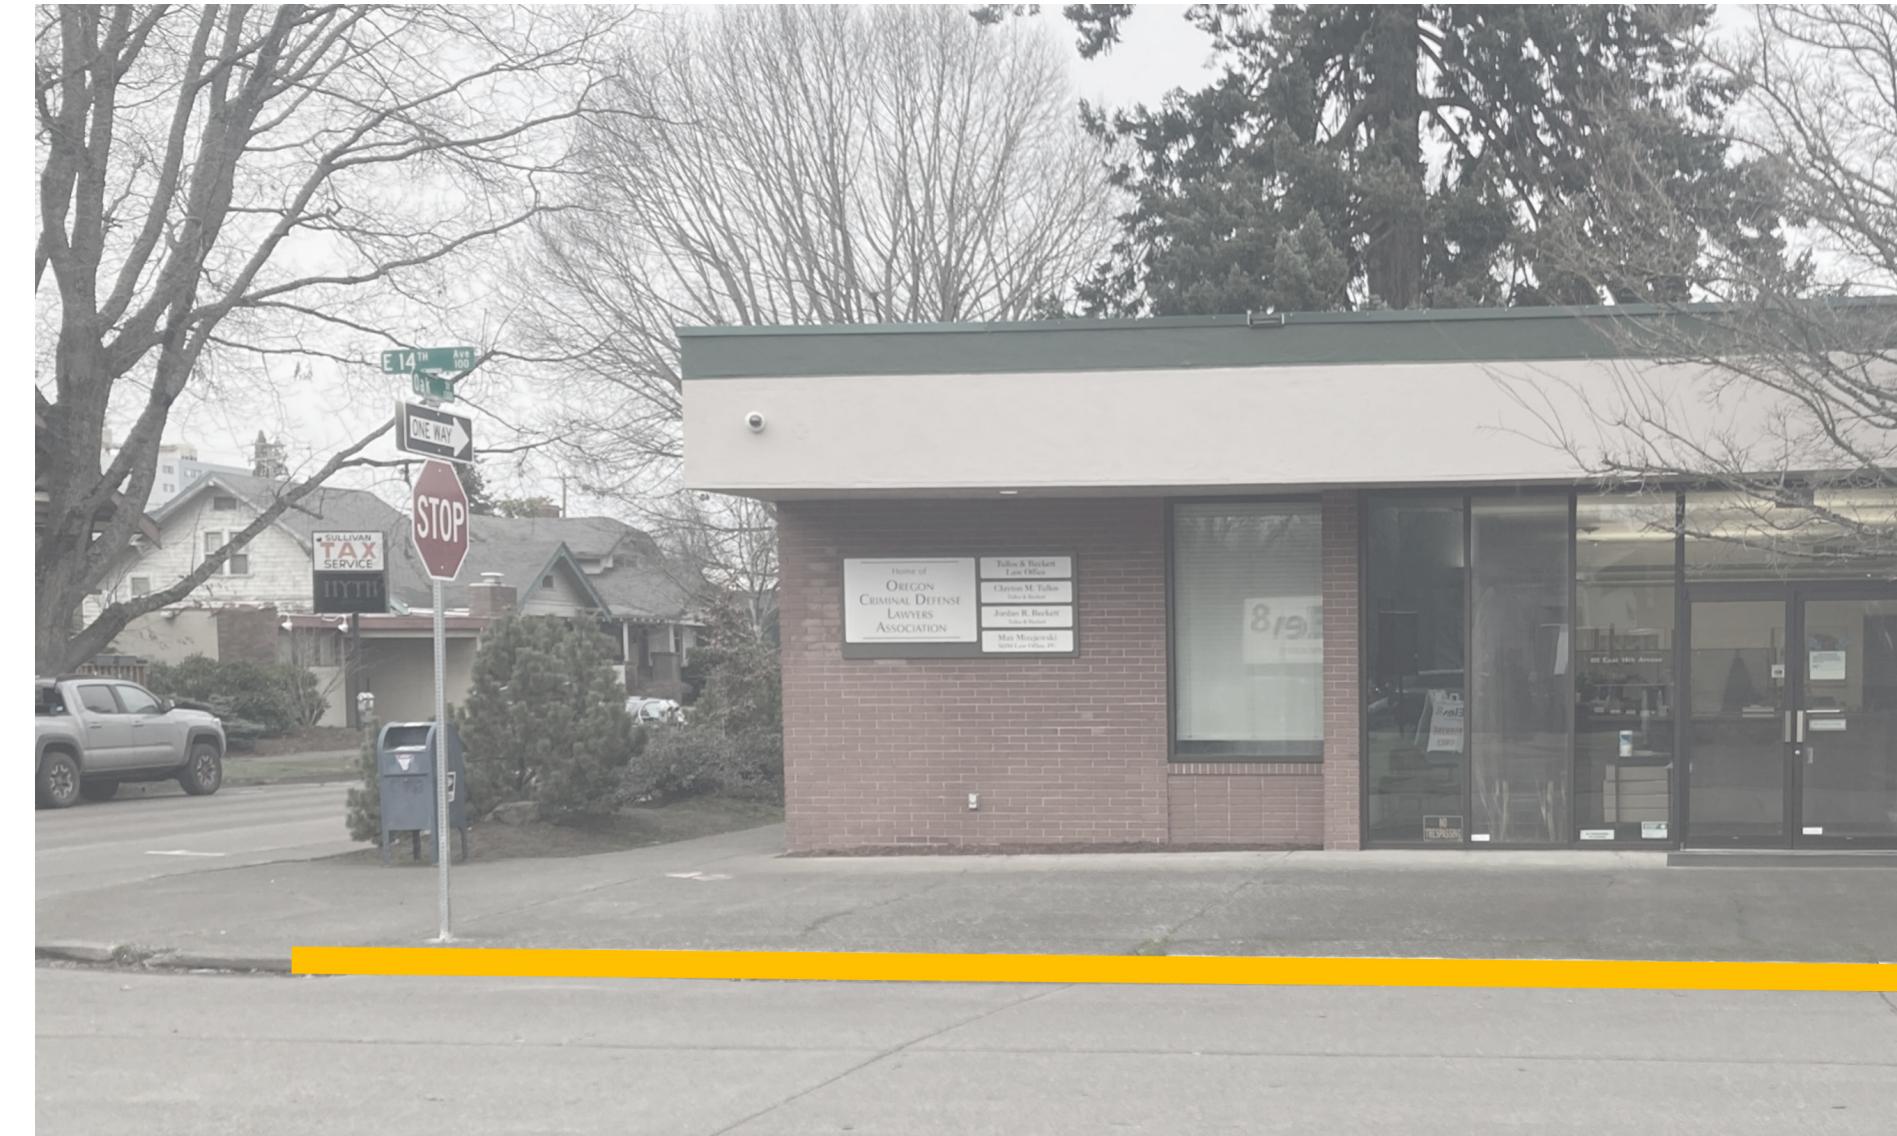
The yellow line at left is a **Parking Restriction on Crosswalk approach** and is the only thing protecting the crosswalk for you to cross while visible to drivers!

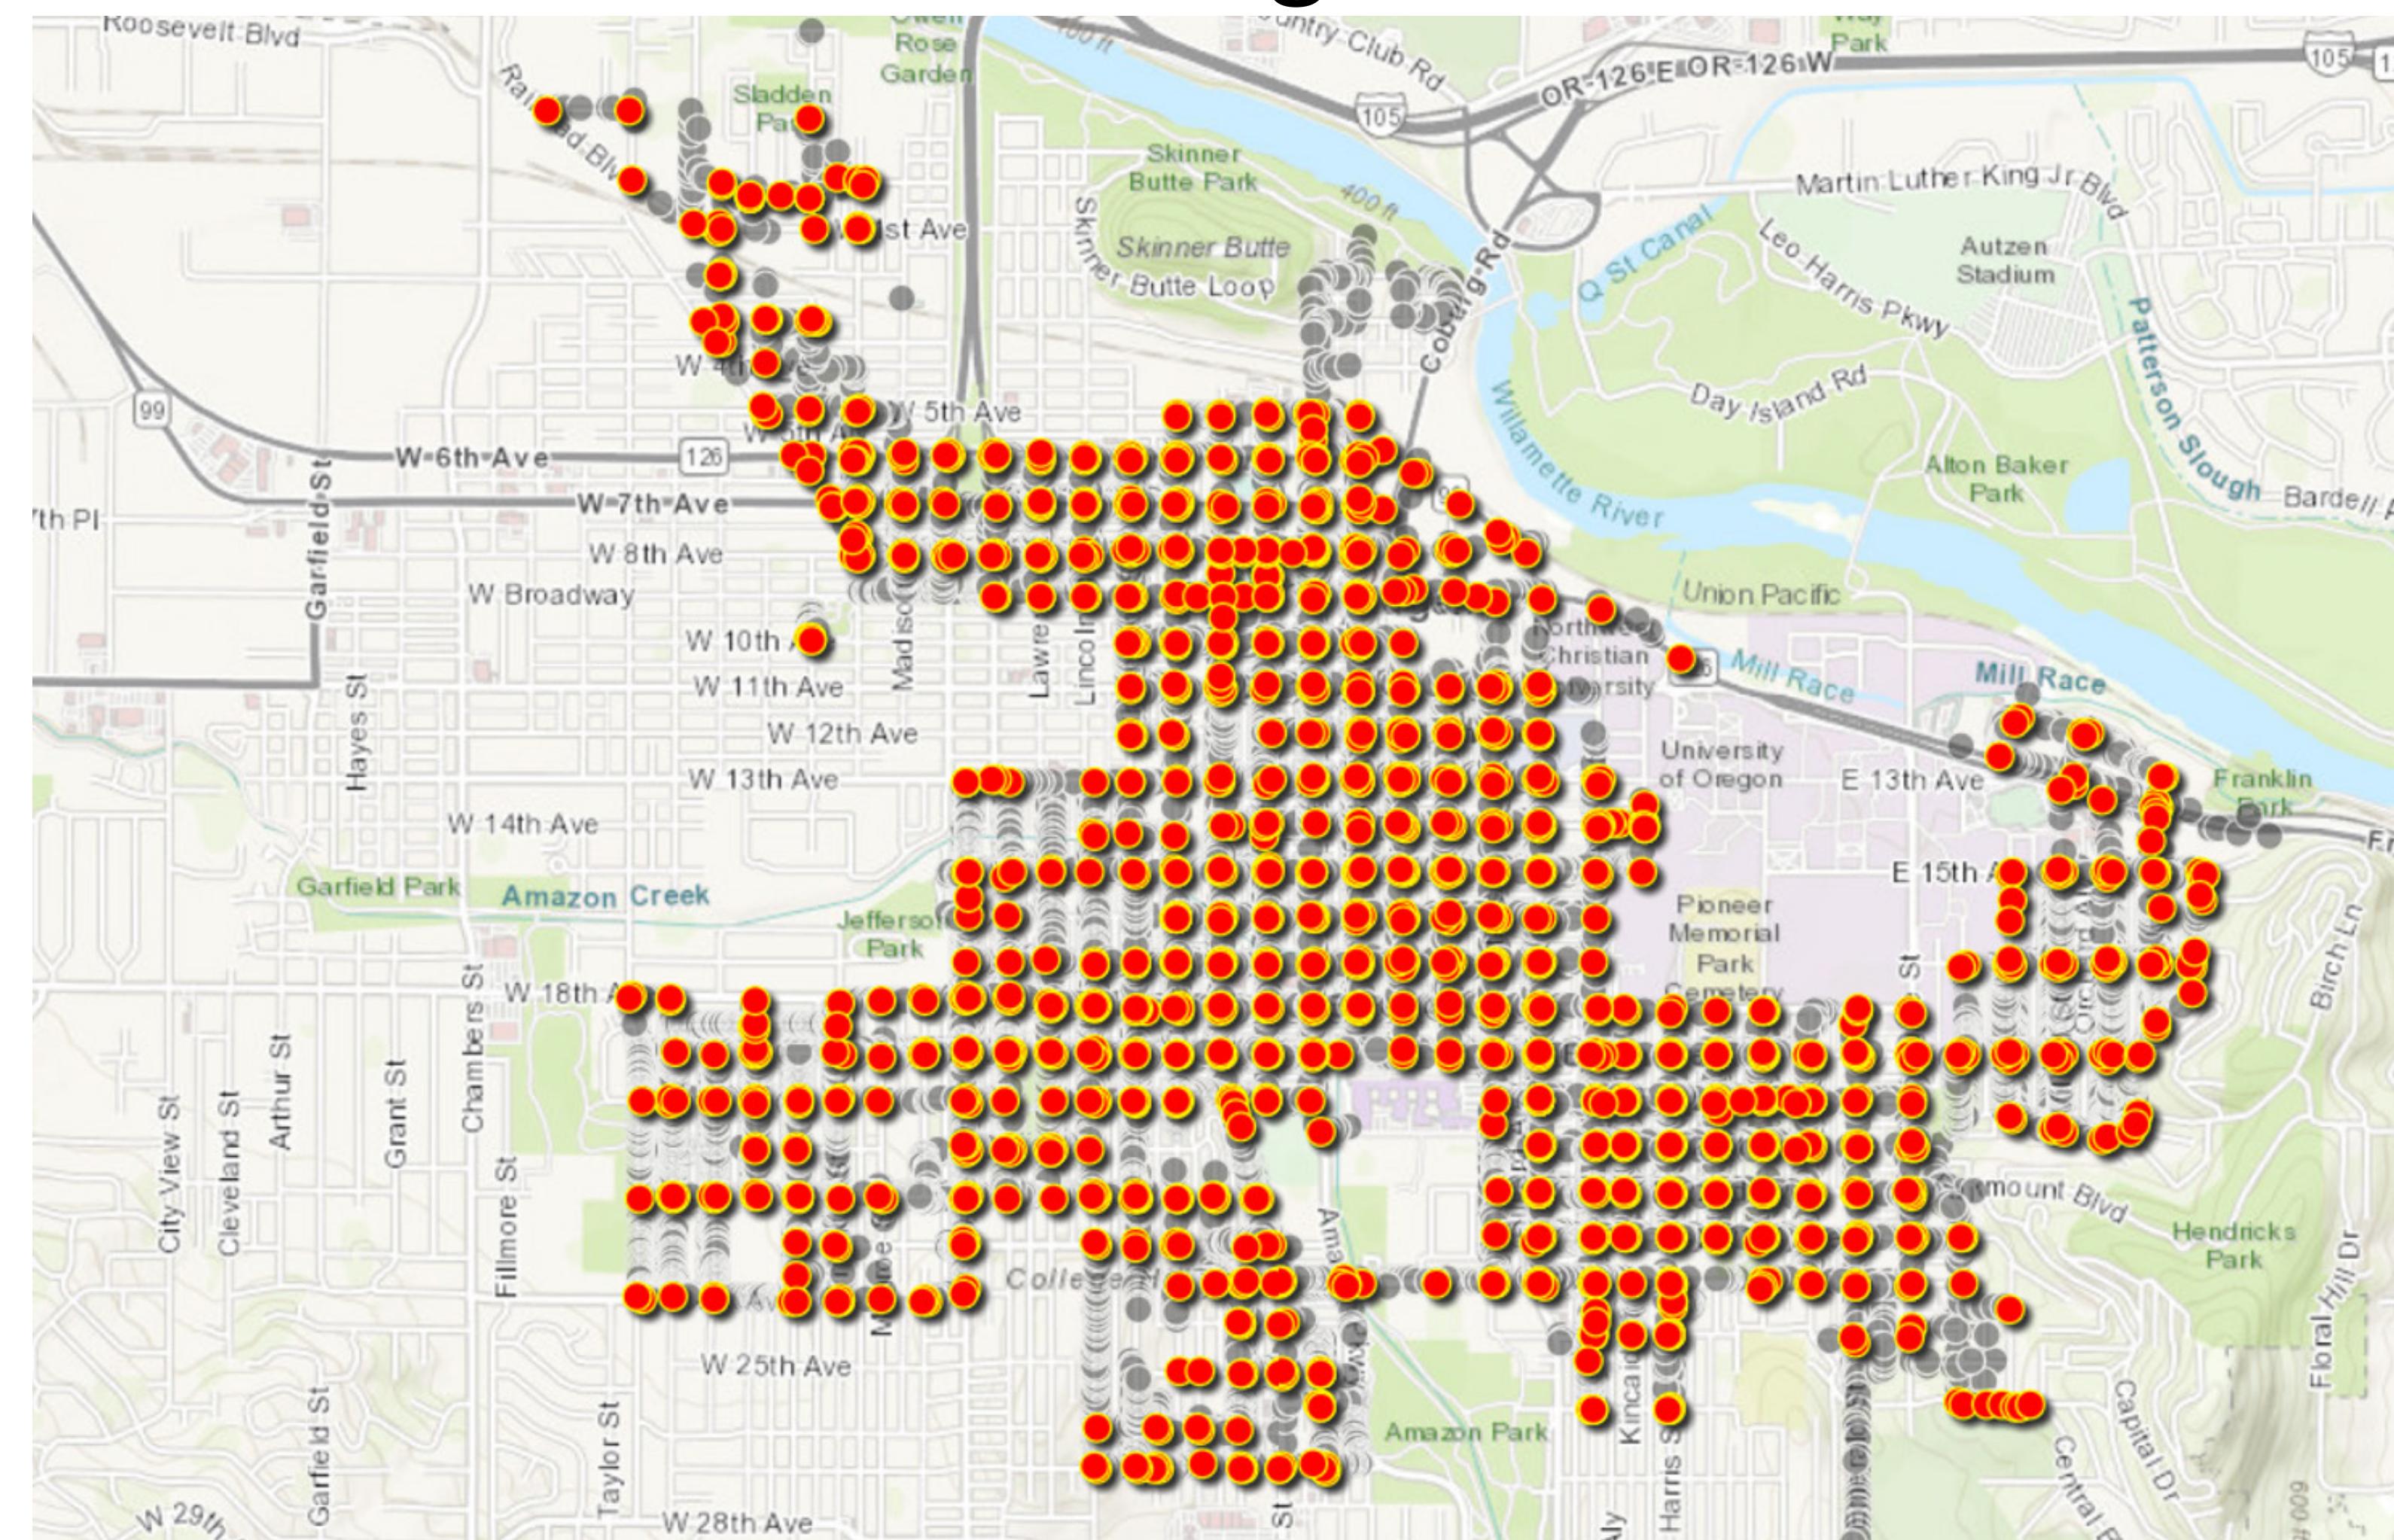
## At Least One Crossing Treatment

Of the area surveyed, many curb cuts had **SOME** kind of treatment to protect or otherwise encourage pedestrian crossings, however...
