# Sidewalk Inventory Findings The Big Picture

# Sidewalks Inventory Findings The Nitty Gritty

# Crossing Treatment Findings

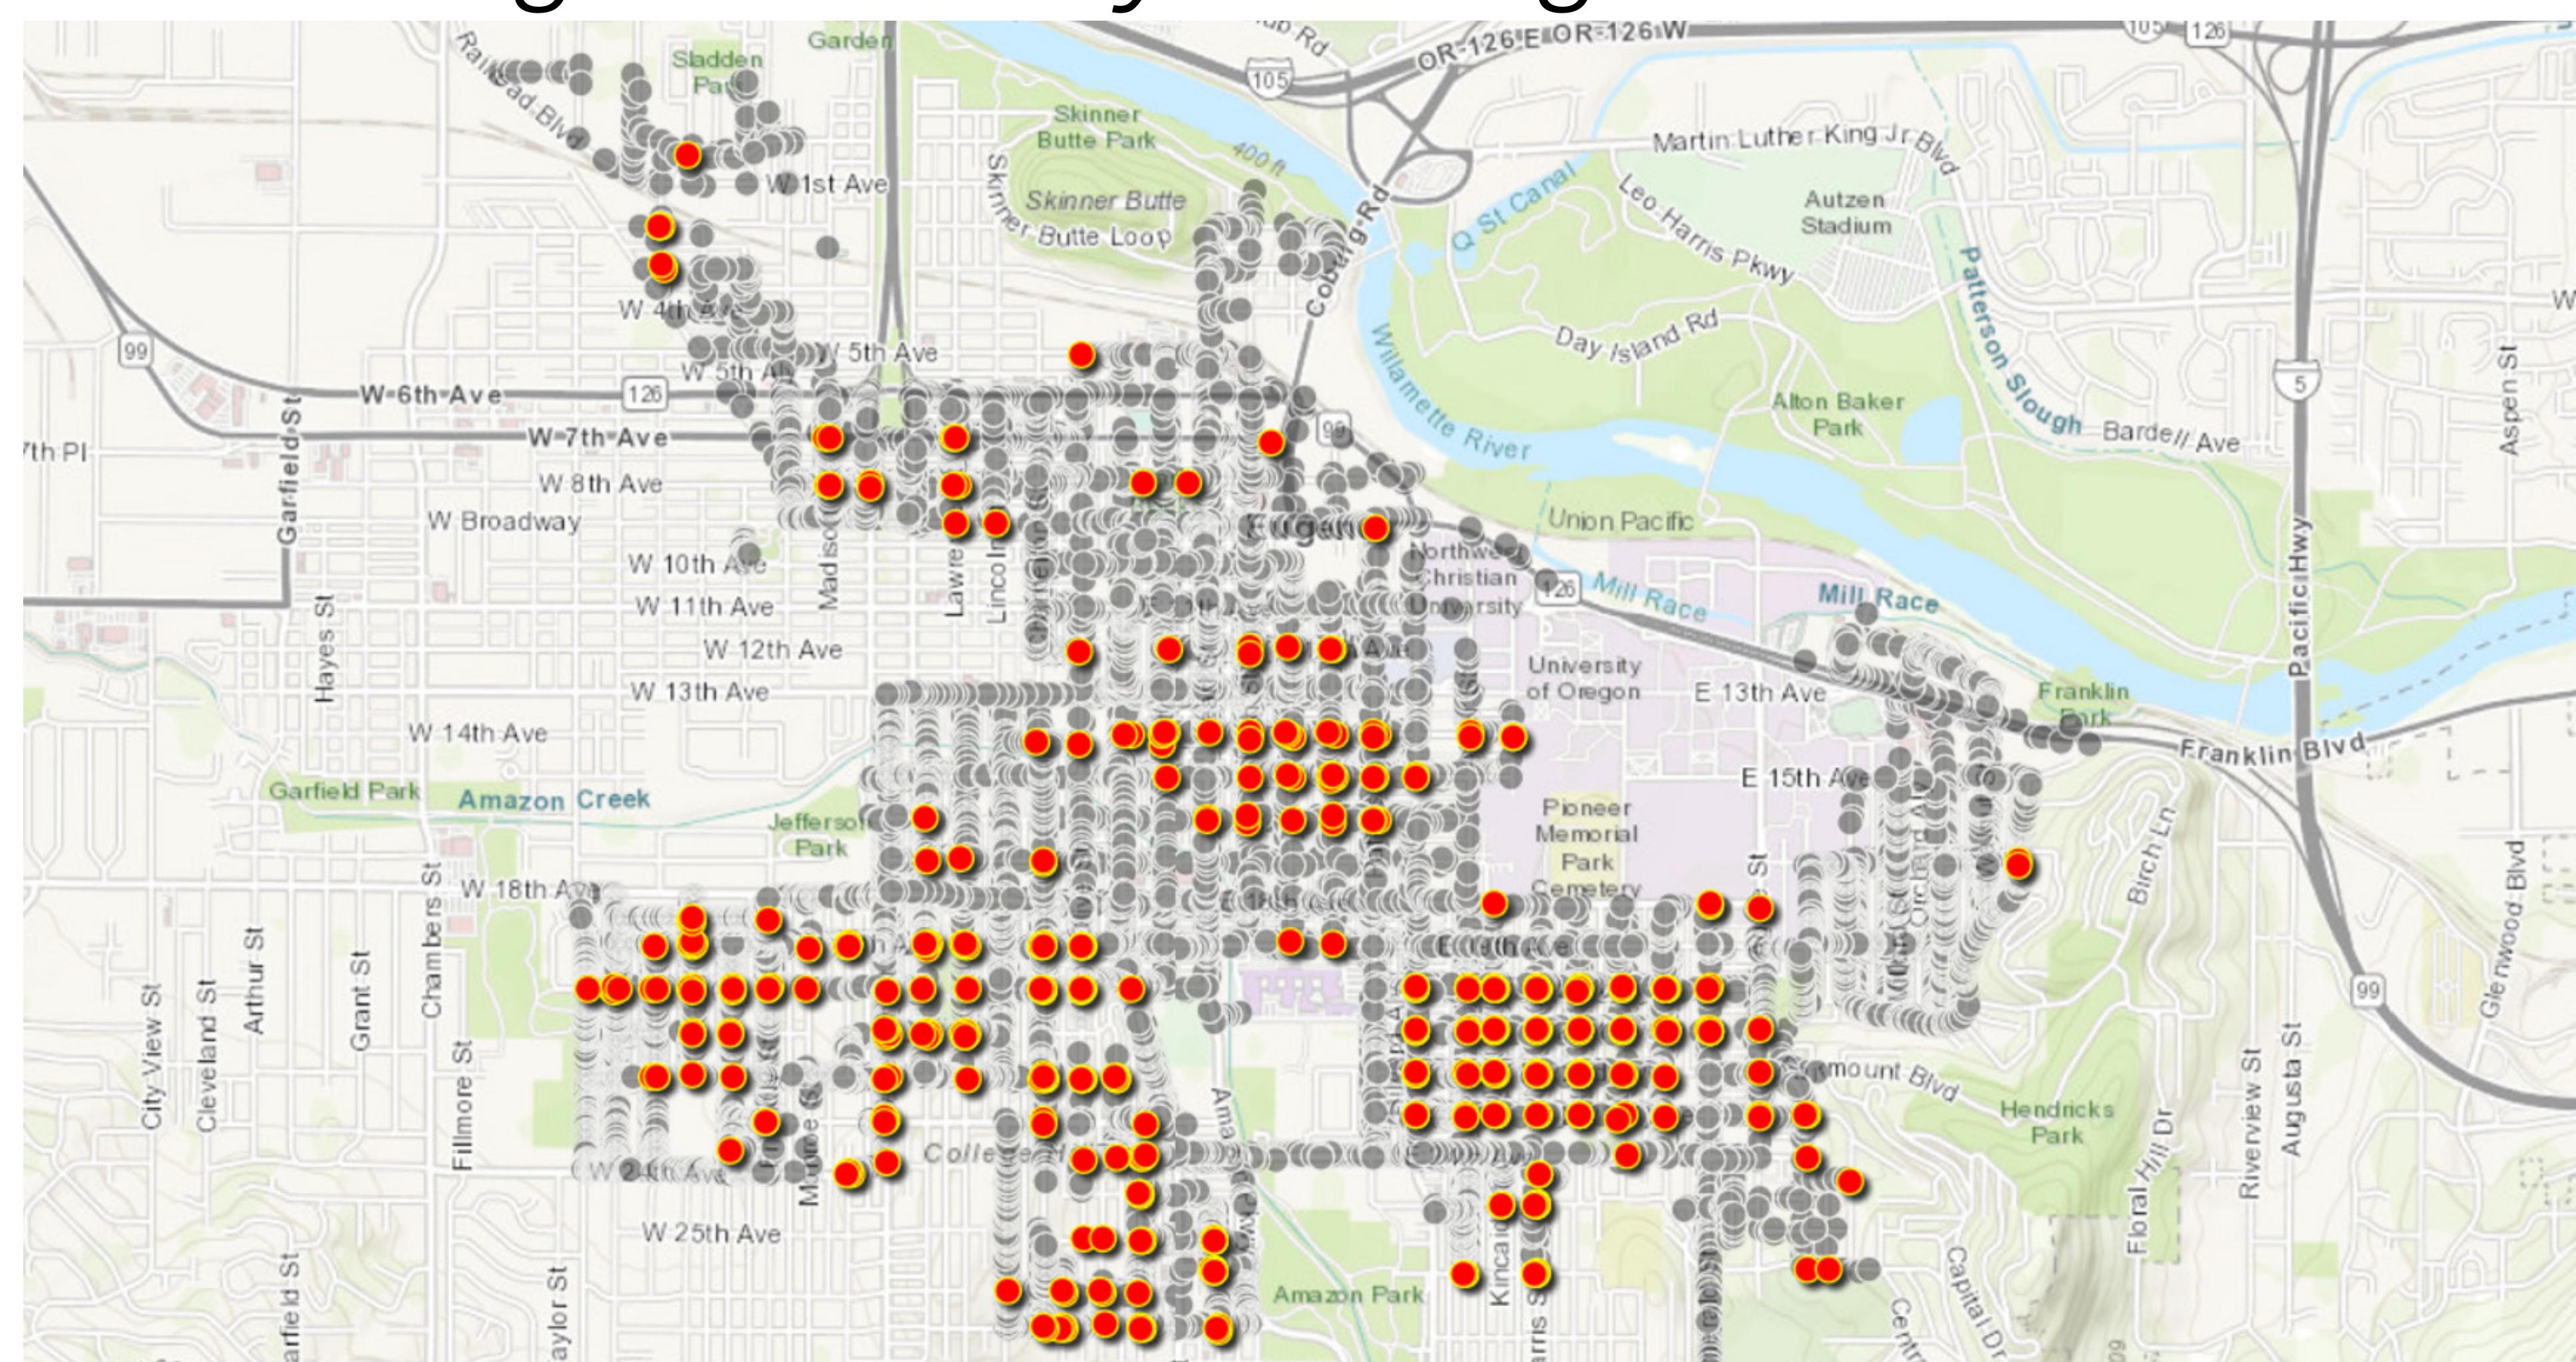
## Crossings With Only Parking Restrictions

Over 300 crossings had **ONLY** Parking Restrictions, meaning no signage, stop lines, or crosswalk paint, including across busy roads like Patterson & Hillyard.
