5210 LINDEN HEIGHTS AVE

INCIDENT REVIEW TEAM

FEBRUARY 26, 2026

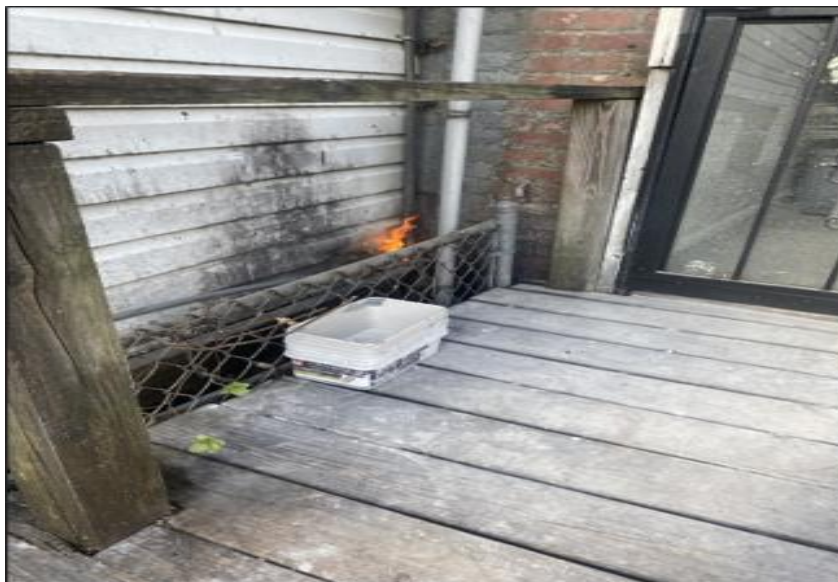
(Photo 7: Fire venting from the exterior wall of the first-floor rear addition of 5210 Linden Heights Avenue, adjacent to 5208 Linden Heights Avenue where contractor was working.)

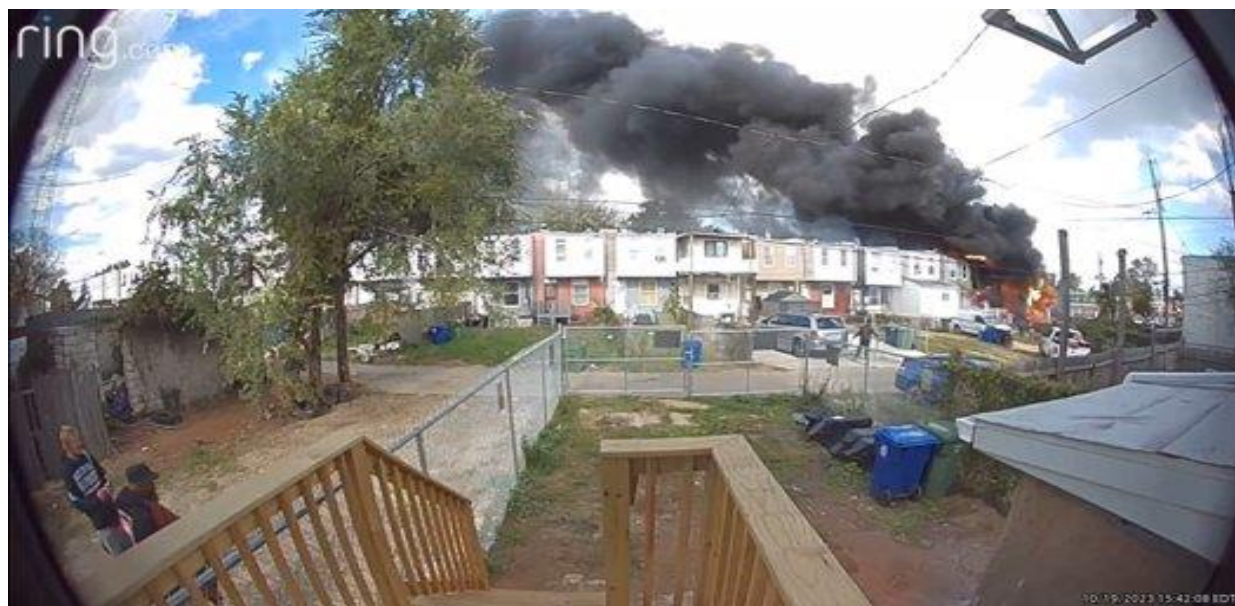
(Photo 8: Ring Camera still shot from the rear at 15:42 hours showing column while units are enroute.)

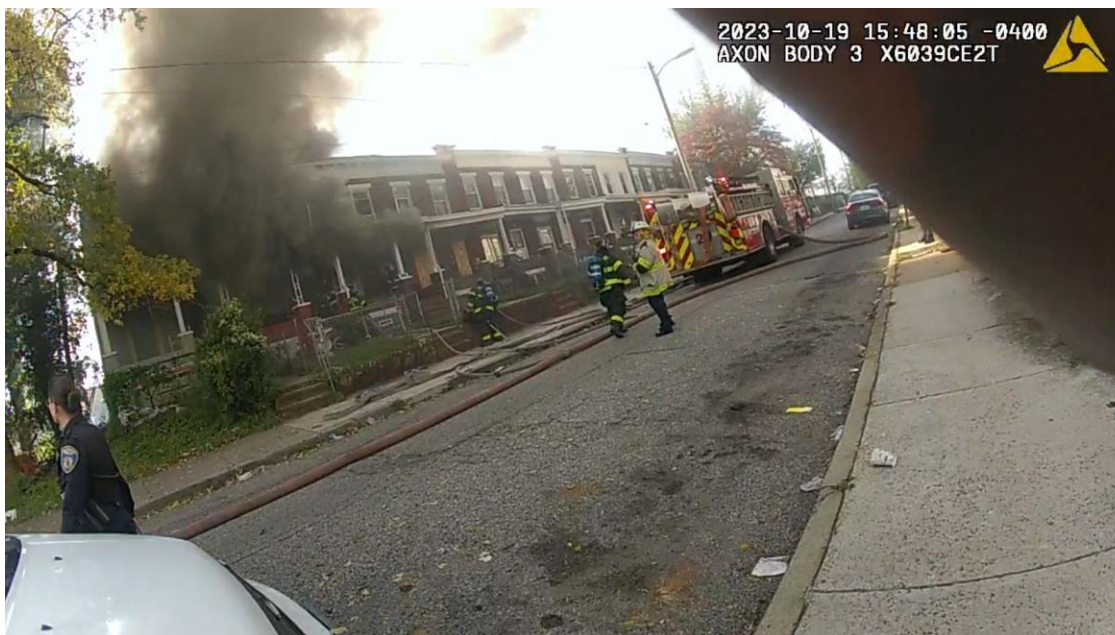
Engine 29 does not respond. There is no indication from apparatus data recordings or any other evidence that Engine 29’s initial attack line flowed water at any point. [Training #1, #6].

(Photo 10: Fire conditions at 15:48 hours when Command is asking Engine 29 for an update.)

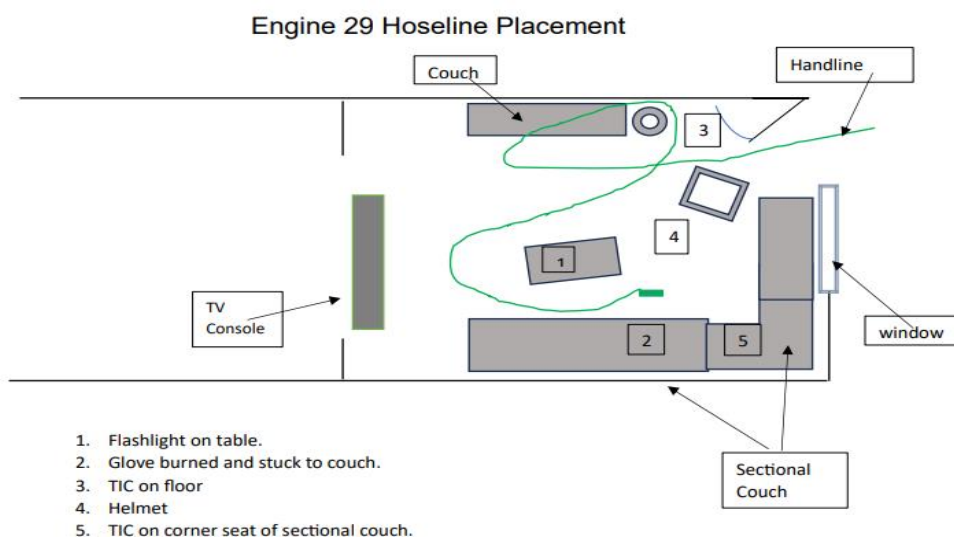
(Figure 1: Engine 29 Hose-line Placement)

Engine 29’s hose-line placement is shown in [figure 1]. After the crew entered the structure with EMT/FF Pitts in the lead and Captain Rinaldo following just behind, EMT/FF Pitts followed the right-hand wall. The crew missed the narrow opening leading to the rear dining room and kitchen, instead circling along the front living room furniture and back towards the front window. (See also figure 1)

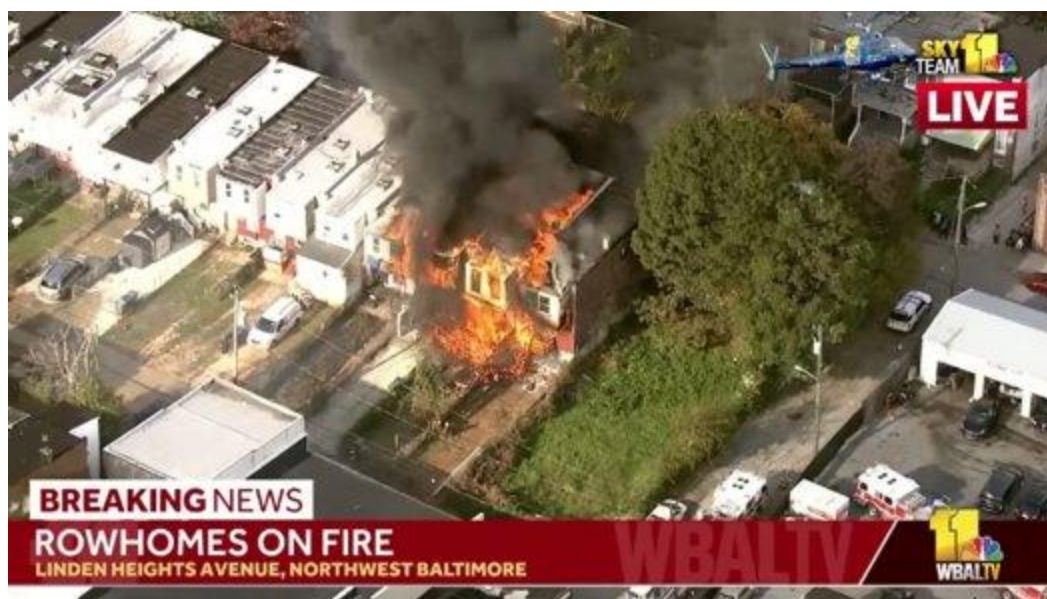
(Photo 11: WBAL News, live aerial coverage at the approximate time the Mayday was declared)

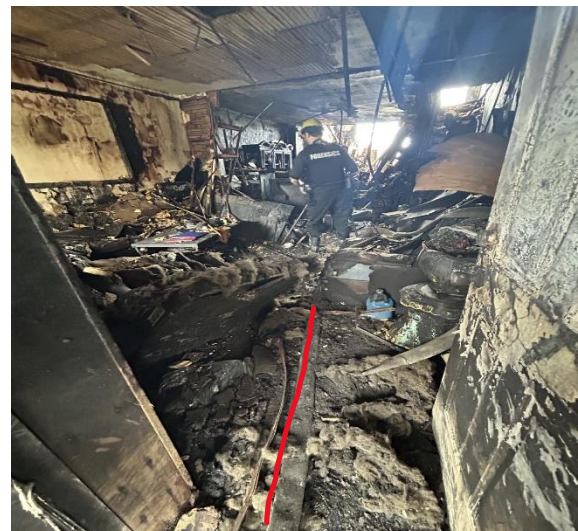
(Photo 13: Additional image of E-29's handline position. Photo taken from the C/D corner of the living room facing the front porch window. E-29's first-in handline depicted in red.)

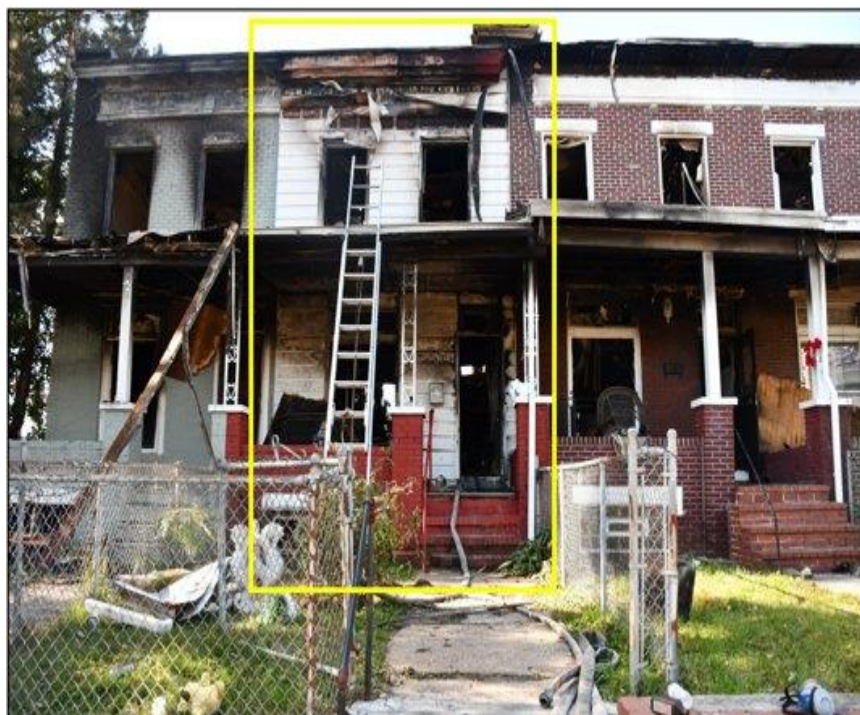
(Photo 14: Exterior of Side Alpha of 5210 Linden Heights as outlined in yellow.)

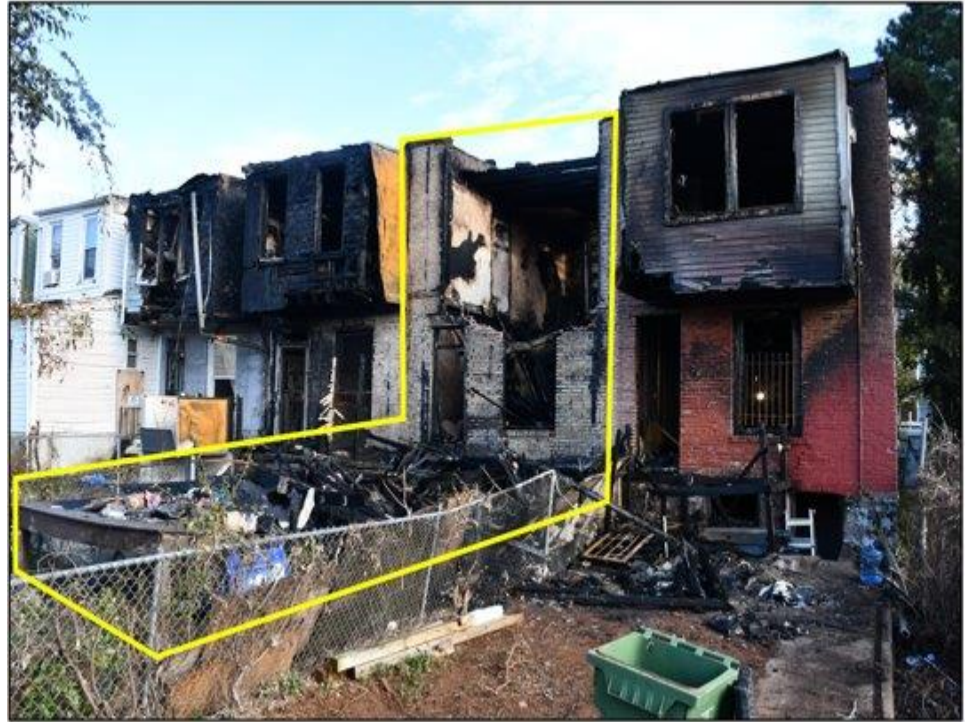
(Photo 15: Exterior of Side Charlie of 5210 Linden Heights as outlined in yellow.)

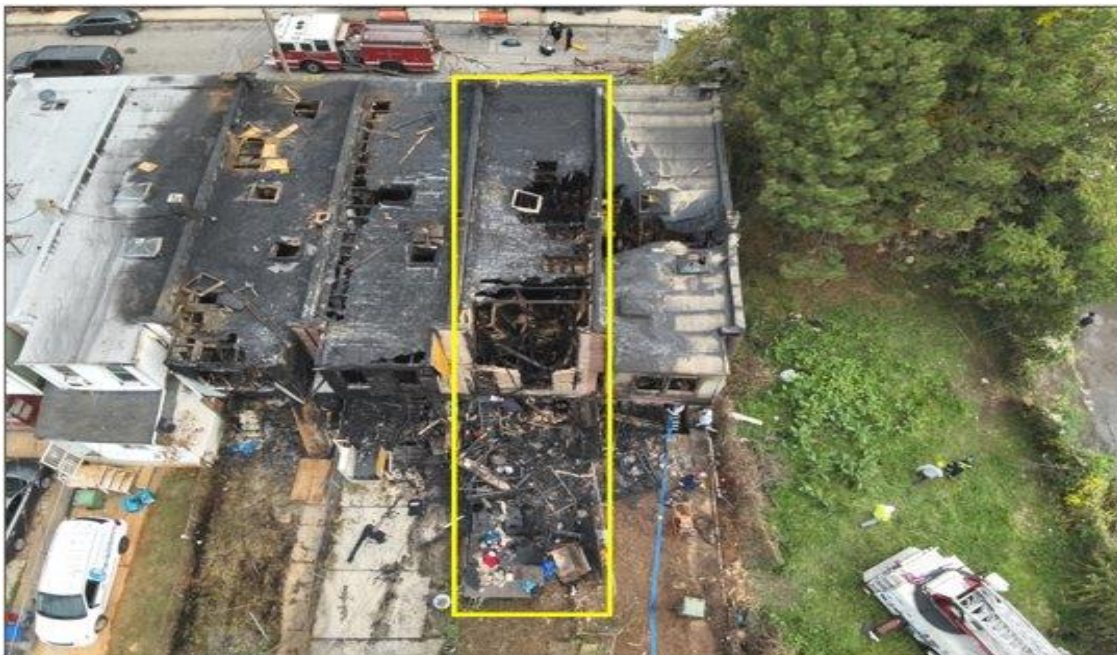
(Photo 16: Overhead post-fire image of the involved structure as outline in yellow. Photograph provided by the Howard County Police Department. Investigator Note – the location of BCFD Engine 29 located on the street on Side Alpha is the location it parked upon its arrival to this fire incident.)

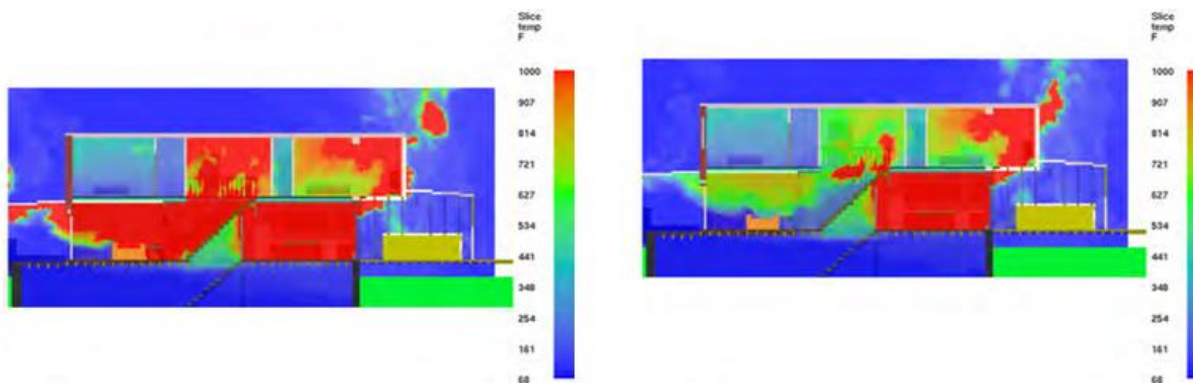
Left image depicts likely temperatures without the flowing of water, while image on right is with water.

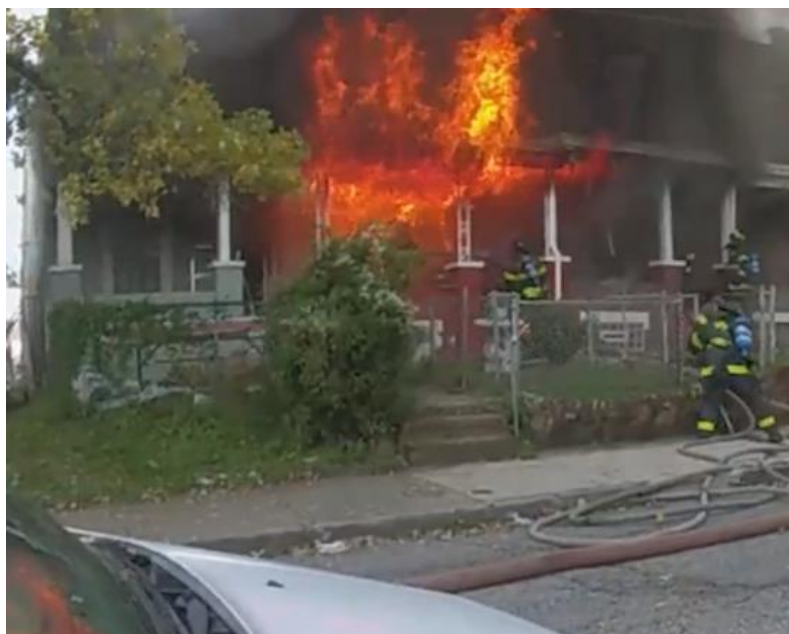
Figure 6: Fire showing from porch just after front window self-ventilates at 1550 hours.

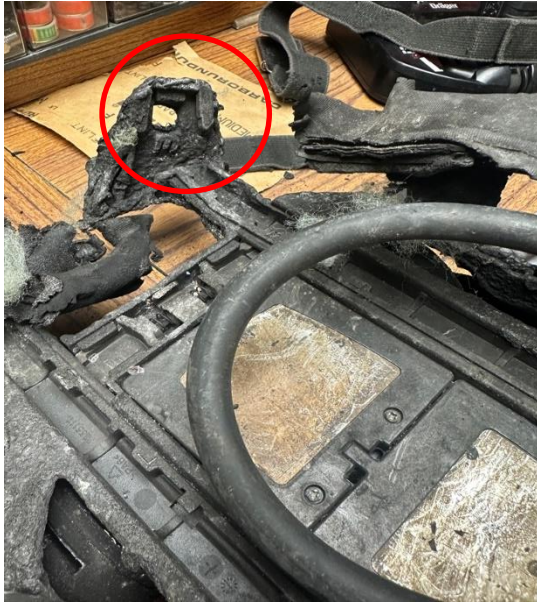
Cpt. Rinaldo’s SCBA – Shoulder Strap Failure Due to Heat (Strap and Clips)

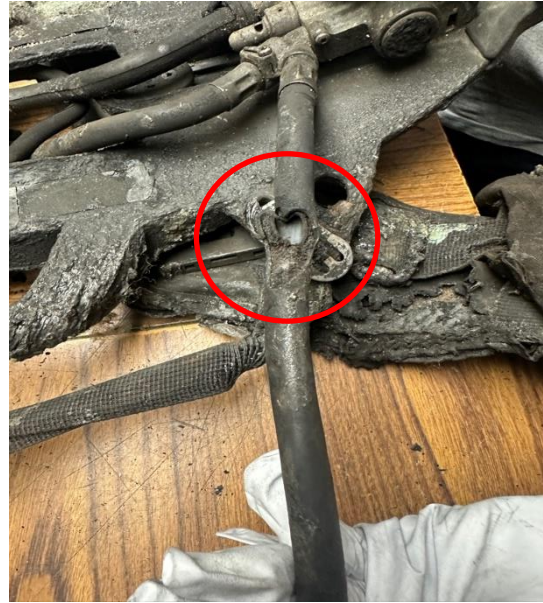
Cpt. Rinaldo’s SCBA – UEBSS Failure 3” from Regulator Block of Buddy Breather whip)

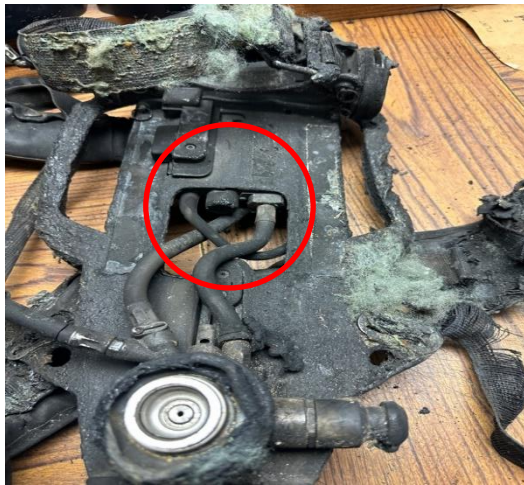
Cpt. Rinaldo’s SCBA – Beginning Stage of Failure in Lung Demand Valve Hose

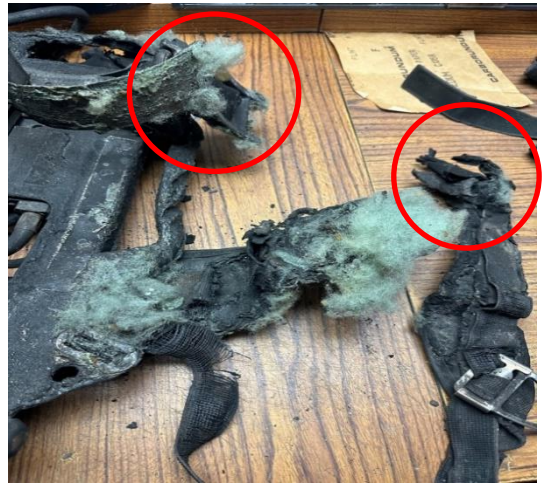
Cpt. Rinaldo’s SCBA – Failure of Cylinder Securing Strap and Shoulder Strap

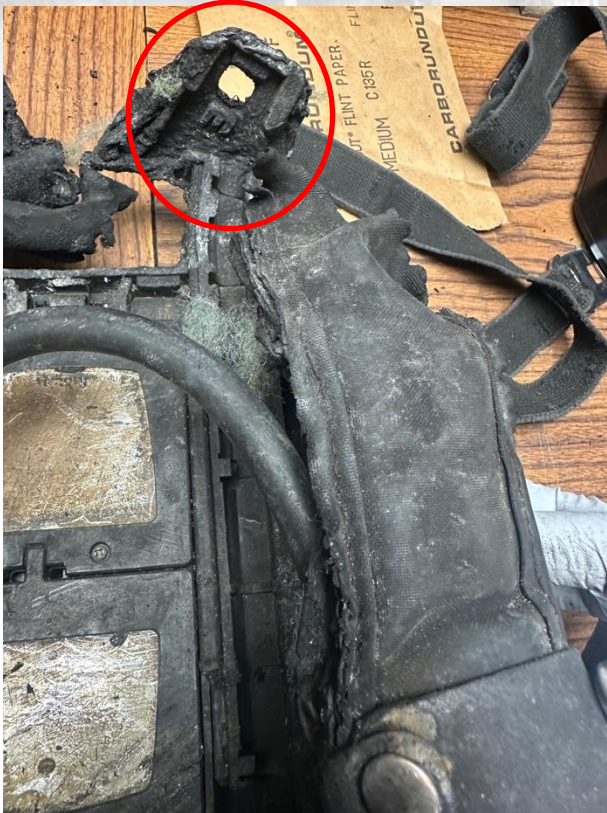
Cpt. Rinaldo's SCBA – Failure of Structural Clip Due to Heat and Elongation

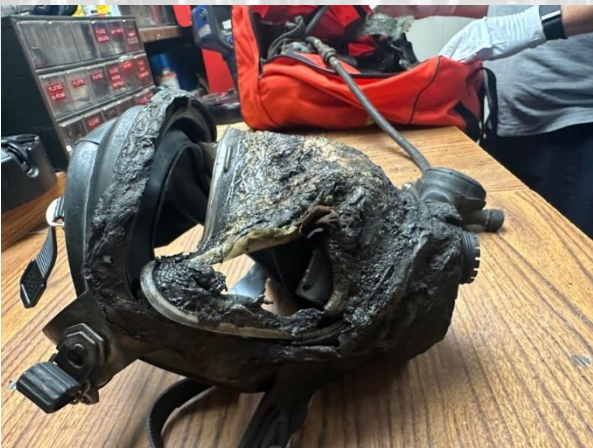
Cpt. Rinaldo's SCBA – Failure of Face Piece

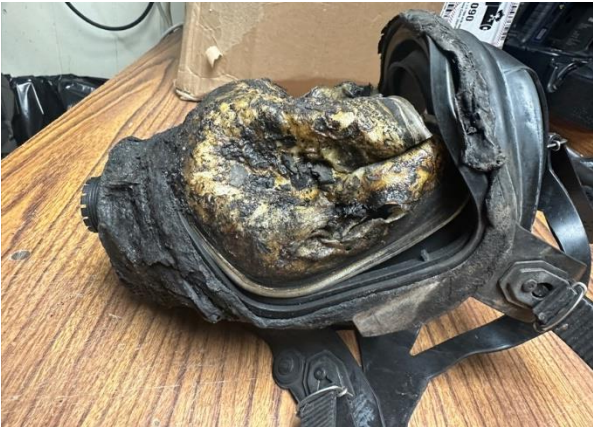
Cpt. Rinaldo's SCBA – Failure of Face Piece

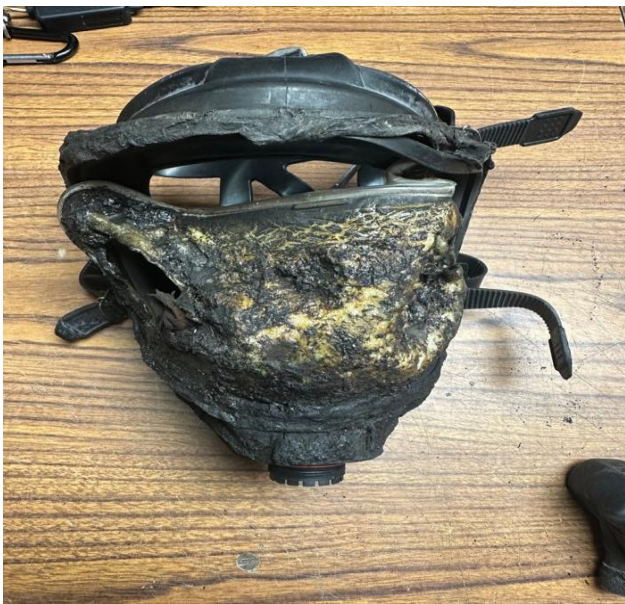
Cpt. Rinaldo's SCBA – Failure of Face Piece

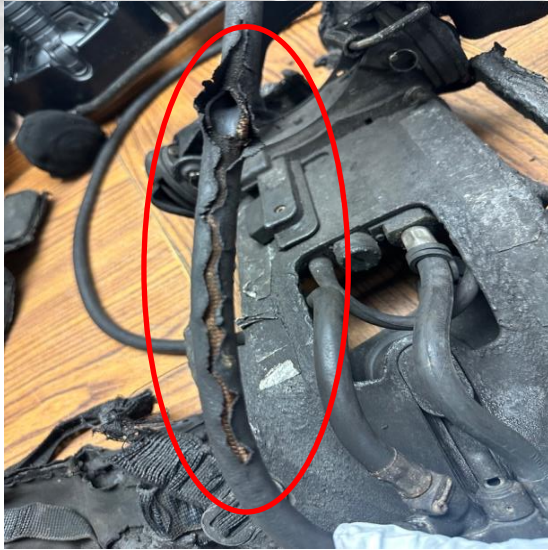
EMT/FF Pitts' SCBA – UEBSS Failure
9" from Regulator Block of Buddy
Breather

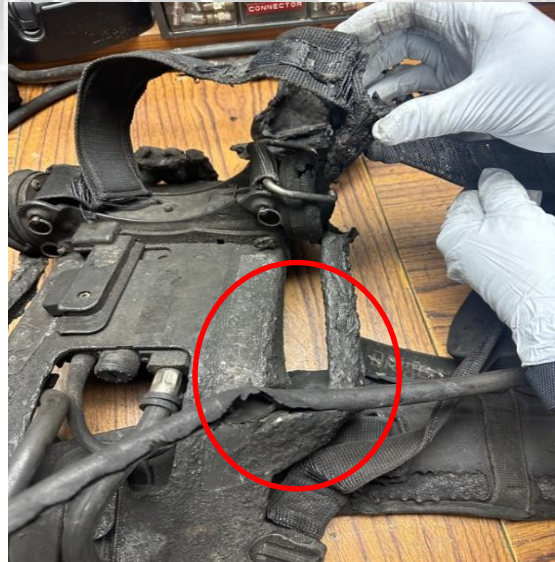
EMT/FF Pitts' SCBA – Failure of
Cylinder Securing Strap

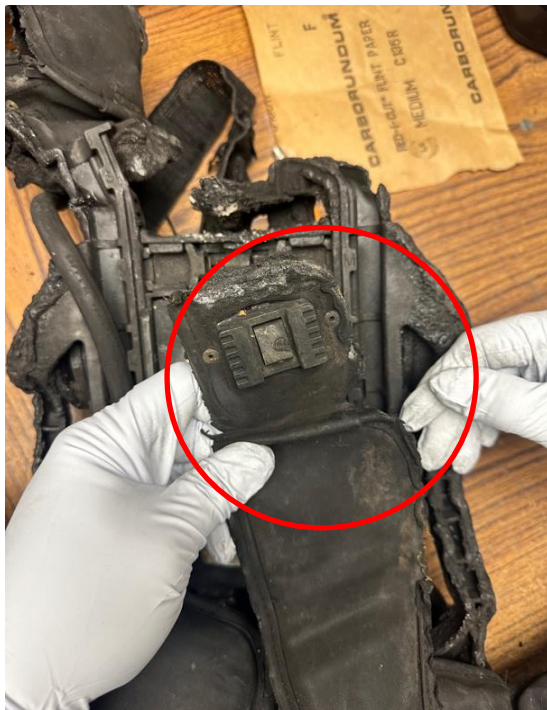
EMT/FF Pitts' SCBA – Failure of
Waist Strap and Connection Points to
Harness

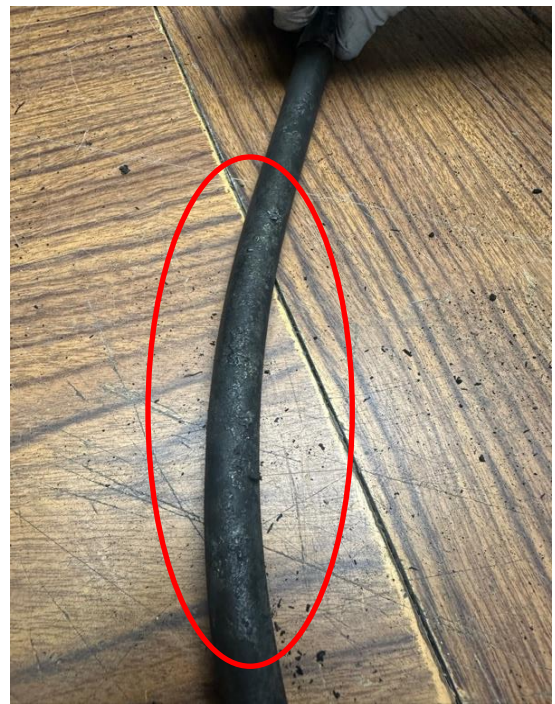
EMT/FF Pitts' SCBA – Beginning
Stage of Failure in Lung Demand Valve

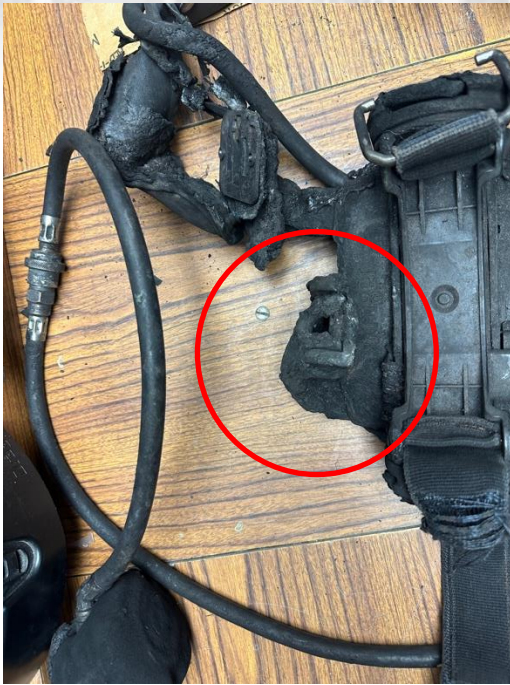
EMT/FF Pitts' SCBA – Failure of
Shoulder Straps and Connection
Point

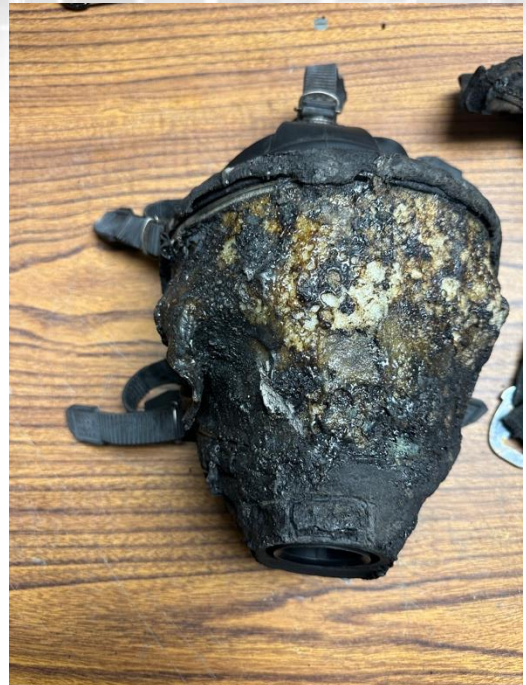
EMT/FF Pitts' – Failure of Face
Piece

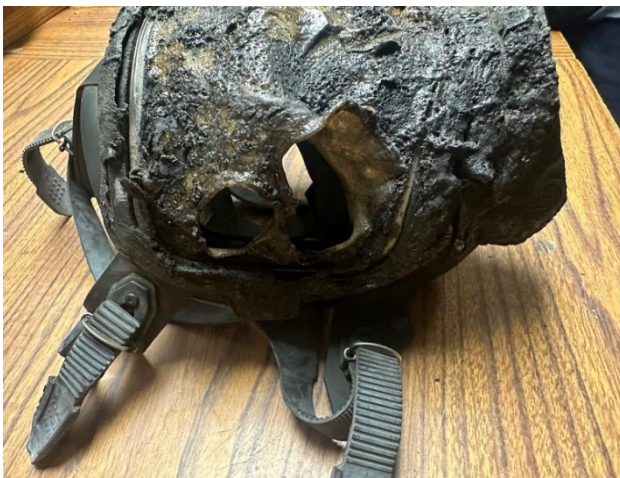
EMT/FF Pitts' – Failure of Face Piece

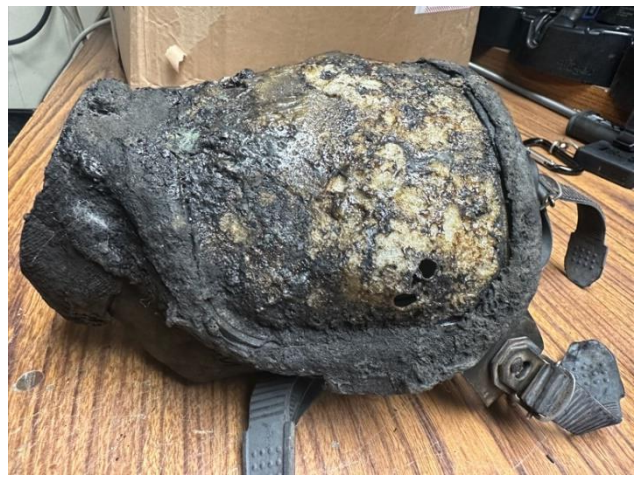
EMT/FF Pitts- Failure of Face Piece
