**Department of Public Works**  
**Response**  
**Case # 27-0001-I**

## DEPARTMENT OF PUBLIC WORKS

RE: DPW Response to OIG Case #25-0027-I, dated July 1, 2026

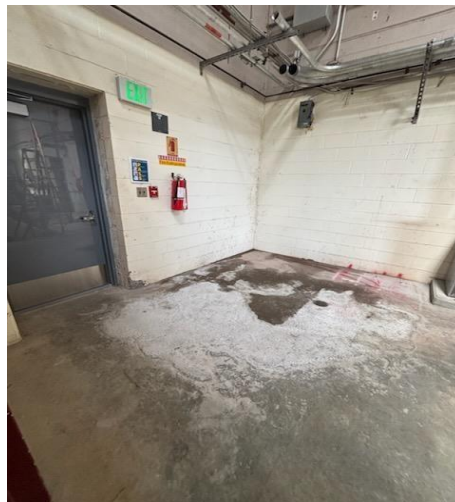
Figure 1. Floor repair at entrance to RSPS 2

We have removed all loose rock and debris and completed concrete repairs to the areas noted in Figures 1 and 2 of the Alert.

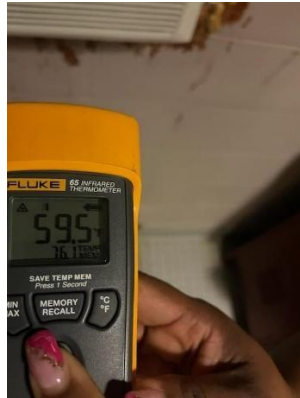
Figure 2. Temperature on AC discharge

In response to the air-conditioning system and its availability, DPW had a contractor on site during the OIG visit to address the HVAC repairs. The repairs to the building's HVAC system were completed on the day of the 7/1 visit. Regarding the temperature in the locker room and the air conditioner, upon follow-up inspection on 7/2/26, we checked the air conditioning unit itself and found the discharge air was 60° F, while the wall temperature across the locker room was 76° F. See figures 2 and 3 below

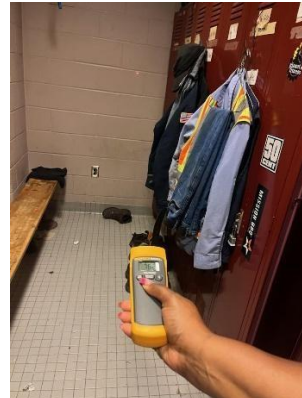
Figure 3. Temperature on wall across from AC unit

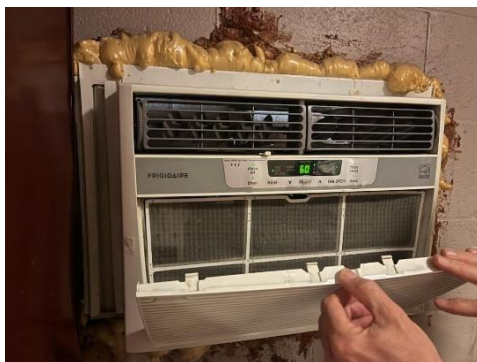
Figure 4. AC Filter free of debris

During our initial walk-through on 7/2, we discovered the unit was off upon entry, so we turned it back on. Note that if the air conditioner is turned off by staff, the room temperature will rise to a concerning level, so running the unit consistently is important. We also noted the air conditioner filter was clean and free of buildup. See Figure 4 below. To take the heat concerns a bit further, we also have a pedestal fan near the locker room entrance to help move the building's conditioned air through the locker room. See figure 5 below.

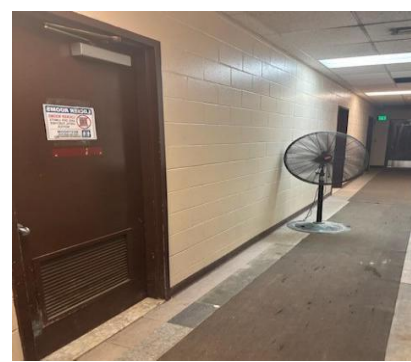
Figure 5. Pedestal fan available for use

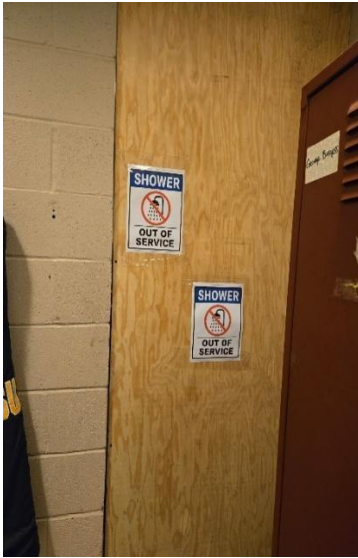
Figure 6. Restricted Access to RSPS 2 shower

Regarding the noted issues with the showers and a broken urinal, both items were submitted for replacement/upgrades previously and are in the process of being scheduled for completion. Additional shower areas and bathrooms are available in the primary and Enhanced Nutrient Removal (ENR) areas for staff, while the showers at Return Sludge Pump Station 2 (RSPS 2) are being addressed. In response, we have closed off the locker room area in the RSPS 2 building, leaving the bathroom usable and accessible, and have temporarily relocated staff to the Primary and ENR Building's locker room areas to store their belongings, allowing improvements to the necessary facilities. **See figures 6 and 7 below.** Additionally, there is a second fully functional urinal directly adjacent to the currently out-of-service urinal. **See figure 8 below.**

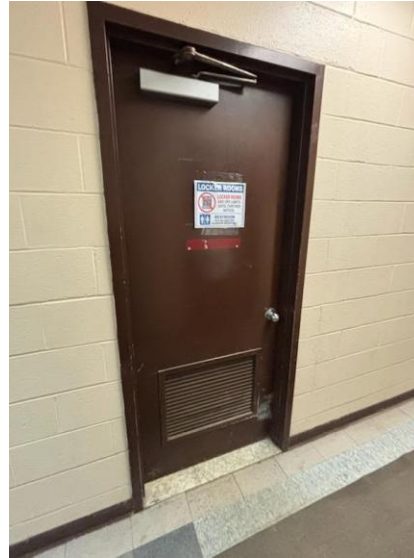
Figure 7. RSPS 2 Men's Room Door w/signage

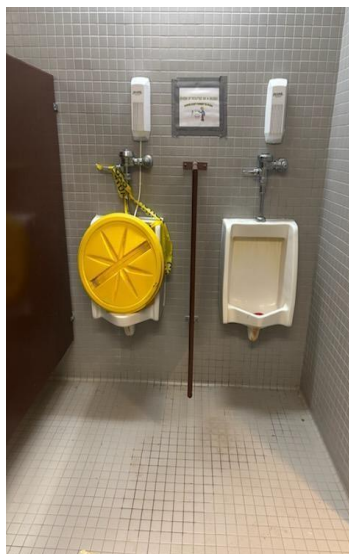
Figure 8. Men's Room Urinals

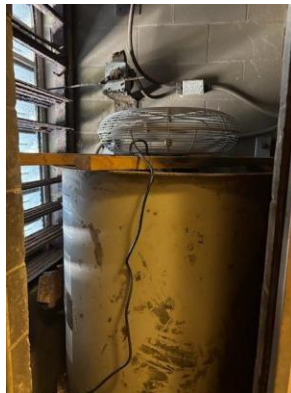
Figure 9. Temporary fan for RSPS exhaust

In Figure 8 of the Alert, there is a reference to the need to prop the door open due to poor ventilation and a chemical smell. A work order for the exhaust fan was submitted for repairs on 6/29/26, and a temporary fan unit was installed in the area on 7/2/26 to address residual odors while the permanent fan repair is being completed (see Figure 9). Regarding the residue on the wall, on 7/2/2026, operators were instructed to spray down the walls to eliminate any residual drops; however, the staining is permanent and should not be construed as a danger. The staining is an inherent result of using iron (ferric). Neither our leadership nor our Safety team has a record of any complaints regarding odors in this area. Nevertheless, we will reiterate to staff the importance of promptly reporting any workplace health or safety concerns to management. In addition, we will engage our internal Industrial Hygienist to evaluate the employee concerns noted regarding air quality.

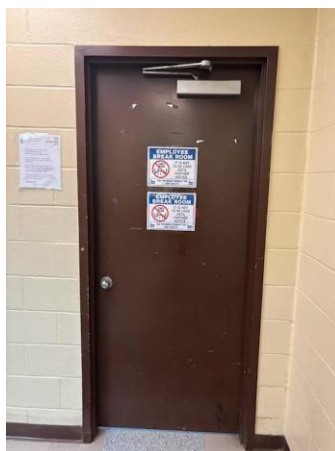
Figure 10, RSPS 2 Break Room – Restricted Access

For the break room area, demolition of the sink and cabinet area will be completed by 7/9/2026 to prepare for replacement with a new stainless steel area. The replacement of the sink/cabinet area was in progress prior to the OIG visit, as the new sink area was already on site for installation. The installation itself was delayed due to limited carpentry staff out on medical leave. While the work is underway, the break room has been closed off, and staff have access to alternative lunch facilities in the nearby ENR building. Cleaning of the ceiling vents and, if necessary, replacement of ceiling tiles will also occur during this time. **See Figure 10 below** for details on restricted access to the break room.
