Stan Jechura, CPI www.asitoledo.com
Certified Professional Inspector
Serving all of NW Ohio and SE Mich. Stan@asitoledo.com
(419)902-1308

Inspection Address - 1855 Green Valley, Toledo OH
Date - July 30, 2019
Client - James and Betty Bright
Phone - (716)628-8736
Email Address - bettybrightrn@gmail.com

General Information

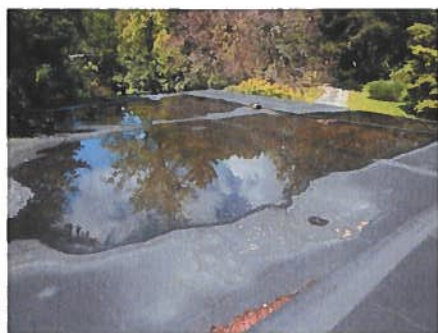
- Pooling water noted at multiple locations with most prevalent concerns over garage with water approximately 1-2 inches deep. Recent rainfall was noted in the area less than 12 hours prior to inspection. Typical pooling water on a flat or low pitched should dissipate within 72 hours.
- Water stains noted at garage roof sheathing, above fireplace, and in bedrooms indicates past leaks. Concerns appeared aged and tested dry at the time of inspection.
- Inadequate gutter installation at front of garage. (Gutters end at center of garage with light fixture installed in between). Current resident stated that the light fixture has been replaced multiple times due to water damage.
- Rotted and deteriorated wood gas line risers on roof.

Excessive pooling water on garage.

- Monitor the roofing over the garage for adequate dissipation and leaks or consider consulting a qualified roofing contractor for appropriate recommendations.
- Re-locate the light fixture and consider installing a full length gutter at the garage.
- Replace the gas line support risers with waterproof materials.

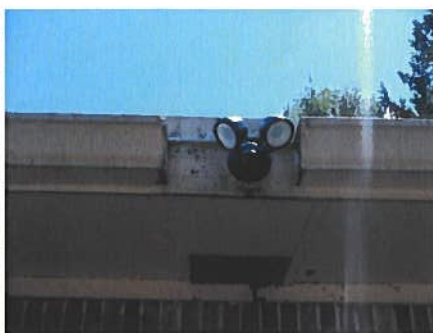
Inadequate guttering/light fixture.

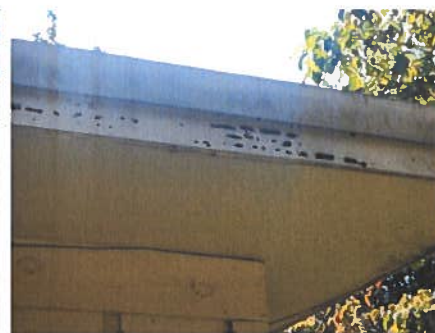
- Carpenter bee holes noted at front fascia boards over master bedroom.
- Open penetration at rear soffit on North end of dwelling and at electrical line entry with active bees noted entering soffits.
- Gaps at fascia boards/soffit noted at multiple locations.
- Minor worn/peeling paint noted at multiple locations.

Carpenter bee intrusion at fascia.

- Replace the damaged section of fascia to determine extent of bee intrusion and possible hidden damage, seal any open penetrations/gaps at the soffits and treat for carpenter bees as needed.
- Repaint as needed.

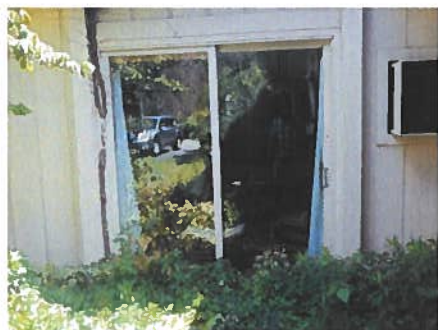
- Wood rot and inoperable sliding glass door in master bedroom.
- Fogged glass/leaking seal at right side rear fixed picture window.
- Damaged window at front bar area was not tested due to obstructions and visible damage.
- Damaged/inoperable casement windows at front bay window (do not fully close at top).
- Multiple worn or inoperable window cranks.
- Window in ½ bath is painted/sealed shut.
- Multiple missing screens including rear sliding door.

Damaged/inoperable patio door.

- Replace the master bedroom sliding glass door.
- Repair or replace the affected windows as deemed appropriate.

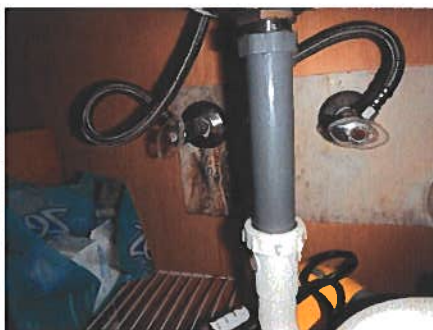
- Damaged drywall and mold growth at multiple locations indicates past or possible leaks and repairs. Areas affected include laundry area, hall bathroom, kitchen sink, and bar sink.
- Space heaters, heat tape, insulation, and previous repairs noted at main water line entry indicates past freezing concerns. Suspected causes include water supply lines installed at exterior walls.
- Visible mold growth on drywall in ½ bath sink cabinet and on insulation in exposed wall cavities at laundry area and bar sink.
- Damaged/questionable laundry drain installation at front of dwelling (drains under patio block).
- Slow drain at master bedroom/bathroom sink.
- Questionable/substandard repairs and original installation/design of plumbing system.
- Current resident stated that the main drain line clogs with tree roots and has to be cleaned regularly.

Mold growth and multiple damaged drywall at plumbing.

- Consult a licensed plumbing contractor/engineer for further evaluation and appropriate recommendations to prevent future concerns.
- Replace the damaged drywall and treat the affected areas for mold growth.

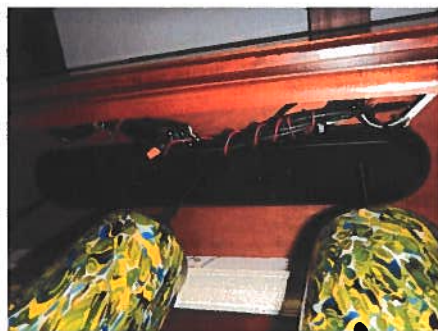
Improper wiring at kitchen light.

- Consult a licensed electrical contractor for a full evaluation of the electrical system and appropriate repairs and upgrades as needed.

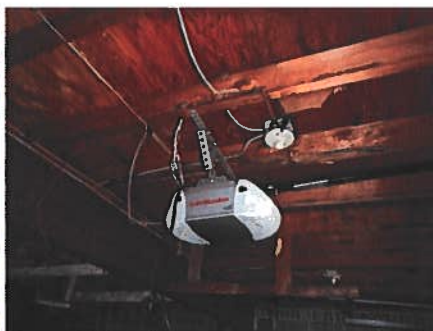
Shorted light fixture at garage ceiling.

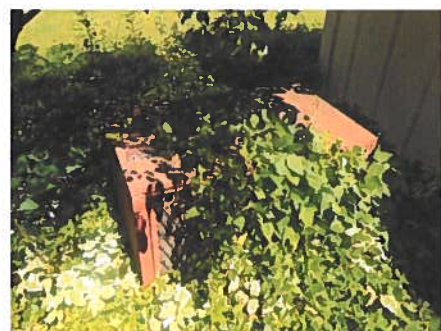
- Inoperable condenser appeared to be in poor condition.

Inoperable AC condenser.

- Replace the AC condenser and coil.

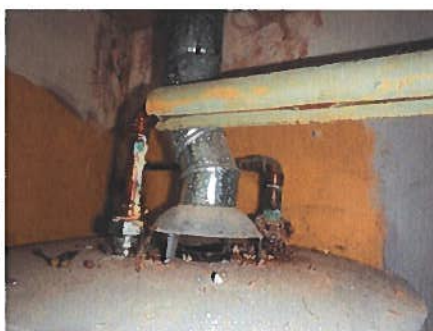
- Heavy corrosion at supply line fitting.

Heavily corroded water heater fitting.

- Monitor for worsening or consider replacement due to age/overall condition.

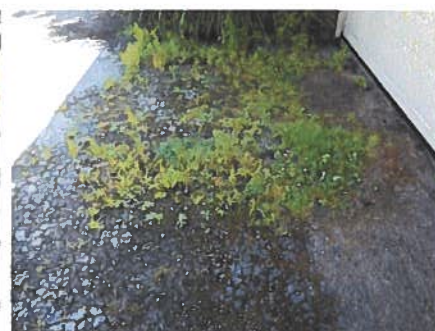
Deteriorated asphalt driveway.

- Troubleshoot and repair or replace the dishwasher and exhaust fan as needed.
- Monitor for ants and treat as needed.
- Repair or replace the affected shower doors.
- Trim the affected areas of landscaping to prevent siding or roof damage.
- Resurface or replace the driveway as deemed appropriate.
- Repair or replace the shed.
