Date of Inspection: 5/11/2022

Property Inspection Report

2615 Old Logan Rd SE, Lancaster, OH 43130

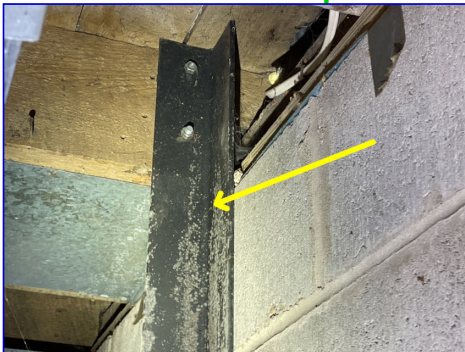
• **Monitor:** Foundation repairs were observed along the (east, south and interior basement) wall(s). Recommend consulting with the the current owners regarding these repairs and any warranties or guarantees that may apply.

Foundation repairs were observed.

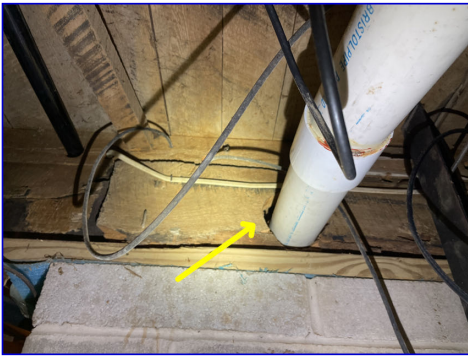
• **Repair/Replace:** A beam is notched. This condition risks movement and damage. Re-supporting this beam is recommended.

A beam is notched. This condition risks movement and damage. Re-supporting this beam is recommended.

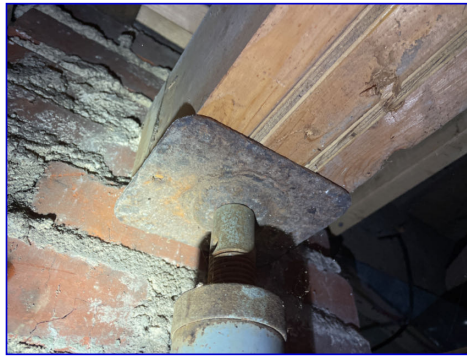
• **Repair:** Support posts for the floor structure should be attached with proper hardware at top and bottom to help prevent displacement.

Support posts for the floor structure should be attached with proper hardware at top and bottom to help prevent displacement.

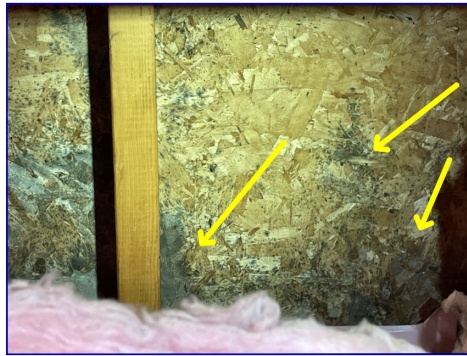
• **Repair:** Evidence of staining and what appears to be mold was observed. This condition is usually the result of insufficient ventilation. Ventilation should be improved and further testing should be performed to determine what type of clean up may be necessary.

Evidence of staining and what appears to be mold was observed.

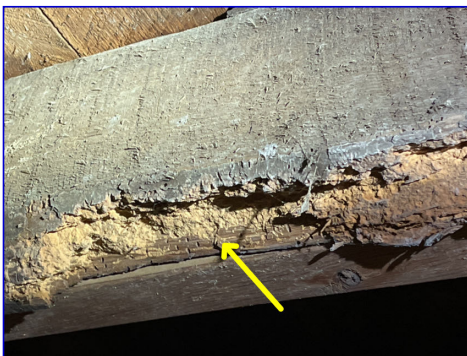
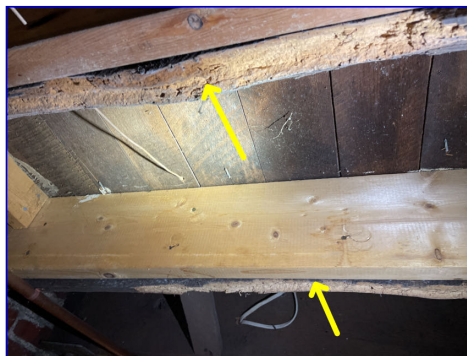
• **Repair:** Evidence of wood destroying insect damage was observed and there is risk of additional hidden damage since termites can do a substantial amount of damage. If the property has not already been treated, a licensed pest control specialist should be engaged to eliminate further wood destroying insect activity within the home. Damaged wood should be repaired or replaced. Any wood soil contact should be eliminated. (Powder post beetles and termite damage on joists in basement)

Powder post beetle damage

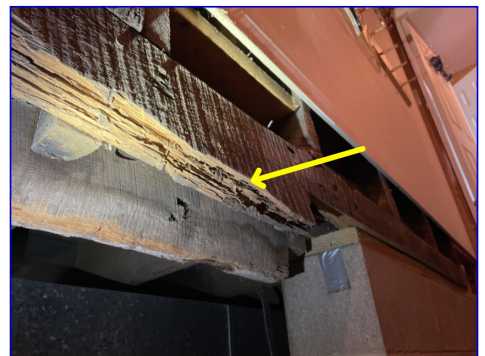
Termite damage

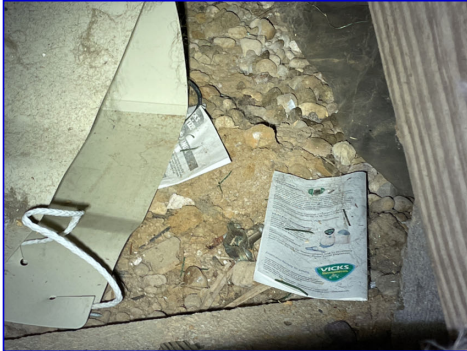
- **Repair:** All wood debris and/or trash should be removed from the crawl space. Organic debris around a property increases risk of insect or rot damage.

All wood debris and/or trash should be removed from the crawl space.

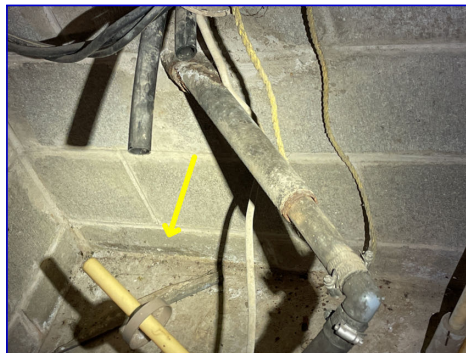
- **Monitor:** The basement shows evidence of common moisture penetration. It should be understood that it is impossible to predict the severity or frequency of moisture penetration on a one-time visit to a home. Review the exterior and roofing sections of this report for opportunities to improve the grading and drainage at ground level. These are often common causes of basement moisture. Further monitoring of the foundation will be required to determine what improvements, if any, will be required. Basement leakage that isn't addressed promptly can lead to structural and indoor environmental concerns.

The basement shows evidence of common moisture penetration.

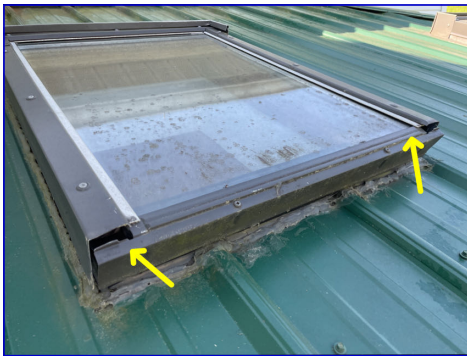
The flashing is damaged and should be repaired to avoid leaks.

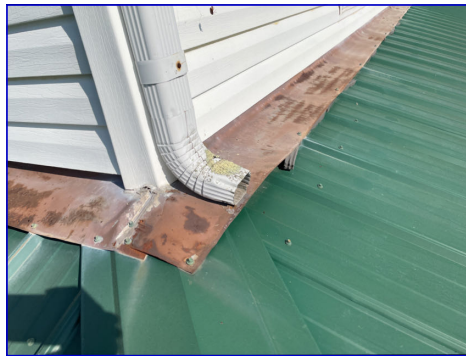
The flashing is rusting. It should be painted to extend its life.

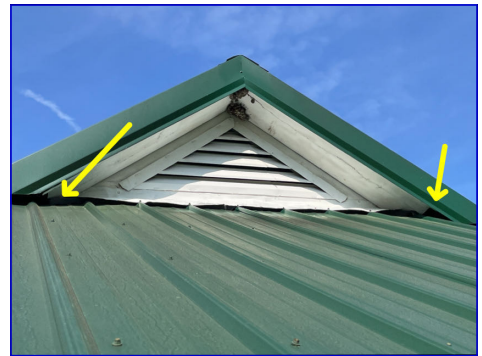
The installation of the flashing is incomplete and should be repaired to avoid leaks.

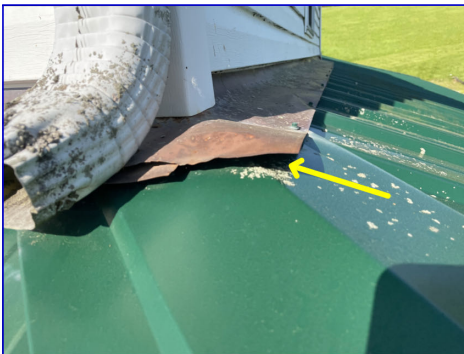
The flashing is loose and should be re-secured to avoid leaks.

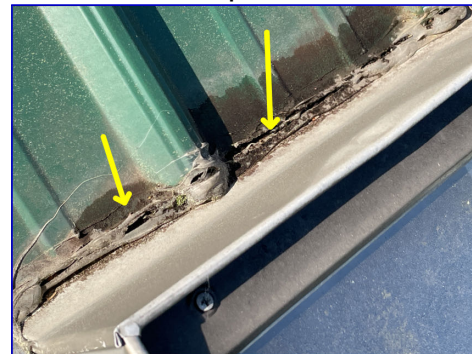
The skylight flashing is vulnerable and should be carefully monitored for leaks.(heavy sealant usage)

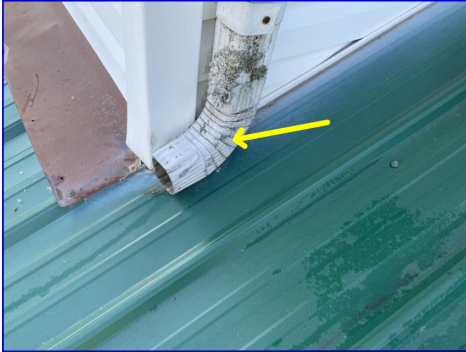
Downspout(s) that discharge onto the roof should be extended to discharge directly into the gutters below.

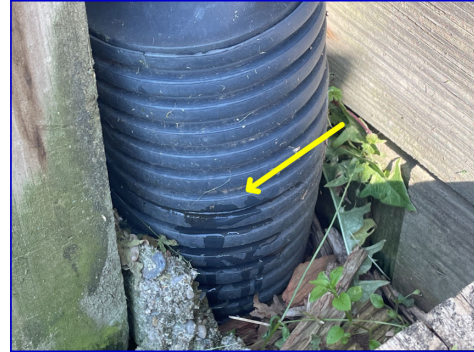
Rear downspout appeared to leak. Monitor.

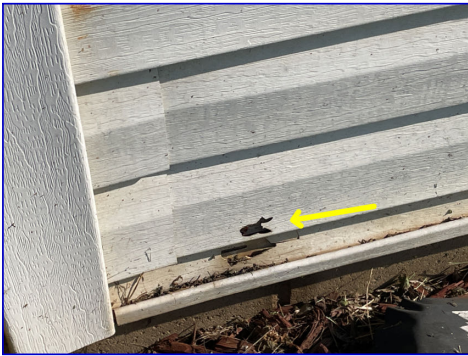
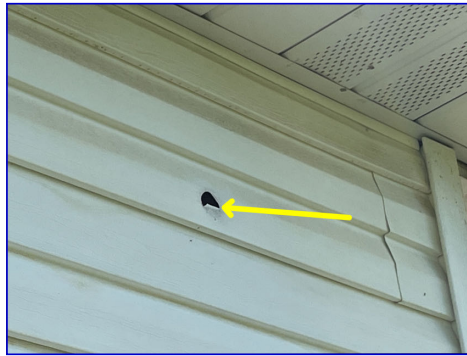
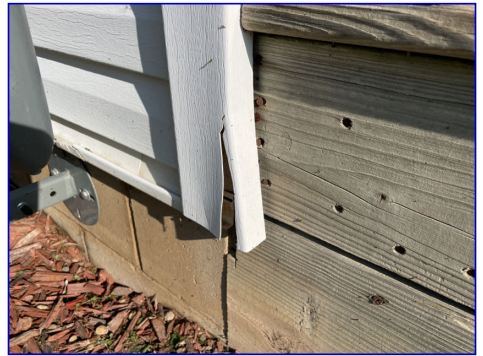
The siding is damaged at (south) and should be repaired or replaced.

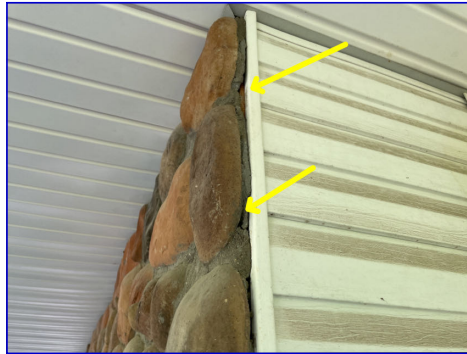
- **Improve:** The siding is lacking proper sealant joints at intersections of dissimilar materials. This condition should be repaired to help prevent moisture intrusion. (Stone meets trim intersections, etc.)
- **Repair/Replace:** The siding is damaged at (south) and should be repaired or replaced.

The siding is lacking proper sealant joints at intersections (Stone meets trim intersections, etc.)

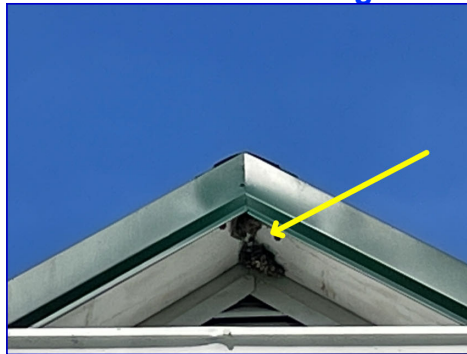
Note for client-nest observed at gable vent facing east

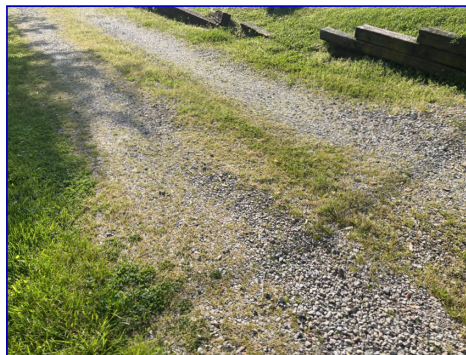
- **Replace:** The driveway surface is in a deteriorated condition. Resurfacing is necessary to correct this condition.

The driveway surface is in a deteriorated condition. Resurfacing is necessary to correct this condition.

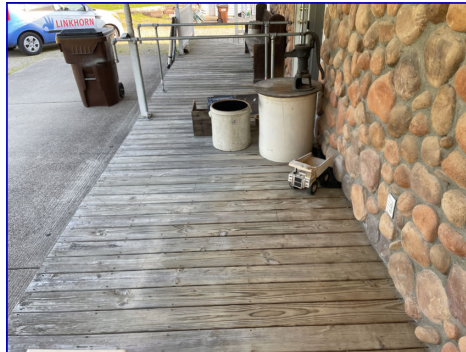
• **Maintenance Item: The deck should be painted or stained to improve durability.**

The deck should be painted or stained to improve durability.

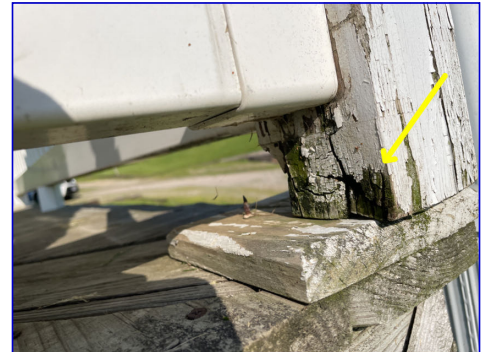
• **Repair: One porch post base is dilapidated. It should be replaced.**

One porch post base is dilapidated. It should be replaced.

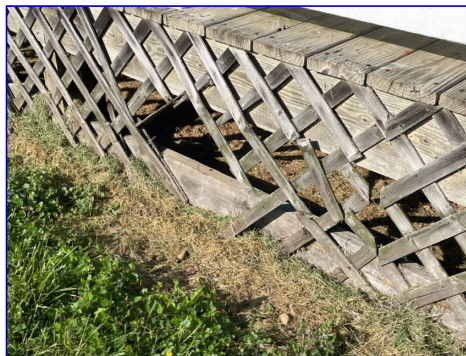
• **Repair: The lattice is damaged. It should be replaced.**

The lattice is damaged. It should be replaced.

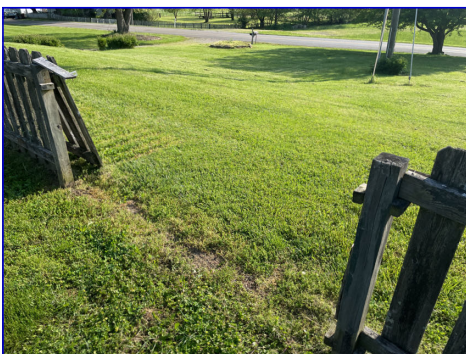
The fencing is in only fair condition. Minor repairs are needed.

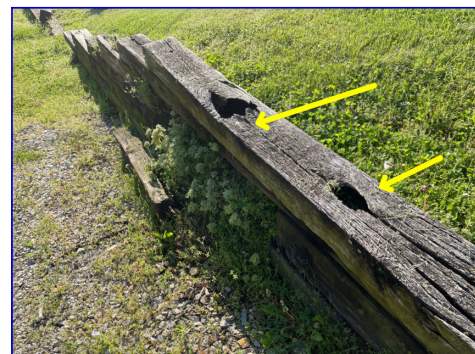
- **Monitor:** The retaining wall shows evidence of movement and rot. This condition should be monitored. It is impossible to determine the rate of movement and/or deterioration during a one time visit to the house.
- **Repair:** The fencing is in only fair condition. Minor repairs are needed.

The retaining wall shows evidence of movement and rot.

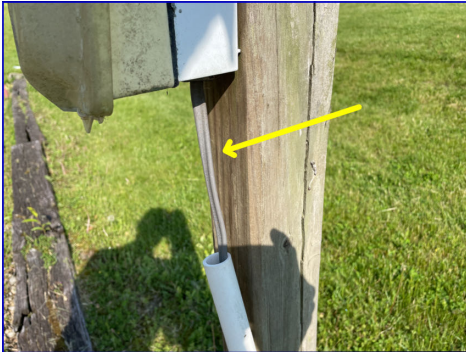
- **Repair:** Wiring exposed on exterior should be protected by a rigid conduit (near driveway).
- **Safety Issue:** All junction boxes should be fitted with cover plates, in order to protect the wire connections (Basement).

Wiring exposed on exterior should be protected by a rigid conduit (near driveway).

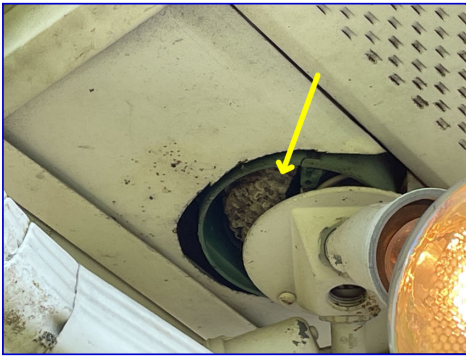
The damaged light fixture should be repaired or replaced at (Rear floodlight).

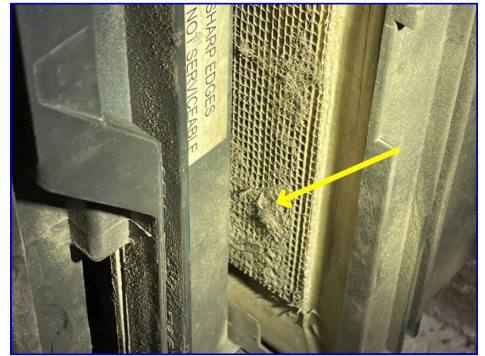
- **Repair:** The dirty air filter should be replaced.

The dirty air filter should be replaced.

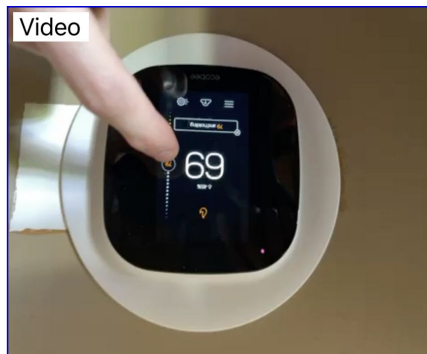
• **Repair:** The heating system requires servicing (did not respond to operating controls). This should be a regular maintenance item to assure safe, operation.

The heating system requires servicing (did not respond to operating controls).

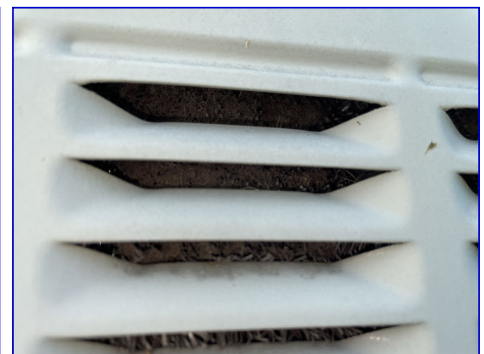
- **Repair: The outdoor unit of the air conditioning system requires cleaning.**

The outdoor unit of the air conditioning system requires cleaning.

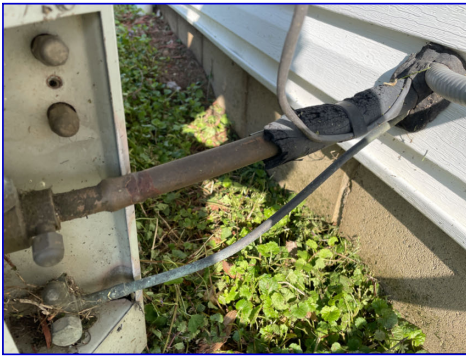
Damaged and or missing insulation on refrigerant lines should be repaired.

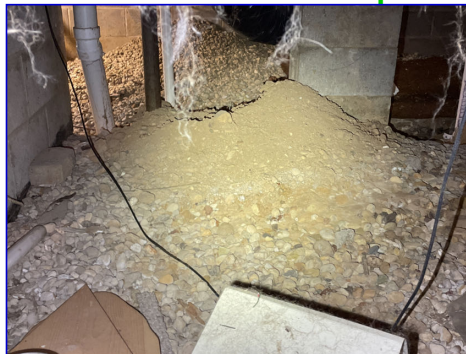
- **Improve: The moisture (vapor) barrier in the crawl space floor should be adjusted to cover all areas of exposed soil.**

The moisture (vapor) barrier in the crawl space floor should be adjusted to cover all areas of exposed soil.

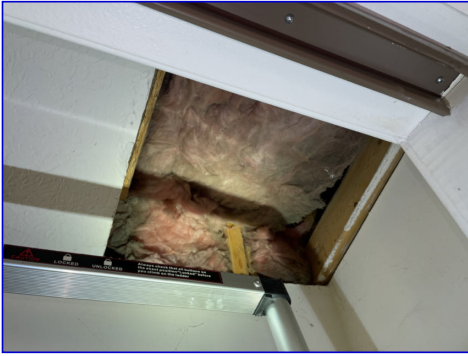
Attic hatch cover was missing.

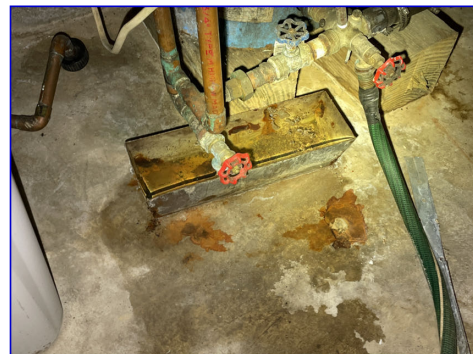
The supply piping is leaking (near well equipment) and should be repaired.

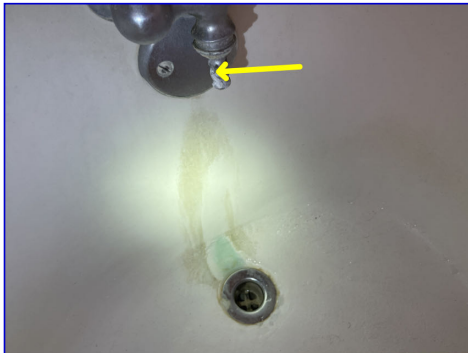
The Second-floor hallway bathtub spout is leaky.

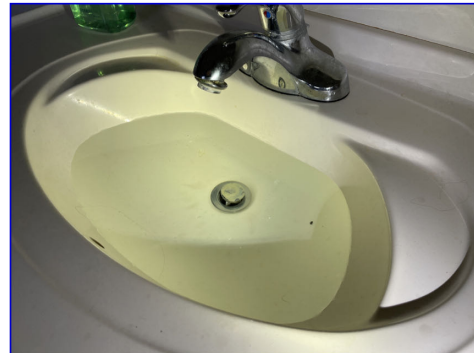
The (Second-floor hallway bathroom) sink was clogged.

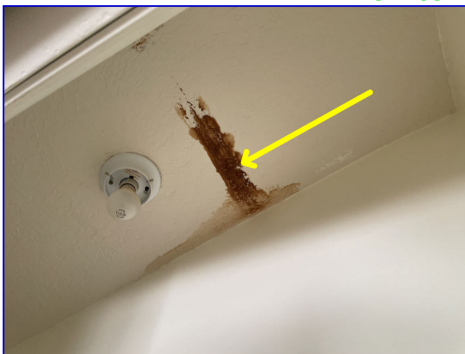
An apparent water staining was noted (East bedroom).

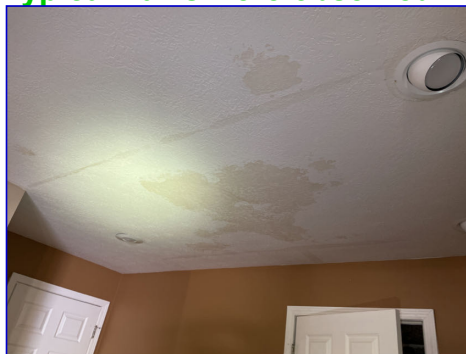
An apparent water staining was noted (dining room).

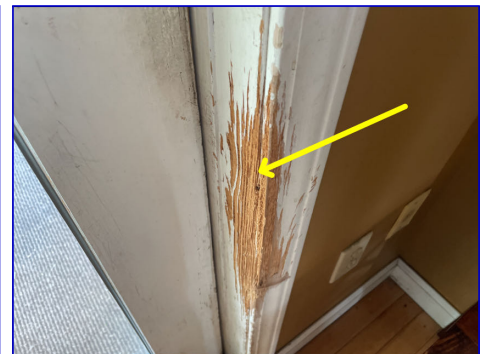
Damage to the interior finish was observed

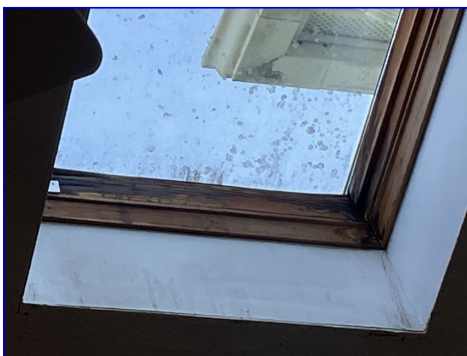
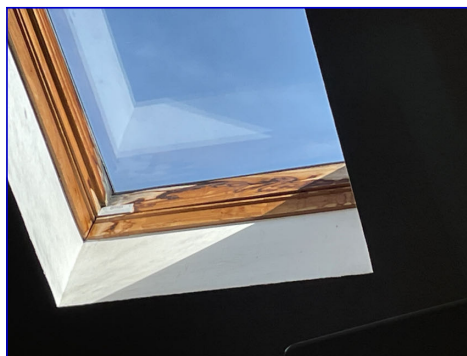
Water staining was observed around the skylight windows. No active leaking found. Monitor.

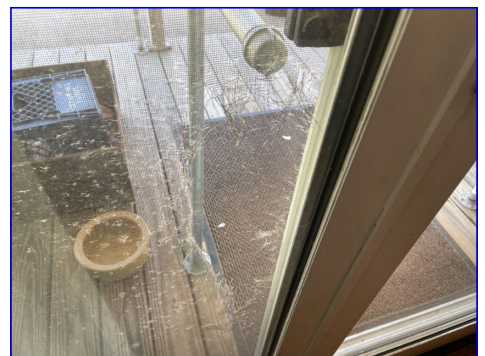
Damaged screen

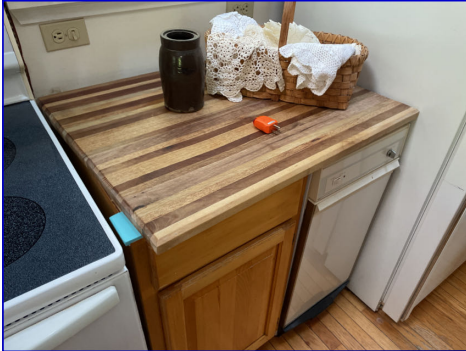
- **Repair/Replace:** The kitchen and master bathroom countertops are damaged.

The kitchen countertop was damaged.

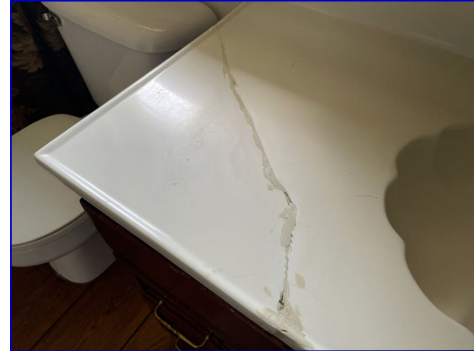
The master bathroom countertop was damaged.
