## 4 Point Inspection Form

Address Inspected: 154 - Bayside Drive, Clearwater, FL. 33767

Actual Year Built: 1956      Date Inspected: 6-8-2022
**Minimum Photo Requirements:**

## 4-Point Repairs Listed Below

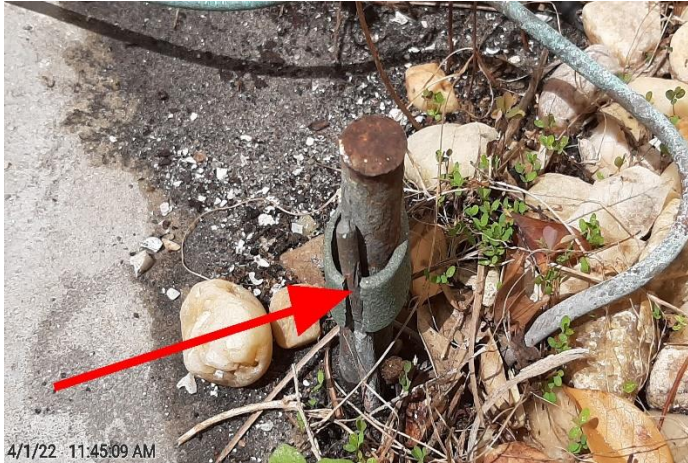
Ground clamp is loose or damaged at ground rod that service is needed by a professional in the electrical field.

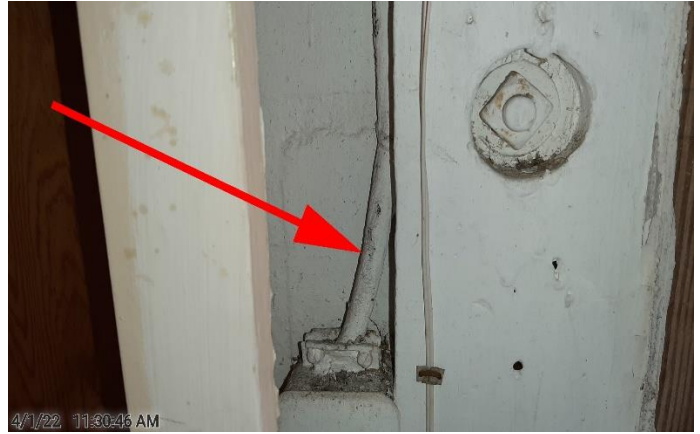
There is exposed wiring in the garage on the front wall that should be in conduit or covered and needs service by a professional in the electrical field.

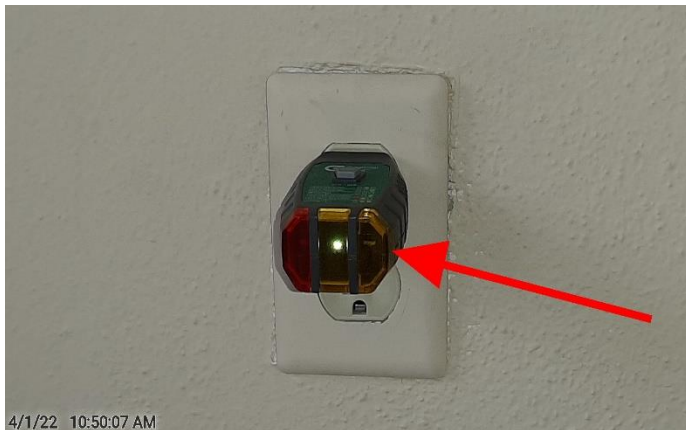
The living room has an ungrounded 3-Prong outlet on the west wall that needs service by a professional in the electrical field.

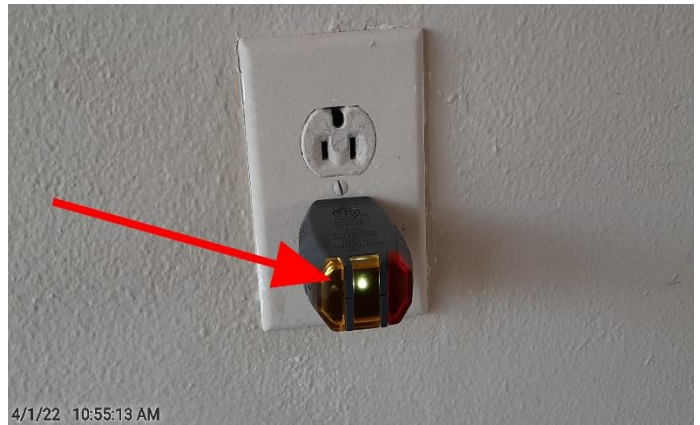
The dining room has an ungrounded 3-Prong outlet on the east wall that needs service by a professional in the electrical field.

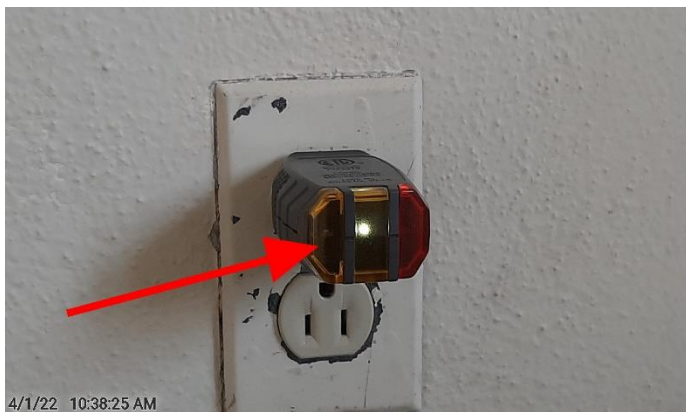
The front guest bedroom has an ungrounded 3-Prong outlet on the east wall that needs service by a professional in the electrical field.

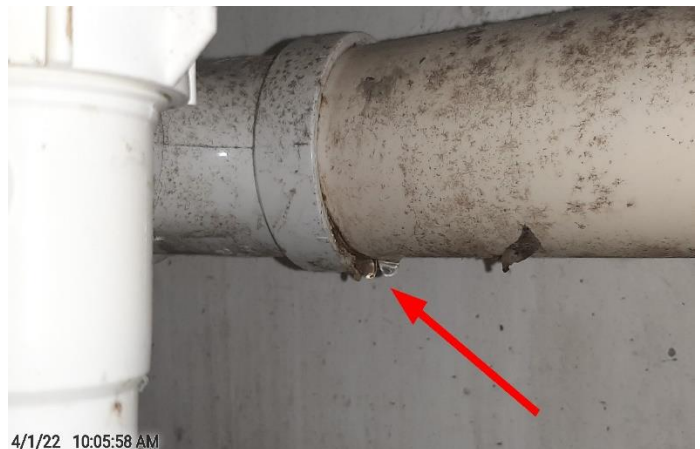
The PVC waste drain pipe in the garage is leaking and needs service by a professional in the plumbing field.

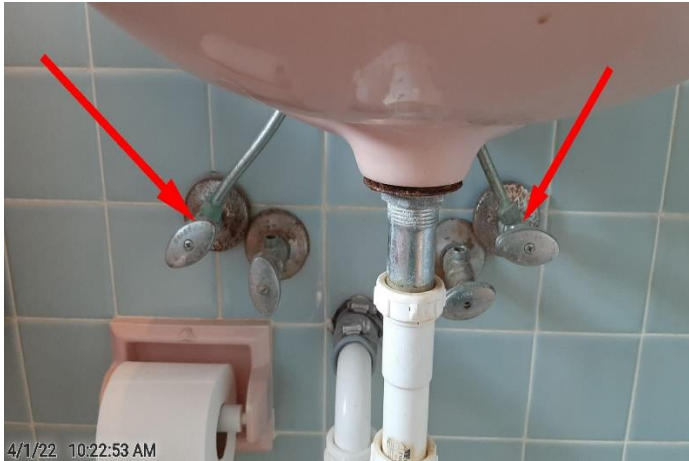
The hallway bathroom sink shutoff valves are frozen and needs service by a professional in the plumbing field.
