Confidential Inspection Report
901 Elmwood Court
Bowling Green KY 42103

August 25, 2022

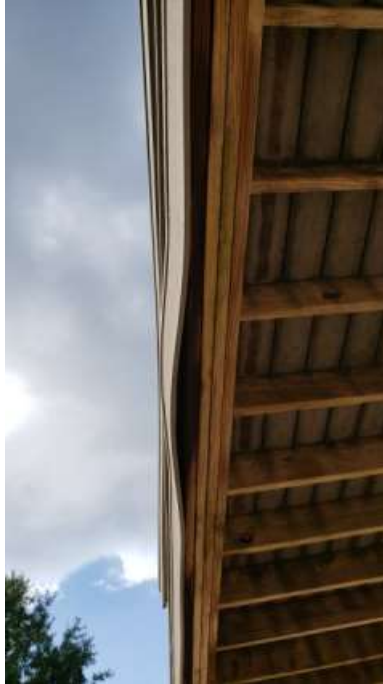
There is an upper level rear deck. The boards on the surface of the deck, the boards around the perimeter of the deck, the bench seats, and the railings are composite. As a whole, observed portions of this deck appear serviceable at the time of inspection with the following problems and conditions noted: 1) The horizontal composite boards below the surface of the deck are not secure in place and are pulling away from the deck. It is recommended to secure these boards into place as intended to prevent possible further problems.

| <i>Condition:</i> | <input type="checkbox"/> | <input checked="" type="checkbox"/> | There is an upper level rear deck. The boards on the surface of the deck, the boards around the perimeter of the deck, the bench seats, and the railings are composite. As a whole, observed portions of this deck appear serviceable at the time of inspection with the following problems and conditions noted: 1) The horizontal composite boards below the surface of the deck are not secure in place and are pulling away from the deck. It is recommended to secure these boards into place as intended to prevent possible further problems. |

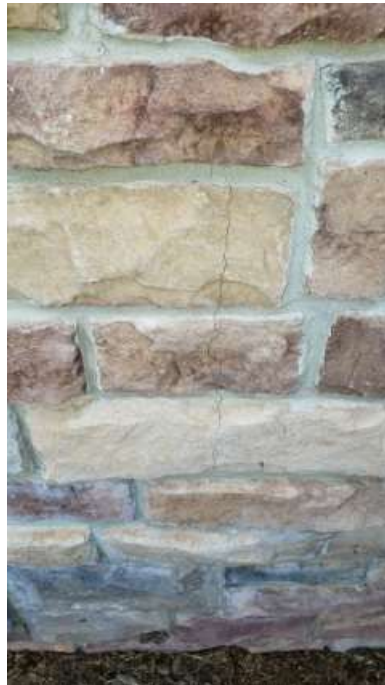
The exterior walls of the home are covered with brick, stone, and stucco. As a whole, observed portions of the exterior walls appear serviceable at the time of inspection with the following problems and conditions noted: 1) There is a vertical crack noted below the far left window on the front of the home. There is no displacement and no separation. Repairs to this crack do not appear to be warranted. Monitor this area in the future and any changes may require further investigation and possible repairs.

- ☒ ☐ The exterior walls of the home are covered with brick, stone, and stucco. As a whole, observed portions of the exterior walls appear serviceable at the time of inspection with the following problems and conditions noted: 1) There is a vertical crack noted below the far left window on the front of the home. There is no displacement and no separation. Repairs to this crack do not appear to be warranted. Monitor this area in the future and any changes may require further investigation and possible repairs.

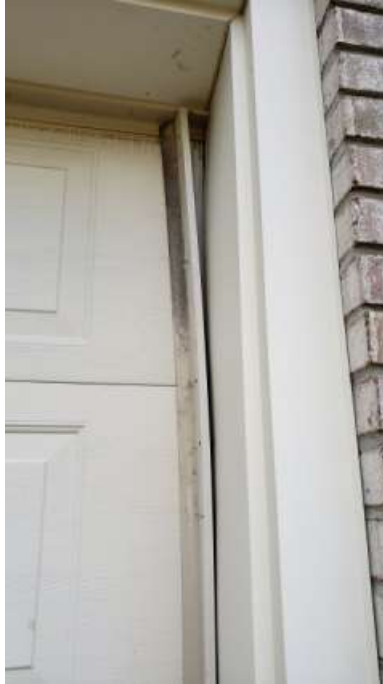
The flashings and trim of the home are composed of wood, metal, and vinyl materials. As a whole, observed portions of the flashings and trim on the exterior of the home appear serviceable at the time of inspection with the following problems and conditions noted: 1) The vinyl trim around the right garage door opening is pulling loose. It is recommended to secure the vinyl trim into place as intended to prevent possible further problems.

- ☐ ☒ The flashings and trim of the home are composed of wood, metal, and vinyl materials. As a whole, observed portions of the flashings and trim on the exterior of the home appear serviceable at the time of inspection with the following problems and conditions noted: 1) The vinyl trim around the right garage door opening is pulling loose. It is recommended to secure the vinyl trim into place as intended to prevent possible further problems.

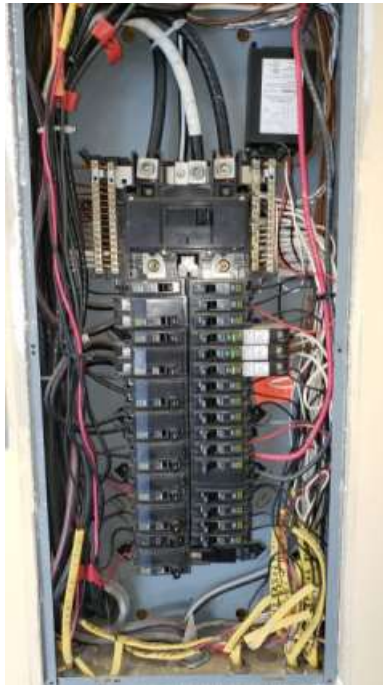
the following problems and conditions noted: 1) There are two double tapped single pole 20 amp breakers in the top right corner of the panel. This is a safety concern as the lugs in each breaker are generally only intended to accept one wire. It is recommended to install two additional single pole 20 amp breakers in this panel to eliminate the double tapped circuits.

Main Panel Observations: As a whole, the wiring in the electrical panel and the panel itself appear serviceable at the time of inspection with the following problems and conditions noted: 1) There are two double tapped single pole 20 amp breakers in the top right corner of the panel. This is a safety concern as the lugs in each breaker are generally only intended to accept one wire. It is recommended to install two additional single pole 20 amp breakers in this panel to eliminate the double tapped circuits.

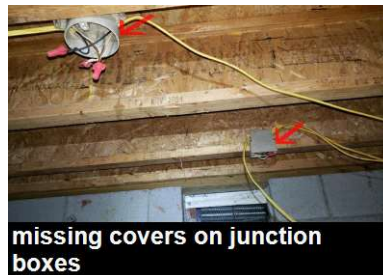
As a whole, observed outlets & wiring in the crawlspace appear serviceable at the time of inspection with the following problems and conditions noted: 1) There are at least three junction boxes without covers in the front left portion of the crawlspace. It is recommended to install the missing covers on these junction boxes as intended.

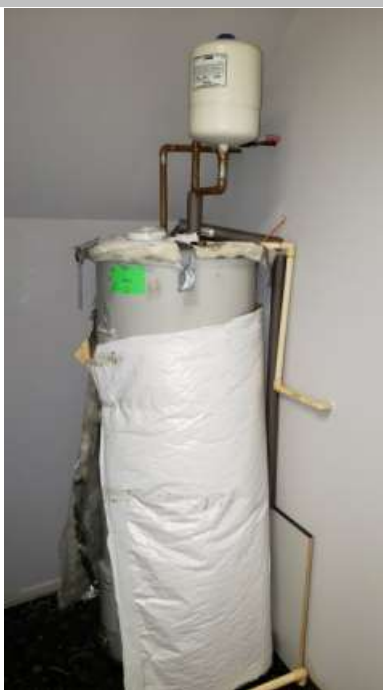
Appears serviceable. Pressure relief valve noted, not tested. A water shutoff valve is installed. The following conditions are noted: 1) The water heater is approximately 17 years old. The average expected serviceable life of an electric water heater is approximately 12 to 15 years. Units operating beyond their average expected serviceable life may require periodic maintenance and inspection to continue operating as efficient as intended.

*Condition:*☒ ☐ Appears serviceable. Pressure relief valve noted, not tested. A water shutoff valve is installed. The following conditions are noted: 1) The water heater is approximately 17 years old. The average expected serviceable life of an electric water heater is approximately 12 to 15 years. Units operating beyond their average expected serviceable life may require periodic maintenance and inspection to continue operating as efficient as intended.

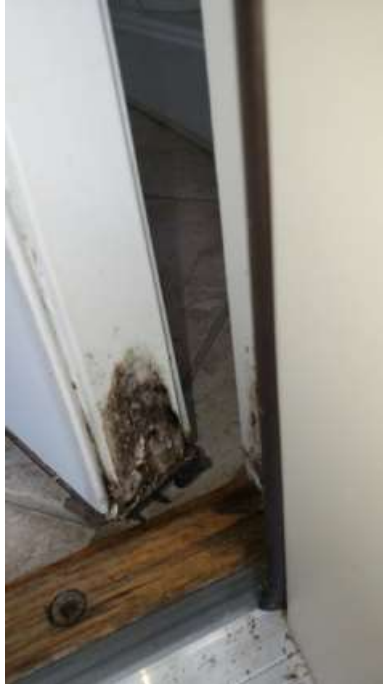
The following problems and conditions are noted: 1) There is damage noted to the wood between the metal skin panels of the service door leading to the exterior of the home. This is noted at the bottom of the door when it is open. It is recommended to repair or replace any damaged wood between the metal skin panels of the door to prevent possible further problems.

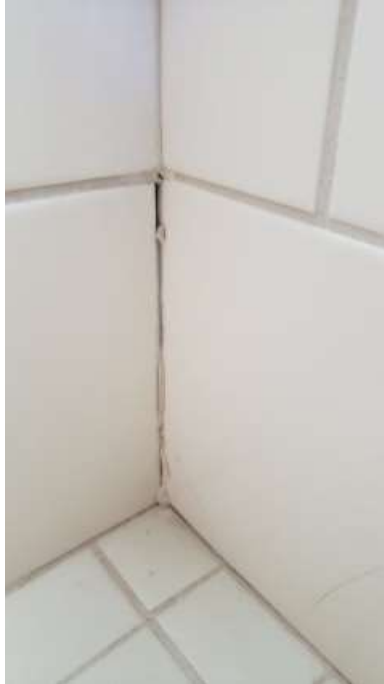
The following problems and conditions are noted with the shower walls: 1) There are cracks noted in the grout between the tiles in the floor of the shower and the walls above them. There are also cracks noted in the intersection of the shower walls in the corner below the fixed window. It is recommended to repair any cracks or gaps in the grout between tiles to prevent possible further problems, 2) There are signs of prior repairs noted to cracks in the floor of the shower enclosure. As a whole, these repairs appear adequate at the time of inspection and this is only of note. Monitor these repairs in the future and any changes may require further investigation and possible repairs.

☐ ☒ The following problems and conditions are noted with the shower walls: 1) There are cracks noted in the grout between the tiles in the floor of the shower and the walls above them. There are also cracks noted in the intersection of the shower walls in the corner below the fixed window. It is recommended to repair any cracks or gaps in the grout between tiles to prevent possible further problems, 2) There are signs of prior repairs noted to cracks in the floor of the shower enclosure. As a whole, these repairs appear adequate at the time of inspection and this is only of note. Monitor these repairs in the future and any changes may require further investigation and possible repairs.

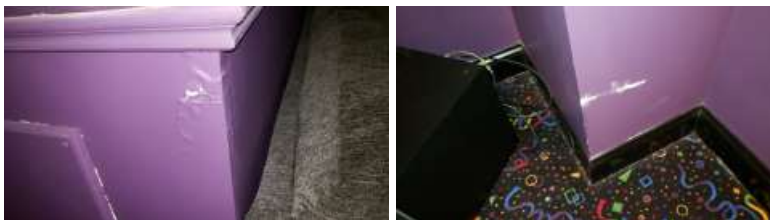
The walls are covered with drywall. Stored items and furnishings limit viewing of the walls. No comment can be or is made as to the possible condition of any unseen/concealed portions of the walls. The following problems and conditions are noted: 1) There is minor damage noted to the drywall around the chase for the laundry chute and on the corner of a wall on the side of the room with the Hollywood Theater mural painted on it. This damage does not appear to be of structural concern but repairs would be needed to address it.

- Doors:* ☒ ☐ There is an operational pocket door.
- Walls:* The walls are covered with drywall. Stored items and furnishings limit viewing of the walls. No comment can be or is made as to the possible condition of any unseen/concealed portions of the walls. The following problems and conditions are noted: 1) There is minor damage noted to the drywall around the chase for the laundry chute and on the corner of a wall on the side of the room with the Hollywood Theater mural painted on it. This damage does not appear to be of structural concern but repairs would be needed to address it.

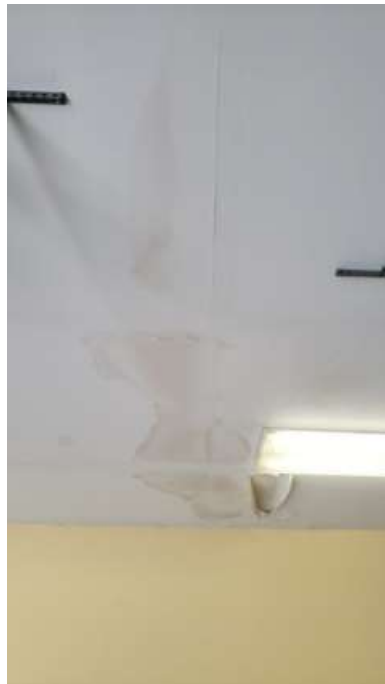
There is a drywall ceiling in the garage. As a whole, observed portions of the ceiling appear serviceable at the time of inspection with the following problems and conditions noted: 1) There are stains and damage noted to the drywall ceiling above the electrical panel that extend out into the middle of the garage and towards the kitchen. These stains are dry at the time of inspection but would appear to be from leaking at some point. There are signs of prior repairs noted to some of the shingles on the roof in a roof/wall intersection above this area. This could have been a source of the leaking and staining noted in the ceiling of the garage. It is recommended to repair any cracks or damage to the drywall in the ceiling. Monitor this area in the future after repairs have been made and any changes may require further investigation and possible repairs, 2) There are a couple of settlement cracks noted in the ceiling. Although these do not appear to be of structural concern, it is recommended to repair any cracks to prevent possible further damage.

- ☐ ☒ There is a drywall ceiling in the garage. As a whole, observed portions of the ceiling appear serviceable at the time of inspection with the following problems and conditions noted: 1) There are stains and damage noted to the drywall ceiling above the electrical panel that extend out into the middle of the garage and towards the kitchen. These stains are dry at the time of inspection but would appear to be from leaking at some point. There are signs of prior repairs noted to some of the shingles on the roof in a roof/wall intersection above this area. This could have been a source of the leaking and staining noted in the ceiling of the garage. It is recommended to repair any cracks or damage to the drywall in the ceiling. Monitor this area in the future after repairs have been made and any changes may require further investigation and possible repairs, 2) There are a couple of settlement cracks noted in the ceiling. Although these do not appear to be of structural concern, it is recommended to repair any cracks to prevent possible further damage.
