### Home Inspection Report

8883 Sam Snead Hwy, Hot Springs, VA 24445

Thursday March 2, 2023

16-03-2023

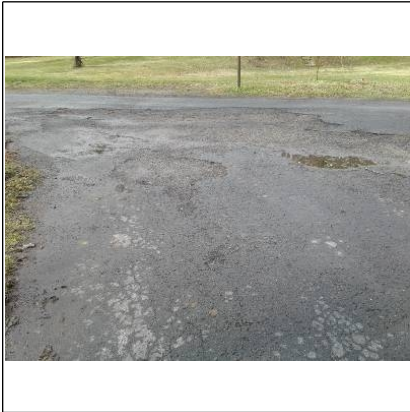
**Comments** Damaged drive. Recommend repair as needed.

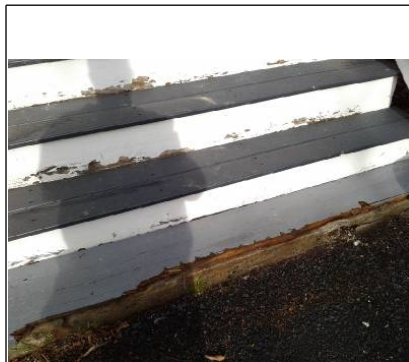
Step broken

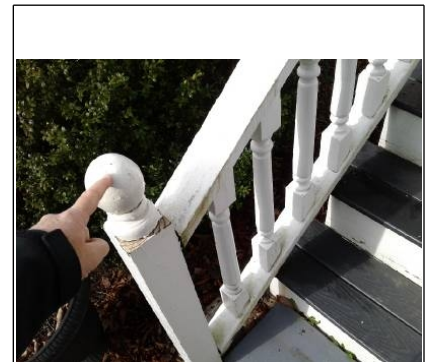
Rail loose

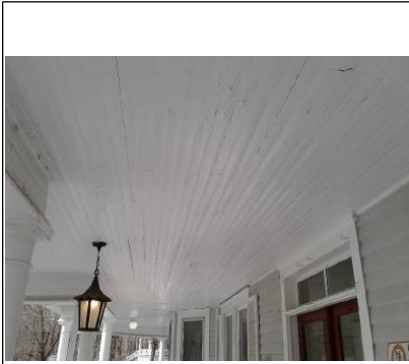
Moisture damage to ceiling

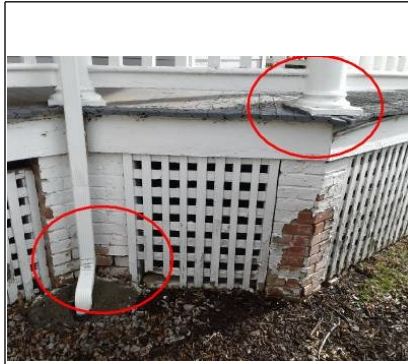
Moisture damage to wood, posts not plumb, columns leaning and bricks loose.

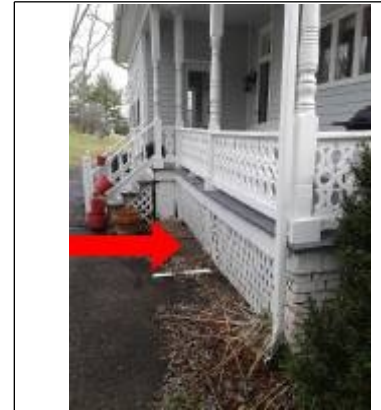
Columns and posts not plumb

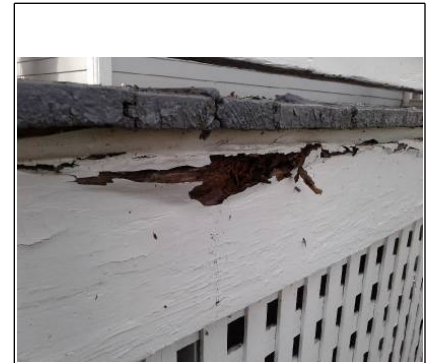
Porch wood damaged

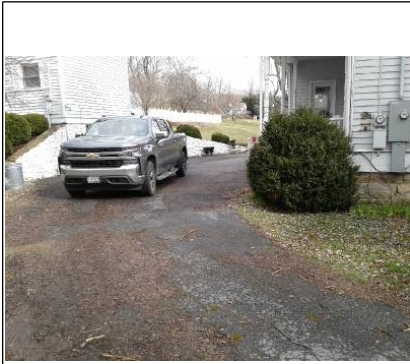
Low soil at foundation and slope towards house

**Comments** Low soil levels at foundation. Recommend improving drainage so excess water doesn't pool and cause settlement and moisture issue in the basement/crawlspace.

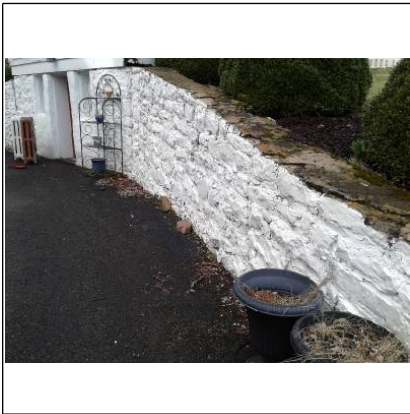
No drainage holes at the bottom of the retaining wall. Recommend installing to reduce risk of cracking.

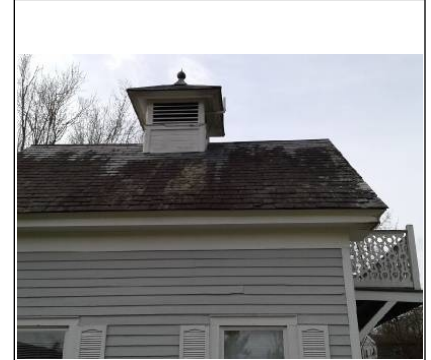
Missing shingles and moisture damage at roof and turret

**Comments** Missing roof shingles. Missing damaged slate shingles. Recommend repair to reduce risk of moisture damage.

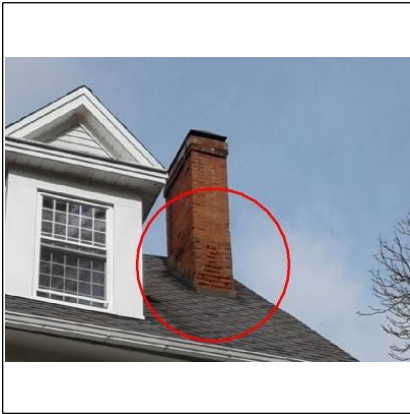
**Comments** Missing mortar on chimney brick. Recommend repair to reduce risk of moisture damage  
Record sealing maintenance to roof flashings.

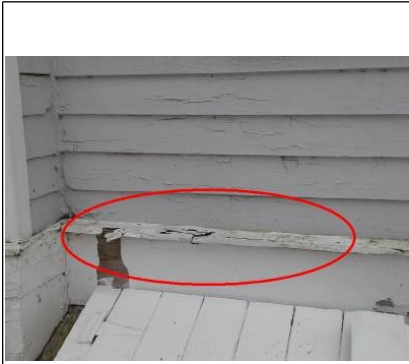
Moisture damage to wood

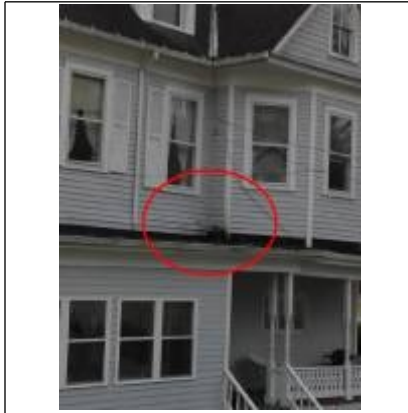
Moisture damage to wall

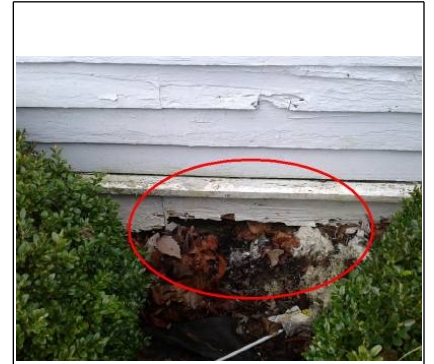
Moisture damage to sill on unit

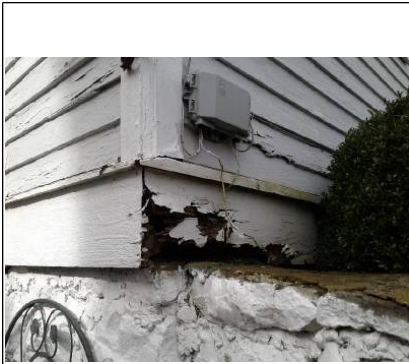
Moisture damage to sill on unit

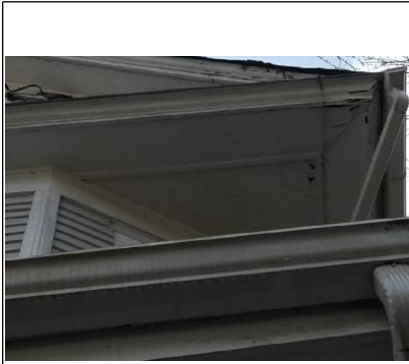
Moisture damage to soffits

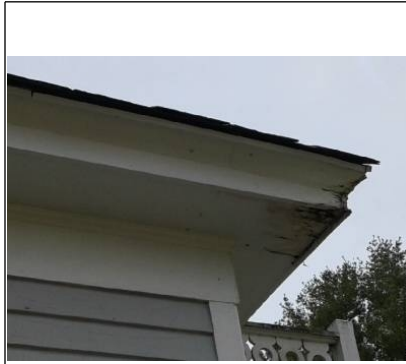
Moisture damage to soffits

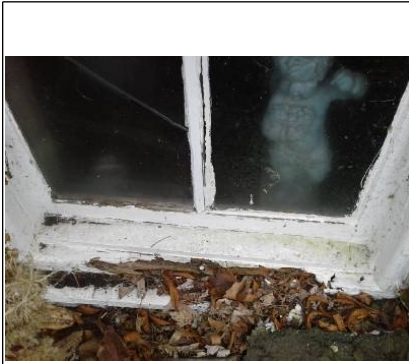
Rot in frames

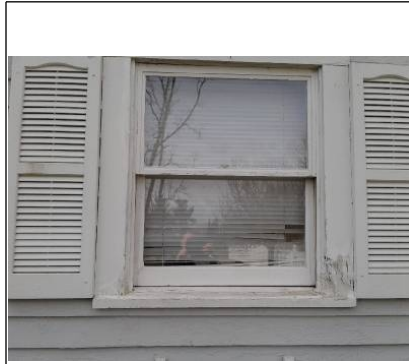
Rot in frames

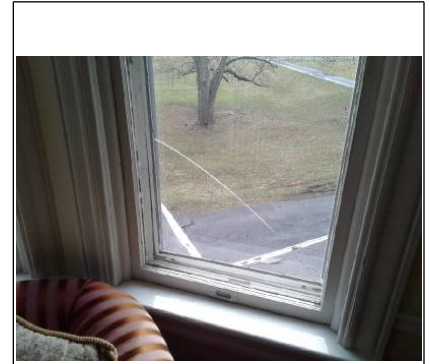
Broken window glass recommend repair

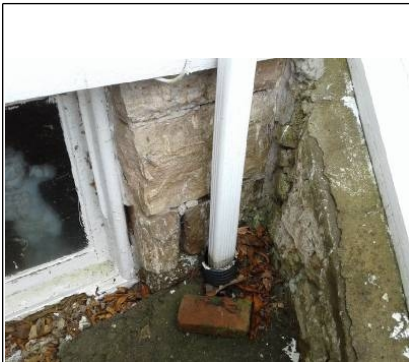
Loose missing mortar recommend tuck point repair

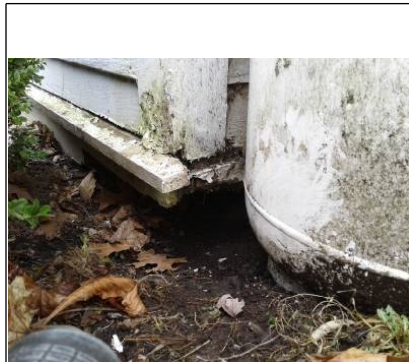
Unit not supported

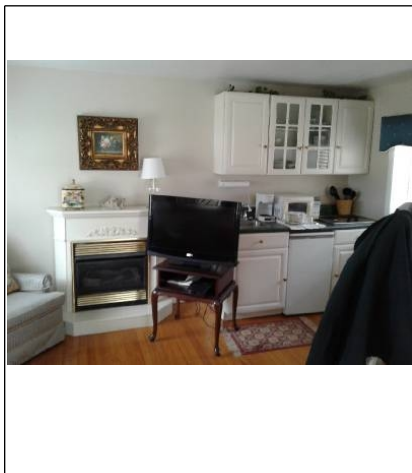
Moisture stains on ceiling

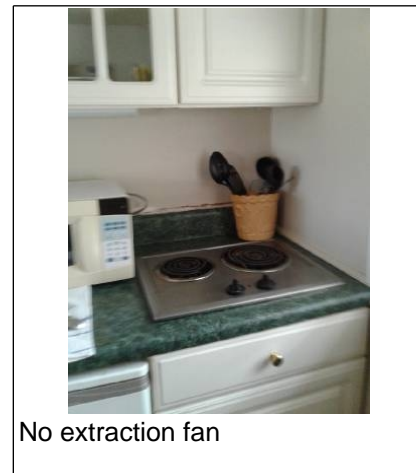
No extraction fan

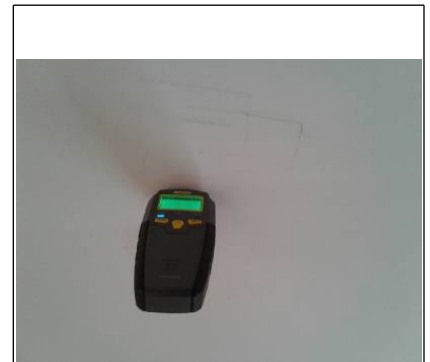
Moisture stains on ceilings

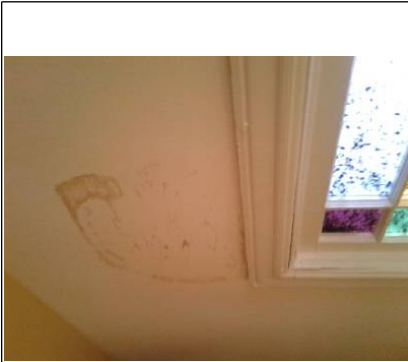
Moisture stains on ceilings

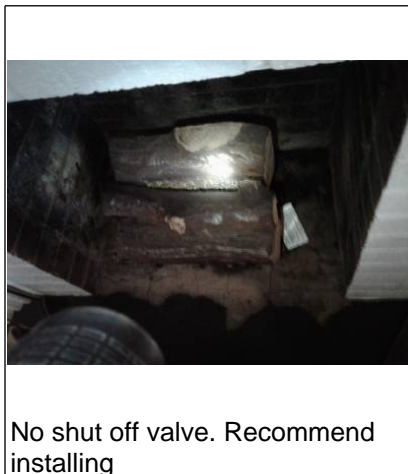
No shut off valve. Recommend installing

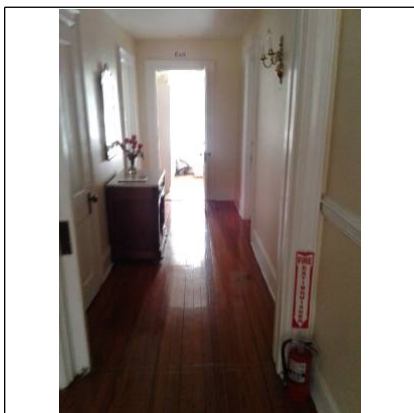
**Comments** Smoke detectors not installed to new code standards. Recommend maintaining and installing additional No carbon monoxide detectors. Recommend installing

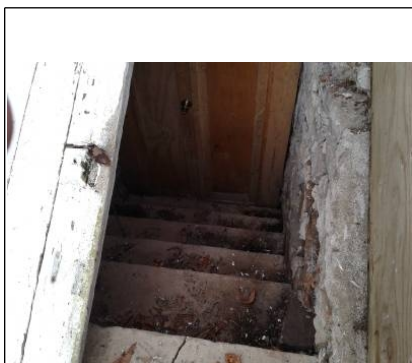
No handrail

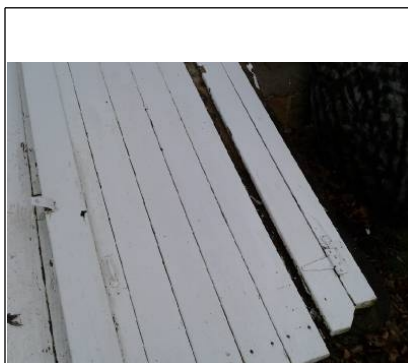
Cover damaged recommend repair

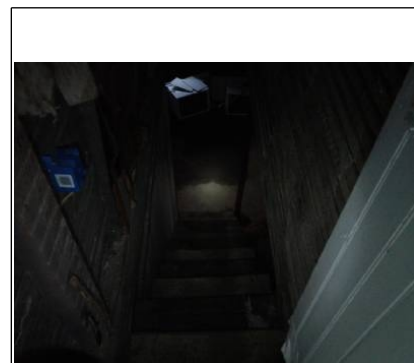
No handrail or balusters on basement stairs. No overhead light

**Comments** No balisters on basement stairs and limited connection to structure. Recommend repair

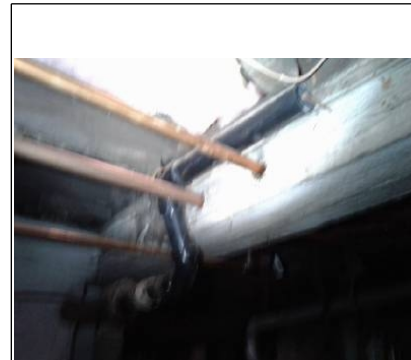
Plumbing vents in basement

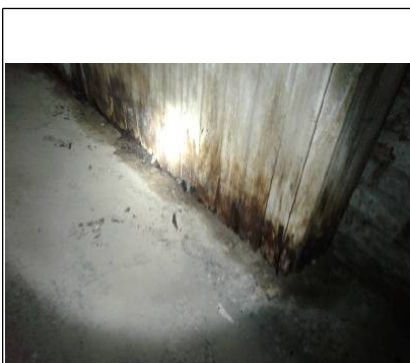
Moisture damage to wood in basement

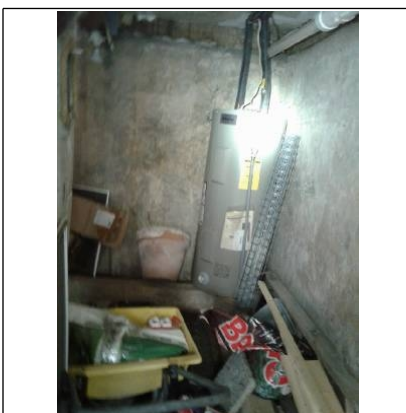
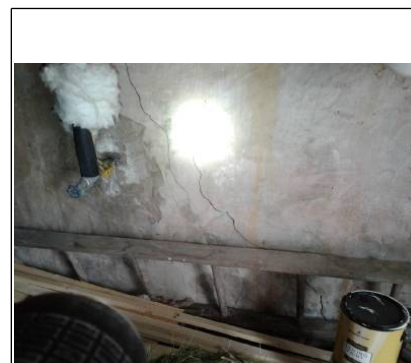
Settlement cracks and moisture stains

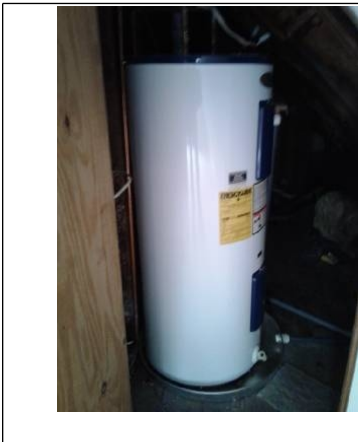
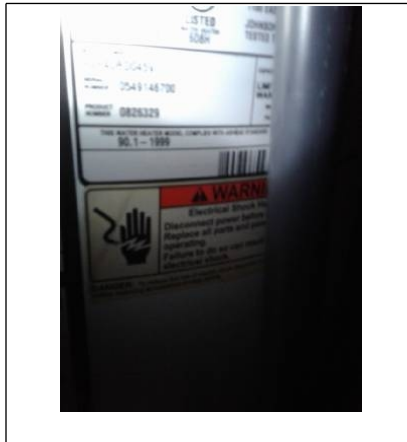
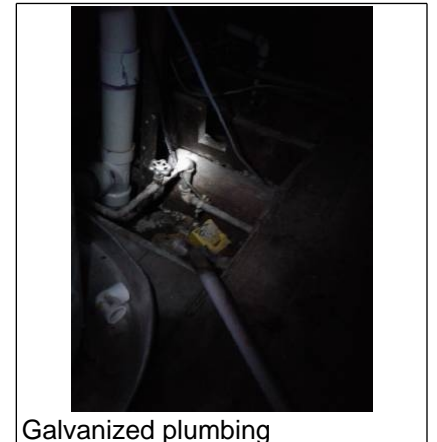
Galvanized plumbing

**Comments** Galvanized plumbing prone to corrosion. Recommend monitoring and repair or replacement as needed.  
 Polybuteline plumbing prone to leaks. Recommend monitoring and repair as needed.

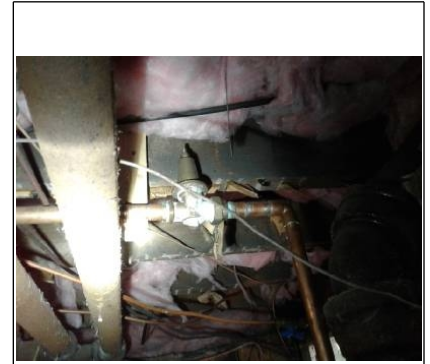
Corrosion

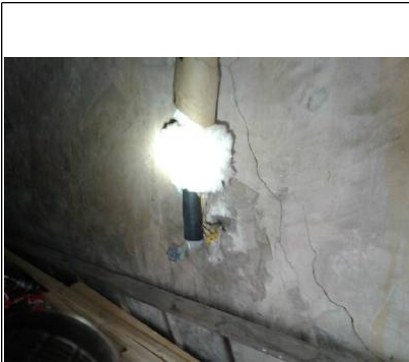
Polybutylene plumbing prone to leaks

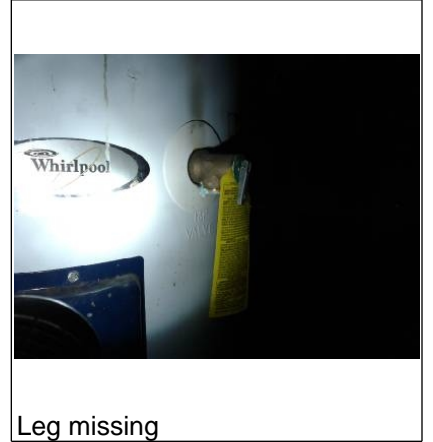
Leg missing

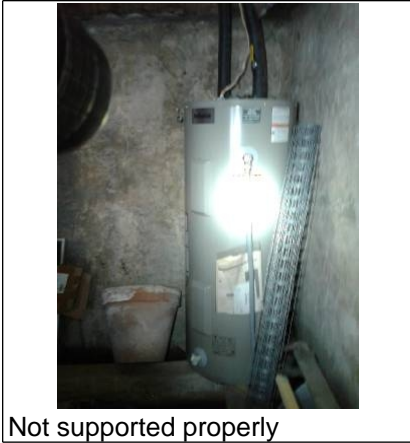
Not supported properly

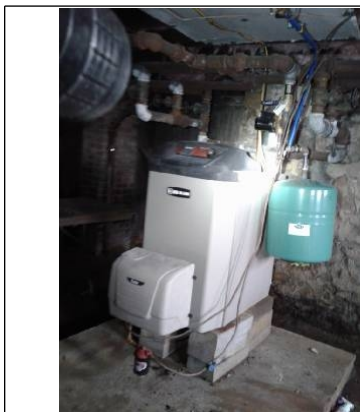
Expansion tank not supported

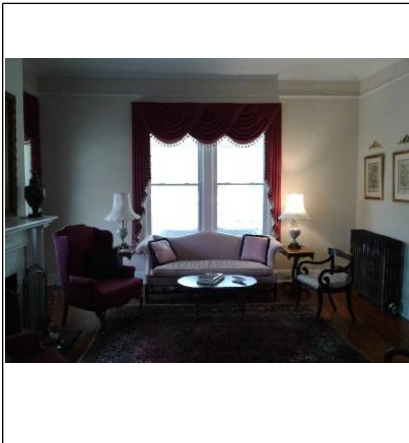
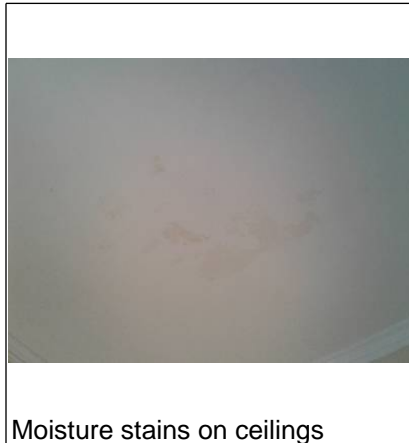
Moisture stains on ceilings

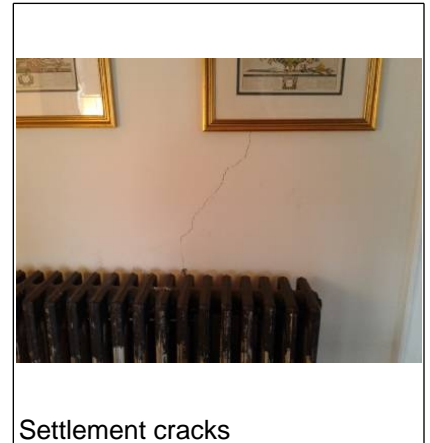
Settlement cracks

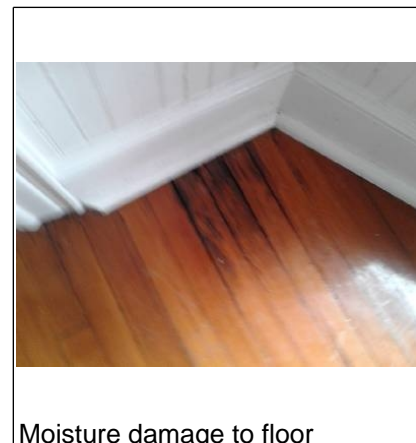
Moisture damage to floor
