Michael Rogers

33 West St
Clintonville, WI 54929

09/15/2023

Home Run Inspection Service, LLC
626 E Center St
Shawano, WI 54166
Phone: 715-853-9718

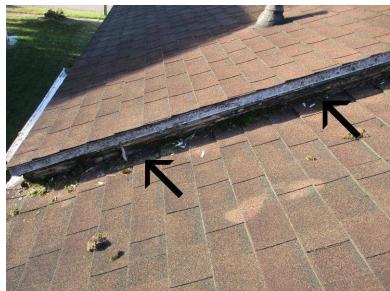
Moisture damaged fascia board where garage roof meets house.

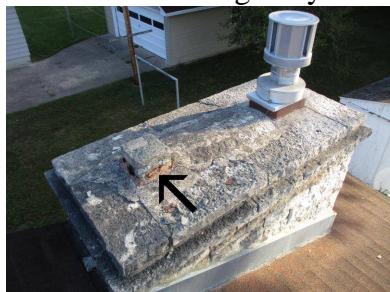
Closed off flue is greatly deteriorated and could leak rain water.

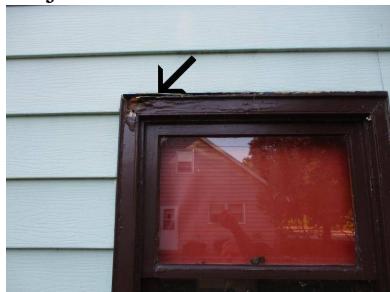
Major deterioration. Consult carpenter or window contractor.

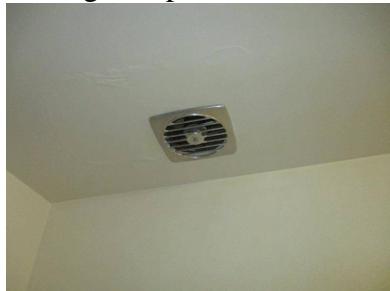
Ceiling. Inoperative.

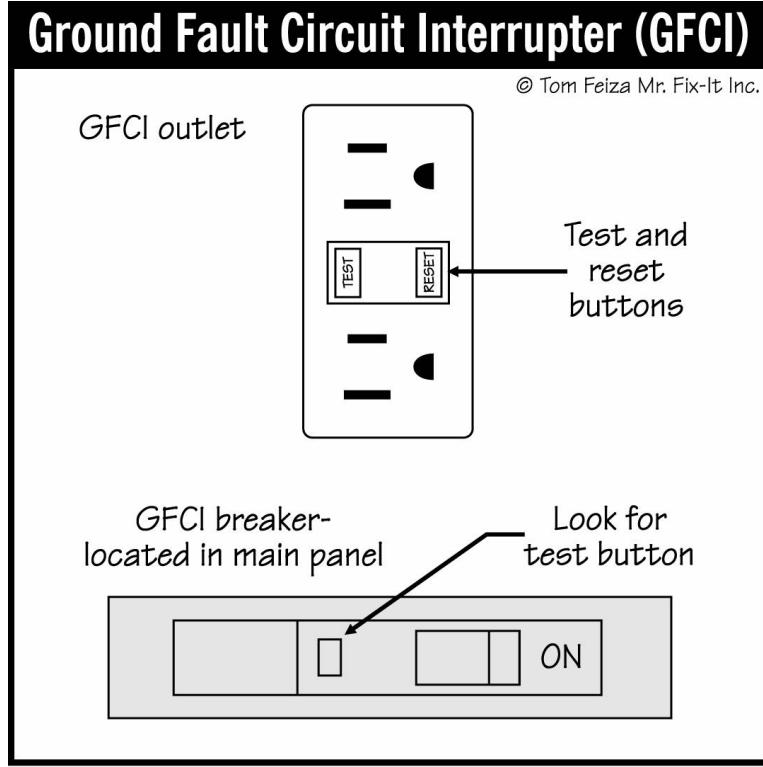
E016

Miswired: Open ground, Suggest Ground Fault Circuit Interrupter. See note on Electrical section, Required since 1973 GFCI IMAGE.

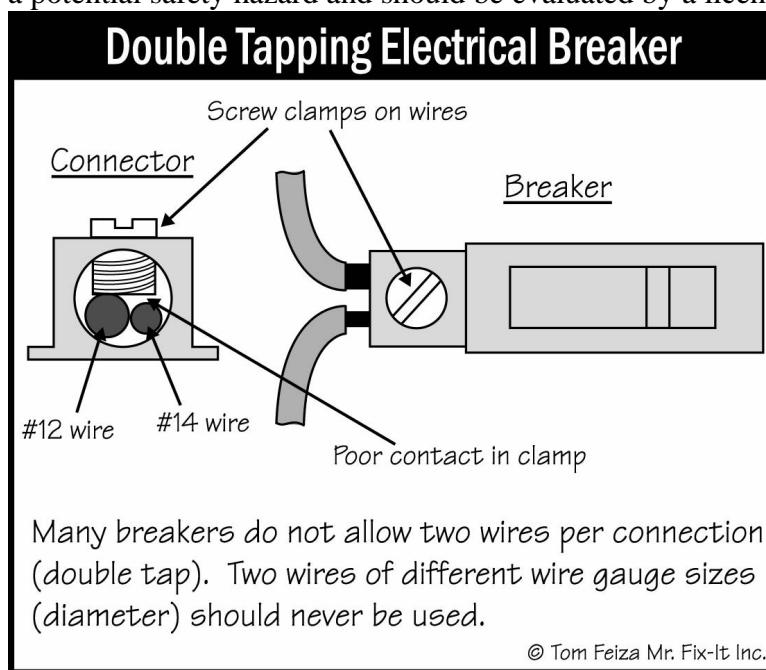
E047

More than one wire per fuse note on three fuses. Federal Pacific panels are listed as a potential safety hazard and should be evaluated by a licensed electrician.

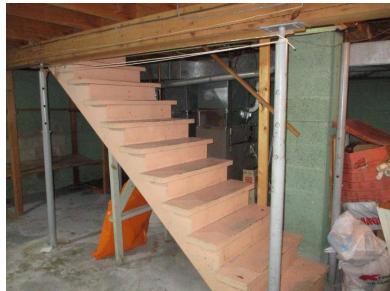
Missing guardrails.

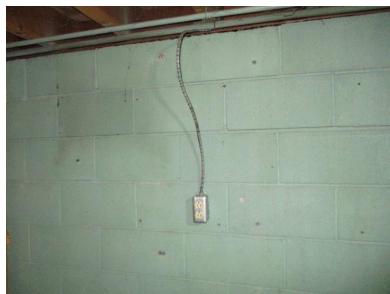
Suggest Ground Fault Circuit Interrupter for all outlets. See note on Electrical section, Required since 1990. NM wires over block walls should be encased in conduit.

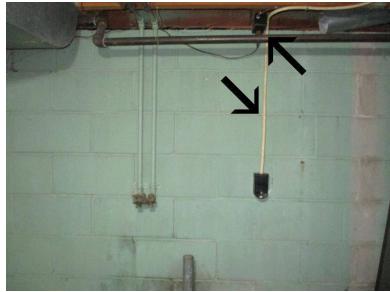
Suggest Ground Fault Circuit Interrupter for washer outlet in ceiling and conduit for 220 NM wire (dryer outlet). See note on Electrical section, Required since 2005.

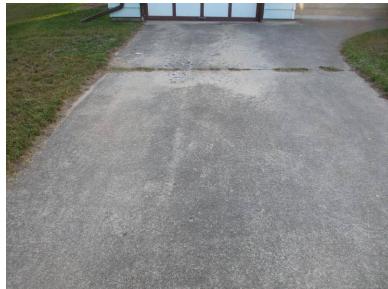
Spalling/surface deterioration section.

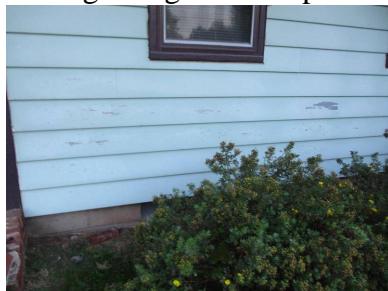
Peeling paint. Possible lead hazard. See note about lead in the "General" section at the beginning of this report.

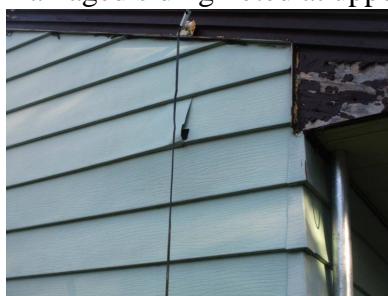
Damaged siding noted at upper south side.

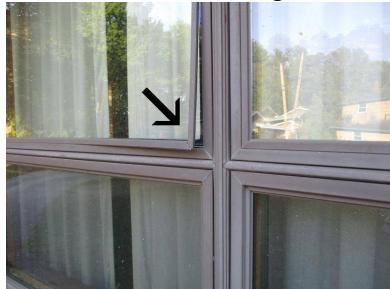
Loose frame around glass at living room window (front of house)

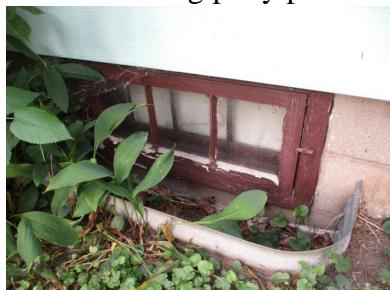
Needs caulking/putty/paint.

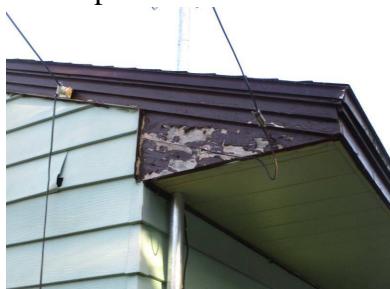
Needs paint/stain.

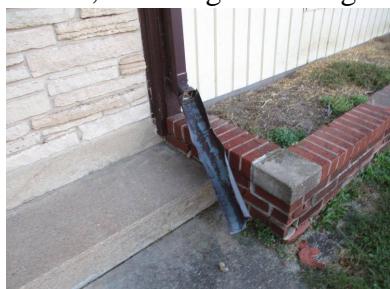
Plastic, Discharges above grade. Damaged extension at front of house.

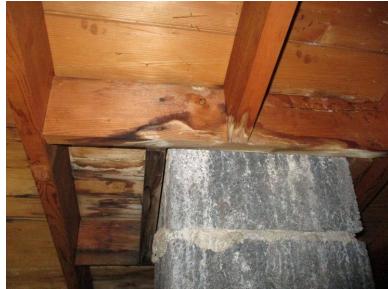
Stains around chimney in attic. Recommend resealing around base of chimney flashing.

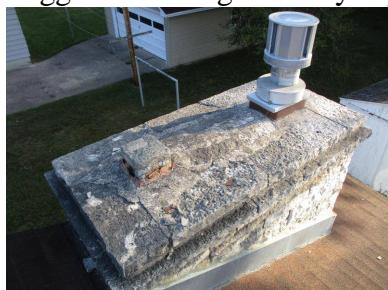
Suggest renewing chimney cap. Cap is deteriorating.

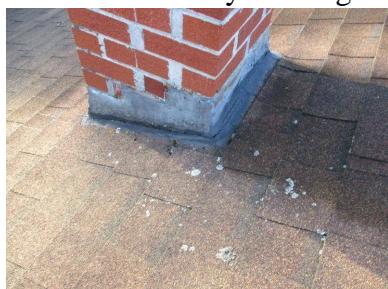
Mastic at chimney flashing cracked. Renew mastic.

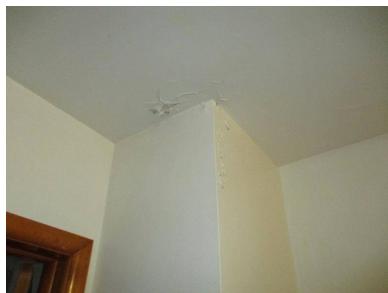
Peeling paint noted around chimney on kitchen ceiling.

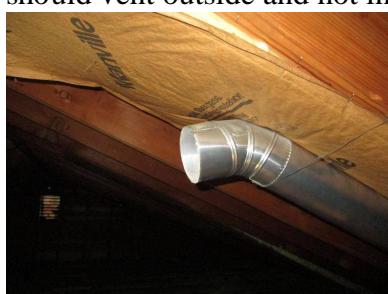
Bathroom exhaust fan does not vent to the outside. All bathroom and kitchen fans should vent outside and not into the attic.

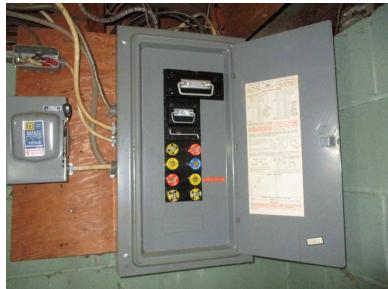
Labeling not complete.

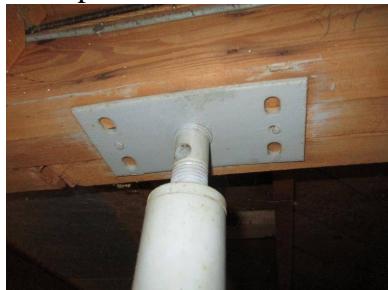
Steel posts should be fastened to beam with lag screws or equal (not nails)

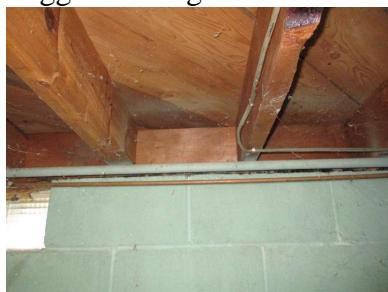
Suggest adding box sill insulation.

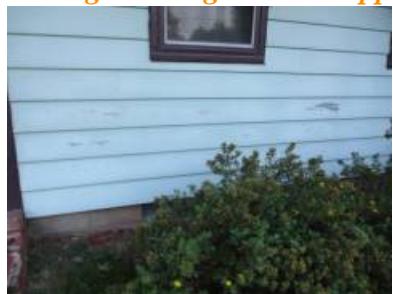
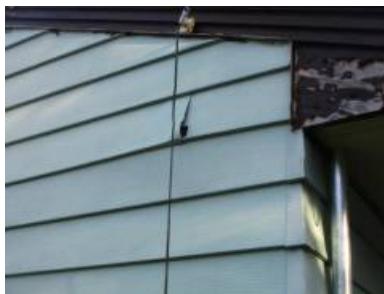
Peeling paint. Possible lead hazard. See note about lead in the "General" section at the beginning of this report.

Damaged siding noted at upper south side.

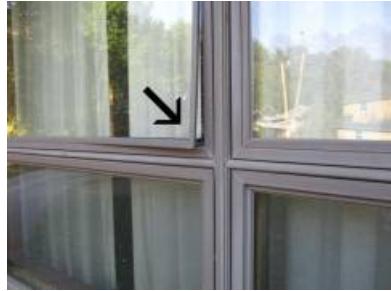
Loose frame around glass at living room window (front of house)

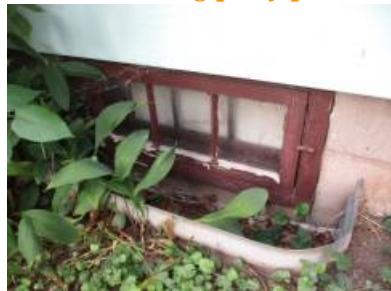
Needs caulking/putty/paint.

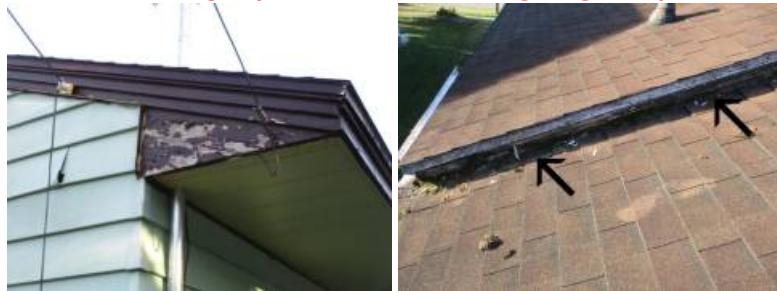
Needs paint/stain.

Moisture damaged fascia board where garage roof meets house.

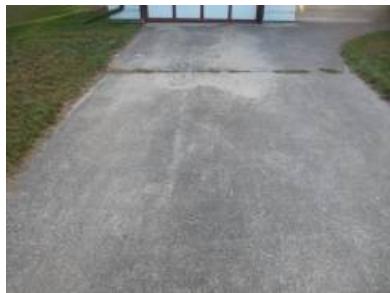
Spalling/surface deterioration section.

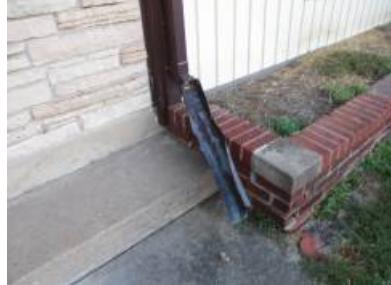
Plastic, Discharges above grade. Damaged extension at front of house.

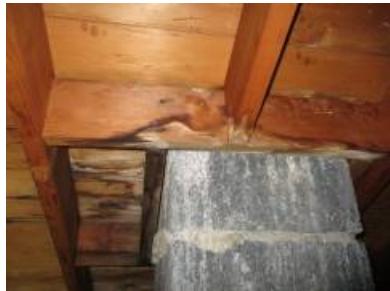
Stains around chimney in attic. Recommend resealing around base of chimney flashing.

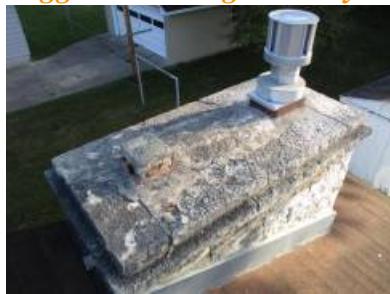
Suggest renewing chimney cap. Cap is deteriorating.

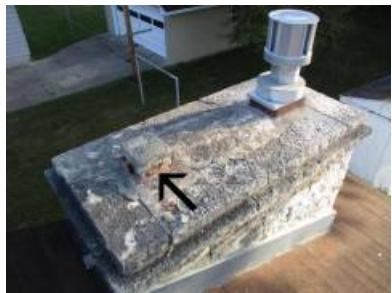
Closed off flue is greatly deteriorated and could leak rain water.

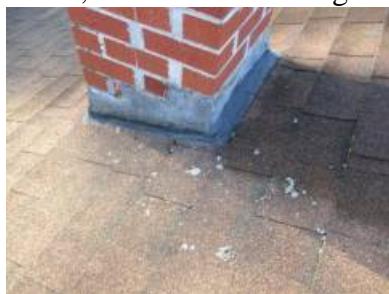
Metal, Sealed with roofing mastic, *Mastic at chimney flashing cracked. Renew mastic.*

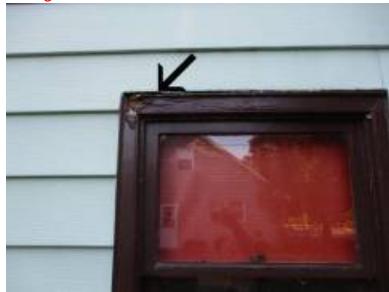
Major deterioration. Consult carpenter or window contractor.

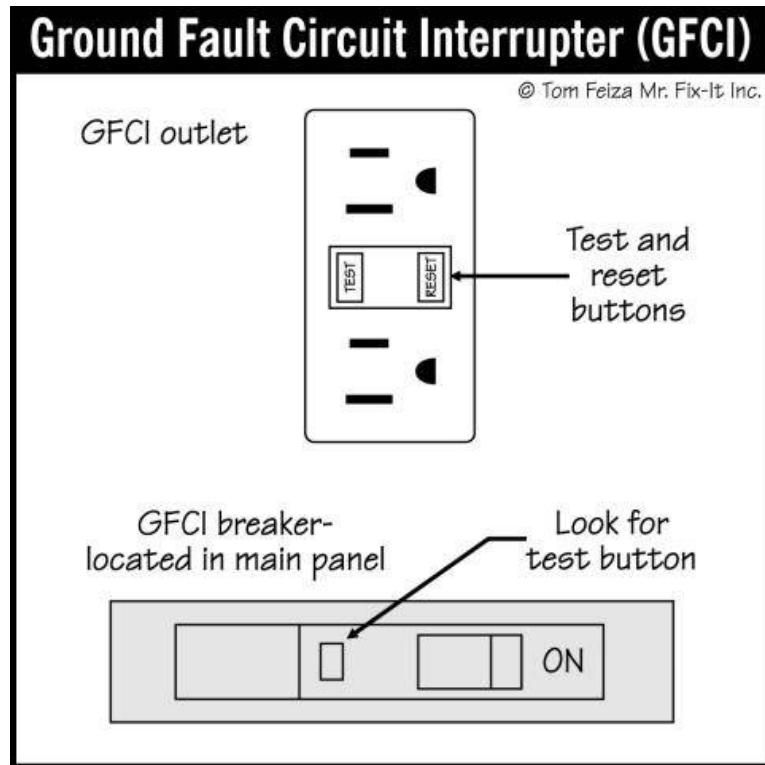
EO16

Miswired: Open ground, Suggest Ground Fault Circuit Interrupter. See note on Electrical section, Required since 1973 GFCI IMAGE.

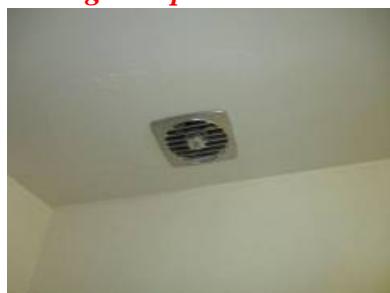
Ceiling. Inoperative.

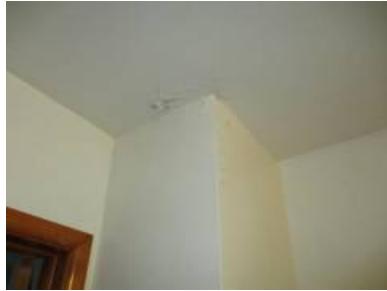
Ceiling and wall framing is not observable due to finishes/insulation. *Peeling paint noted around chimney on kitchen ceiling.*

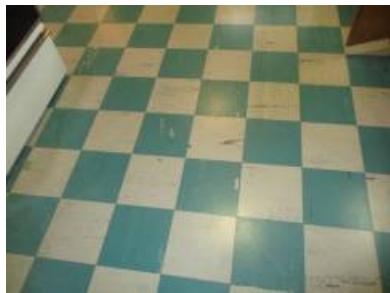
9 x 9 inch floor tiles may contain asbestos. *Determining the presence or absence of asbestos is outside the scope of this inspection. Inspection is limited to visible areas only. Asbestos is a substance that has been used in many building materials and products. It is a health hazard when individuals breathe in asbestos particles that are in the air. These particles enter the air when the substance containing asbestos is disturbed. Consult an asbestos abatement specialist for testing and recommendations before disturbing or altering any substance that may contain asbestos or if the substance is damaged."*

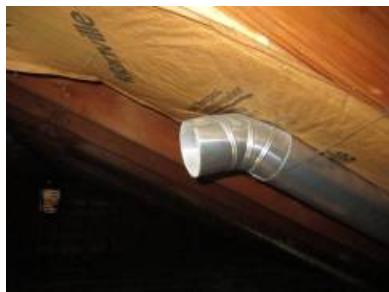
Bathroom exhaust fan does not vent to the outside. All bathroom and kitchen fans should vent outside and not into the attic.

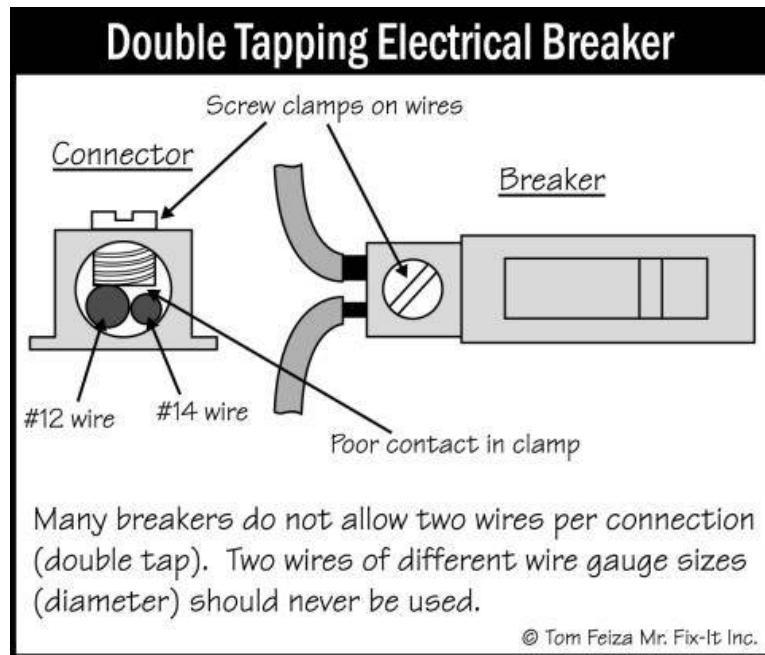
EO47

More than one wire per fuse note on three fuses.

Federal Pacific panels are listed as a potential safety hazard and should be evaluated by a licensed electrician.

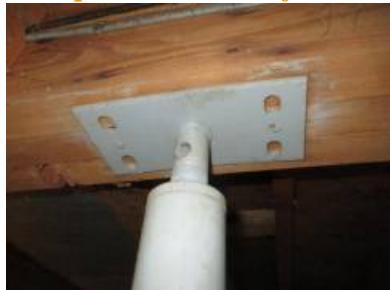
Steel posts should be fastened to beam with lag screws or equal (not nails)

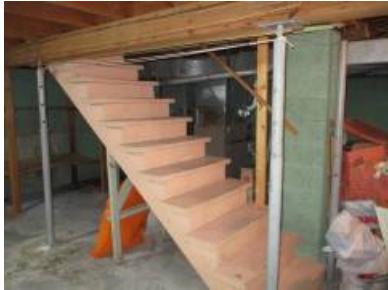
Missing guardrails.

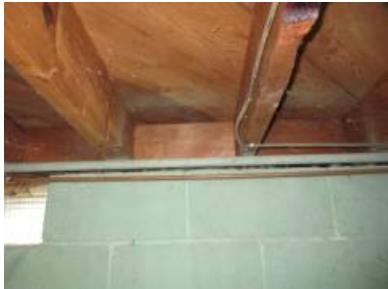
Suggest adding box sill insulation.

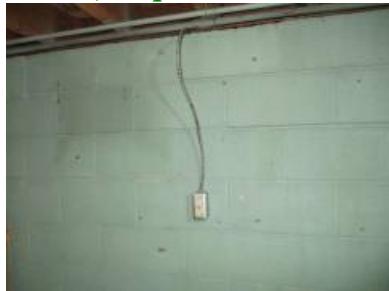
Suggest Ground Fault Circuit Interrupter for all outlets. See note on Electrical section, Required since 1990. NM wires over block walls should be encased in conduit.

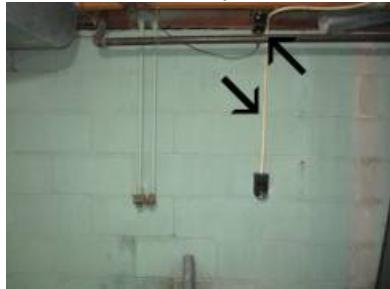
Suggest Ground Fault Circuit Interrupter for washer outlet in ceiling and conduit for 220 NM wire (dryer outlet). See note on Electrical section, Required since 2005.

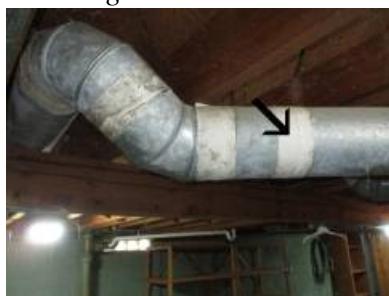
Distribution method: Forced air fan at heat exchanger. Non-Insulated sheet metal ducts. There appears to be an asbestos-like material present. *Determining the presence or absence of asbestos is outside the scope of this inspection. Inspection is limited to visible areas only. Asbestos is a substance that has been used in many building materials and products. It is a health hazard when individuals breathe in asbestos particles that are in the air. These particles enter the air when the substance containing asbestos is disturbed. Consult an asbestos abatement specialist for testing and recommendations before disturbing or altering any substance that may contain asbestos or if the substance is damaged.*
