## **Fire Risk Assessment**

**Tobacco Warehouse Block B  
Commercial Road  
Liverpool L5 9XB**

**Date: 5th November 2019**

**randr Safety Systems Ltd.**

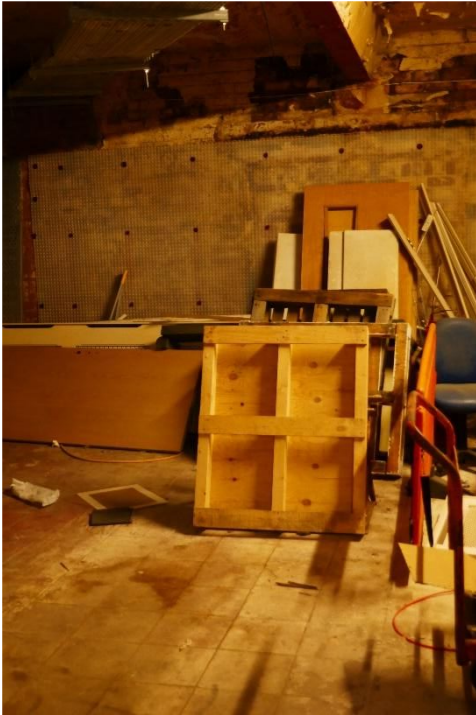
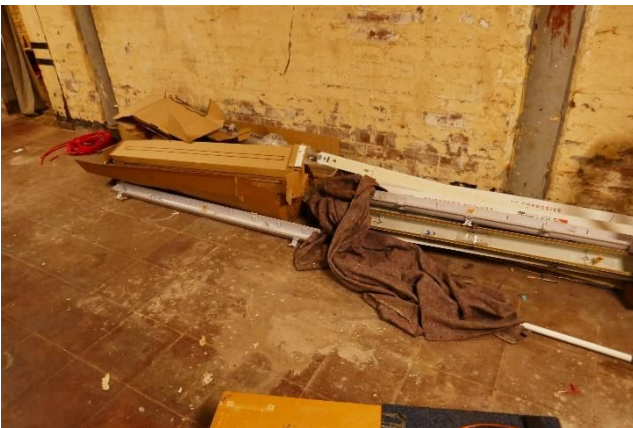
Work is currently ongoing to remove a quantity of waste and surplus items from the basement store area; this work should be completed as soon as possible. Also, the bin storage area is currently overloaded with waste timber and furniture, this needs to be removed.

Basement Area store, all waste to be removed

1. Remove all waste and surplus items from basement stores and bin stores
2. Provide effective fire stopping to all ducts and risers throughout
3. Confirm adequate fire stopping to all service ducts and voids

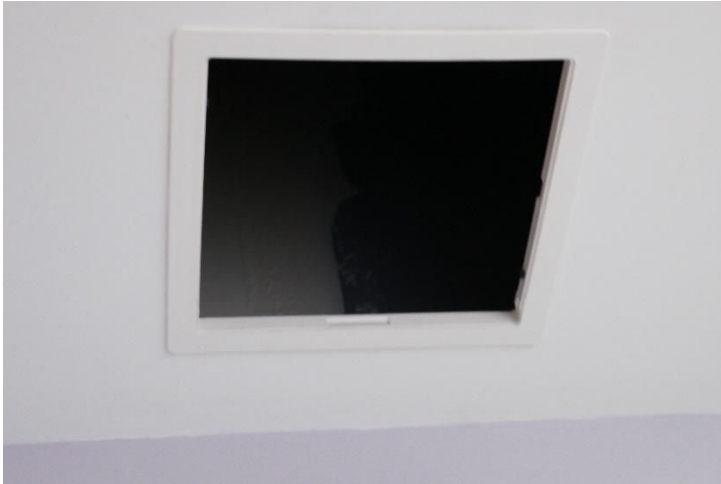
**Ceiling Panel outside Flat 113 to be replaced**

The ceiling panel outside Flat 113 should be replaced.

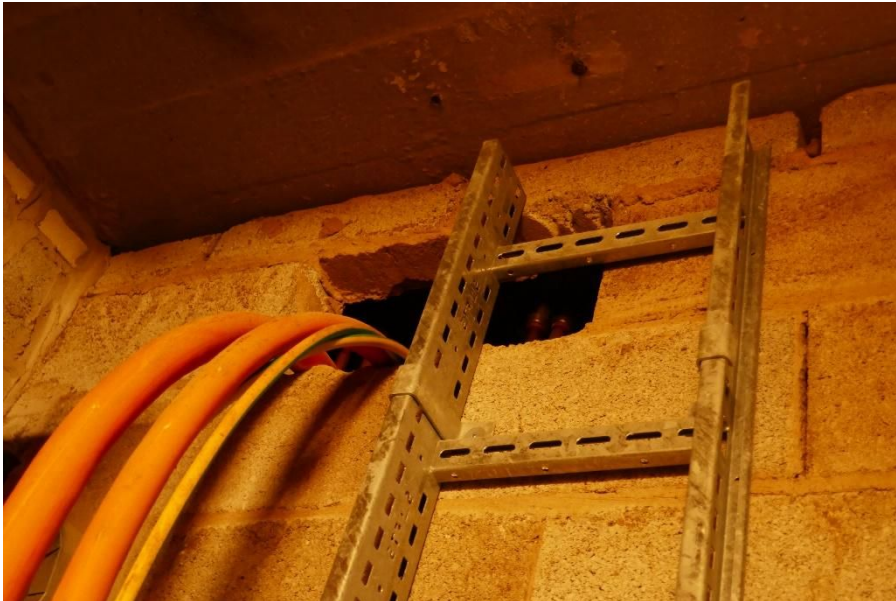
There are numerous voids and ducts throughout the basement area, the voids rise throughout the building, it wasn't possible at the assessment to determine the full layout of the voids and the extent of the protection, if any, of the spaces above and around the void areas. There may also be void spaces above ceilings of the flats.

**Basement ceiling and walls in poor condition, numerous voids and gaps**

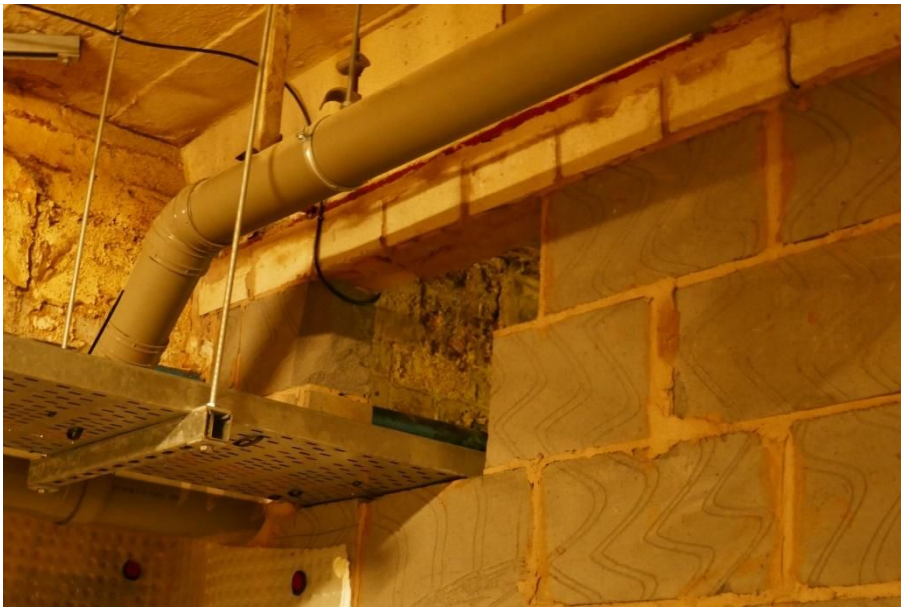
The general standard of workmanship throughout the basement plant rooms area is poor, there are numerous missing bricks in walls, especially where cables and pipes pass through, also, where walls meet the ceiling, the pointing has not been completed leaving gaps throughout.

**Basement Plant room, missing brickwork**

The plant rooms along the basement area are therefore not adequately fire protected, missing brickwork should be replaced and all gaps should be adequately fire stopped.

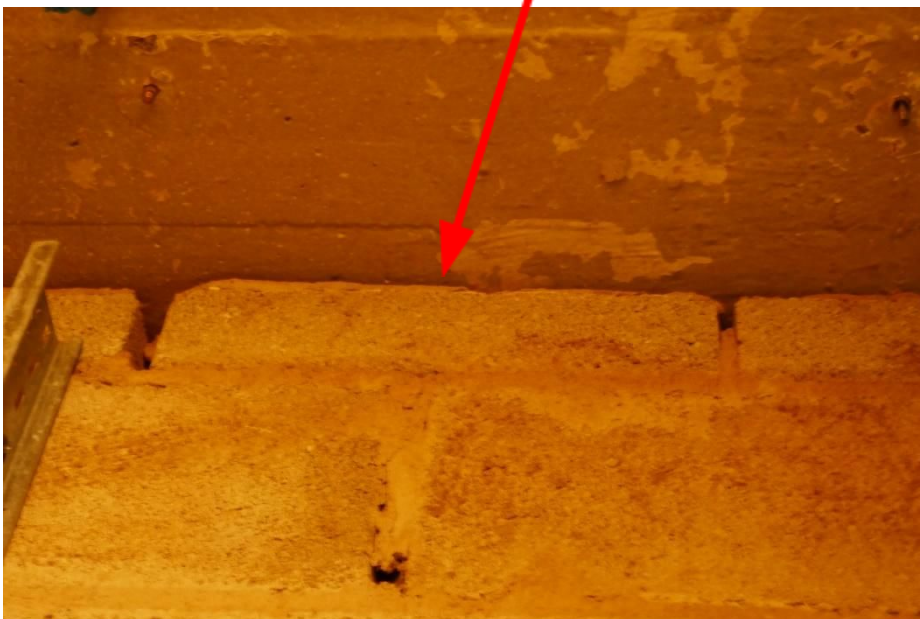
**Basement area, no fire stopping where walls meet ceilings**

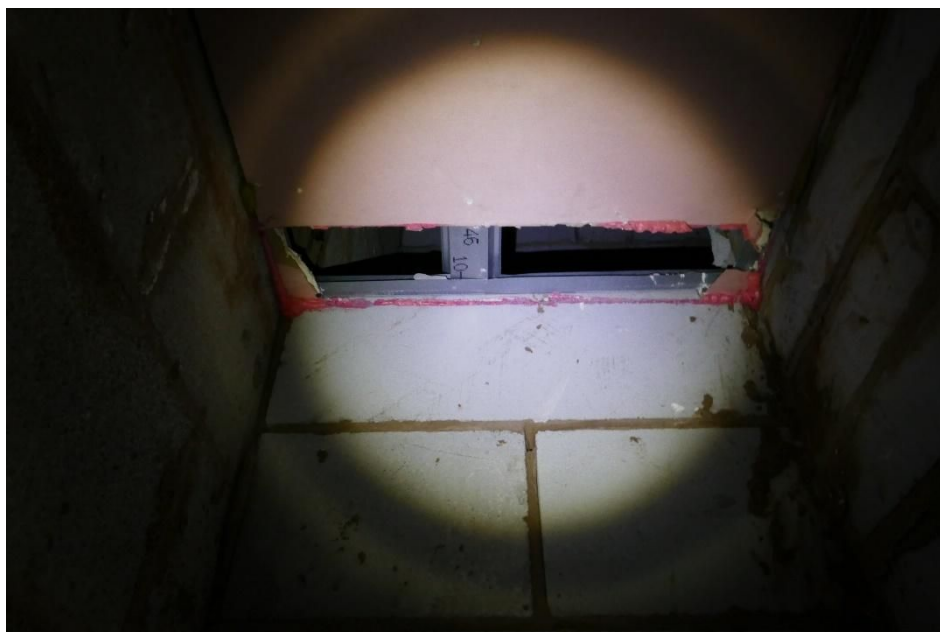
**Electrical Intake riser cupboard, ceiling to be repaired and fire stopped**

4. Repair ceiling and walls to basement electrical intake rooms and provide fire stopping throughout
5. Upgrade door to car park from basement
6. Confirm all Flat fire doors and seals are in good order, implement regular inspection procedure to check all fire doors throughout.

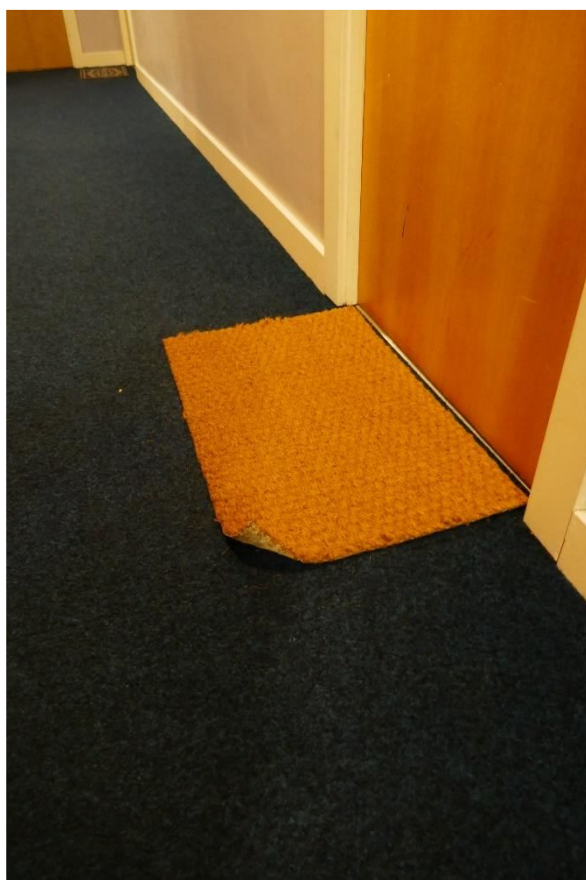
**Door mat, tripping hazard outside Flat 70**

10. Remove door mat outside Flat 70
11. Repair step tread North Staircase, stairs to basement, step 5
12. Switch Room 1, light fitting support chain should be shortened so light is not in contact with timber
