Change Notification I-Control Touchpad Responsiveness.

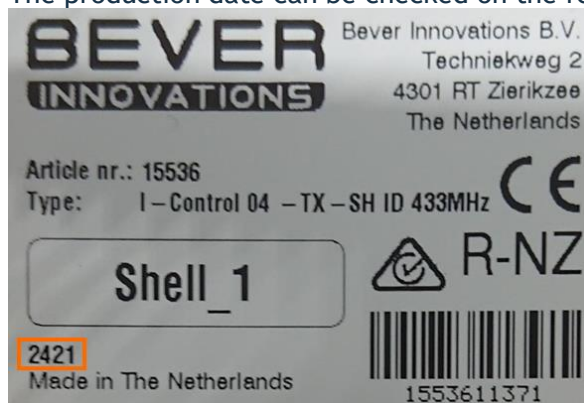
The above is applicable to I-controls with a production date of 2421 (wk24/Y2021) and later. The production date can be checked on the rear of the I-Control remote.
