Known Causes of RS-485 Communication Issues

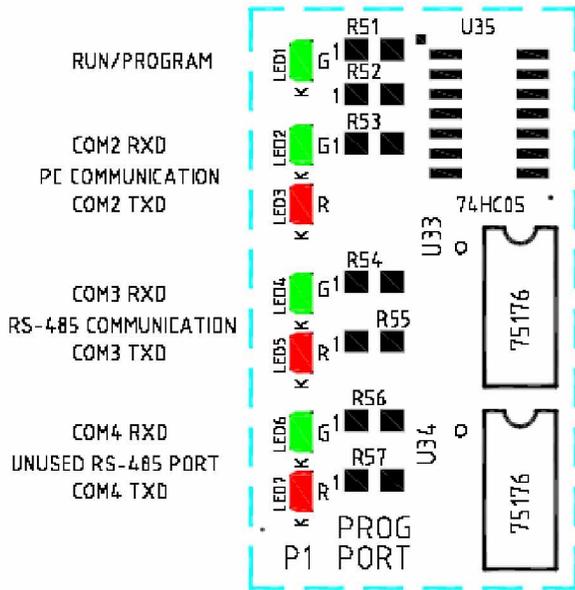
31866XX DI BOARD SIDE VIEW

With some problem RS485 transceiver chips or with an excessive amount of noise on the RS-485 wiring the green COM3 RXD LED stays on constantly and RS-485 communication error alarms are reported.

NOTE: THE RS-485 TRANSCEIVER COMPONENTS ARE IN AN 8-PIN DIP PACKAGE AND ARE SOCKETED AT LOCATIONS U33 AND U34 OF THE DI BOARD.

THE TEXAS INSTRUMENTS SN75176BP COMPONENT IS USED FOR THE RS-485 TRANSCEIVER.

U33 CAN BE SWAPPED WITH U34 IF REQUIRED.
