COUNTAX™

SERVICE BULLETIN

15-T4-71

MODELS CONCERNED: All MK4 B, C, F & T Series Tractors & XRD Decks.

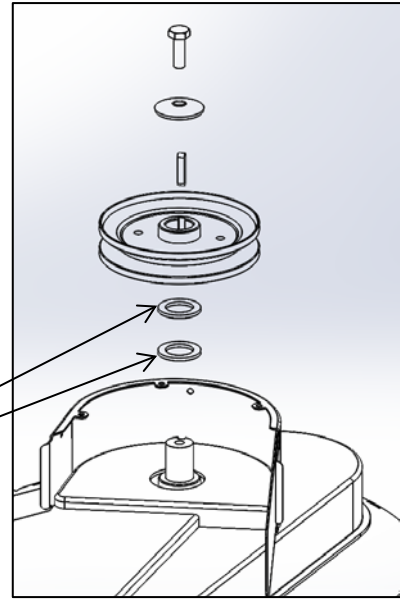
Deck Input Pulley:

Additional Shim x 2
549011500

1. Remove M10 bolt & dome washer.
2. Slide off pulley & key.
3. Place new shims over the top of the shaft.
4. Put back pulley, key, dome washer and re-tighten M10 fixing bolt to the correct torque.
