January 7, 1964  
Model B-11, B-11E, B-12,  
B-12W, B-12E.

ENGINEERING MEMORANDUM #89

SUBJECT: #701039 - STANDARD TRANSMISSION GEARSHIFTER REWORK

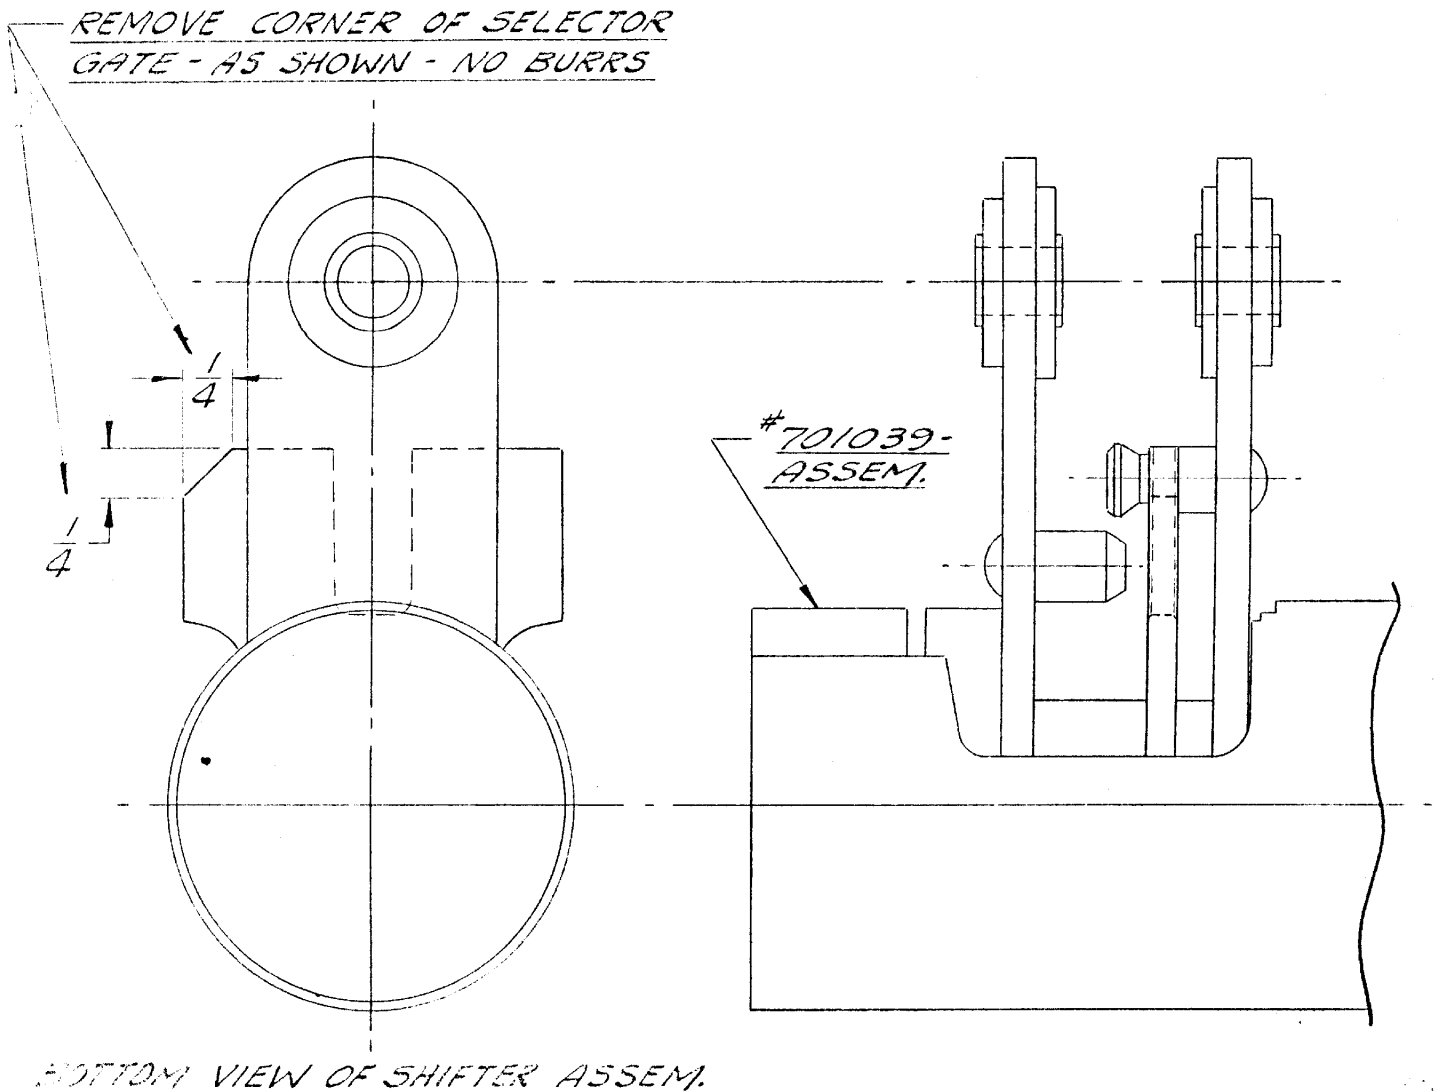
Due to general assembly line variations, there exists on some cars interference between the selector gate of the Shifter Assembly and the 2nd & 3rd Shift Rod. This interference occurs when shifted into 2nd gear position only. It is recommended that these Shifters be reworked per sketch, as shown, before being installed in the car.

On cars already built, or in the field, the same clearance can be obtained by removing the Shifter Rod and grinding the edge of the flat to provide sufficient clearance-if necessary.

NOTE: DO NOT REWORK SELECTOR GATES ALREADY INSTALLED IN VEHICLES BY BURNING WITH TORCH.
