AEROSTAR INTERNATIONAL, INC.

SERVICE LETTER 110

SUBJECT: Modifications to the Aerochute vent/deflation system in S-81A.

S-81A Aerochute Retrofit Instructions

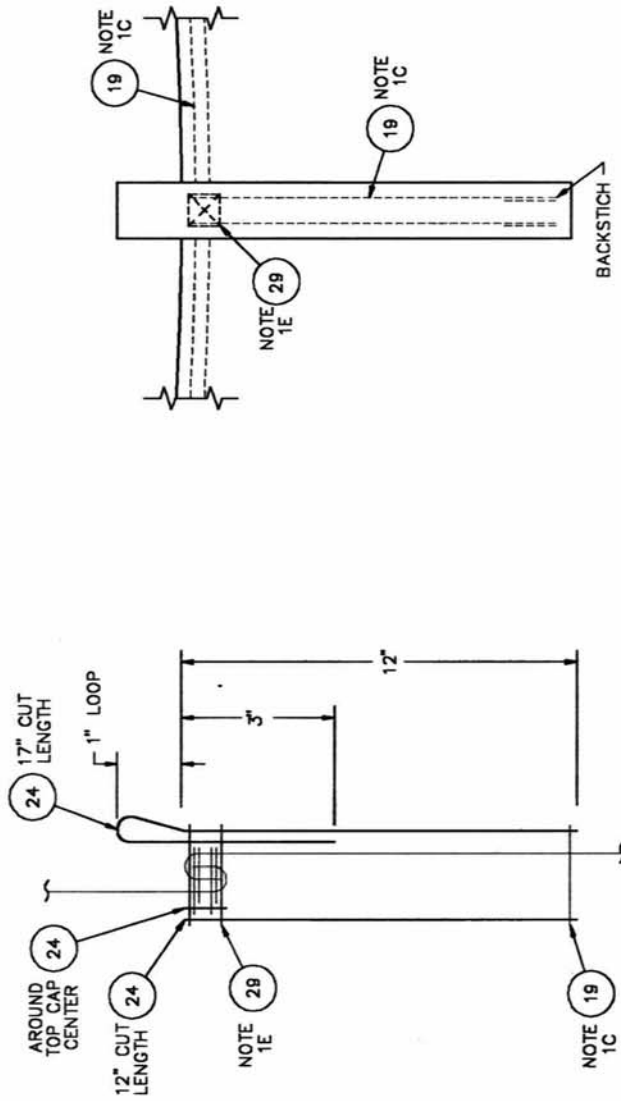
DETAIL CT

CENTER TABS & RELATED FEATURES
7 PLACES; SEAMS 2, 10, 18, 26, 34, 42, & 50

Top Cap: (Refer to Pages II & III) Install center tabs, center tab backers and 1" webbing around the perimeter of the top cap nucleus. (See drawing "DETAIL CT")

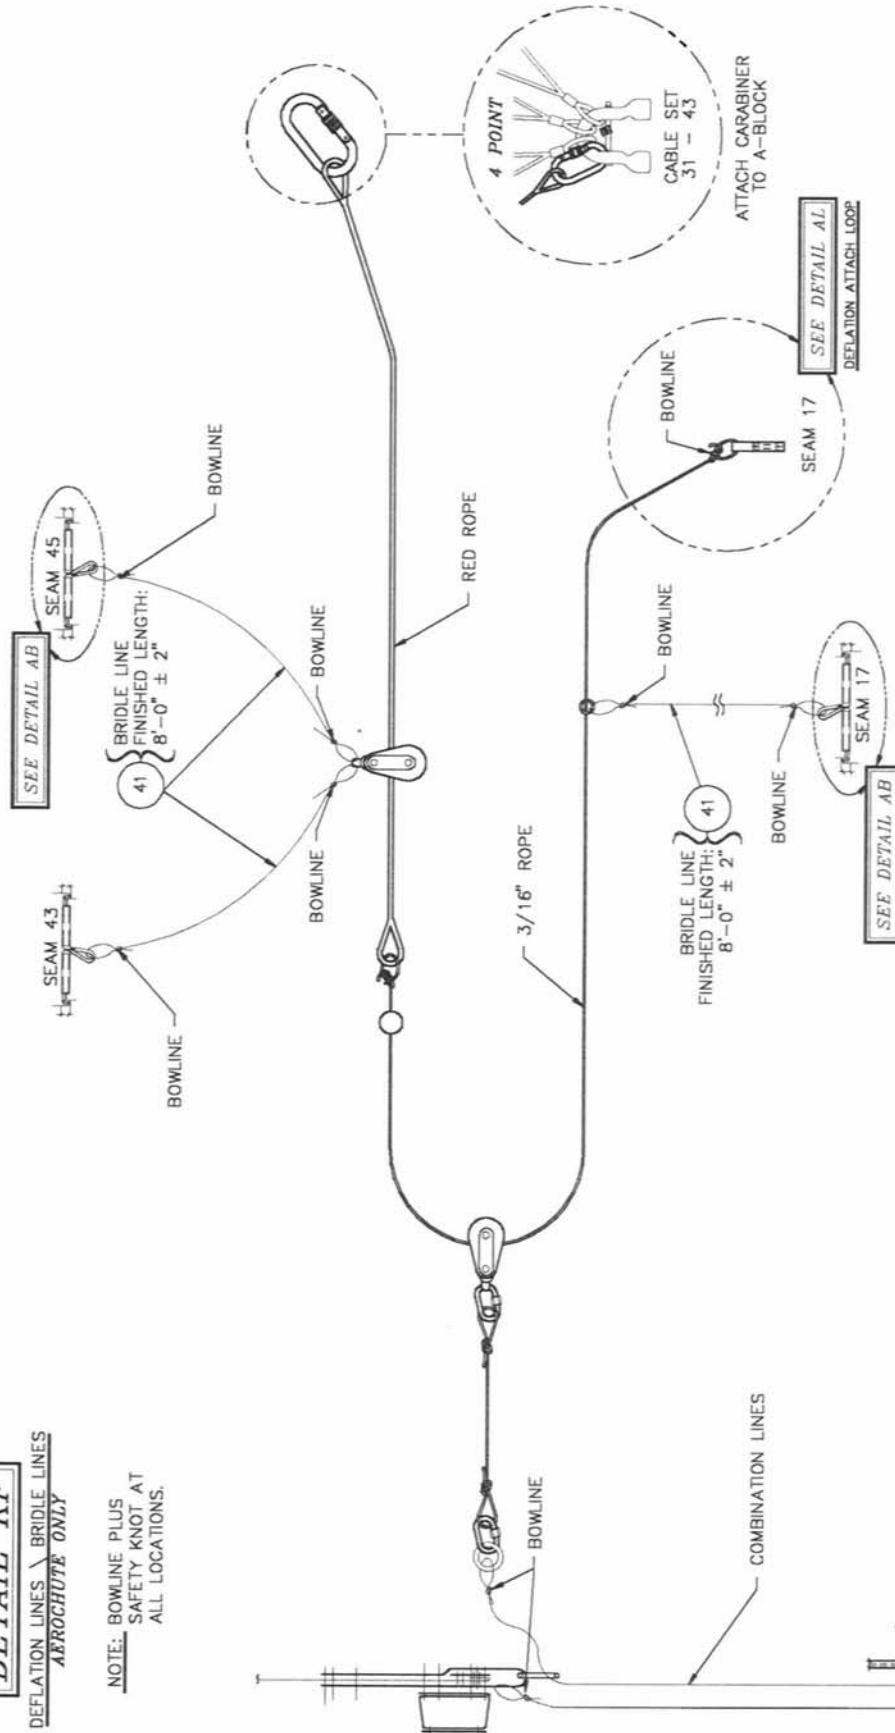
DETAIL KF

DEFATION LINES \ BRIDLE LINES
AEROCHUTE ONLY

* LINES STAY ON THE INSIDE OF ALL ROTATOR LINES.

Aerochute Deflation - Vent Pull Assembly: (Refer to Page V, VII) Install deflation attach loop on "seam 17"; top of loop at "station 19", (See drawing "DETAIL AL" page VII). Install one bridle anchor on "seam 17, station 41" (See drawing, "DETAIL AB" page VII). Install single 8 foot bridle line with guide ring. Install 2 bridle anchor loops, "seams 43 and 45" at "station 49.0" (See drawing, "DETAIL AB" page VII). Install 8ft. Bridle cords and pulley.

Route vent pull line assembly as specified on Page V. (Note * Lines stay on the inside of all rotator lines.)

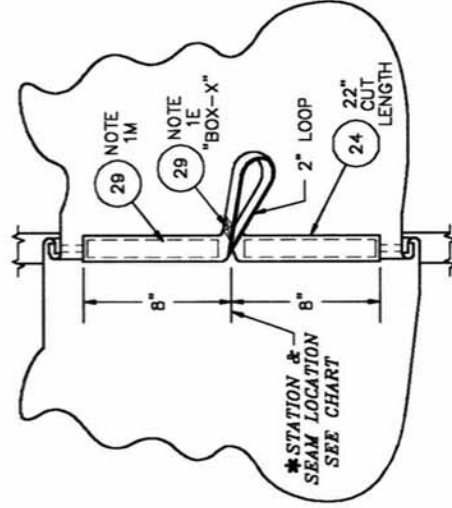
DETAIL AB

BRIDLE ANCHOR

BRIDLE ANCHOR SEAM & STATION LOCATION			
TOP CAP	* ONE EACH AT	* STATION	
AEROCHUTE CENTER PULL	15 & 17	49	
AEROCHUTE DEFLATION / VENT	43 & 45	49	
AEROCHUTE DEFLATION / VENT	17	41

Install bridle anchor loops on “seams 15 and 17” at “station 49” (See drawing, **“DETAIL AB”** page VII).

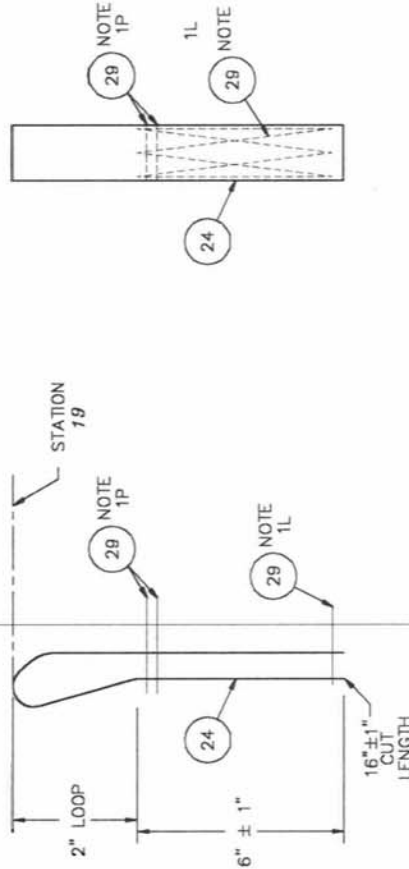
DETAIL AL

DEFLECTION ATTACH LOOP
AEROCHUTE
