QS ENERGY PROVIDES AOT TESTING UPDATE

Update on AOT component testing

Key findings that prevented the AOT from operating during the Demonstration Project

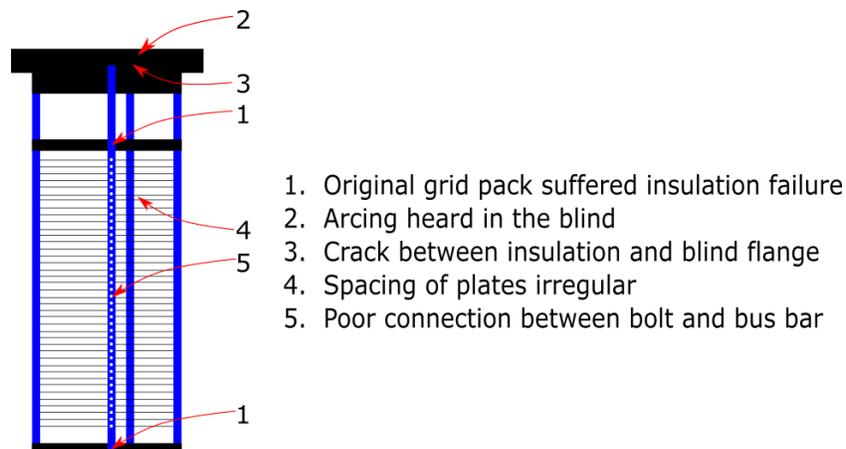
Diagram 1: Conceptual Drawing of Current Stack

A few major issues have prevented the AOT from achieving the voltage necessary to apply the AOT technology at the previous demonstration site. A conceptual drawing of the grid pack is shown in Diagram 1 with the locations of the problems identified with arrows.

We found that the current internals had significant spacing variation as indicated in Diagram 1 item 4. During the demonstration project the issue had been noted and insulated spacers were designed and made to improve plate spacing and to provide additional electrical isolation to the shell. The spacers worked to a degree, but we noted variation in plate spacing was still present. Given the limited voltage we had been able to achieve, it was not deemed a major issue at the time. During recent testing, we found that when the plates were isolated, arcing occurred at the closest point between them as expected. By investigating the grid pack where arcs formed, we found that there were a few locations where the gap decreased to almost half of the designed gap toward the centerline of the grid pack.

One of the major issues was arcing between assembly bolts and the negative bus bar. This issue was caused by the mechanical failure of spacers connecting the plates to the bus bar. The collapsed spacer created a very small gap, where there should have been strong metal to metal contact to connect, between the bolt and the bus bar. The gap allowed arcs to occur. Replacement spacers eliminated the issue.

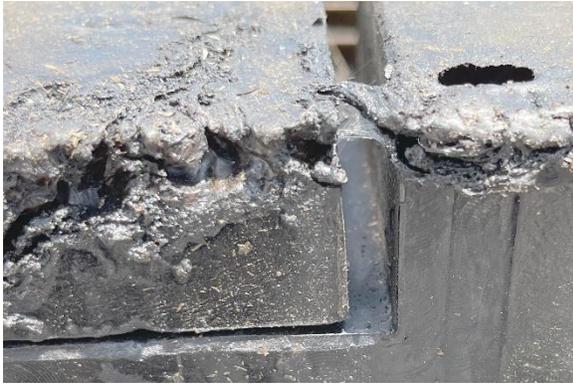
Figure 1: Photo of damaged insulation.

The original grid pack installed at the demonstration site was recently found to have two locations where the electrical insulation had been damaged, and arcing limited the amount of voltage that could be applied. By isolating the components, we were able to recreate the failure in the original grid pack. The electrical insulation appears to have suffered many arcs and has melted. It is likely the damage started as a point failure and grew with more energy discharge. While we were not able to create a short circuit, it is possible and perhaps even likely the gaps became filled with carbon due to the electrical discharge, which led to a short circuit during the demonstration.

As reported on September 13, 2019 in the [Demonstration Project Status Update](#), the original AOT grid pack was replaced with the current grid pack to improve the intended reliability of the AOT by eliminating locations of potential arcing and short circuits. The implemented changes seemed to prevent damage like what is shown in Figure 1. We have been able to achieve higher voltages without similar damage. We believe this points to the new materials of construction being better for our application.

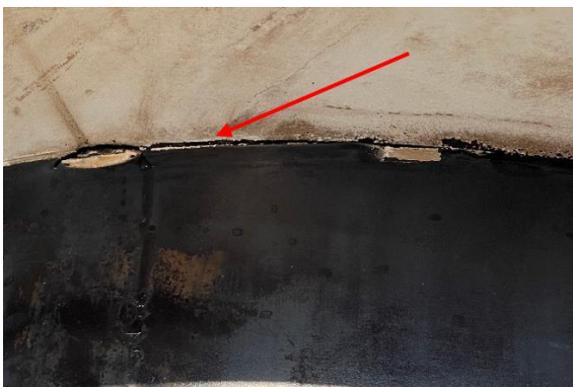
Figure 2: Insulation at blind flange.

As a result of our recent testing of the AOT, we discovered the blind flange required additional evaluation. Throughout testing, it was determined the blind presented some issues as well. Arcing can be heard from inside the blind. Additionally, a crack has formed where the insulation was cast on the blind flange—see Figure 2. The crack may only be a surface crack, or it may be a separation which could allow fluid to penetrate.

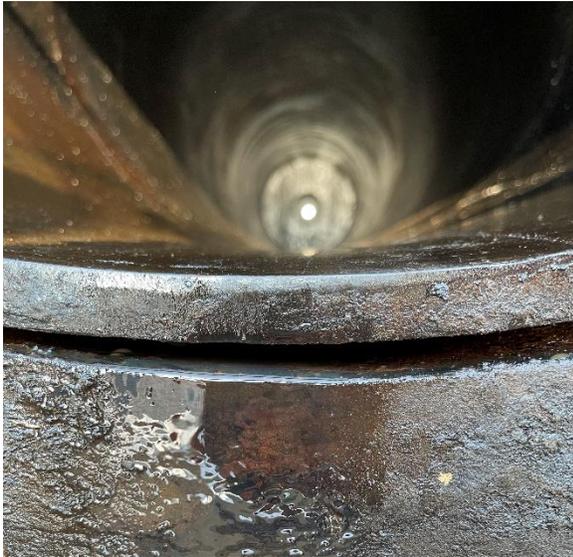
Figure 3: Pressure vessel insulation.

We also observed that the electrical insulation separated from the pressure vessel—see Figure 3. This observation has not yet correlated with any operational limitations and may not need to be addressed.
