*Batley Carr
1959 Housing Surveys
Prior to Demolition*

Chapel Street

Contents

The Borough of Batley Housing Inspection document known as "Pinks" related to both internal and external condition of each house in each street. The documents included the families that lived there and recorded to a certain extent to what conditions these families lived in. They represented a Social History of an area in the Heavy Woollen District at that moment in time.

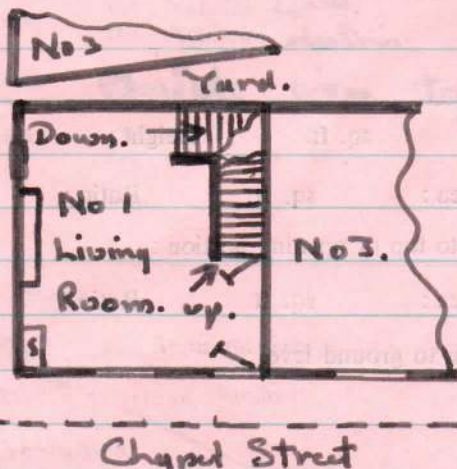
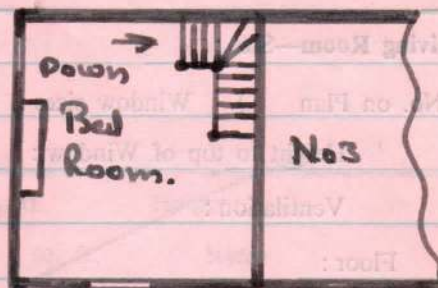
Sketch Plan—

Staircase—Twisting wooden stairs. Worn treads & nosing
No handrail.

Cellar—Descent : Twisting stone steps worn. Rough walls.
 General Condition : Broken & uneven floor. Rough walls
 off underdrain. Defective window

- A. External Walls Require pointing at front.
 Roof Sagging & patched blue slate. Heavily a defective chimney stack
 B. Internal Walls Placed damp plaster near wall of living room.
 Ceilings Defective expanded marked damp plaster in bedroom.
 Floors Uneven stone flags in living room and cellar.
 Woodwork Generally dilapidated esp. cellar window
 Staircase No handrail. Twisting. Worn treads.

| Dampness | In bedrooms due defective roof.
| Drainage | Broken gully at corner. | Yard | Dist. Shared. Not readily cleaned & drained. |

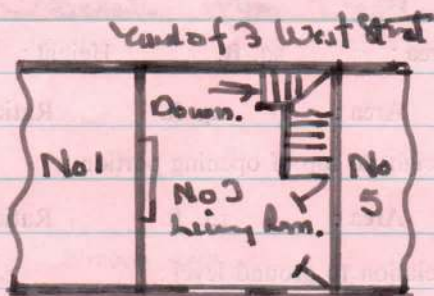
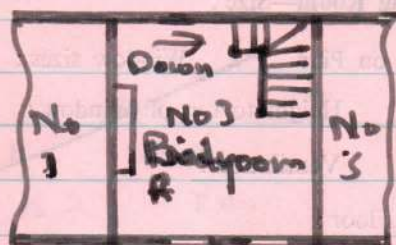
Roof: **Damaged blue slate patches.**

Walls—Front: **5" Stone par walling damaged B.R. cill. Requires pointing**

Windows: **Defective oil mastic & potty pointing Broken glazing**

Staircase—twisting steep wooden staircases. Open well. No handrail
Worn treads & risers.

Roof Leaking and damaged barge slates.

B. Internal Walls Peeling & defective plaster in bedroom & cellar steps.

Ceilings Extensive defective & damp plaster in bedroom.

Dampness In cellar. In bedroom due to defective roof.

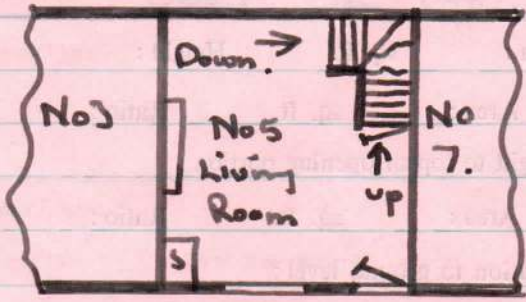
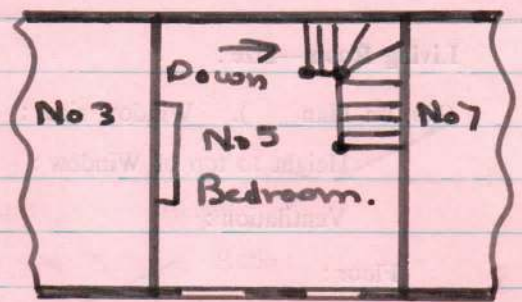
Sketch Plan—

Chimney Stack: **Short stone stack 2 pots. requires pointing Def flanking.**
 Roof: **Decayed & patched blue slate.**
 Gutters and downspouts: **wood spout with c.i. resp. not disconnected on No 9**
 Walls—Front: **5" Stone poor work. Requires pointing**
 Rear: **Weather worn brick work.**
 Painting—Front: **Fair** Rear: **Dilapidated.**
 Existence of Dampproof Course: **No evidence**
 Windows: **Such type. 2 pane each each Def oil mastic & putty pointing**
 Doors: **flushed. worn steps**

Cellar—Descent : Twenty stone steps. Rough walls.
 General Condition : Broken & uneven stone flags. Rough walls, arched roof
 Not underdrawn. Loose stone flags.

A. External Walls Ragged pointing, decayed stonework
 Roof Decayed blue slate.
 B. Internal Walls Pecked plaster in living room & bedroom
 Ceilings Pecked & cracked plaster in bedroom.
 Floors Uneven stone flag in cellar and living room.
 Woodwork Generally dilapidated.
 Staircase No handrail. Twisting. Worn wooden treads & risers

Not thro'
 External. Partial. Shared.
 Dilapidated & defective.
 No proper facilities
 No separate facilities
 In living room due no d.p.c.
 In bedroom due defect roof
 Shared. Not really closed & drained

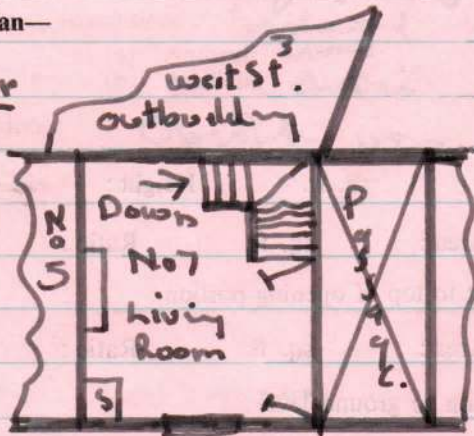
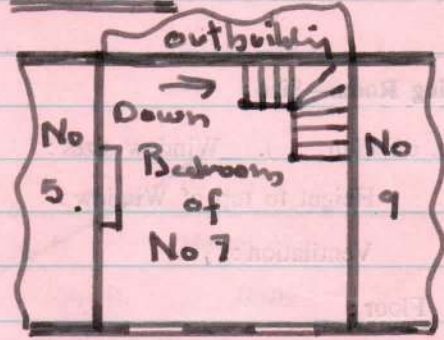
Sketch Plan—

Chimney Stack: Short stone stack fractured above blocking course. Def flashing

Roof: Damaged blue slats.

Walls—Front: 5" Stone par walling Requir pointing. damaged cill & courses at top.

Rear: Bricks. fractured on small gable thro passage.

Staircase—Twisting wooden steps worn treads. No handrail.
Damp or perished plaster.

A. External Walls Requisite pointing.
 Roof Decayed Blue Slate.
 B. Internal Walls Perished plaster.
 Ceilings Perished plaster.
 Floors Green stone flags in living room & cellar.
 Woodwork Generally dilapidated
 Staircase No handrail. Damp & perished wall planks.

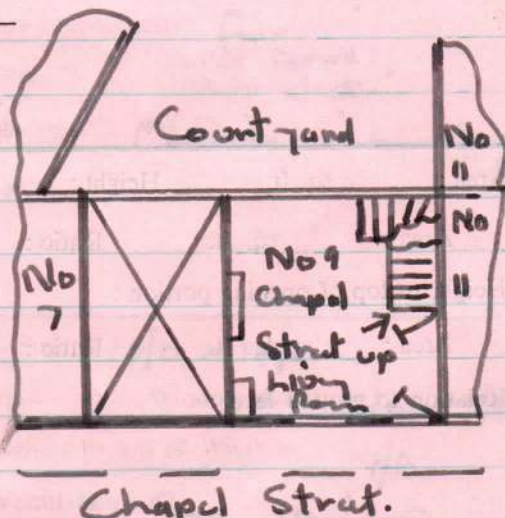
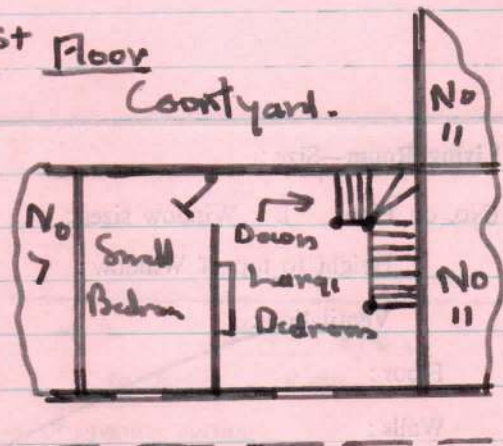
Sketch Plan—

Chimney Stack: short stone stack & pots defective pointing & flanking

Roof: Extremely defective & decayed grey slates

Staircase—Twisting wooden stairs. Open well. No ventail
Defective truss.

Ceiling: Plastered. Very severe dampness. Cracked defective or panned

General Condition : Broken or uneven stone flag floor. Rough walls. Defective window & frame. Damp. Not up drawn.

Roof Externally defective blue slates leaking & patched
Chimney stack requires painting & weathering.

Staircase Worn treads & riser. Loose or unstable staircases

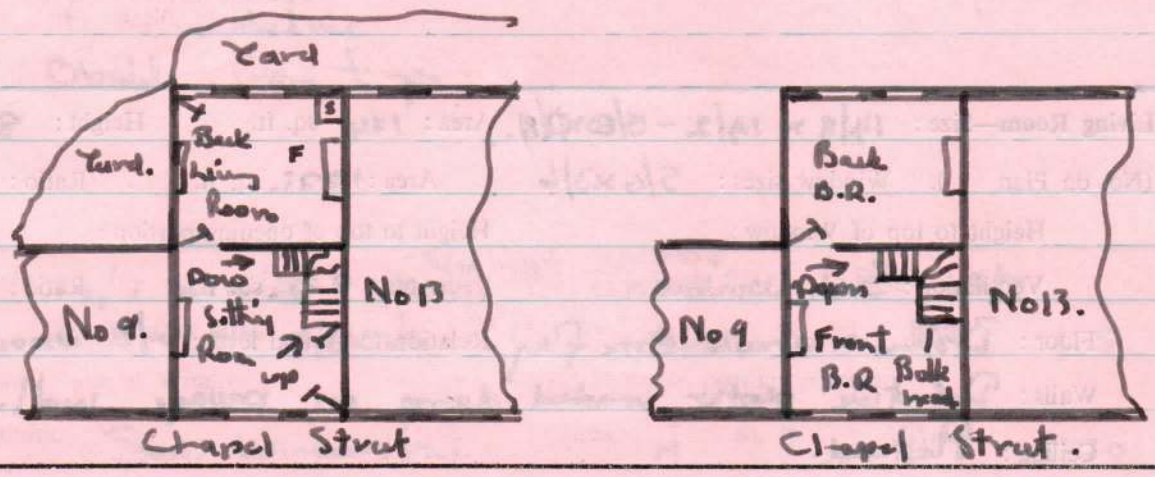
Sketch Plan—

Chimney Stack: Short brick stacks, perished. Defective flaunching.

Roof: Decayed blue slate leaking or defective

Windows: Defective & perished woodwork, mastic, gobby & gummy

Doors: 4 panel type very badly decayed. Def mastic. Def fanlight
No threshold. Insert in steps

A. External Walls Perished brickwork & decayed stone sills with rep. Repairs pending at front.

Roof Defective & leaking blue slates. Perished brickwork & stonework to chimney stacks

B. Internal Walls Perished & defective plaster in all rooms.

Ceilings Perished damp & missing plaster in bedrooms.

Dampness In bedrooms due defective roof.

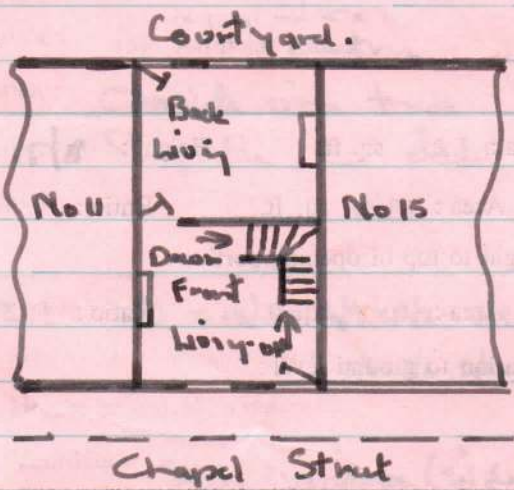
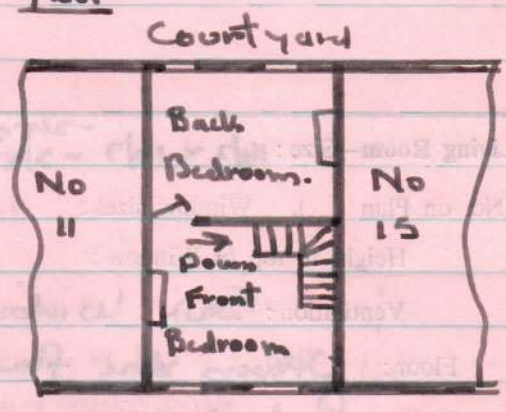
Sketch Plan—

Chimney Stack: **Rear. short brick stack open seams. front short stone stack requires pointing**
 Roof: **Damaged blue slats.**
 Gutters and downspouts: **Wood spoofs 12 years over top.**
 Walls—Front: **5" skin on walling. requires pointing.**
 Rear: **Brick with damaged cells**
 Painting—Front: **Dilapidated.** Rear: **D°**
 Existence of Dampproof Course: **No evidence**
 Windows: **Damaged & dilapidated woodwork, defunct oil mastic & putty**
 Doors: **2-pane type damaged woodwork & mastic. Insert in step at rear.**

Staircase—Twisting wooden staircases. Defective floorboards in stairhead

Cellar—Descent : *twisting & worn stone steps. Defective plastering.*
 General Condition : *Broken & uneven stone flag floor. not underdrawn.
 Rough walls. Defective window in area.*

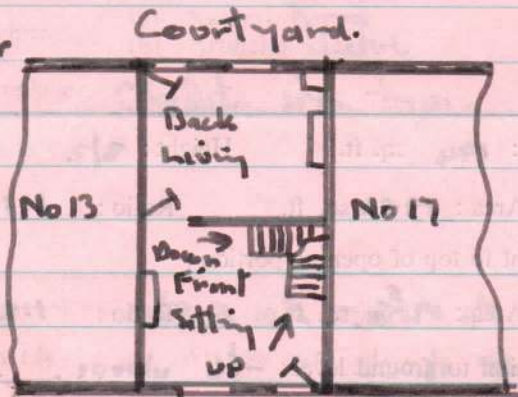
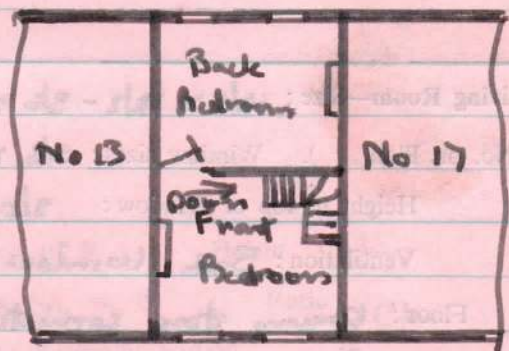
Sketch Plan—

Chimney Stack: Rear. short brick stack requires painting. Defective flashing. front stack requires painting.

Roof: Damaged blue slate.

Gutters and downspouts: Wood work with c.i. rust.
