# Electrical Assessment of Bicol University - Legazpi East Campus, Philippines

Garry V. Hilutin, Alwin M. Lunas, Fernan D. Dematera, Zendy D. Mañago, Laurence Albert D. Ayo, and Pee Jay N. Gealone

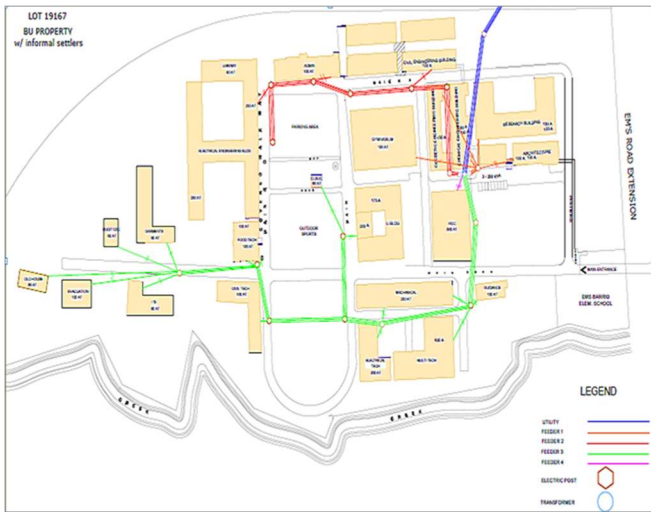
Figure 1. Existing Electrical Distribution Map of BU East Campus

Figure 1 shows the existing overhead electrical distribution system in BU East Campus with four feeders. Also shown in the figure are the distribution lines from Albay Power and Energy Corporation as the distribution utility/service provider in the province.

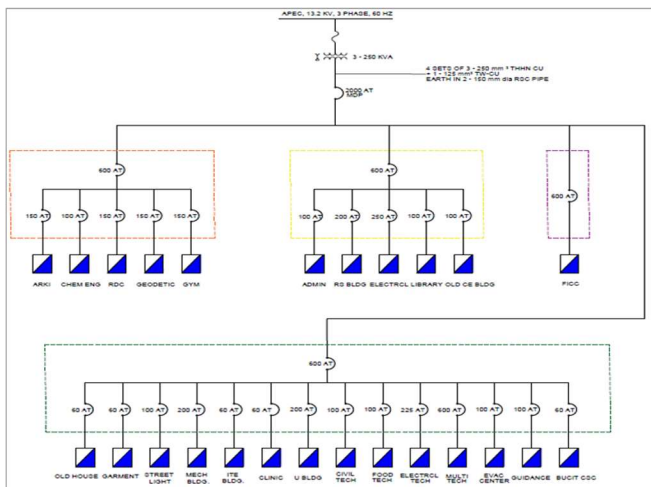
Figure 2. Existing Single Line Diagram of BU East Campus

Figure 2 shows the existing Single-Line Diagram (SLD) of the campus. It is currently connected to the 13.2 kV line of the Albay Power Electric Corporation (APEC), with a 3-250 kVA transformer. The distribution system is composed of four (4) feeders with 600 AT each line for protection.

1. The Main wires used as feeder lines for all feeders (which is 60 mm<sup>2</sup>) ACSR are all undersized if calculated based on the Total Connected Load.
2. In terms of Voltage Drop, Feeders 1, 2, and 4 have branches that does not comply with PEC standard even with the current load. Hence, it is inferred that with higher utilization factor, the whole system will experience under-voltage.
3. Old Buildings have poor Over-Current Protection Devices (OCPD).

1. The existing electrical system of BU East Campus is composed of four feeders being supplied by 3-250 kVA transformer, 13.2/0.240 kV, Y-Δ, 60 Hz system. The inventory result of Section 2.1.2 shows that the total connected load is 739.02 kW or approximately 870 kVA at 0.85 pf. With these, the existing transformer is deemed undersized;

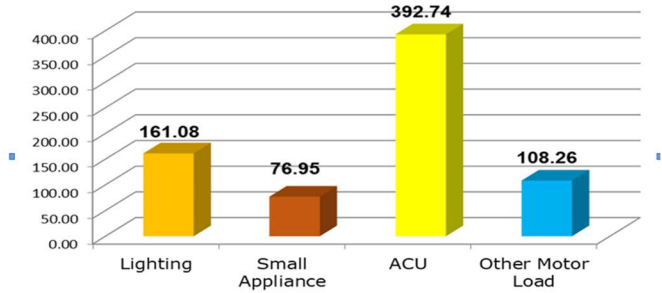
Figure 3. Total Connected Load by Load Type, in KW

Figure 3 shows the summary of loads by load type. The ACU system is the biggest load carried by the system with 392.74 kW of calculated load.

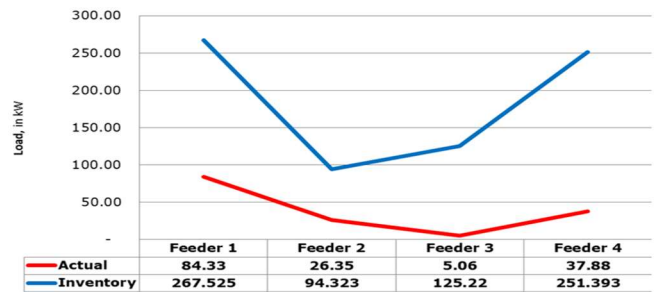
Figure 4. Connected Load VS. Actual Load Consumption

Figure 4 shows that the actual load of the feeders is lower than the calculated load based on the inventory of connected load, hence we can conclude that system is underutilized resulting to a very low utilization factor.

2. The utilization factor of the system is very low; this is concluded upon comparing the actual current measured during peak hours versus the total connected load (based on inventory);

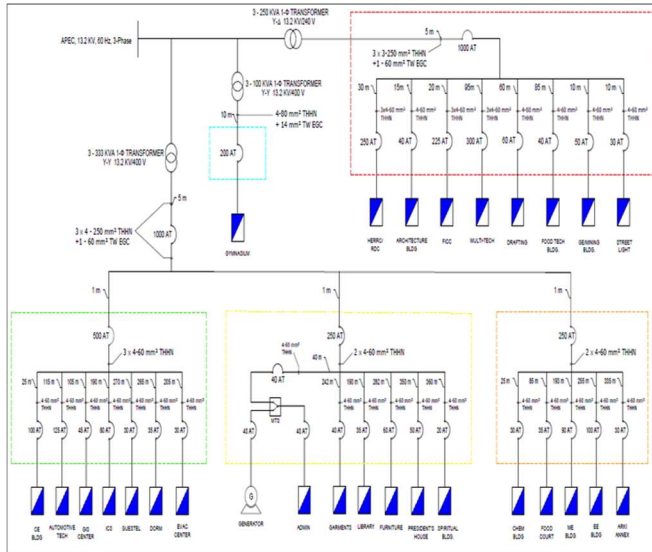
Figure 5. Connected Load VS. Actual Load Consumption

Figure 5 shows the single line diagram of the proposed electrical system based on the electrical calculations such as

Voltage Drop Computation, Short Circuit Analysis, OCPD calculation, and Arc Flash Analysis.

In the proposed design, the existing 3-250 kVA Transformer, located near the FICC Building, will supply most of the existing load and will have a 13.2/0.240 kV, Y-Δ system since this is the system used by the existing buildings. For the new buildings, the university opts for a 400 V, Wye-Wye, and three-phase electrical system. Hence, the proposed design will also include a system that operates in the said system. The new buildings will be supplied by 3-333 kVA Transformer, 13.2/0.230 kV, Y-Y, through Feeders 1 to 3.

In summary, the four (4) feeders will be operating in two separate systems. Feeders 1 to 3 will be operating at 13.2/0.23 kV, Y-Y system, and will serve most of the new buildings. While Feeder 4 will retain its 13.2/0.24 kV, Y-Δ system, and serve existing buildings.

3. Incorporating the said considerations, the proposed system is composed of three separate transformer banks connected to the local utility (APEC). Feeders 1 to 3, serving the North Side of the campus composed of the new buildings, are supplied by the proposed 3-333 kVA transformer, 13.2/0.400 kV, Y-Y, 60 Hz system. The existing buildings will form Feeder 4 that is supplied by the existing 3-250 kVA transformer, 13.2/0.240 kV, Y- $\Delta$ , 60 Hz system. The Gymnasium (Feeder 5) is served by the proposed 3-100 kVA 13.2/0.400 kV, Y-Y, 60 Hz system;
