Southern

West Virginia Community and Technical College
www.southernwv.edu

Master Plan

May 5, 2014

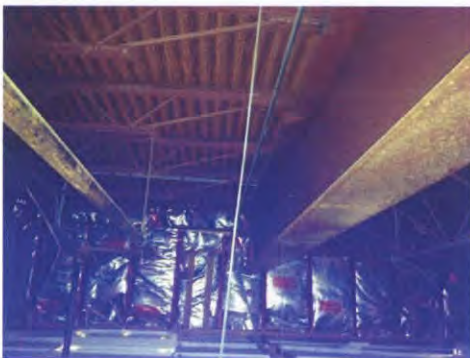
Deteriorated Steel

The roof structure consists of open web steel bar joists with metal decking. There are various leaks in the roof that have contributed to some minor deterioration of the metal roof deck in some areas. The rear storage structure roof consists of wood framing with metal corrugated roof decking. There are some signs of water damage to the wooden roof members in the storage area. The building structure falls under a seismic design category B according to the current 2012 International Building Code which West Virginia has adopted. While the structure can withstand some seismic loads, it is not clear if the design accommodates loads according to the current building codes.

1. Clean and repair any deteriorated roof structure members that have been subjected to water damage.
2. Repair any exterior concrete that has been subjected to soil erosion.

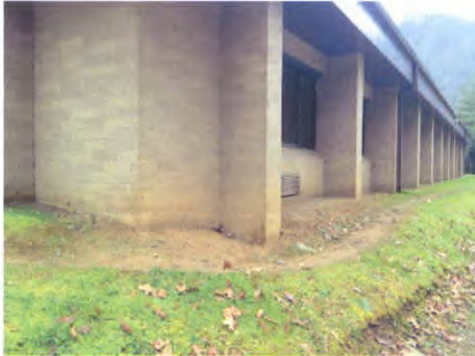
The overall structural system consists of load bearing masonry walls with structural steel and open web steel joist framing. The foundations were not visible and there were no structural drawings available to verify the foundation construction. There are some signs of soil erosion around the building perimeter. A concrete pad located on the northeast side of the building beside the garage door is showing signs of undermining.

Soil Erosion

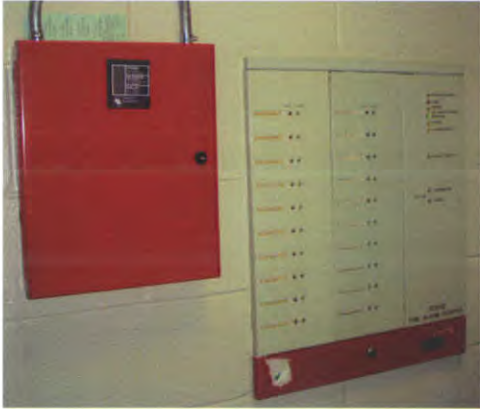
All of the campuses fire alarm systems are tied into one main fire alarm control panel located on the first floor corridor wall of Building A. The fire alarm control panel is an Edwards General Signal with a Honeywell Silent Knight backup battery. The Computer Center room, located on the first floor, uses a dry fire suppression system. All emergency lighting and the data center are on a Kohler 80kW, 3 phase, 480/277V natural gas generator. The elevator does not have backup power. The Exit signs

Fire Alarm Control Panel

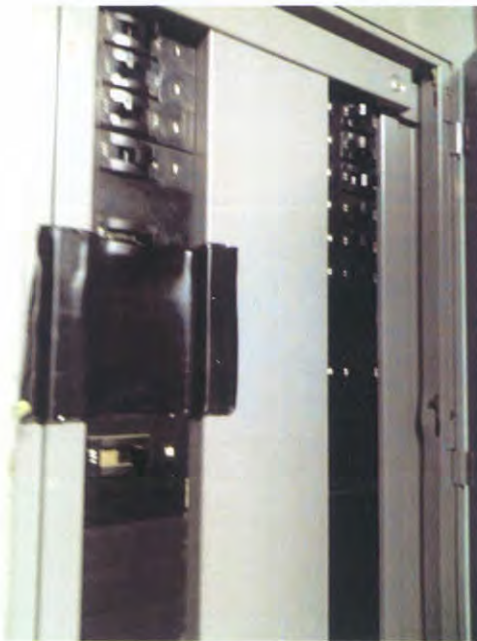
Panel 'C' Main Electric Room

The electrical service for the building is fed underground via a pad mounted transformer to the service meter located in the main electrical room. With the moving of the TV station to the Williamson campus the overall electrical load has been lightened. The electric service is 1200 amps which appears adequate for the buildings need. Some panels that have had loads removed do not have updated panel schedules and taped covers were breakers are removed. The MDP (Main distribution panel) was rebuilt after an internal electrical fire caused by the old service transformer two years ago. The MDP is in fair condition with no notable damage. In the modular classroom the power poles that are utilized in some of these locations are falling apart making them unsafe.

1. Create new accurate panel schedule labeling all loads, spare breakers and available space.
2. Install blank space covers on panels where breakers have been removed.
3. Install weather covers on all exterior receptacles.
4. Replace all power poles with new a dual channeled portable power poles for both data and electric connections.

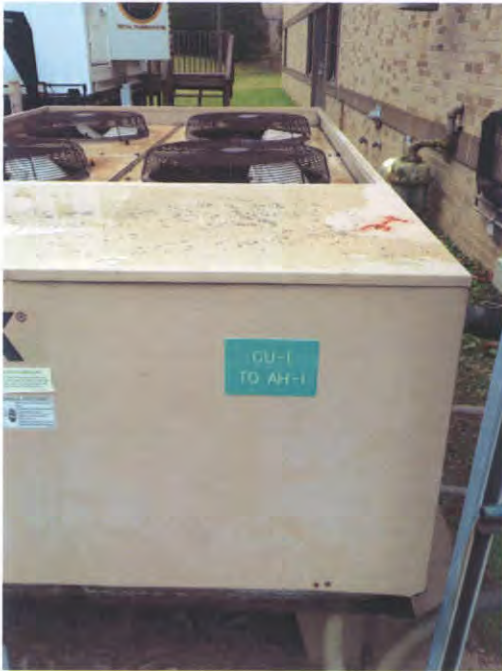
DX Condenser

Replace the existing split DX refrigerant condensing unit and cooling coil for the AHU. The refrigerant system and components have been experiencing operational issues that need to be addressed. There is a Carrier Aquasnap, approximately 125 ton chiller located outside building 'B' that currently serves only building 'C'. During the construction of Building C and the installation of that chiller, underground chilled water piping was provided to Building 'B.' It is suggested to investigate the chiller and its capacity related to Building 'B' and 'C', provide chilled

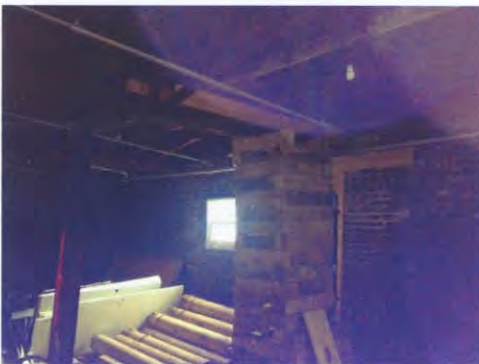
Temporary Shoring

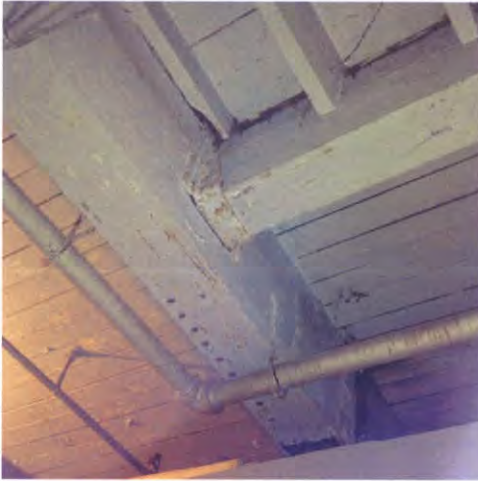
Inoperable Sprinkler System

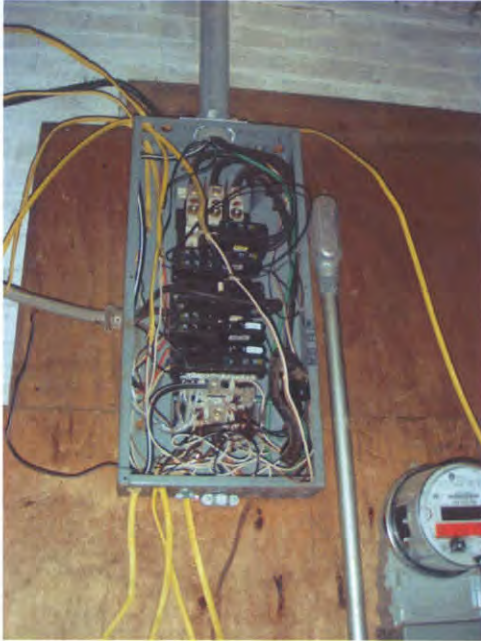
Exposed Panel/Exposed Wiring

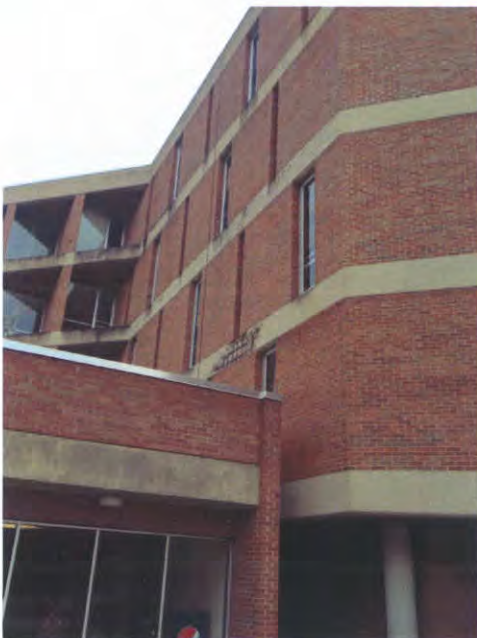
Exposed Reinforcing Steel

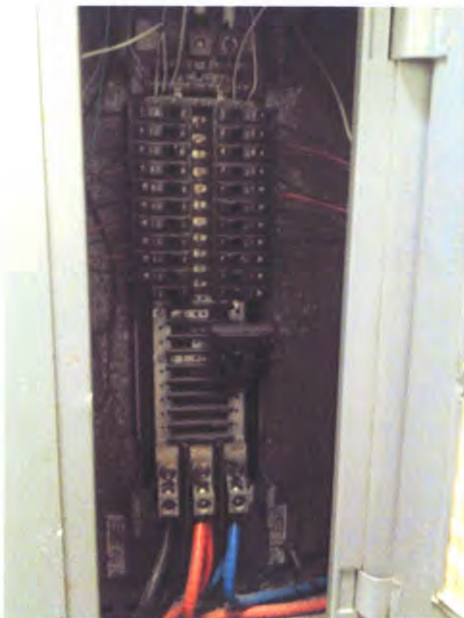
Exposed Panel Wiring

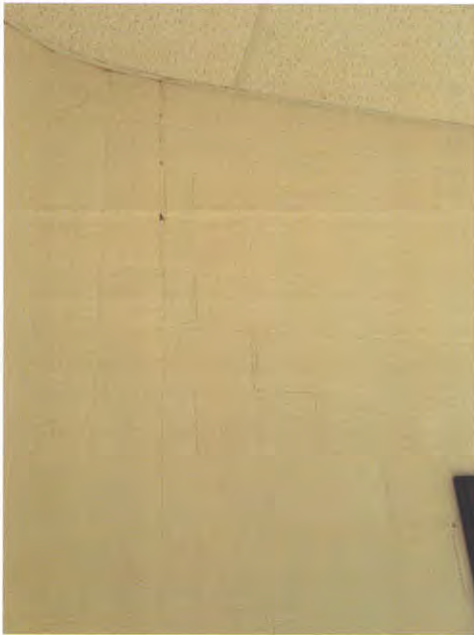
Masonry Damage

masonry blocks. The masonry walls also serve the purpose of resisting the lateral loads for the building. There are various cracks in the masonry walls throughout the structure. The ground floor is a concrete slab on grade. Various cracks in the concrete slab on grade were observed in the areas where it was visible. The floor tiles in several locations were cracked indicating the underlying concrete slab may also be cracked. The loads applied to the floors appear to be consistent with typical educational and administrative loadings. The roof structure consists of open web steel bar joists with metal decking. There were several locations in the roof where signs of water leaks were observed.

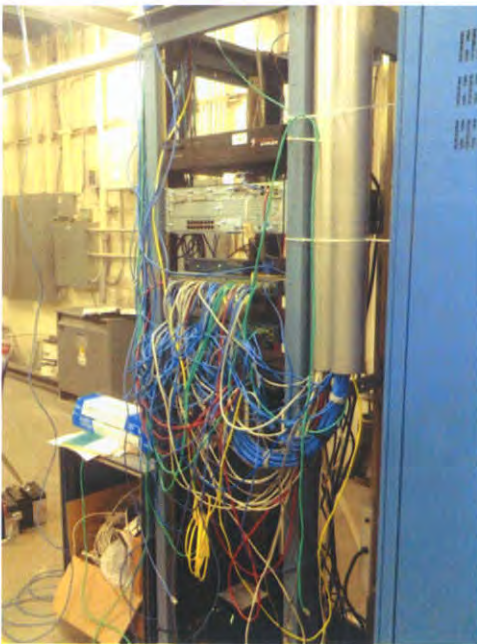
Lack of Cable Management

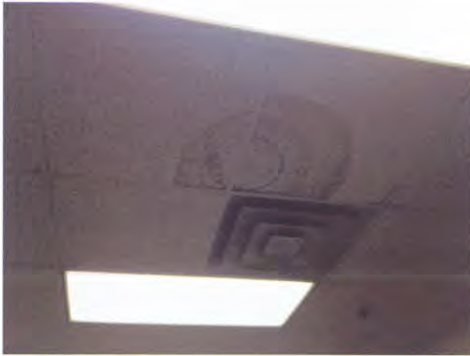
Ceiling Damage

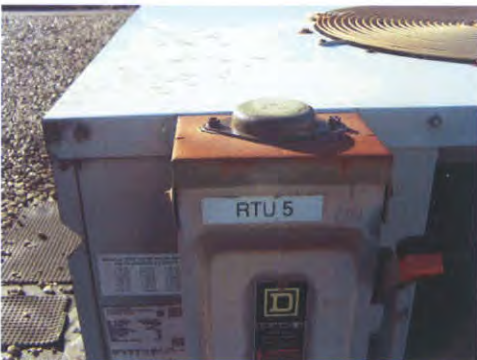
1997 Rooftop Unit

location. The RTUs were installed in 1997 and appear to be reaching the end of their expected service life (15-20 years). The Science Lab exhaust fans for the containment hoods also appear to be reaching the end of their service life.

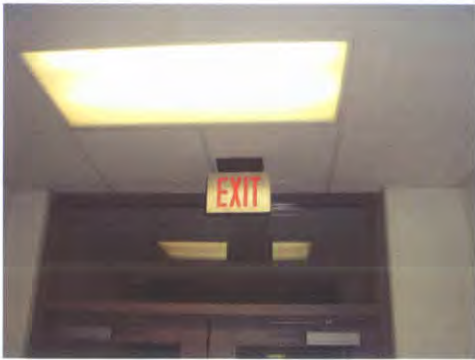
'Yellowing' Lenses

and some classrooms have 2x4 T12 recessed troffers. Most of these troffers have yellow stained parabolic lens. The commons area lighting has both suspended indirect fixtures and recessed fixtures both lamped with metal halide bulbs.
