## PROPERTY INSPECTION REPORT

**Concerning:** 11619 Dunlap St. Houston, Texas 77035

**Inspection Date:** 10/23/2012

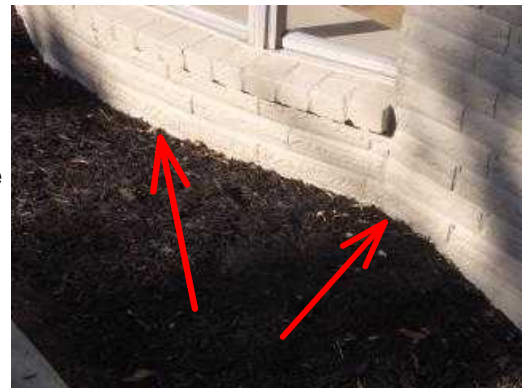
However, high soil/mulch was noted at the back flower bed (see photo). A 5 to 7 inch clearance between the soil and the top of the slab is adequate. Clearances less than this range create conditions considered conducive to termite infestation and moisture penetration.

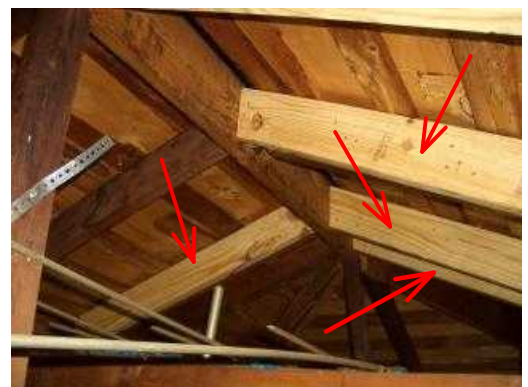
Additional 2x6 members have been added alongside existing members to add support where there were gaps between some of the rafters and the ridge board (see photo).

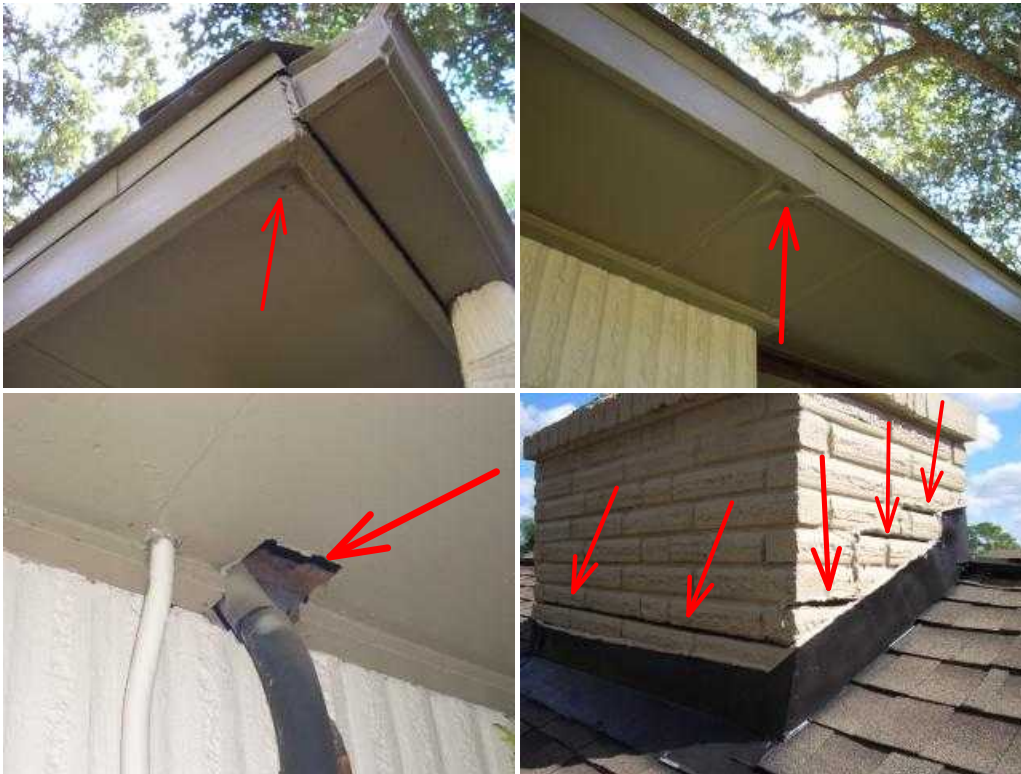
However, some sections of the soffit boards have deteriorated. These areas have been painted over and need to be repaired/replaced. These areas are generally located at corners or under splices in the fascia boards. See photos taken at the soffit panel at the southwest corner of house and at the panel located in the middle of the front of the roof.

I also recommend properly sealing the soffit around the point where the air conditioning refrigerant lines enter the eave at the south side of the house (see photo).

Some gaps were noted in the mortar joints in the exterior masonry chimney (see photo). They appear to be from where old step flashing has been removed. The gaps do not appear to penetrate all the way to the interior of the structure, but you may wish to have these gaps re-pointed to ensure proper sealing.

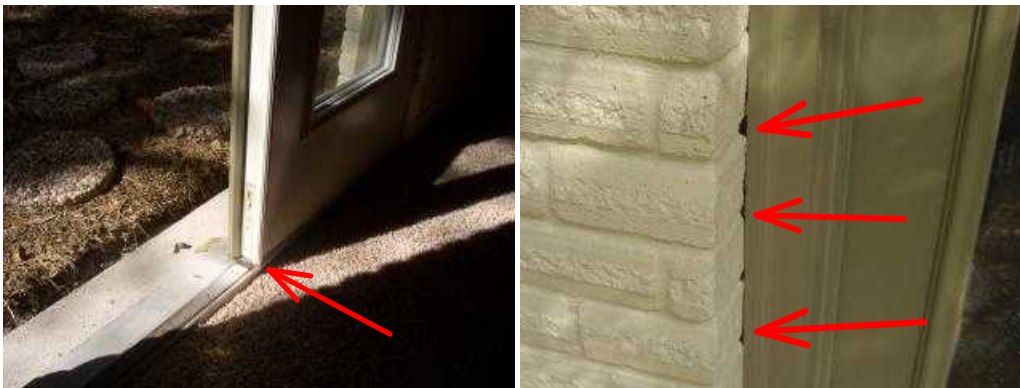
I recommend properly sealing the small gaps at the perimeter edges of the back door at the southeast corner of the house (see photo).

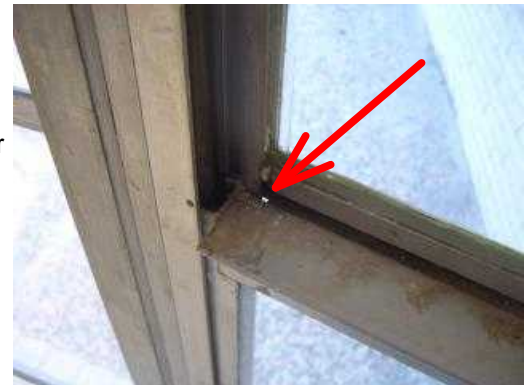
A few small gaps were noted at the corners of the sashes in the living room bay windows (see photo).

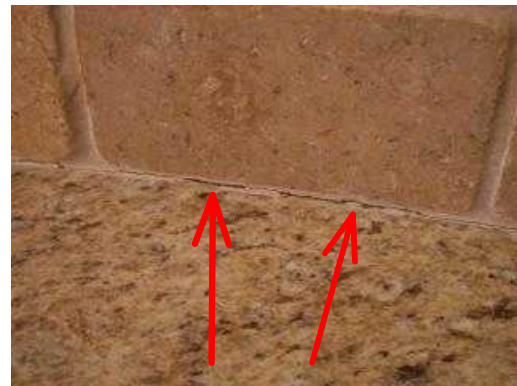
- ☒☐☐☒ **L. Other** - Comments: I recommend properly sealing the gaps in the grout line where the kitchen counter tops meet the back splashes (see photo).

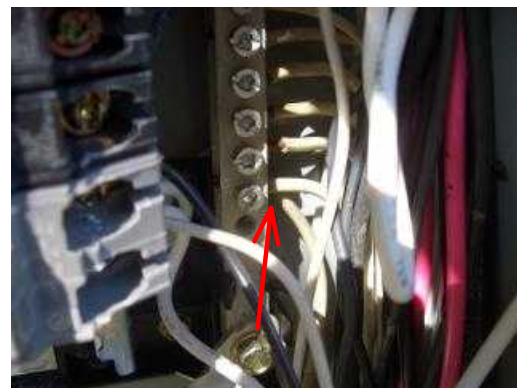
However, it was noted that two of the neutral wires have been improperly double-tapped on the neutral bus bar with two wires secured under one contact (see photo). Neutral wires should be secured individually with only one wire per contact.

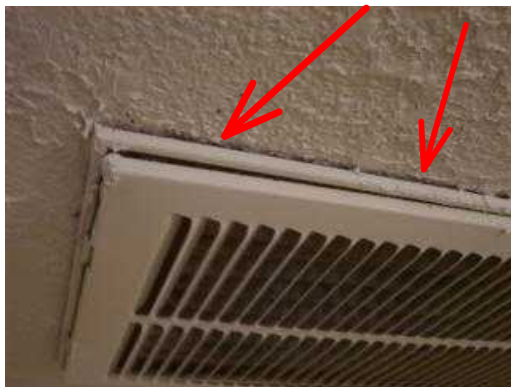
However, I recommend sealing the small gaps around the outer edges of the air return grills (see photo).

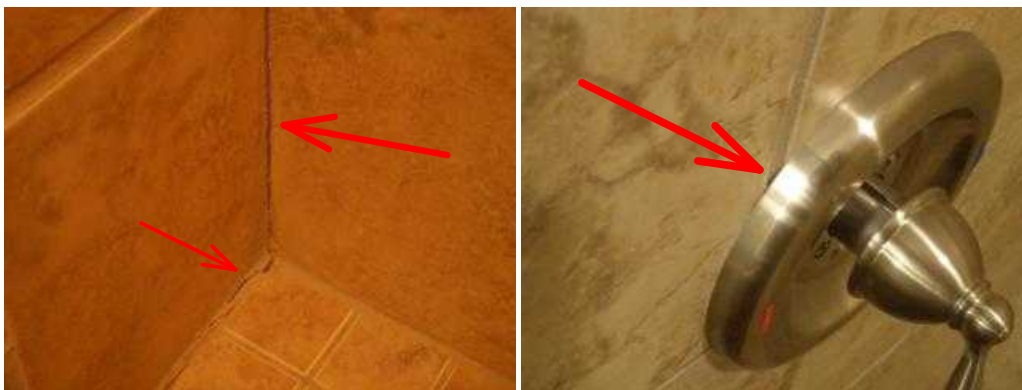
Small gaps were noted in the corners of the tile shower enclosures in the bathrooms (see photo). Properly seal.

Ensure that all gaps at the escutcheons (where the plumbing penetrates the shower/tub enclosures) of the tub faucets, handles, and shower heads in the bathrooms are properly sealed (see photo).

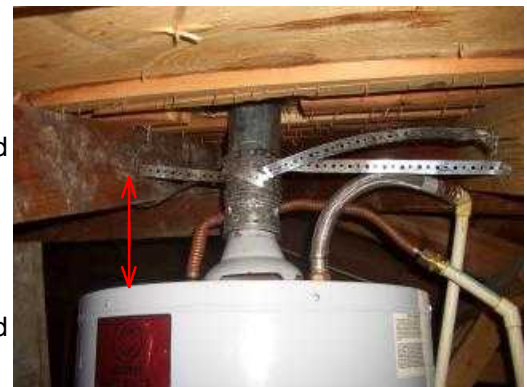
However, it was noted that the wooden rafters and decking are less than 12" above the top of the tank (see photo). It also appears that the total height of the exhaust vent stack (inside the attic and above the roof surface) is less than 5' total. I recommend installing the unit as per manufacturer's specifications.

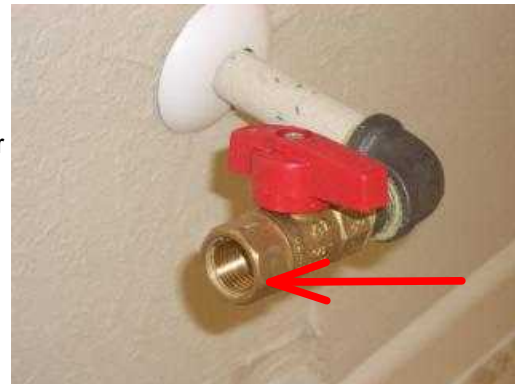
I recommend capping the natural gas supply outlet in the laundry room unless a gas fired dryer is going to be installed (see photo).

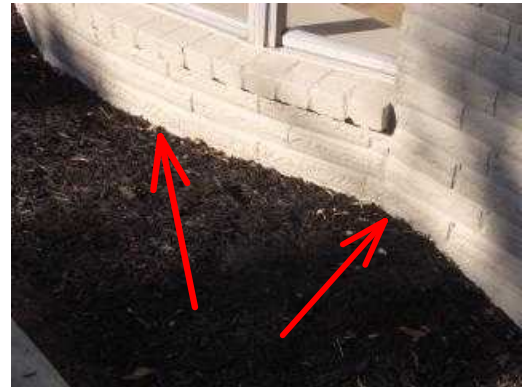
However, high soil/mulch was noted at the back flower bed (see photo). A 5 to 7 inch clearance between the soil and the top of the slab is adequate. Clearances less than this range create conditions considered conducive to termite infestation and moisture penetration.

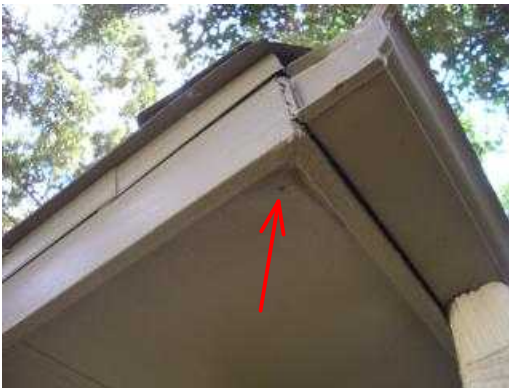
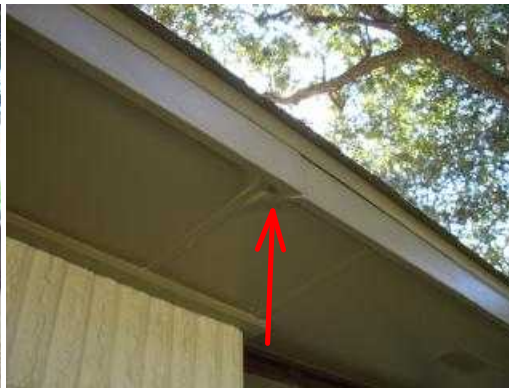
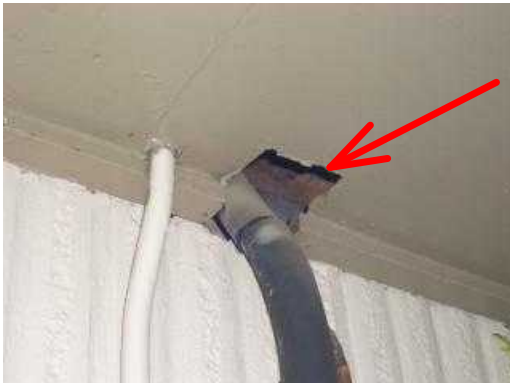
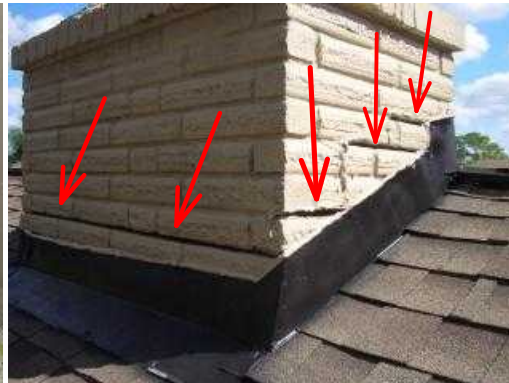
However, some sections of the soffit boards have deteriorated. These areas have been painted over and need to be repaired/replaced. These areas are generally located at corners or under splices in the fascia boards. See photos taken at the soffit panel at the southwest corner of house and at the panel located in the middle of the front of the roof.

I also recommend properly sealing the soffit around the point where the air conditioning refrigerant lines enter the eave at the south side of the house (see photo).

Some gaps were noted in the mortar joints in the exterior masonry chimney (see photo). They appear to be from where old step flashing has been removed. The gaps do not appear to penetrate all the way to the interior of the structure, but you may wish to have these gaps re-pointed to ensure proper sealing.

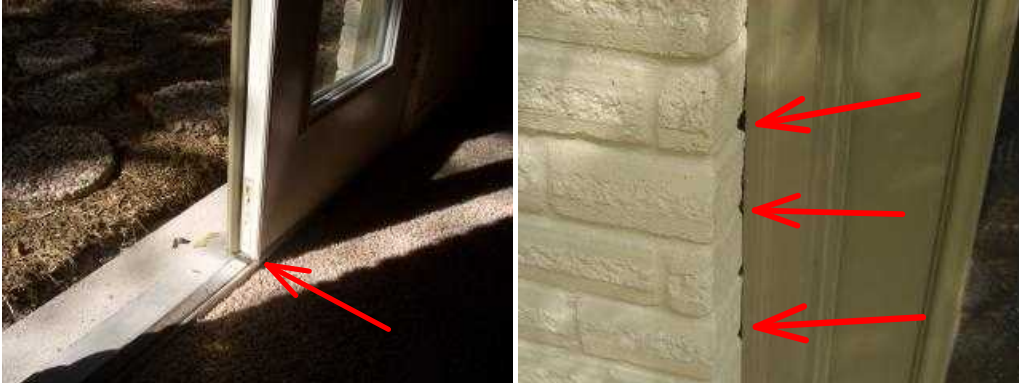
I recommend properly sealing the small gaps at the perimeter edges of the back door at the southeast corner of the house (see photo).

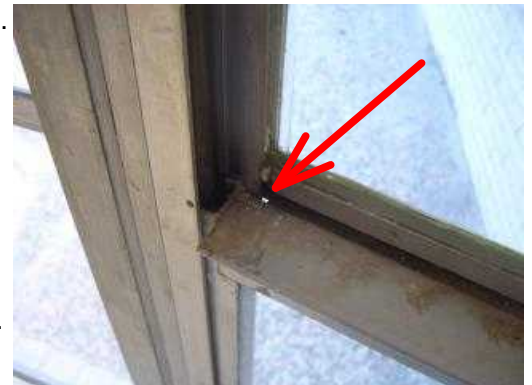
A few small gaps were noted at the corners of the sashes in the living room bay windows (see photo).

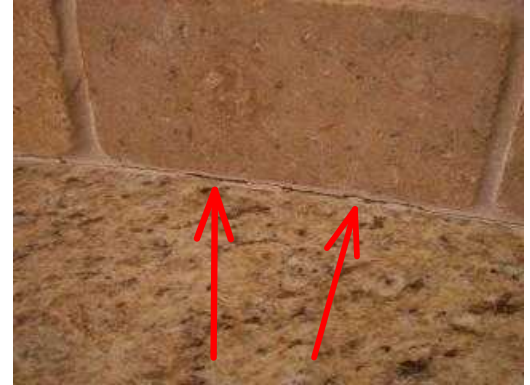
- L. Other I recommend properly sealing the gaps in the grout line where the kitchen counter tops meet the back splashes (see photo).

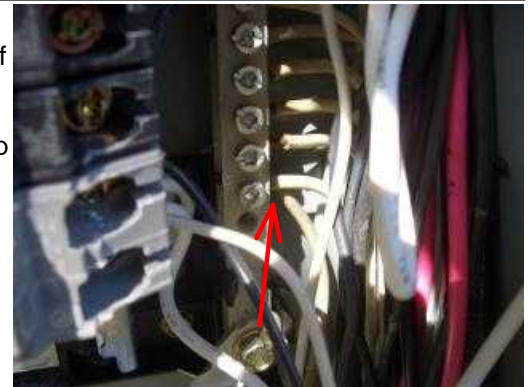
However, it was noted that two of the neutral wires have been improperly double-tapped on the neutral bus bar with two wires secured under one contact (see photo). Neutral wires should be secured individually with only one wire per contact.

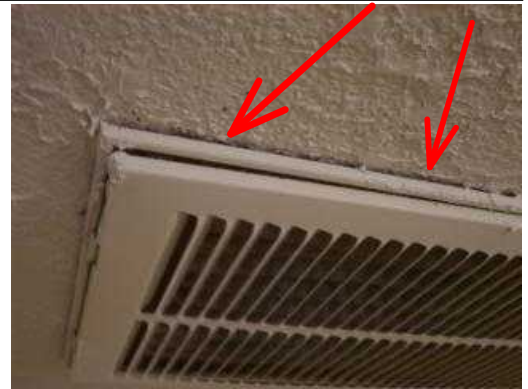
However, I recommend sealing the small gaps around the outer edges of the air return grills (see photo).

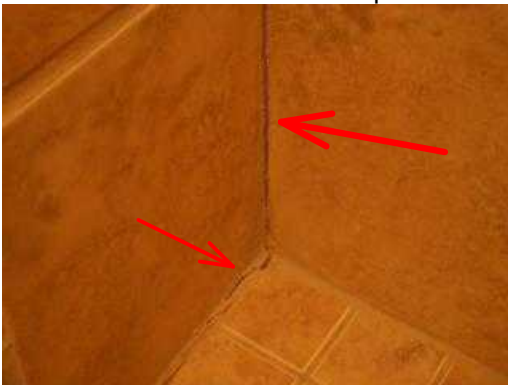
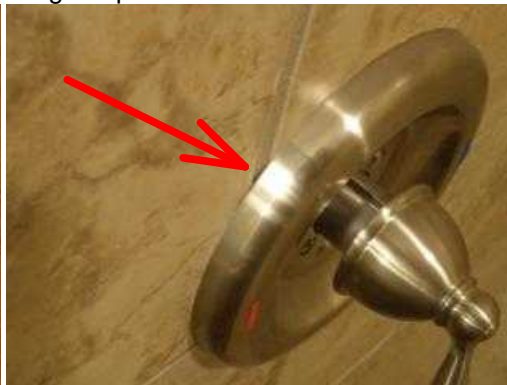
Small gaps were noted in the corners of the tile shower enclosures in the bathrooms (see photo). Properly seal.

Ensure that all gaps at the escutcheons (where the plumbing penetrates the shower/tub enclosures) of the tub faucets, handles, and shower heads in the bathrooms are properly sealed (see photo). Location of water meter: At the southwest corner of the lot. Location of main water supply valve: In the interior wall of the middle (south) bedroom. Static water pressure reading: 55 psi.

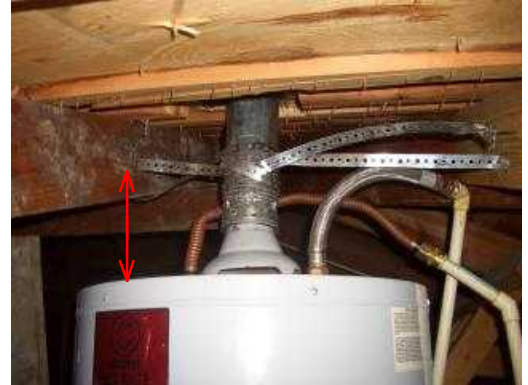
However, it was noted that the wooden rafters and decking are less than 12" above the top of the tank (see photo). It also appears that the total height of the exhaust vent stack (inside the attic and above the roof surface) is less than 5' total. I recommend installing the unit as per manufacturer's specifications.

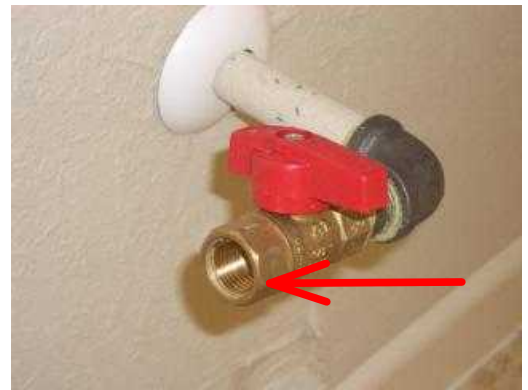
I recommend capping the natural gas supply outlet in the laundry room unless a gas fired dryer is going to be installed (see photo).
