Property Inspection Report: 11619 Dunlap

PROPERTY INSPECTION REPORT

Concerning: 11619 Dunlap
(Address or Other Identification of Inspected Property)

July 3, 2012
(Date)

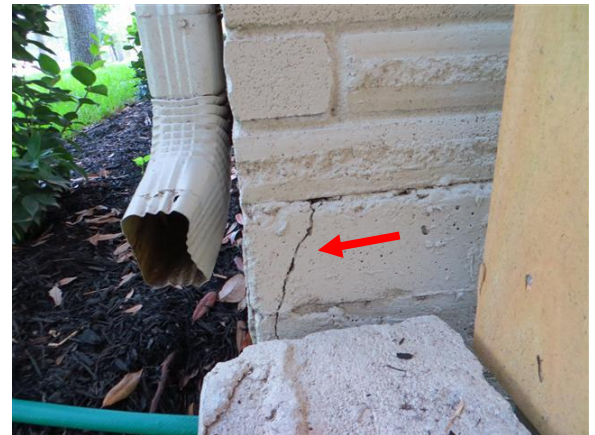
Spalling (i.e., corner pops) observed at one or more corners of the slab. Spalling at corners typically occurs due to different thermal expansion rates between the wall and foundation. The foundation reinforcement does not extend into the corners, which often develop wedge shaped cracks. These cracks are common and do not affect foundation performance.

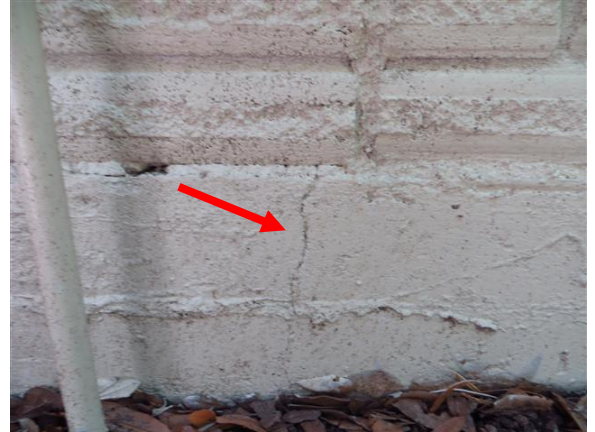
Observed one or more cracks in foundation.

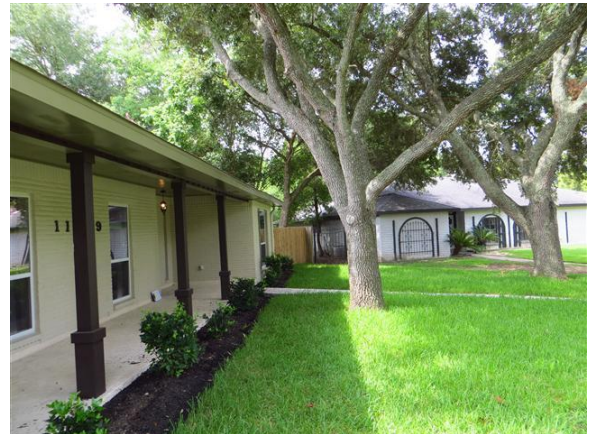
Large tree(s) near house foundation. Large trees draw significant amounts of moisture from the soil which can affect foundation performance in areas with expansive soils.

Soil conditions in this area are known to be unstable. We recommend a program of conscientious watering of the soil in close proximity to the foundation to help maintain consistent moisture content and thus stabilize foundation movement caused by soil expansion and contraction.

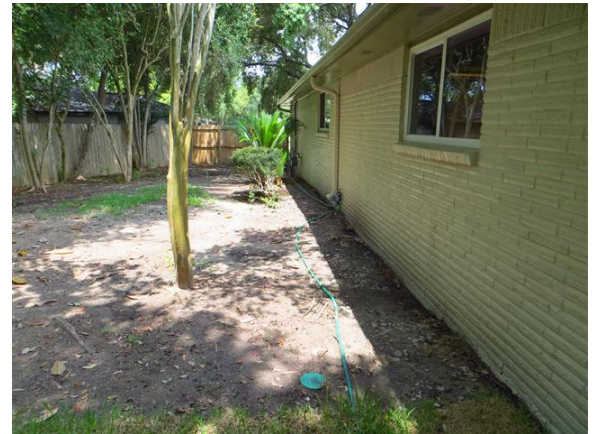
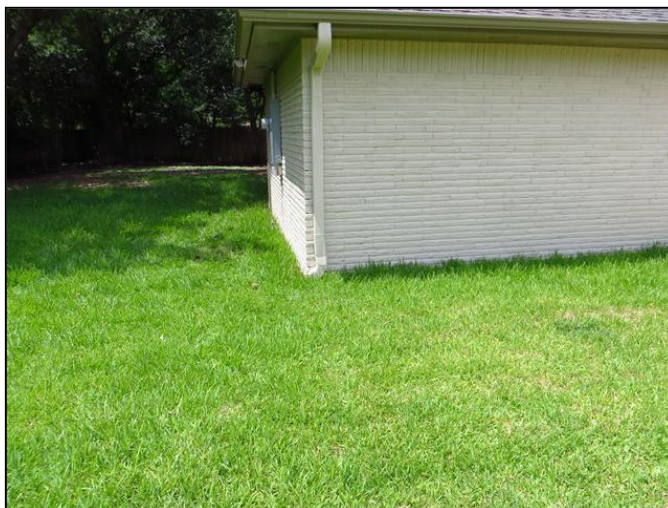
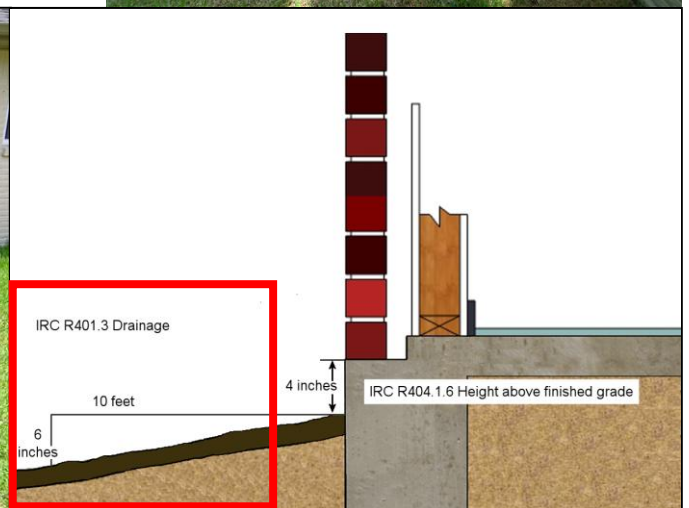
Soil grade and drainage patterns around some areas of house do not appear to properly direct water away from foundation to aid in controlling runoff water at rear and south.

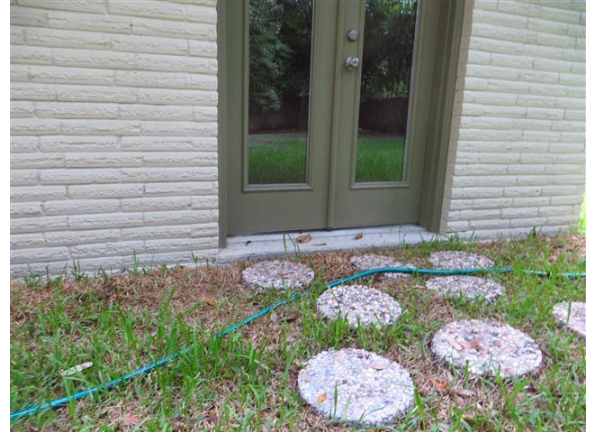
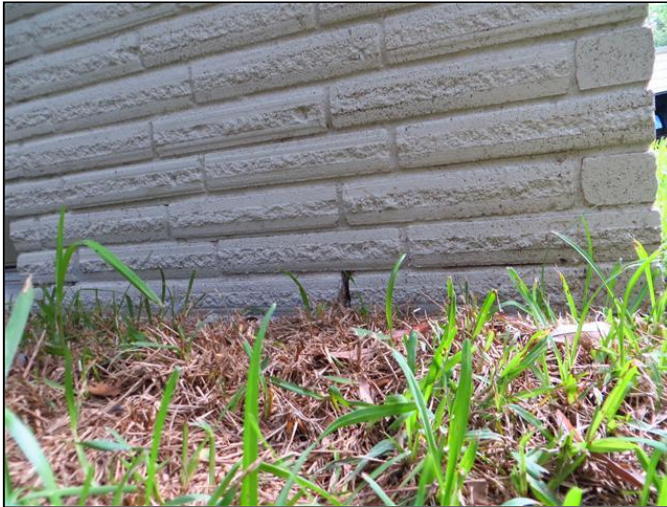
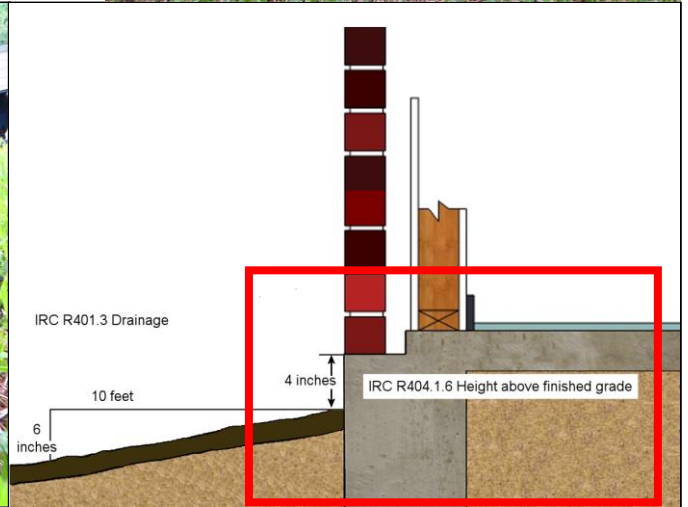
✂✂ The soil level is too high on the slab below masonry siding at rear and south. As a result, splash-back (during rainstorms) and upward migration of water from the adjacent ground can lead to rot and facilitate insect intrusion in this area. Regular maintenance and monitoring of this area are recommended. A best practice is to keep at least 4 inches of the slab edge exposed below masonry.

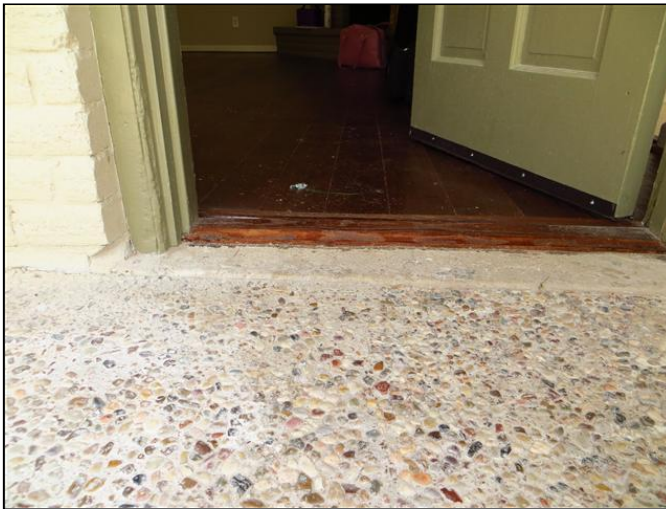
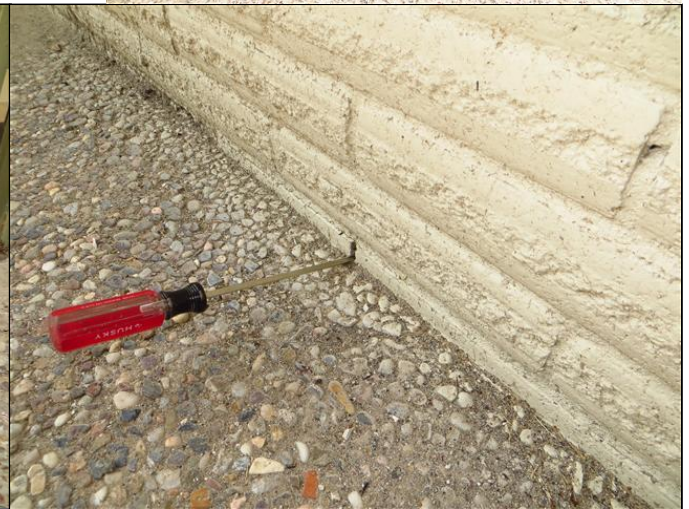
✖ Rear patio does not slope properly away from house and is or above interior floor elevation. Weep holes in brick wall are actually below the patio surface. This condition greatly increases the potential for water penetration during heavy wind-driven rains.

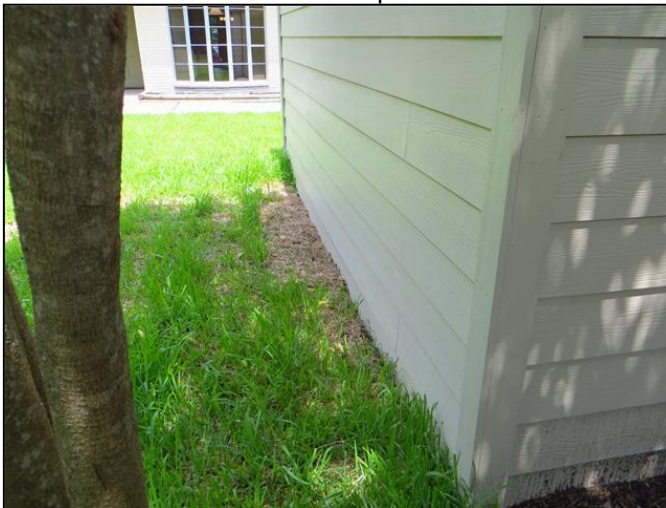
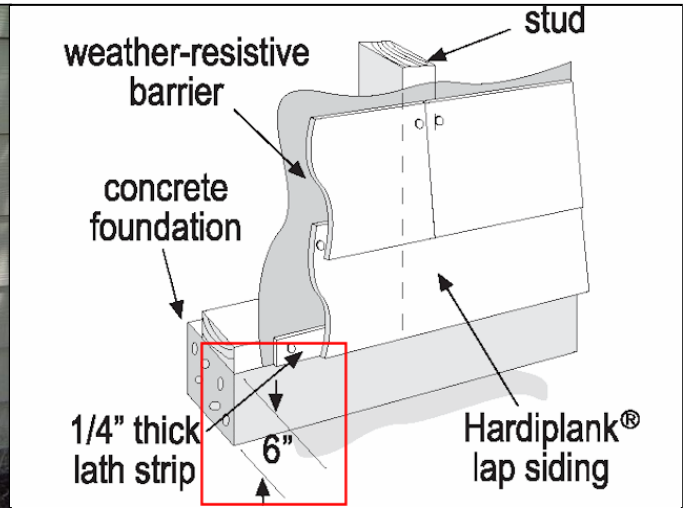
✖ Soil level is too high near Hardi-plank siding at carport storage room. This condition promotes wood rot and is conducive to termite activity. The manufacturer specifies that a minimum 6 inch clearance be maintained

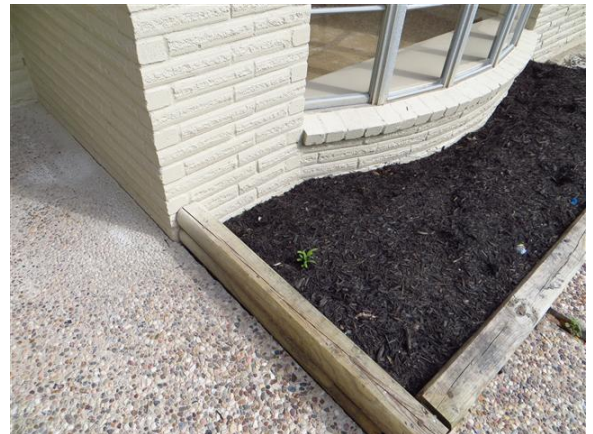
✘ Mounded flower beds and/or perimeter bricks/timbers may hold water near house (rear).

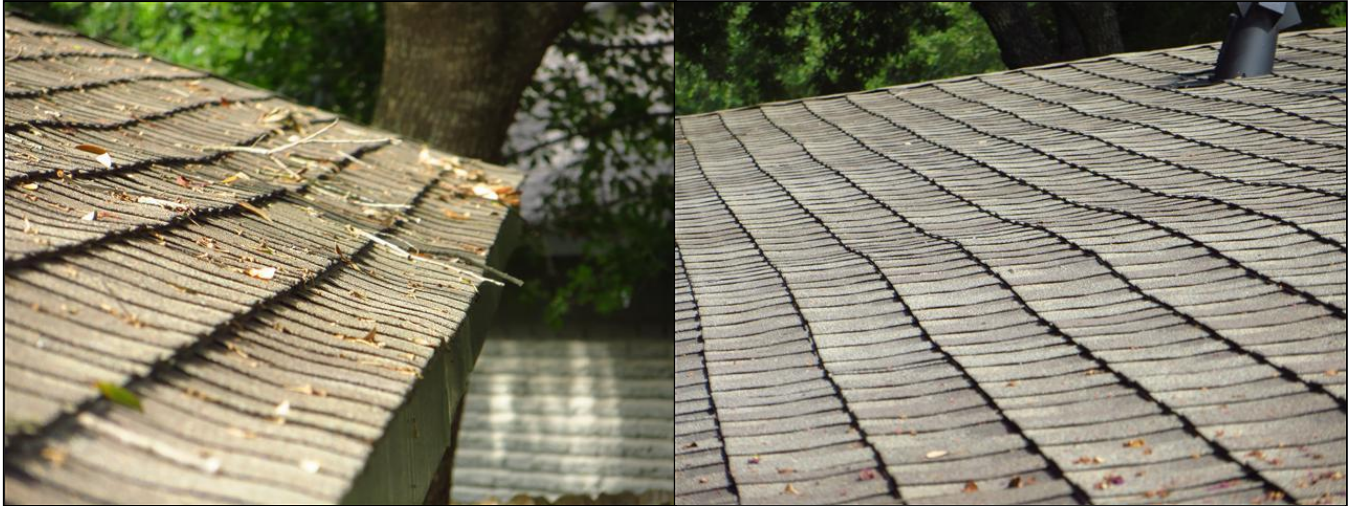
✂ Observed sag(s) in roof decking. Probably due to improper or inadequate framing in attic. Recommend proper installation of purlins with bracing down to load bearing walls to correct or arrest further sagging of roof

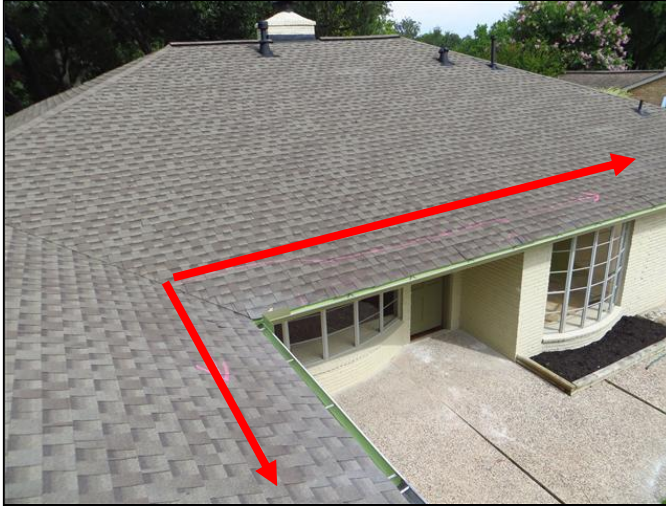
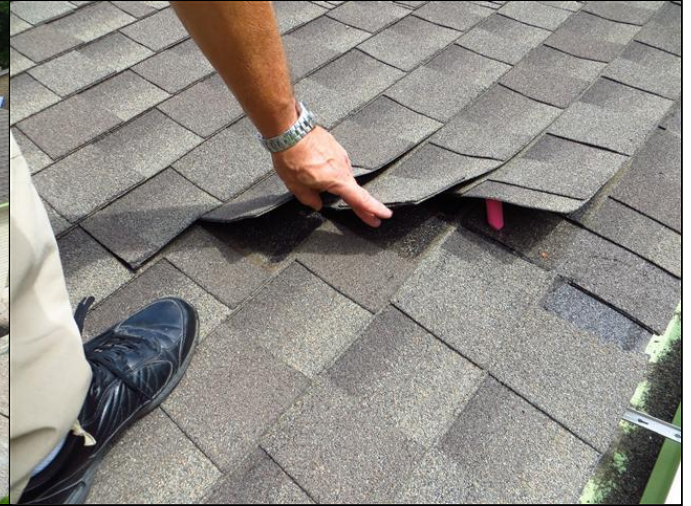
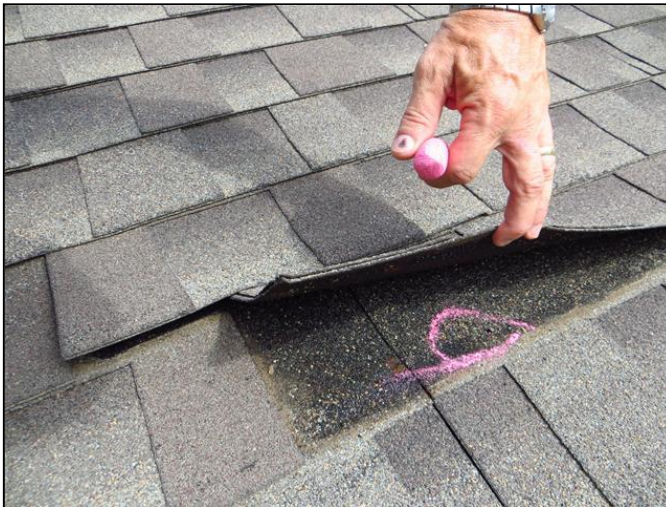
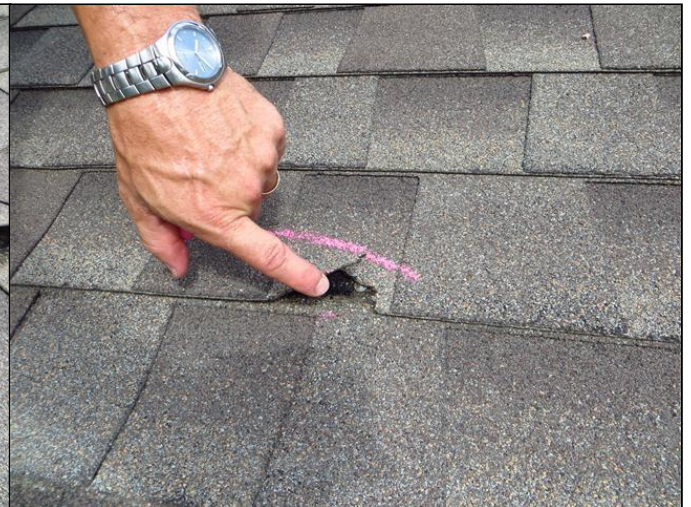
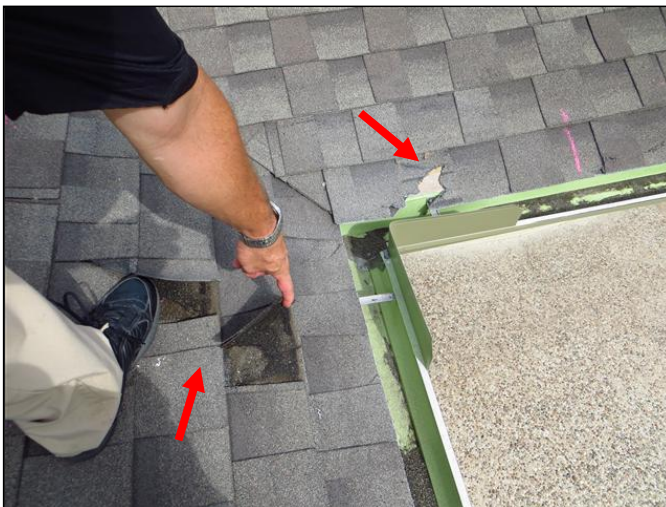
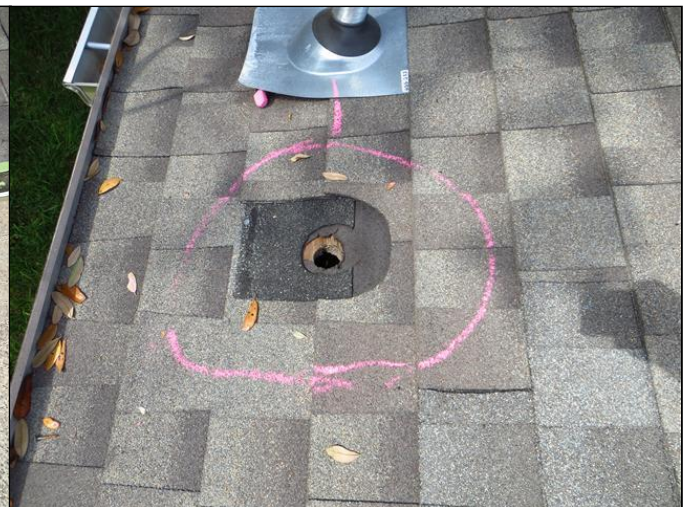
✂✂✂ Observed numerous areas of deficient roof shingles and damaged areas affecting a large portion of the roof covering, including but not limited to: torn or damaged shingles; shingles not bonded; holes in the roof decking, etc.

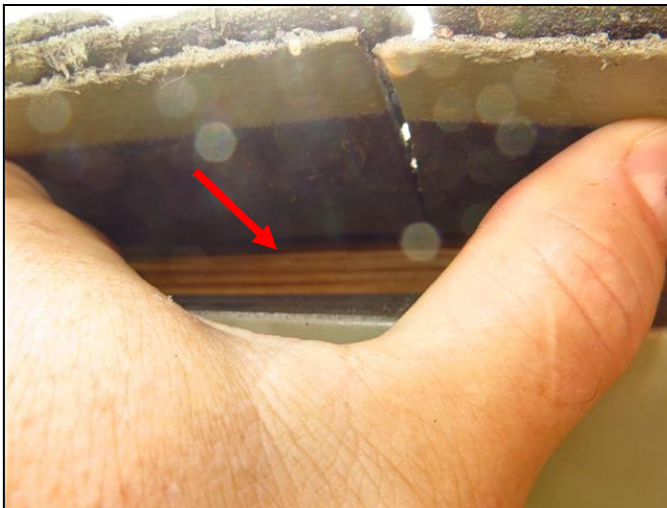
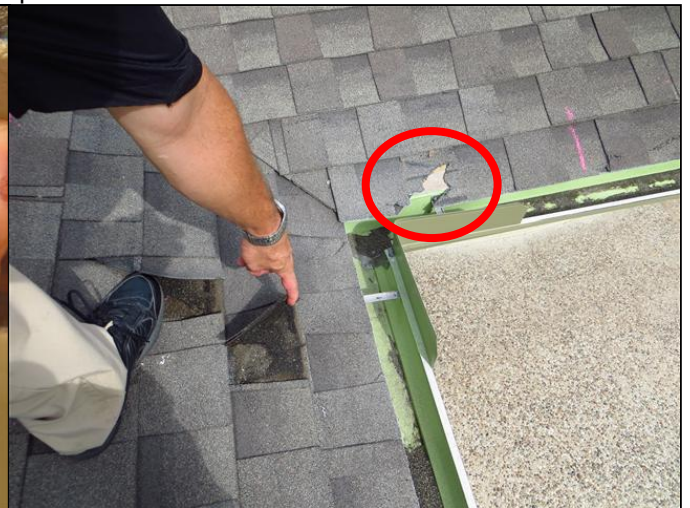
✂✂ Random inspection for proper installation of felt below shingles revealed no felt paper below the shingles. This installation does not comply with the manufacturer's installation standards or Asphalt Roofing Manufacturers Association recommended practices.

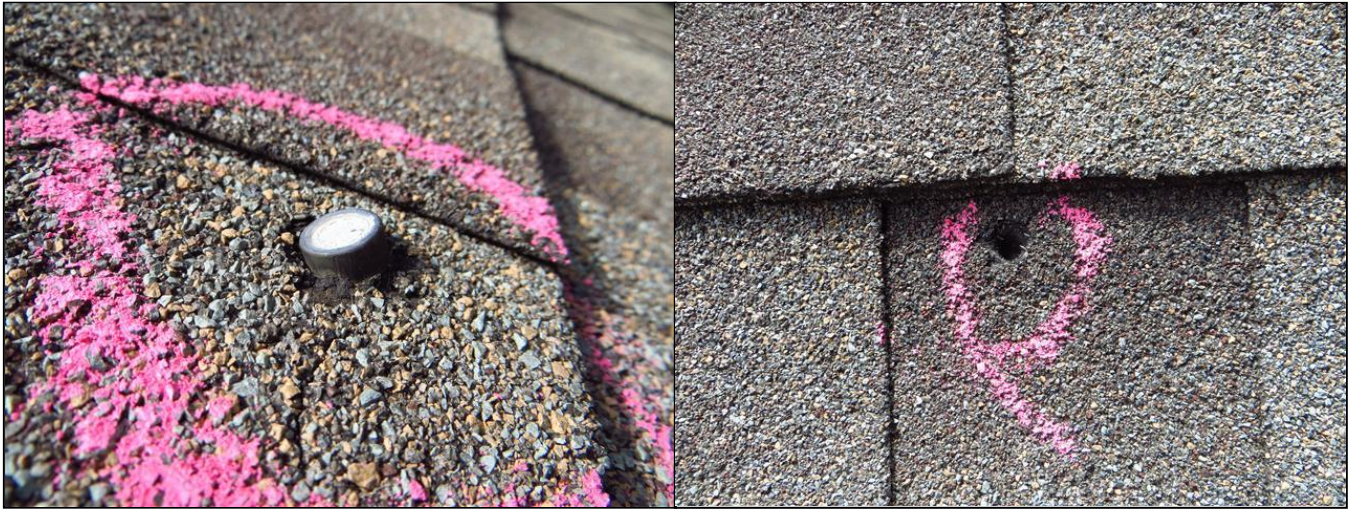
✂ Observed one or more bullets and/or bullet holes in roof surface.

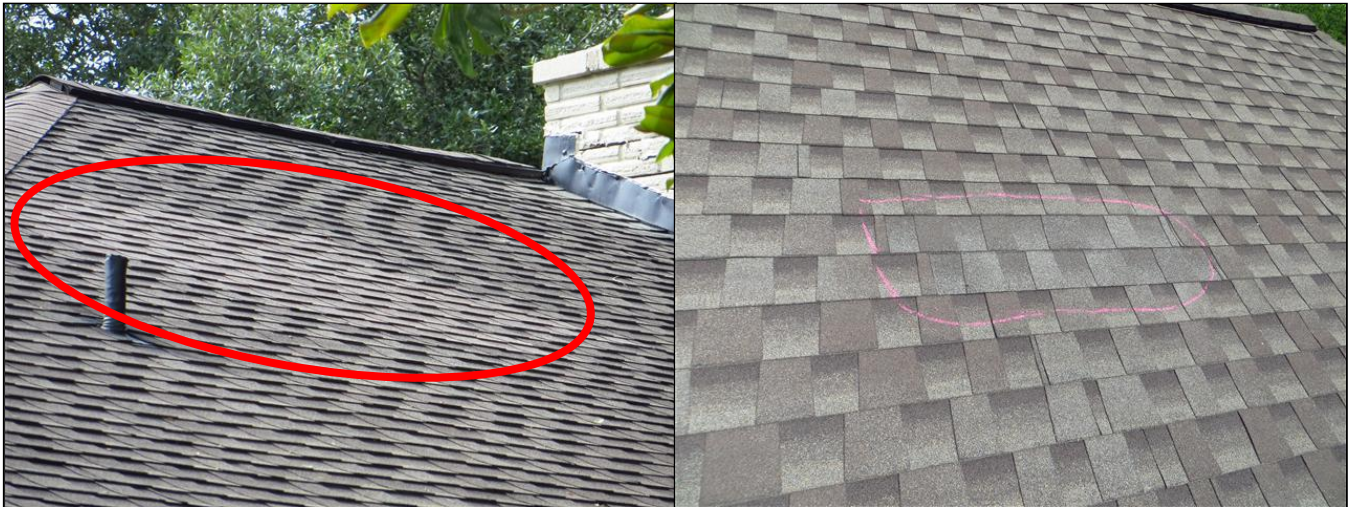
👁 Observed multiple repairs to roof surface.

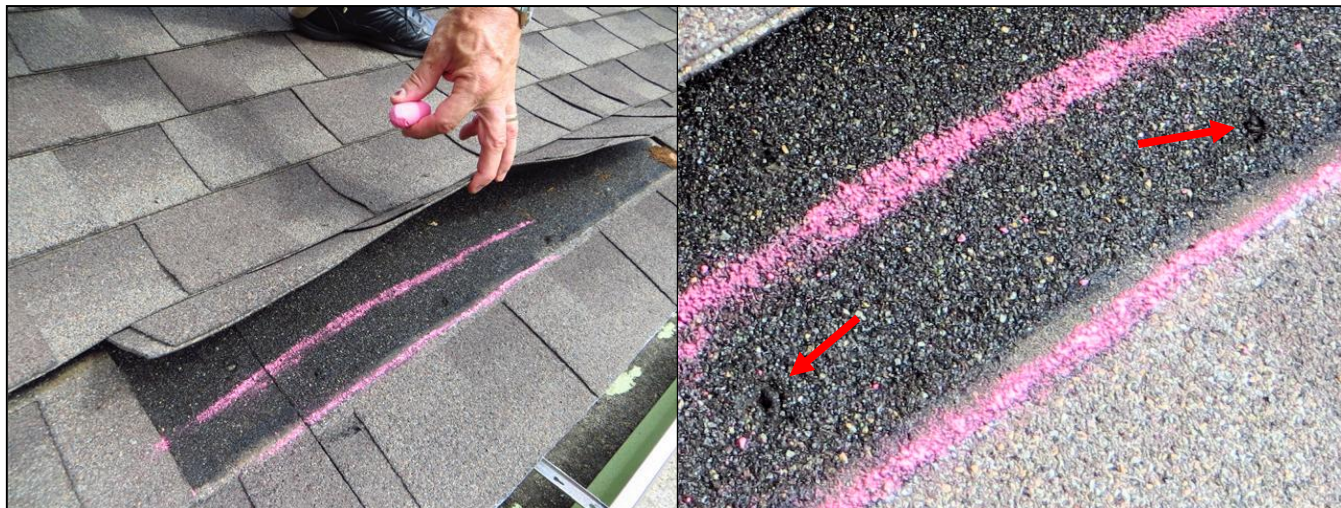
Proper and improper nailing.

✂✂✂ Spot check of roof fasteners (e.g., nails, etc.) indicated improper roof fastener installation. Fasteners appear to be over driven and / or driven at an angle which causes the nail to cut into the shingle and substantially reduces the shingle's ability to remain secured during high winds. Some shingles show full tear through of nail heads and are not secured to the roof. Some show signs of slippage down the roof surface at rear.

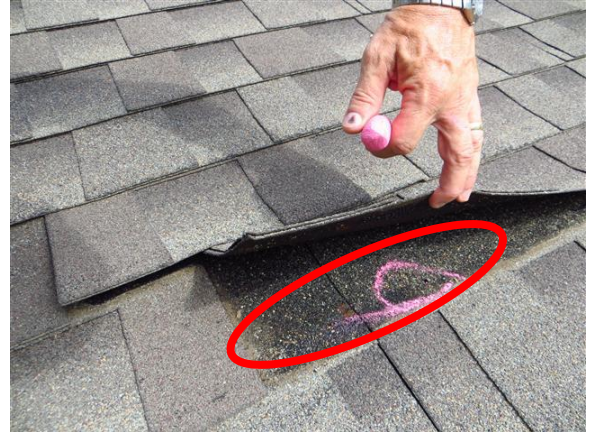
✖ Spot check of roof fasteners (e.g., nails, etc.) indicated an inadequate number of roof fasteners are installed. A minimum of 4 fasteners are required for each full tab and a minimum of 2 fasteners for each short piece. In 110 mph wind zone areas 6 fasteners should be used for each full tab.

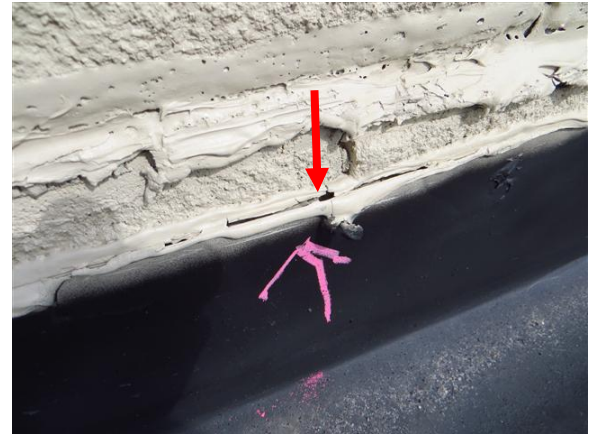
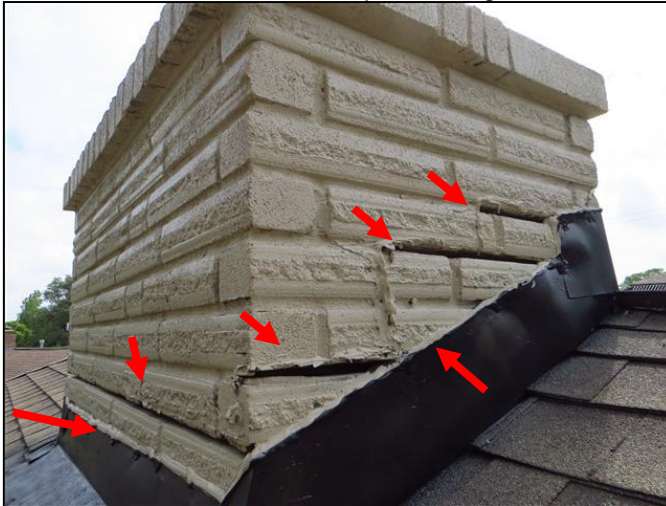
✖✖✖ Counterflashing is inadequately sealed, pulling away or missing from masonry chimney or wall. Counterflashing should be let-into into the brick or masonry a approximately 1¼ inches with and bead of high quality caulk placed along the top edge of the flange to keep water out. Surface application of flashing is an inferior method which depends entirely on the caulk joint to keep water from penetrating behind the flashing,

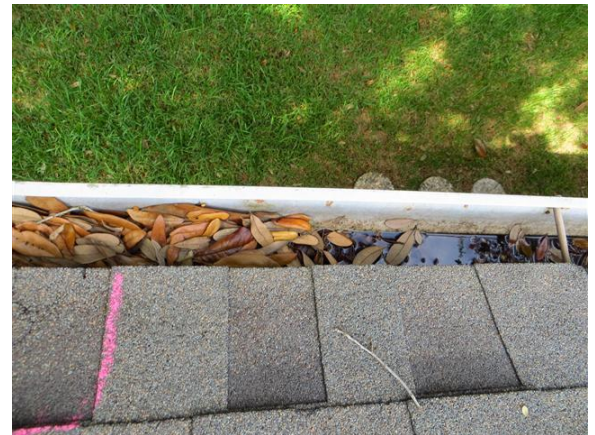
✂ Gutters are in need of general maintenance such as: cleaning out debris; re-securing gutters to fascia; tilting gutters toward drains, sealing leaks, etc.

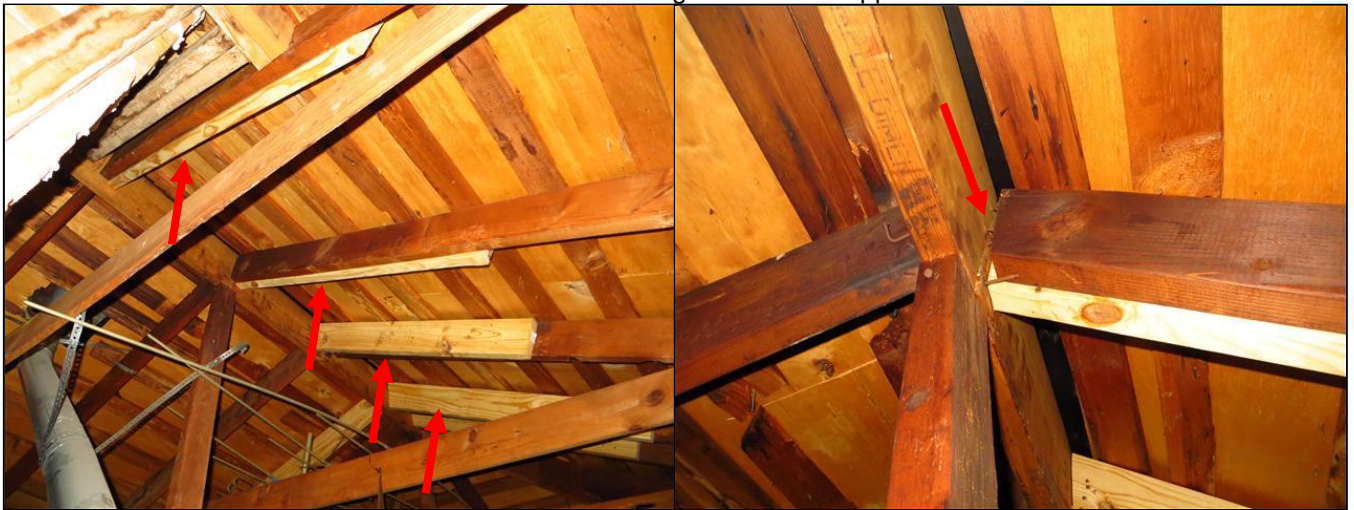
Observed separation of rafters from ridge at several locations, possibly due to structural movement. Observed improper repairs using scab lumber. Repair pieces should extend from the ridge down to a support.

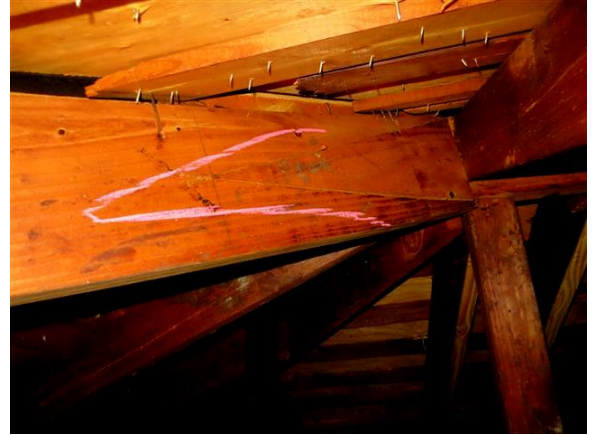
👁️ Observed ridge and/or valley rafter splice(s) not properly supported in attic.

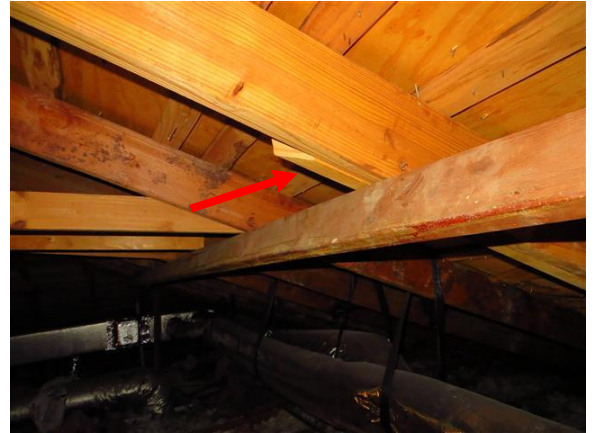
⚡ Observed rafter splice not properly supported in attic.

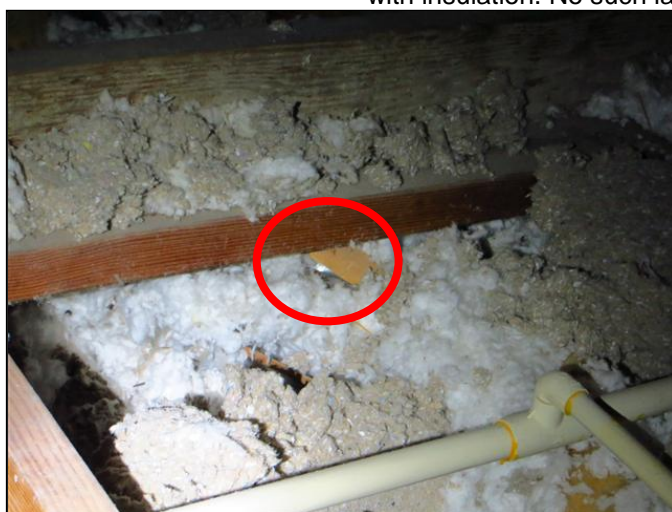
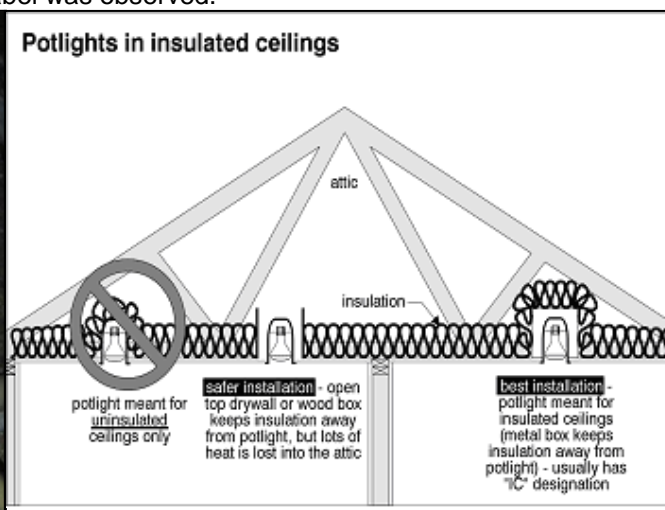
Insulation should be maintained a minimum of 3 inches and wood a minimum of 1 inch from around all recessed lights to reduce possible fire hazard. Exception: when lights are listed and labeled as IC (insulation contact) they may be in contact with insulation. No such label was observed.

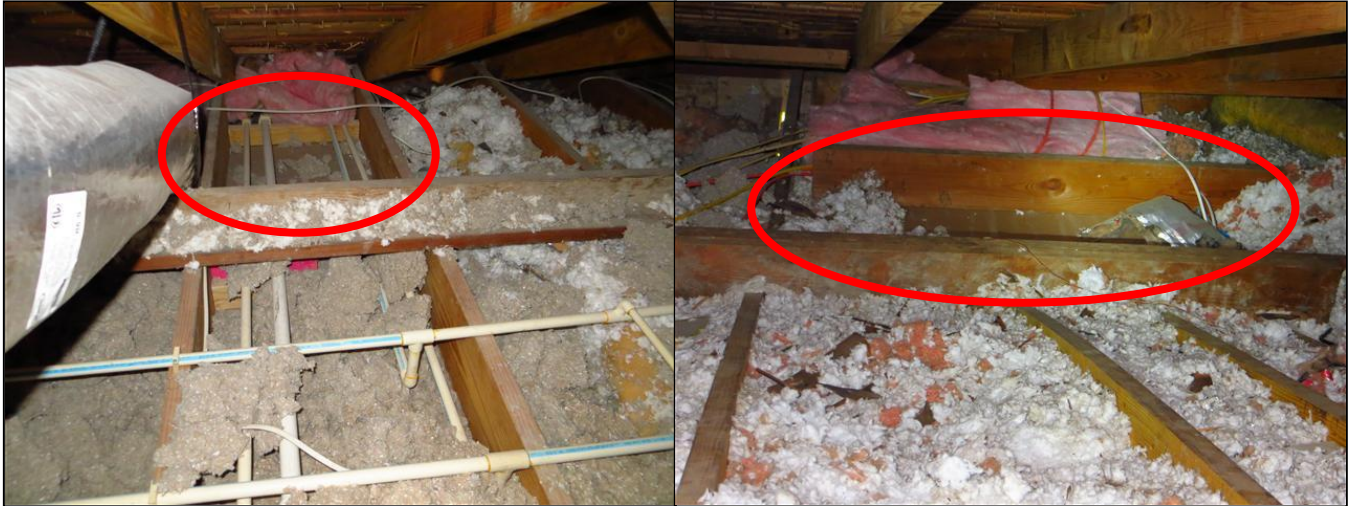
✘ Insulation missing, not properly positioned, packed down in areas, etc. numerous through the house.

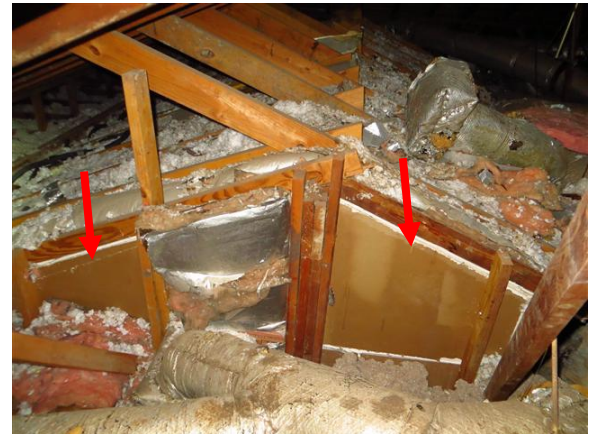
✘ Vertical sections of insulation are not properly secured and have sagged away from the wall, fallen down or are missing off interior walls in attic. Insulation must be held in direct contact with the air barrier (e.g., sheetrock) in order to be effective. An insulation backer will help secure the insulation to the wall.

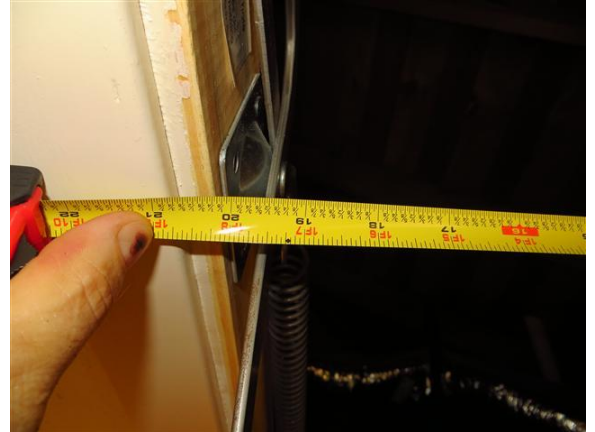
✖ Inadequate access opening to mechanical equipment in attic. Does not conform to building standards. The opening is too small. It is difficult to service and impossible to remove the equipment from its current location through the opening. (Ref: IRC Section M1305.1.3 Appliance Access | Appliances in attics) *Attics containing appliances requiring access shall be provided with an opening and a clear and unobstructed passageway large enough to allow removal of the largest appliance... The clear access opening dimension shall be a minimum of 20 inches by 30 inches...*

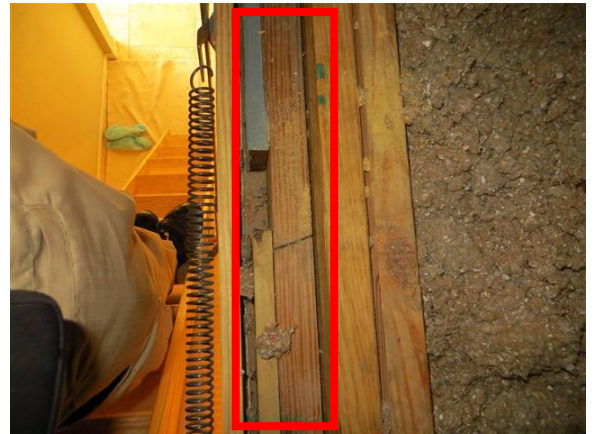
✖ Attic pull down ladder frame is not properly shimmed / supported in attic opening or the rough opening is improperly sized. Open gap places excessive stress on fasteners. Risk of failure.

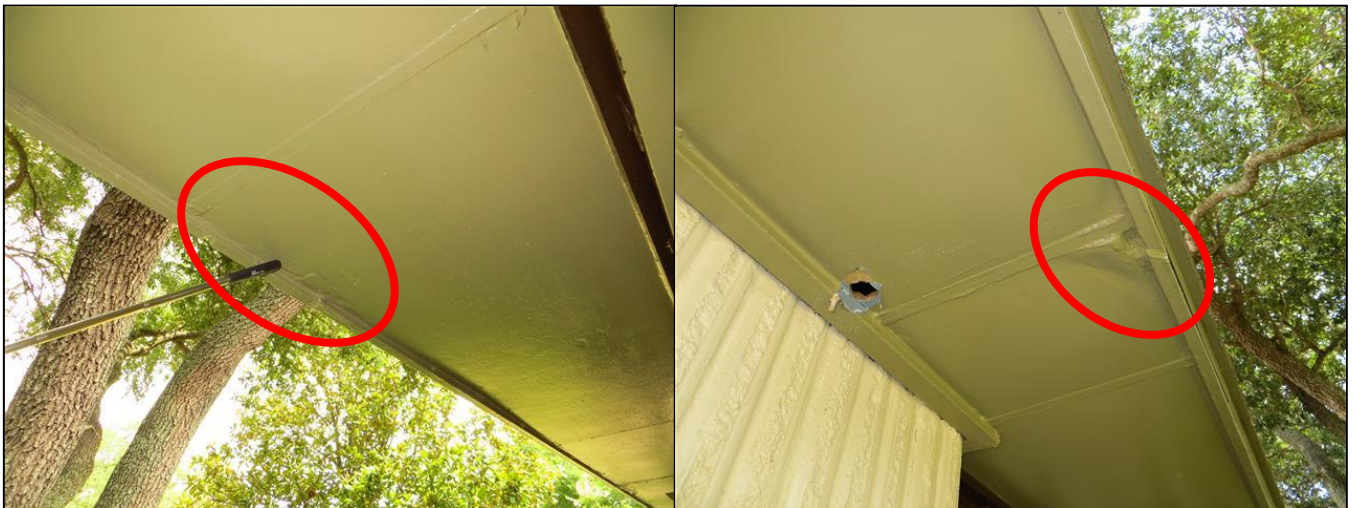
x Wood rot observed in one or more locations of structure. Numerous areas of soffit at front and rear

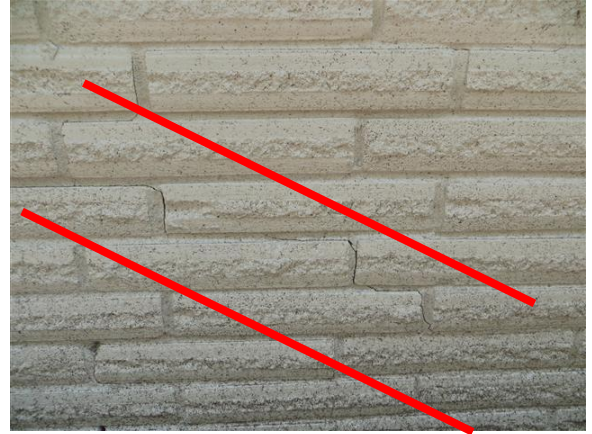
✘ Cracks in masonry (brick, stone, mortar, etc.) veneer and / or masonry repairs observed at several locations around house. Recommend client take photographs of cracks, their location, and width (ruler across the crack) with a high resolution camera that has a date stamp for future reference.

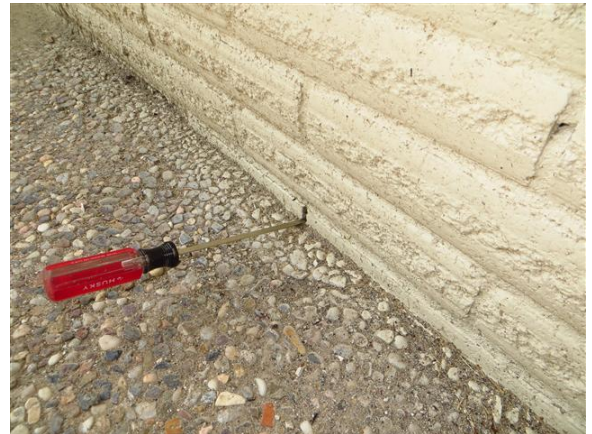
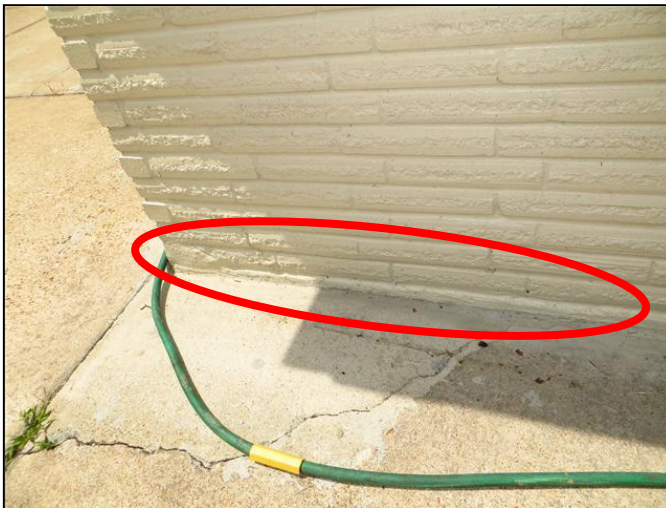
✘ Noted several blocked / obstructed weep holes in brick veneer siding (rear). Some are below grade. Weep holes allow moisture to escape from behind exterior walls and prevent wood rot / decay.

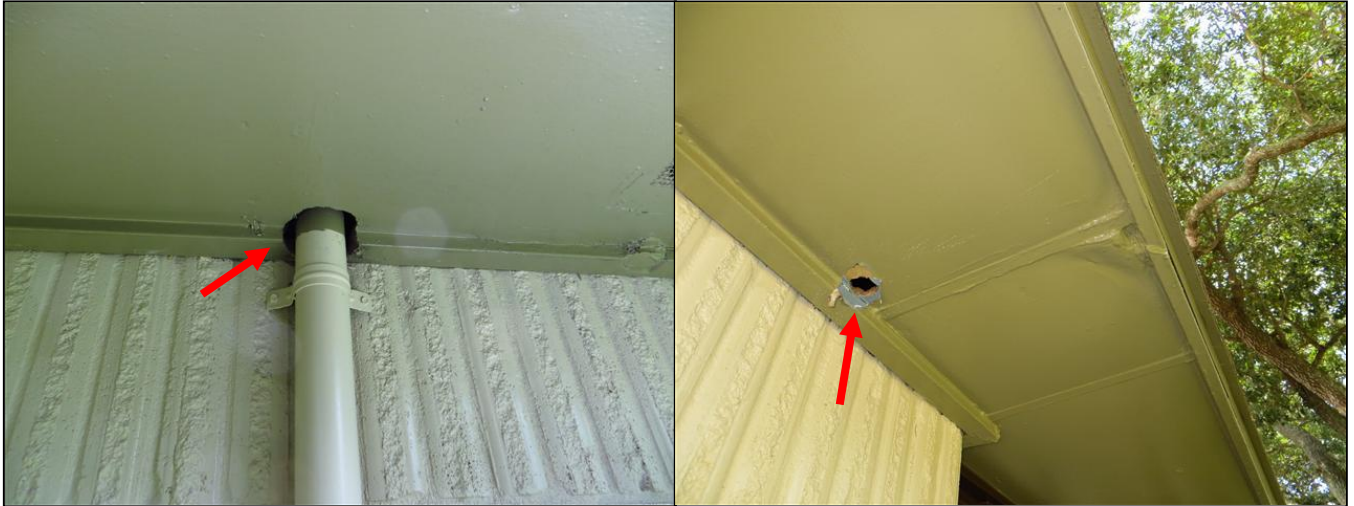
✂ Observed potential rodent entry point at several locations. Recommend sealing.

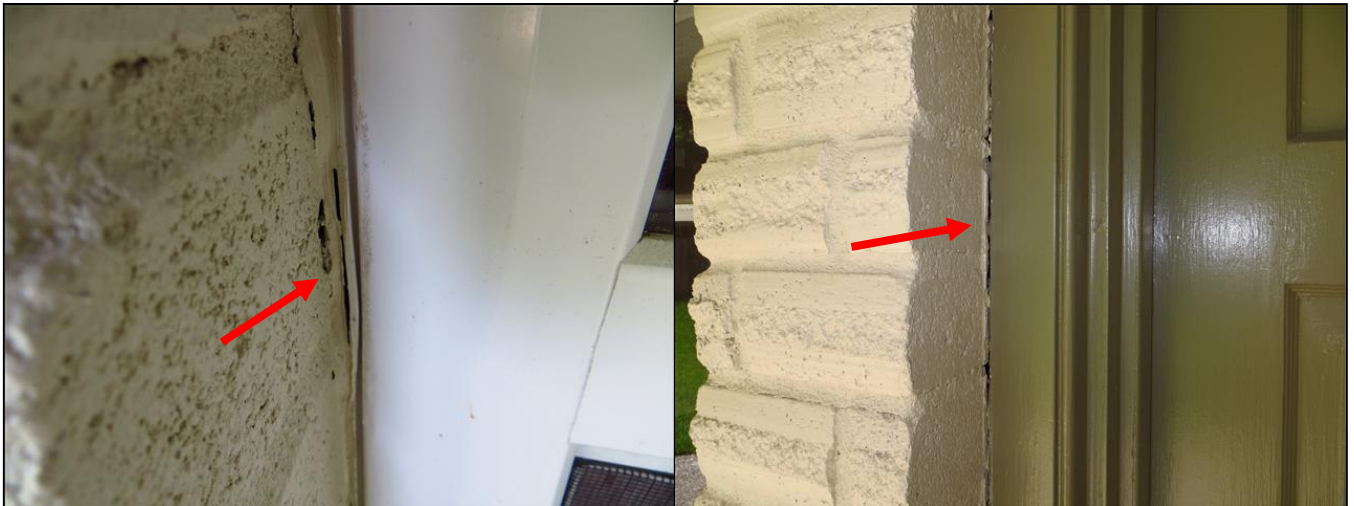
✂ Caulking missing and/or deficient around some windows and / or doors can allow wind driven rain entry.

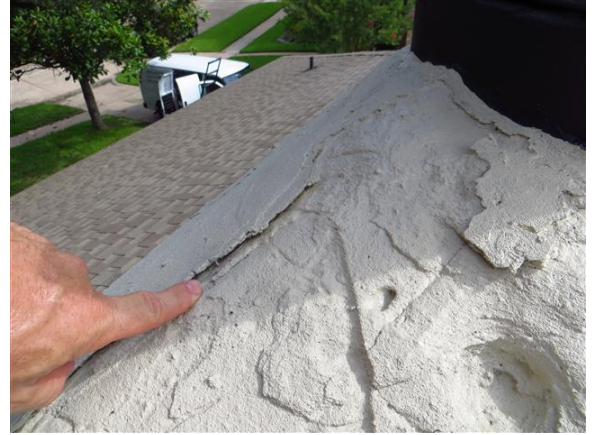
✘ Masonry coping cracked, on top of chimney, possible source of water entry.

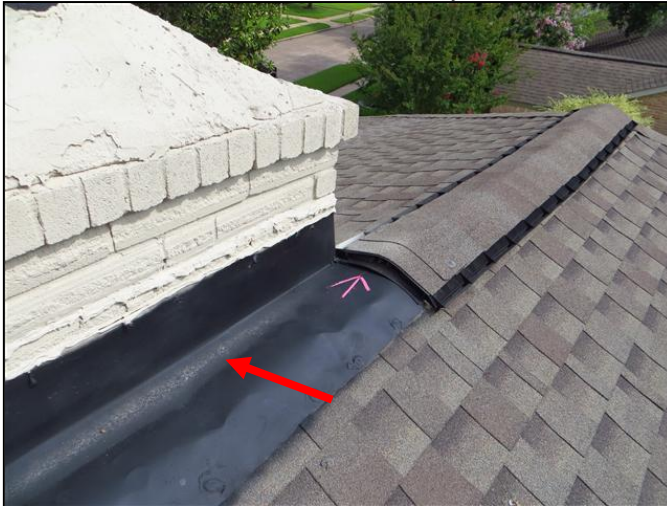
✘ Chimney is larger than 30 inches wide without a cricket present on back side to reduce chance of water entry during heavy rains, recommend addition of chimney cricket when new roof is applied.

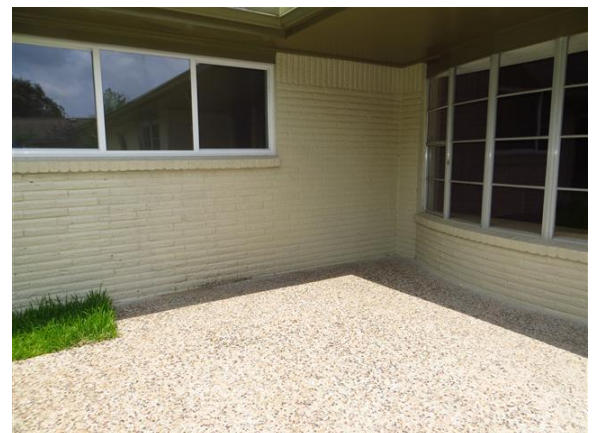
✘ Patio lacks adequate slope away from the house or improperly slopes toward the house. This condition increases potential water penetration during heavy rains and can be detrimental to the foundation.

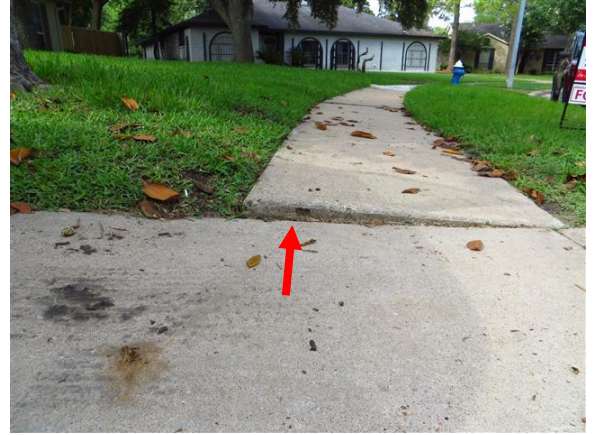
✘ Tripping Hazard(s), walks and/or driveways are uneven in some areas.

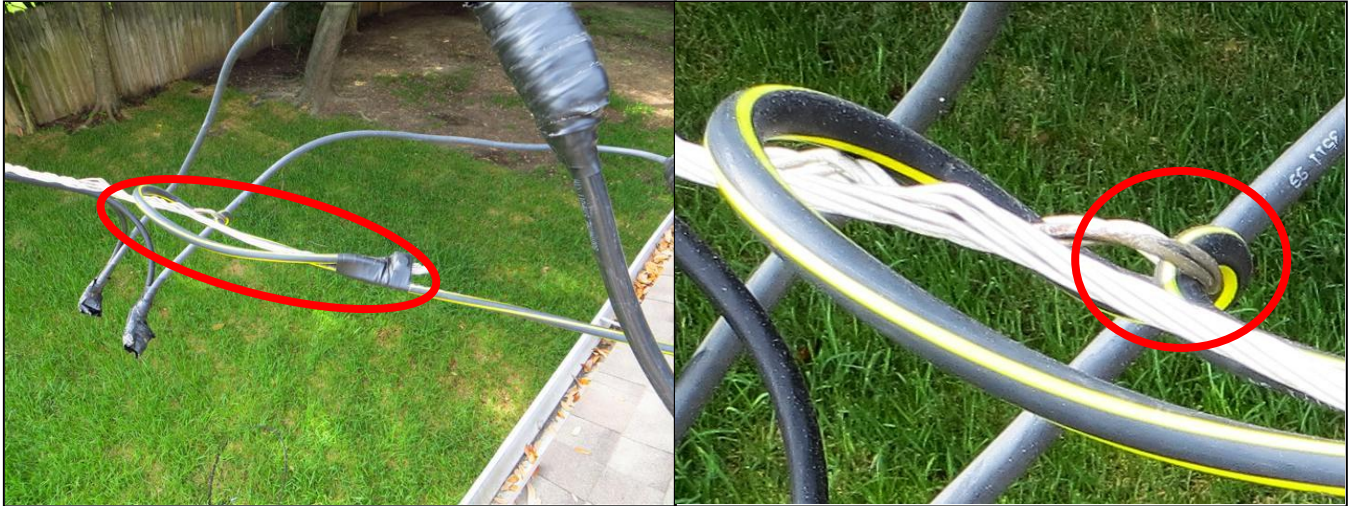
✘ Messenger wire is spliced and appears to be poorly secured / at the splice.
This wire supports the other service wires.

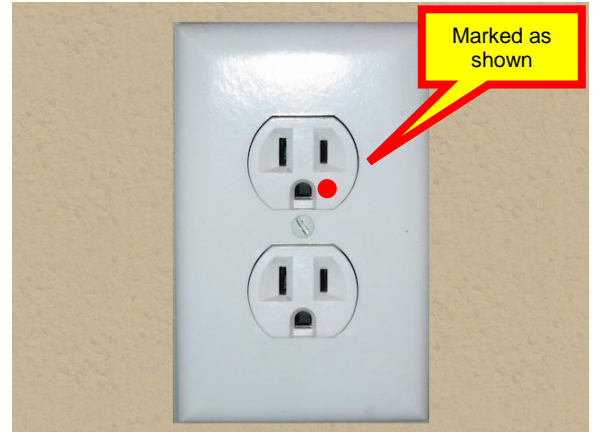
✘ 3-prong outlet not grounded or poor ground connection (multiple).

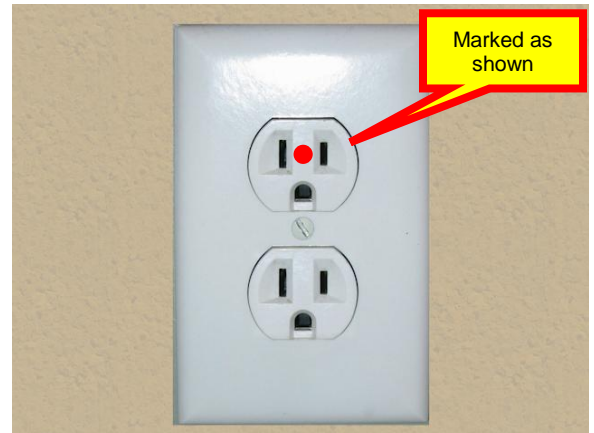
✘ Improperly wired, 3 prong outlet(s) polarity reversed, open neutral, etc., including but not limited to the exterior GFCI outlet at panel. Known improper outlets are marked with red dots.

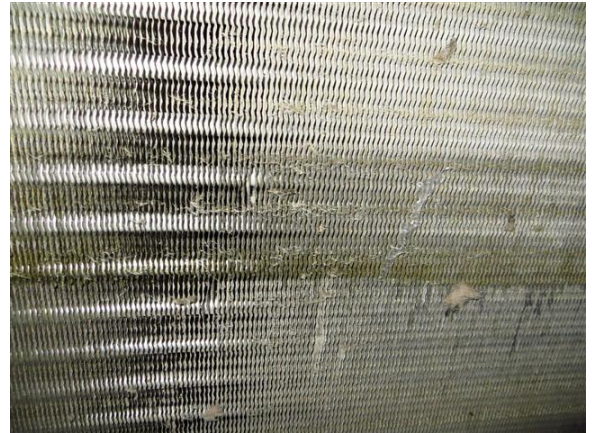
✂ Coils are dirty, needs cleaning. Dirty coils reduce air flow through the system and can create high head pressures at the compressor, stressing the system and reducing life span of system components.

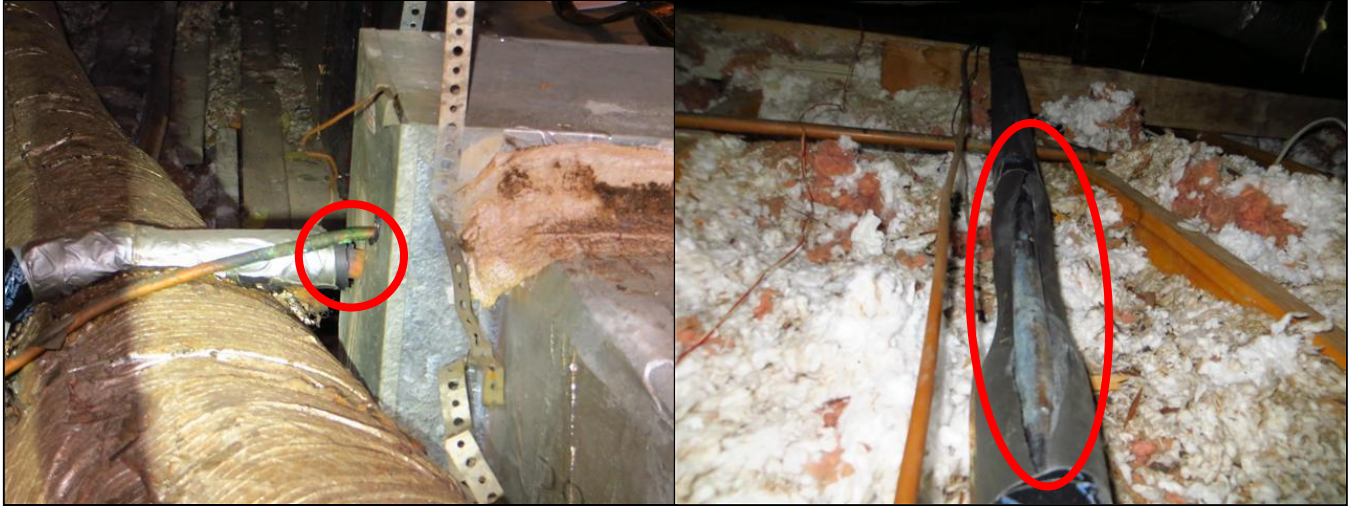
✂ Section of insulation missing or gap between insulation sections on refrigerant suction line in attic. Warm attic air condenses on cold suction line/expansion valve and drips condensation onto ceiling below.

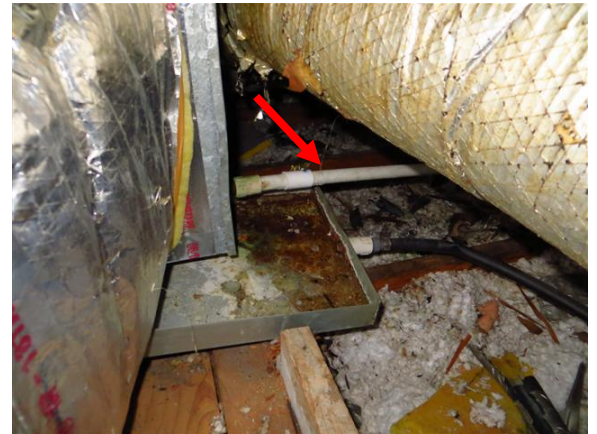
✂ Primary drain line should be insulated along entire length in attic to prevent warm attic air condensing on cool drain line and dripping condensation.
