Property Inspection Report: 11619 Dunlap

PROPERTY INSPECTION REPORT

Concerning: 11619 Dunlap
(Address or Other Identification of Inspected Property)

July 3, 2012
(Date)

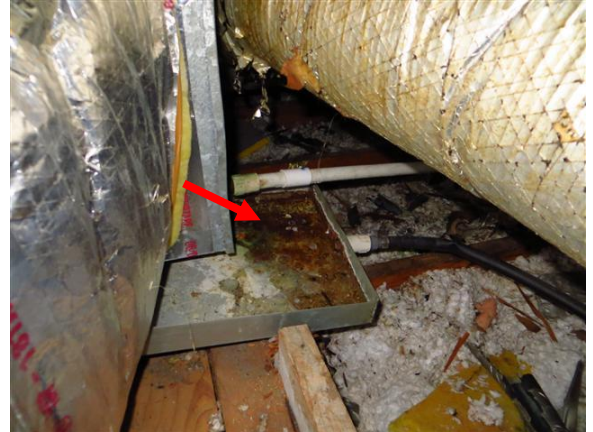
✘ Secondary drain pan contains water indicating possible blockage of primary drain or leak from coil enclosure. System requires service to correct condition.

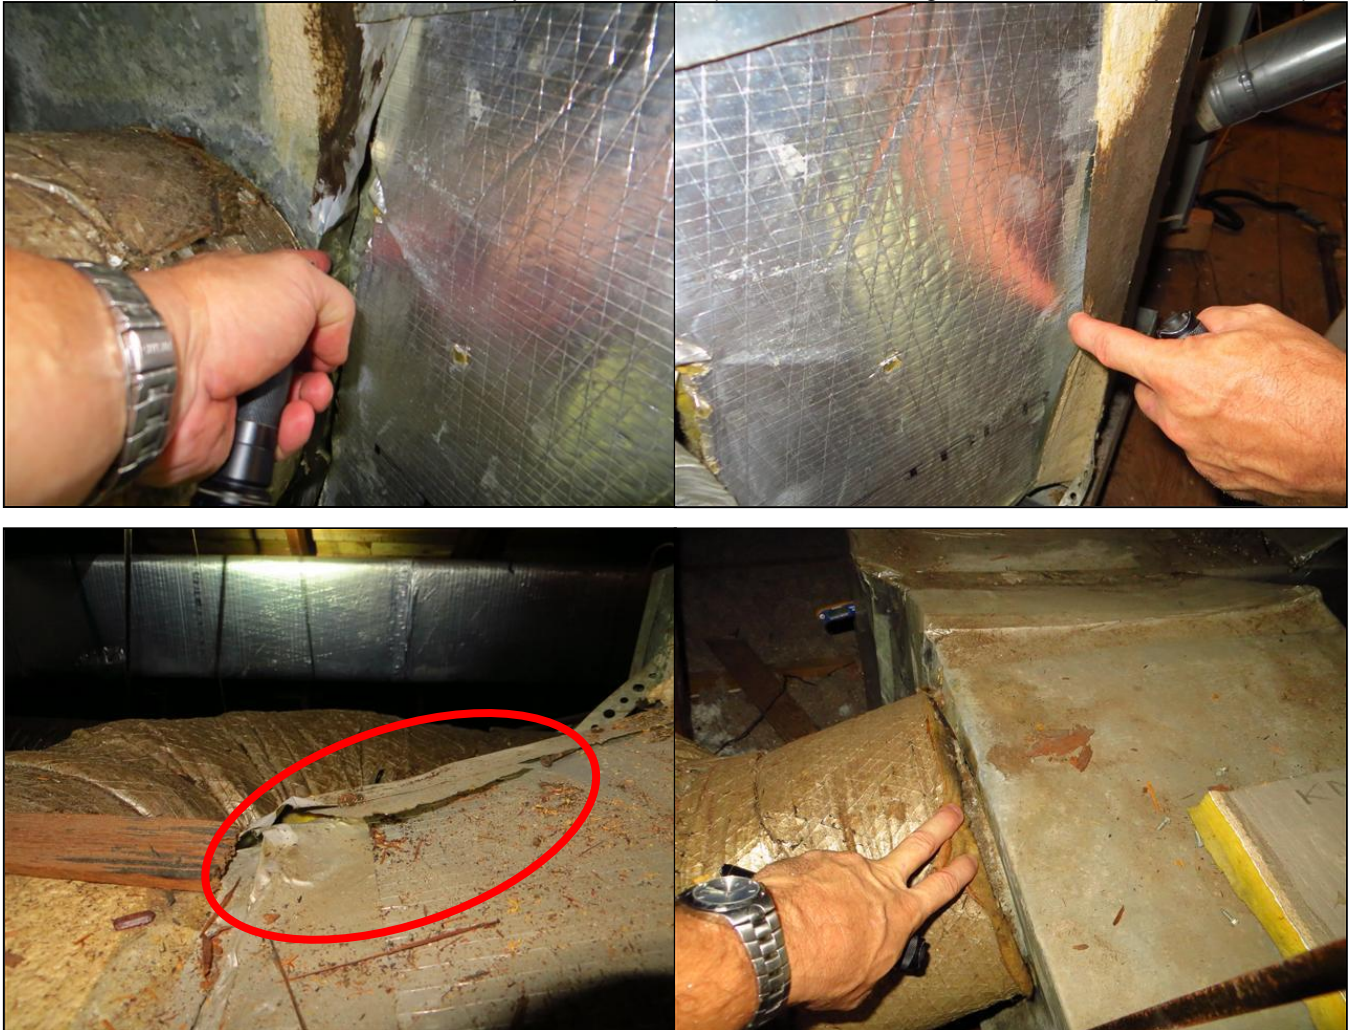
✂✂ Excessive air leakage at the joints of the transition between the coil, air handler and plenum or ducts (massive air leakage into attic at multiple locations).

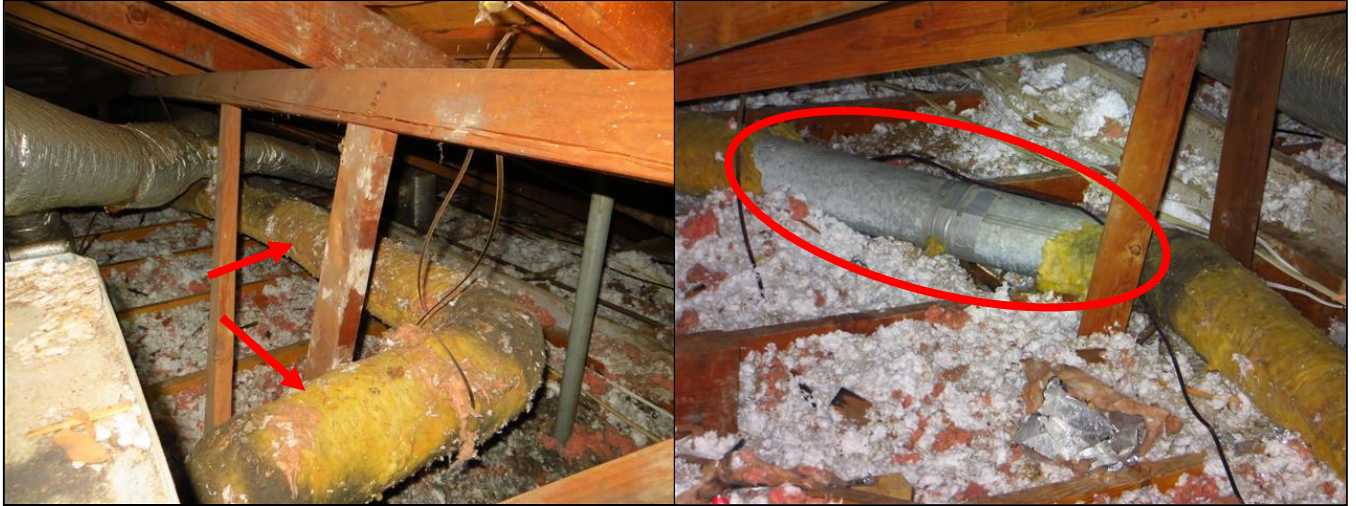
✖ Some insulation missing, loose or damaged on metal ducts in attic. Exposed metal ducts reduce efficiency, can sweat condensation, drip onto ceiling and cause moisture / water damage.

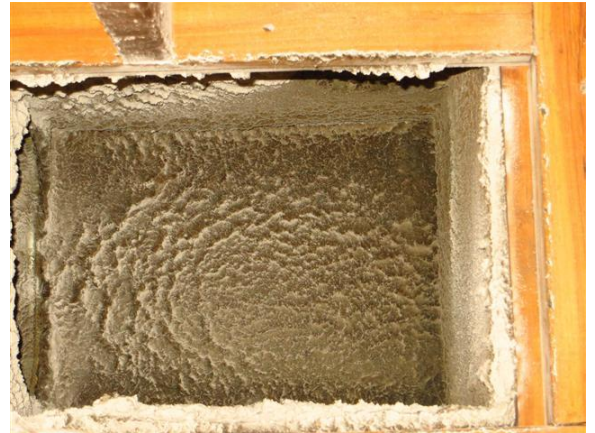
✖ Return air chase is dirty, needs cleaning.

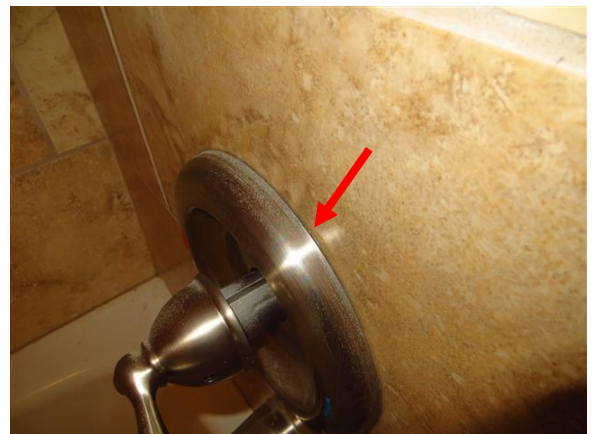
🔧 Caulking needed around all tub/shower faucets, spout and shower arm escutcheons to prevent water entry behind wall.

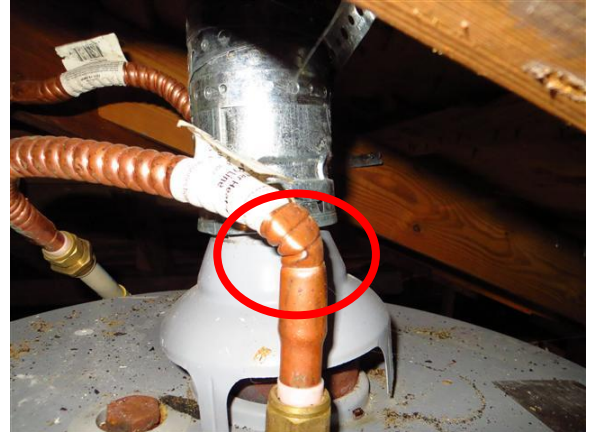
✖ The water supply connector is kinked at the top of the unit.

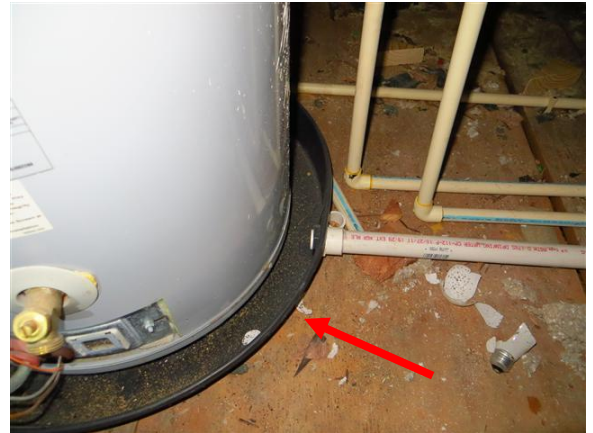
✖ Gas water heater drain pan is improper material, plastic. Should be a galvanized steel pan. (Ref: IRC Section P2801.5 Required pan). *Where water heaters or hot water storage tanks are installed in locations where leakage of the tanks or connections will cause damage, the tank or water heater shall be installed in a galvanized steel pan having a minimum thickness of 24 gage or other pans for such use. Listed pans shall comply with CSA LC3.*

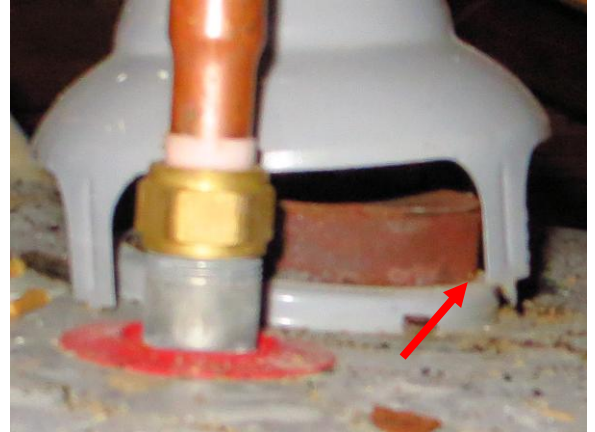
**Water heater is improperly vented. The vent pipe not properly aligned / engaged at top of water heater, which may allow byproducts of combustion (i.e., carbon monoxide) to vent into house and attic.**

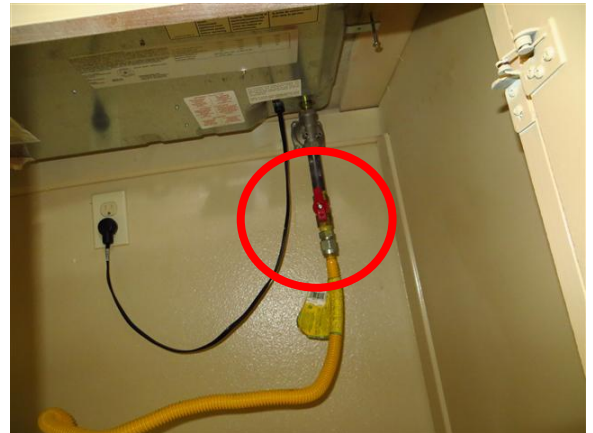
Gas shutoff valve is improperly installed downstream of the flexible appliance connector for the cooktop. The valve is required to be installed before the flexible appliance connector.

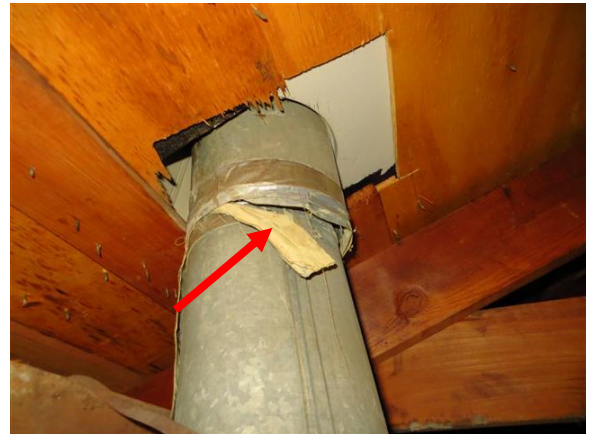
Vent pipe connection is loose in attic. Kitchen exhaust improperly vents into attic. Potential fire hazard.
