New Bosch Coil Design for BMWs – Where’s the “Snap?”

Newly-redesigned Bosch coils for BMWs, part numbers 0 221 504 464/00124 and 0 221 504 407/00044 have had a number of technicians and field installers wondering what happened to the “snap”.

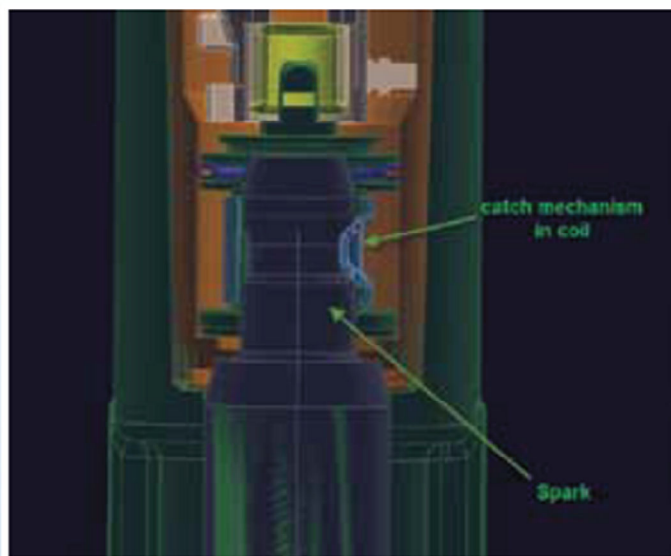
Old design coil with catch mechanism producing “snap”

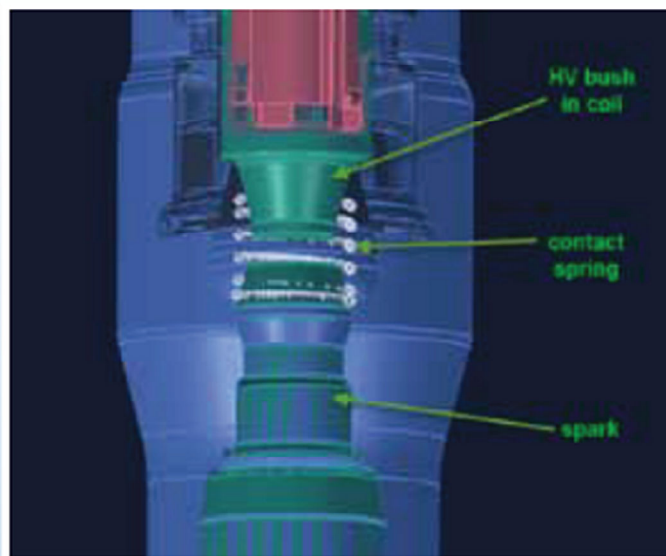
With the newly-designed coil, the customary “snap” is no longer heard nor is it an indication that the coil has been properly installed. This new design does, however, provide better coil performance at the spark plug connection point, which was the area that concerned some technicians. In other words, the original design actually gripped the spark plug tip and felt more secure; whereas the new design uses a contact spring on the spark plug tip and this design may not feel like the connector is gripping the spark plug, but in reality it does the job just as well or better than the old design.

New design coil with HV bush in coil and contact spring
