PROPERTY INSPECTION REPORT

Concerning: 213 Easy St, Fort Worth, TX 76244
(Address or Other Identification of Inspected Property)

By: Graham Waring, Lic #22823 01/22/2018
(Name and License Number of Inspector) (Date)

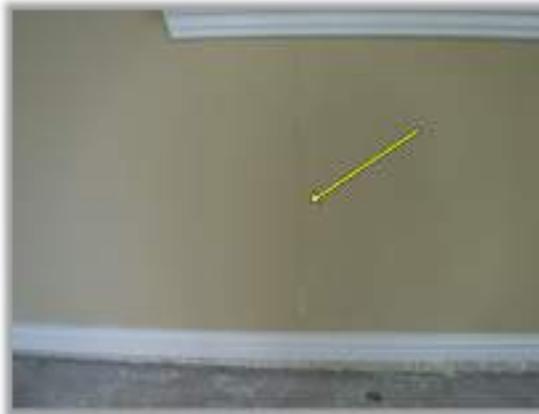
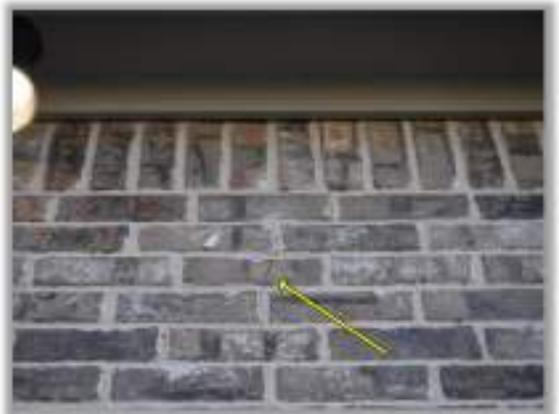
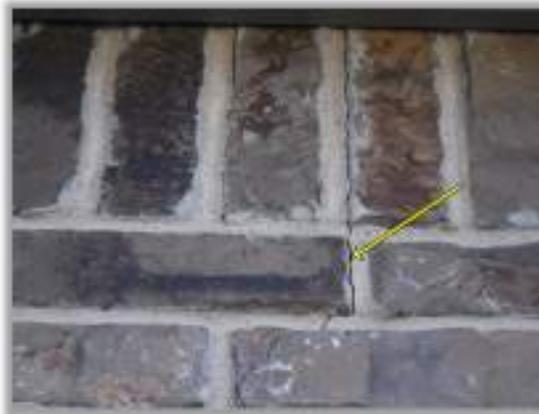
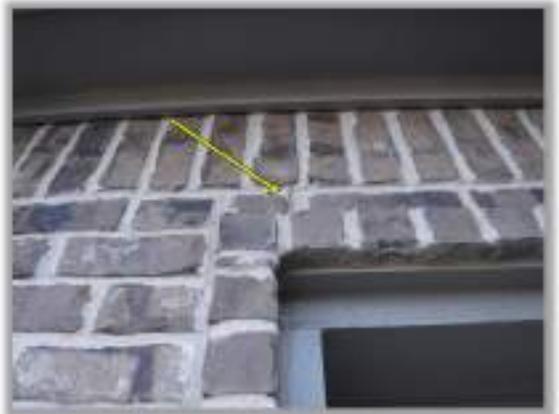
In my opinion, the foundation appears to be providing adequate support for the structure at the time of this inspection. I did not observe any apparent evidence that would indicate the presence of adverse performance or significant deficiencies in the foundation. The interior and exterior stress indicators showed little affects of adverse performance, and I perceived the foundation to contain no significant unlevel areas after walking the floors. The indicators located but are not limited to:

- Stress cracks were observed in the exterior veneer.
- Interior drywall cracks and/or stress indicators.

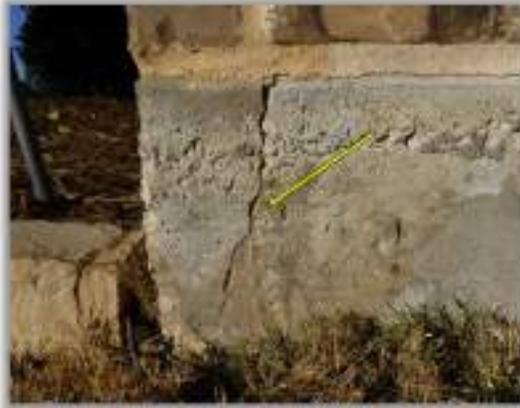
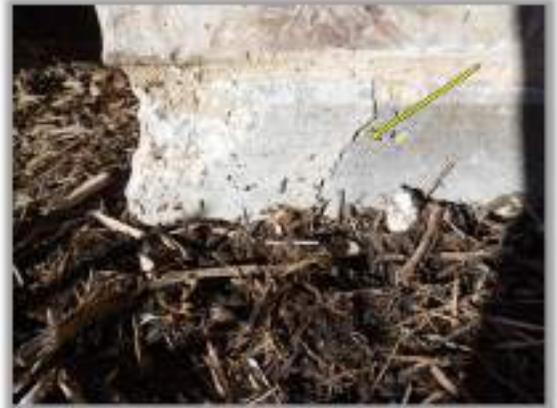
- One or more of the foundation perimeter beam corners were observed to be sheared off (corner pop). This is a common condition in slab on grade foundations. This condition does not adversely affect the performance of the foundation. However, the cracks should be properly sealed.

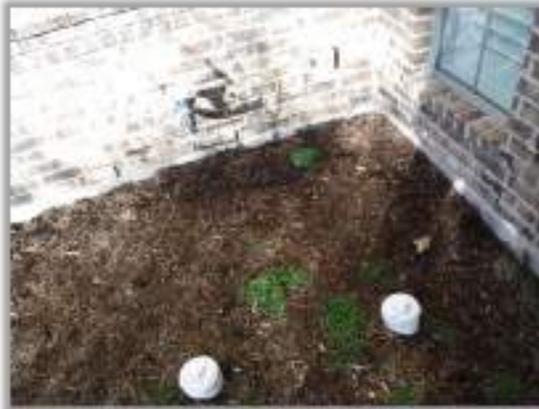
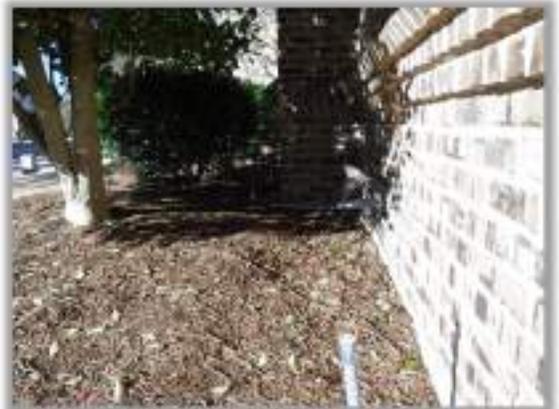
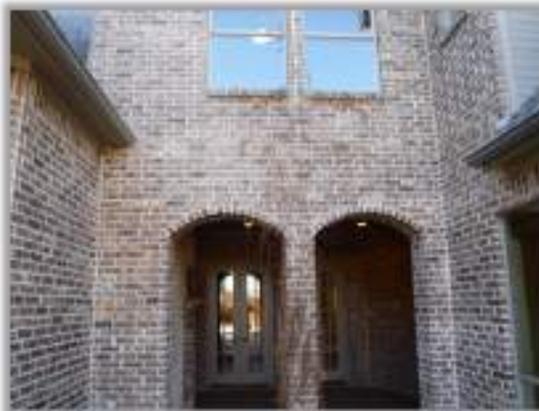
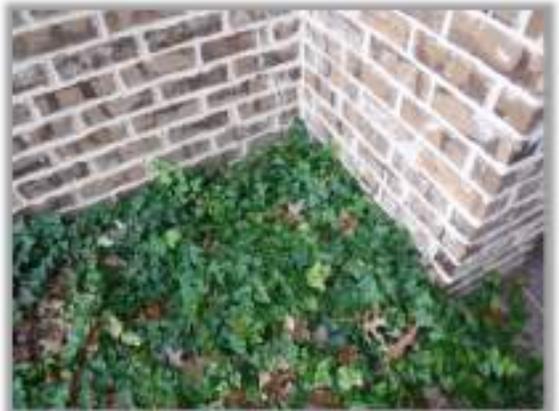
- Vegetation was too close to, touching, or growing on exterior walls. This condition can promote excessive damage and deterioration by movement of branches, root growth and/or attachment, can cause moisture retention, and can promote pest infestations. Recommend having vegetation trimmed or removed from affected areas, and regular homeowner monitoring and maintenance thereafter.

- Poor to negative site drainage was observed on multiple sides of the structure. Proper drainage is needed to help prevent water from standing and/or ponding next to the foundation beam. Corrective measures may be needed if the water stands within 10-feet of the foundation perimeter beam for more than 24-hours.

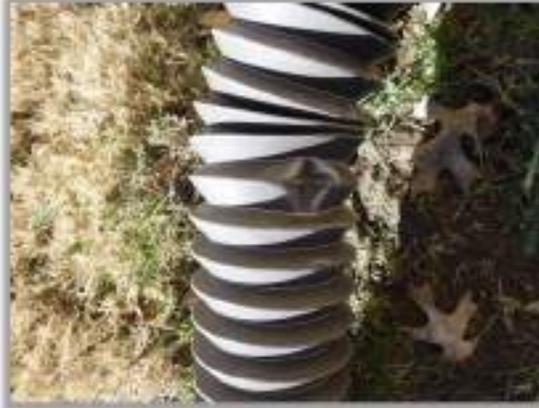
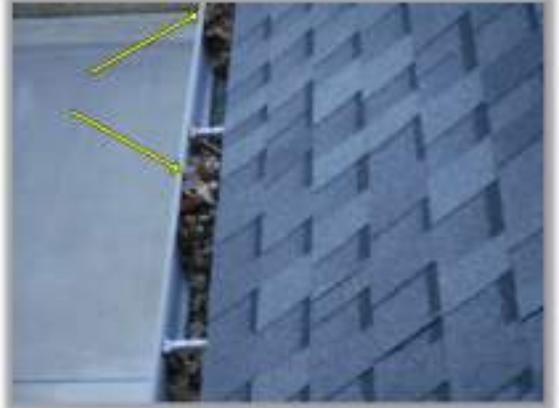
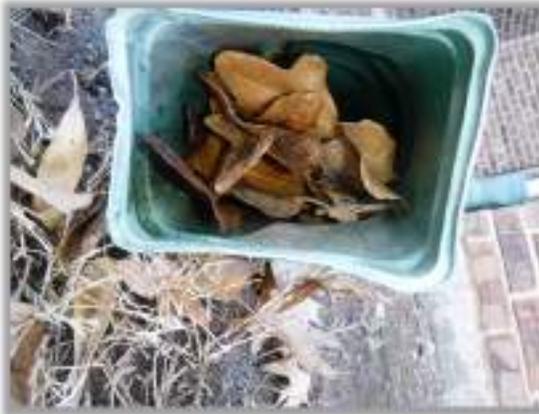
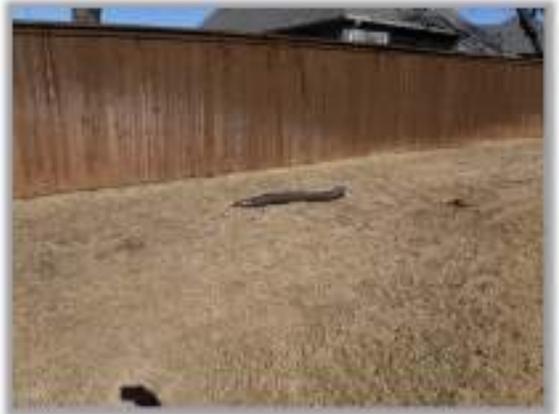
Gutter & Downspout System

- Multiple downspout extensions are damaged around the structure. Functionality not impaired.
- Some sections of the gutters and or downspout extensions are clogged with debris and need to be cleaned.
- Downspout extension located in backyard not attached.

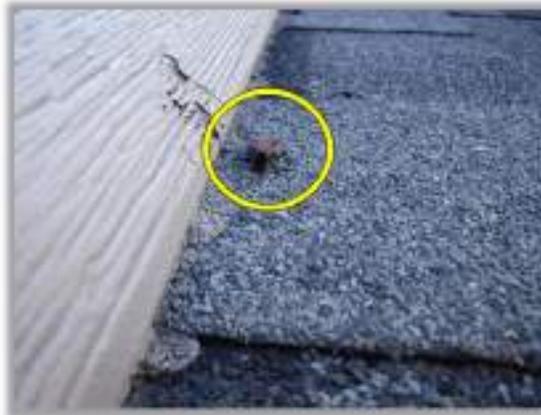
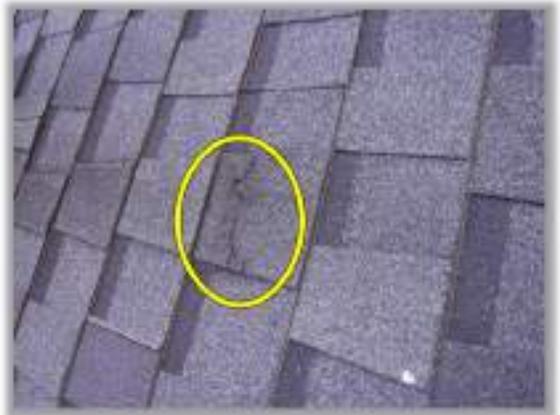
Roof Covering

- Roof fasteners (nail or staples) were observed to be exposed and should be properly sealed at the shingles and/or flashing areas.
- Damaged shingles were observed on the left exposure of the roof structure.
- Note: The roof was not able to be walked due to limited accessibility. If any concerns exist about the roof, a qualified roofer should be consulted for further evaluation.

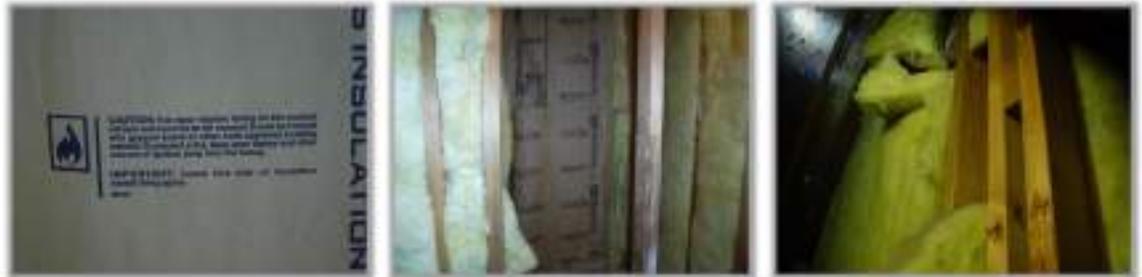
Attic Insulation

- The vertical insulation has been installed incorrectly. Repair is needed.
- Some of vertical insulation was observed to be loose at the sidewall in the attic area and should be corrected as necessary.

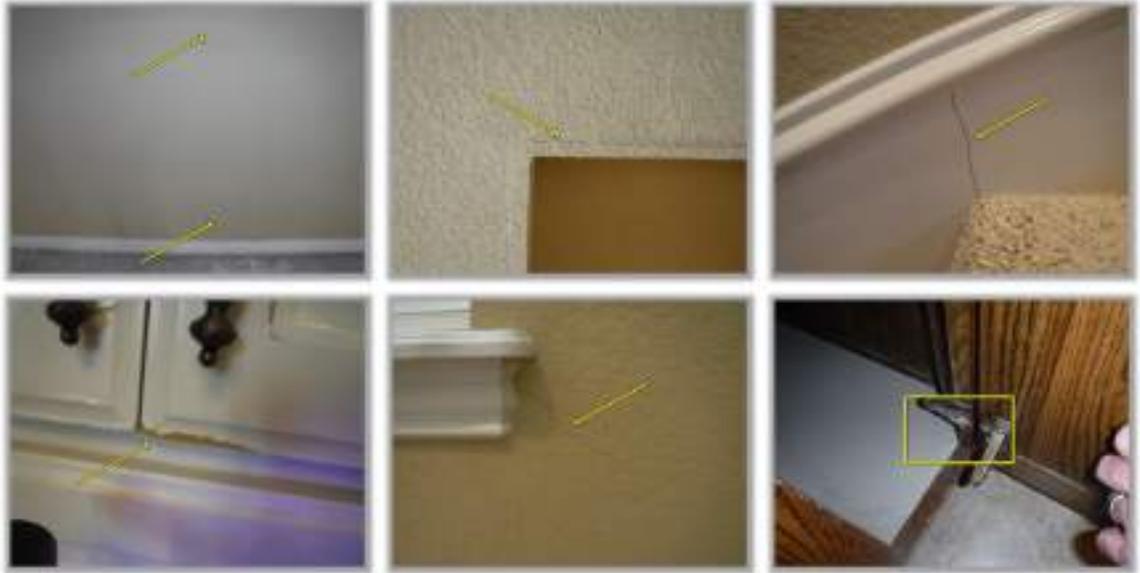
Interior Walls & Surfaces

- Minor drywall flaws were observed at various locations throughout the structure.
- Some damage noted to the cabinets in the master bathroom.
- One of the kitchen cabinets needs adjustment/repair.

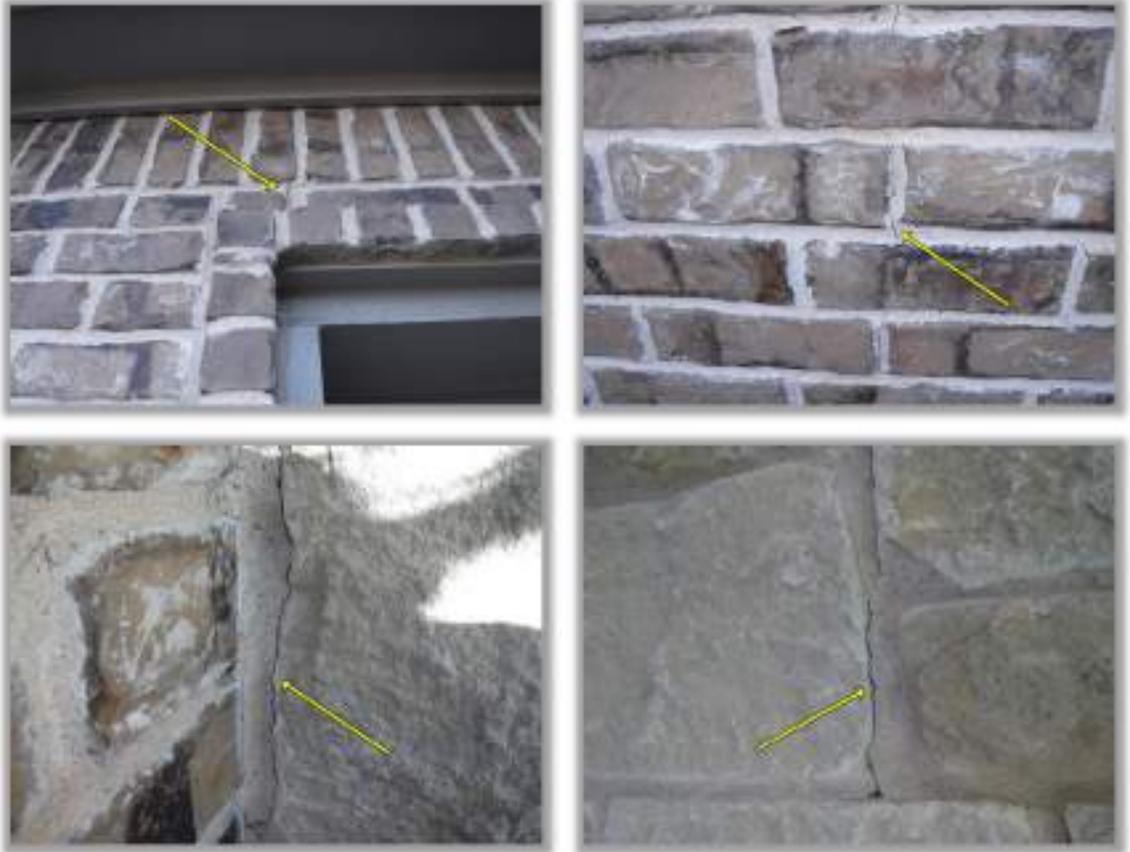
Exterior Walls & Surfaces

- Mortar improvements are recommended for the exterior masonry veneer on the multiple sides of the structure.

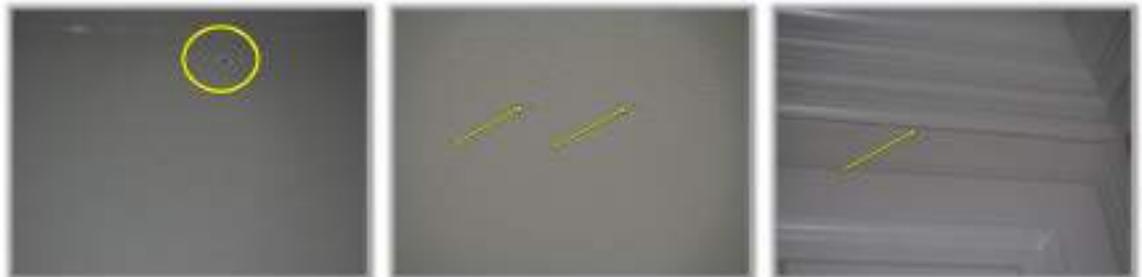
Ceilings

- Observed minor drywall flaws at some locations throughout the structure (nail pops, tape joint loosening.)
- The cabinets in the game room have their caulking separating on right side. Repair as needed.

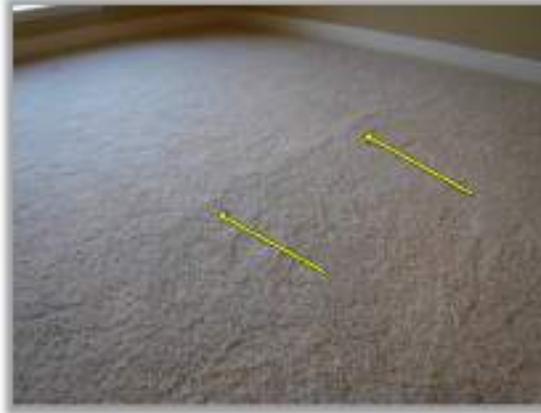
Floors

- The carpet is rolled at the upstairs right rear bedroom and needs to be stretched.

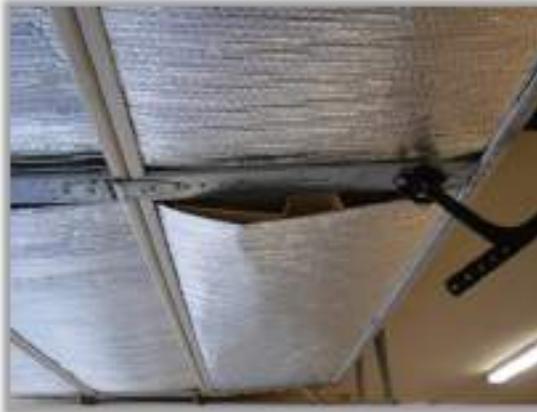
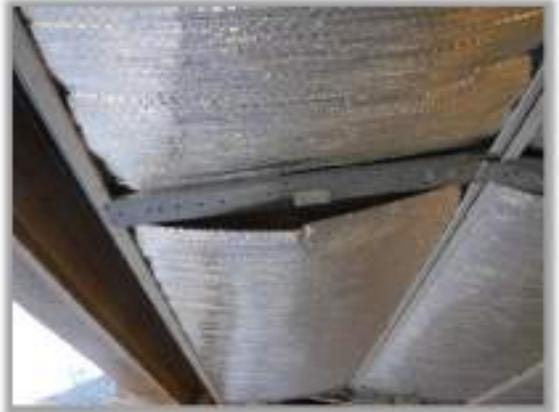
Overhead Garage Door

- The 2-car and 1-car overhead garage door thermal barrier paneling is coming loose. Repair as needed.

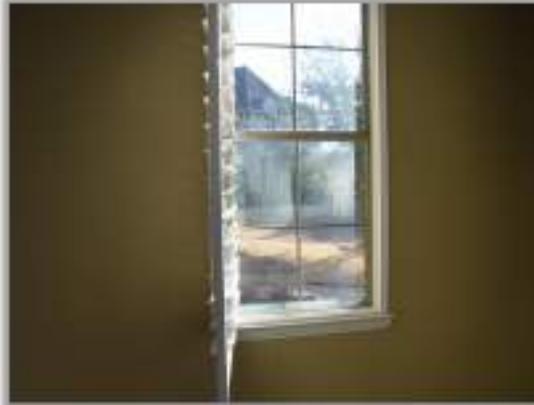
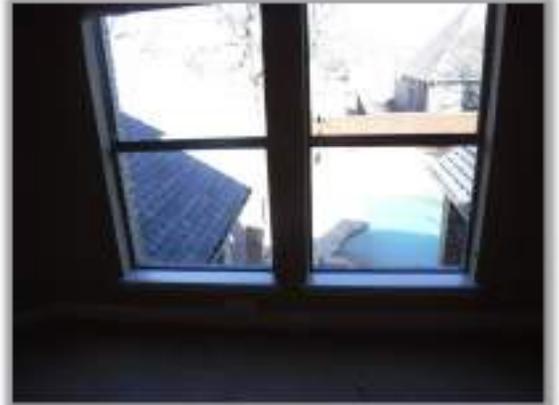
- One thermal pane window in the garage was observed to have lost its seal. This has resulted in condensation or a fog like film to develop between the panes of glass. The thermal pane windows no longer function as designed when they loose their seal and replacement may be necessary.
- The upstairs windows are missing any type of fall protection. This is an "as-built" condition.

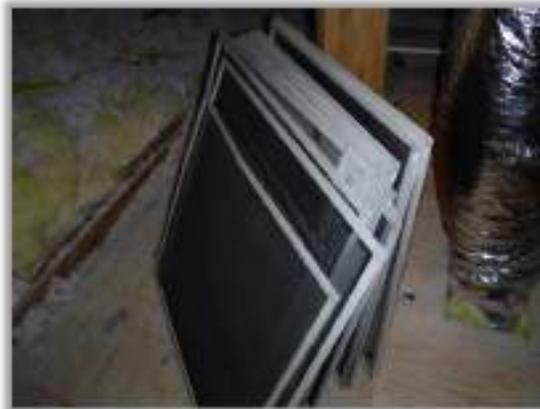
Window Screens

- Multiple window screens were observed to be missing.
- Note: Screens appear to be stored in the attic.

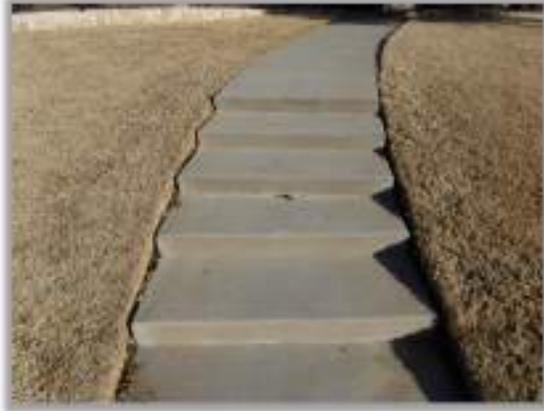
- There is no handrail in place for the front exterior stairs.

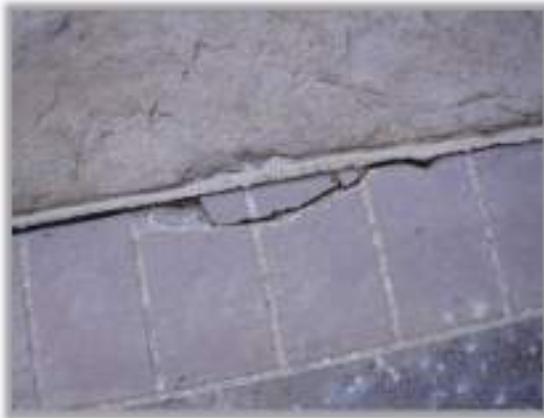
- There are multiple cracks in the pool decking; seal as necessary.

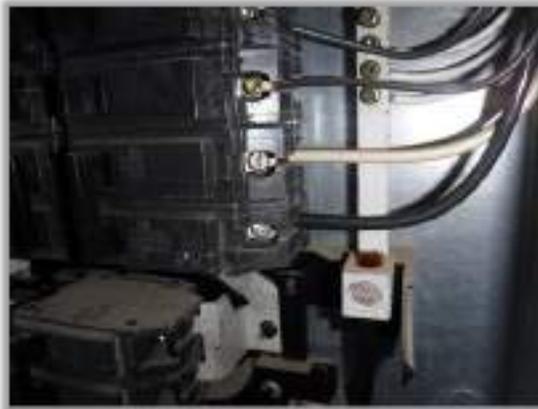
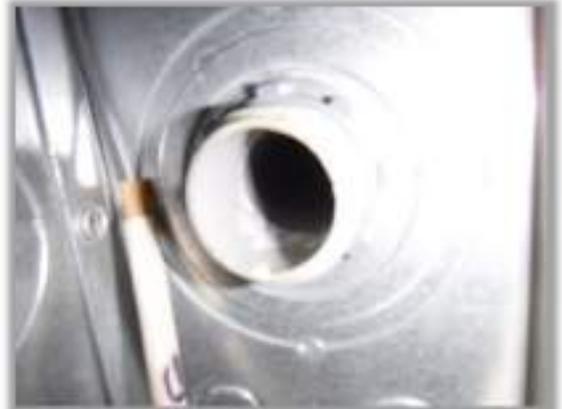
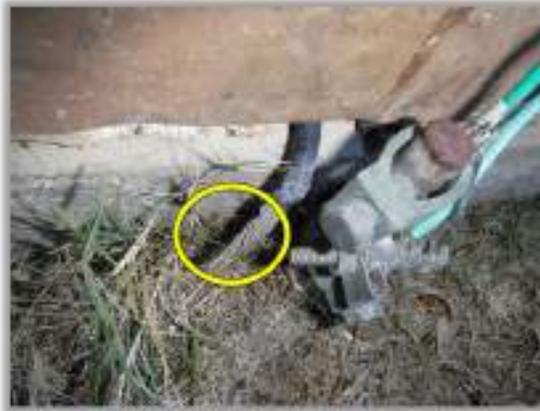
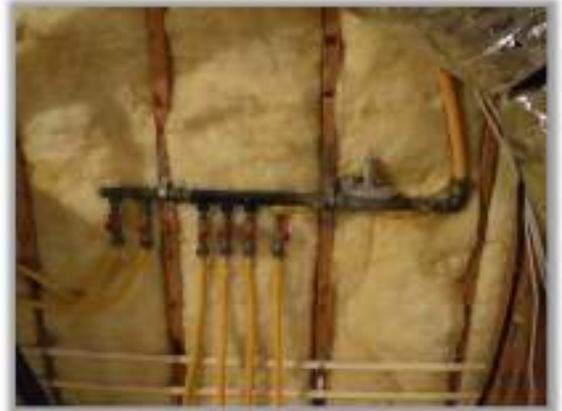
- The bonding wire connection to the ground electrode rod has pulled loose and needs to be repaired as necessary.
- All open spaces in the electrical cabinet need to have fillers for reasons of safety.
- One or more unmarked white wires were observed to be connected to breaker(s) in the electrical cabinet. This does not meet current electrical standards. It is recommended to re-identify "hot" white wires by marking with black electrical tape or marker at all terminations.
- I was unable to locate all the electrical bond connections for the CSST gas piping back to the grounding electrode system. According to current standards, all bond connections should be accessible for inspection, repair, or replacement. This condition should be further evaluated and corrected as necessary.

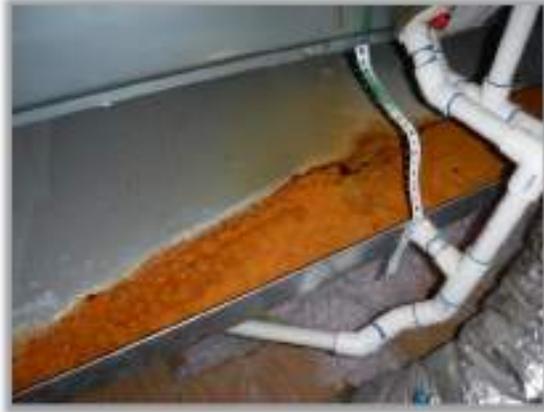
- The auxiliary/secondary drain pan under the coil housing has rust build-up. This would indicate that the pan has held water in the past. Due to the low ambient temperature, it was not possible to test for blockages in the primary condensate drain line or leaks at the evaporator housing.

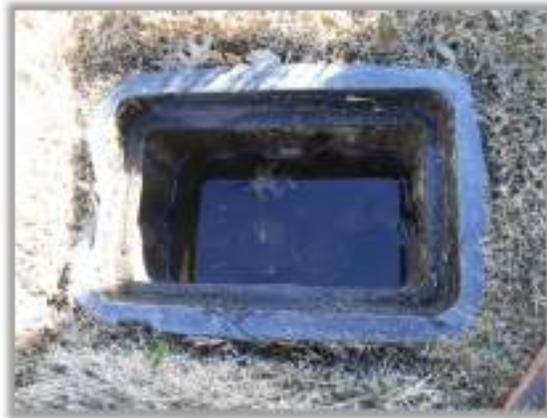
- The water meter box was filled with muddy water at the time of the inspection. The meter could not be inspected.

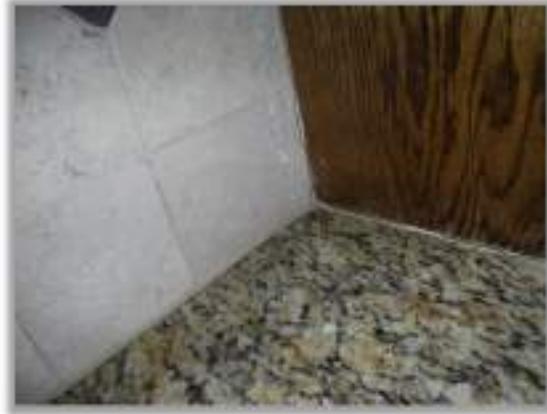
Kitchen:

- The sink backsplash grout/caulk is deteriorated or missing at the countertop.

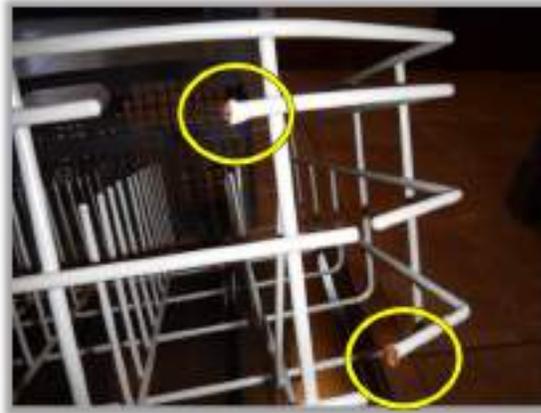
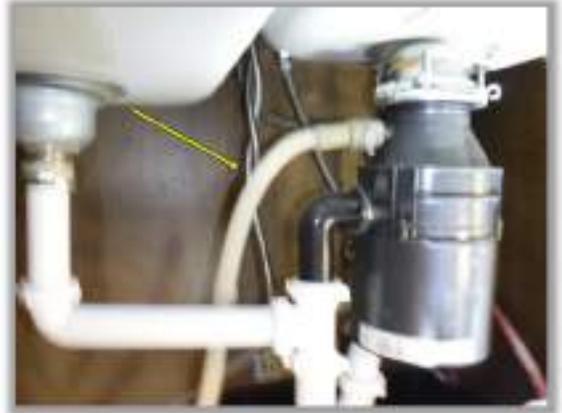
- Some rusting of the dishwasher interior components was observed.
- The dishwasher drain hose is not properly installed to prevent back flow or anti-siphoning. It is recommended that an air gap device or high drain loop be installed in the drain line.

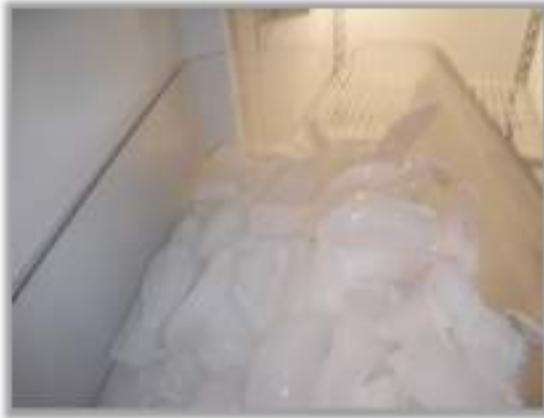
Refrigerator

- The ice machine was not functioning at time of inspection. Appears ice in unit has melted causing blockage.
- The refrigerator in the game room needs to be secured.

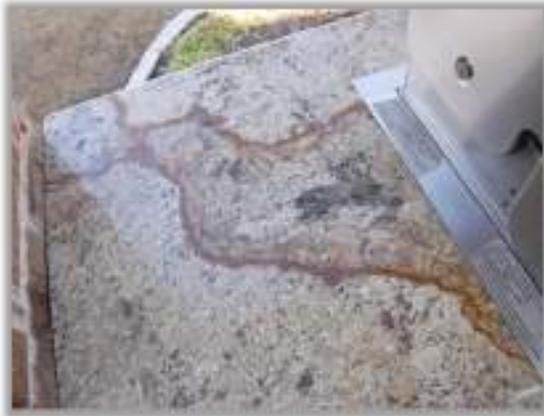
Outdoor Grill Area

- I was only able to get the left burner on grill to light. Repair as needed.
- The left side of grill has damage and staining to granite counter.

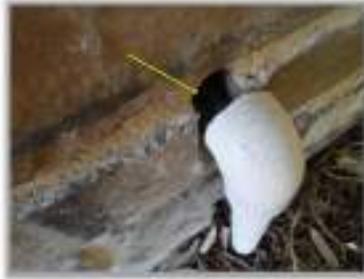
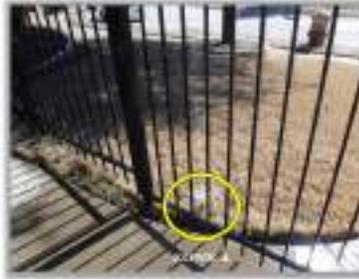
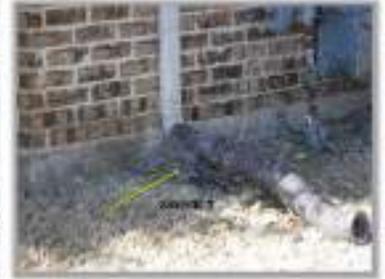
- Adjustments and/or leveling are needed at random heads for proper coverage or to prevent spraying of walls, fences, and/or concrete.
- The conduit that is protecting the sprinkler system wires by the control panel is loose and needs to be secured to wall. Repair as needed.
- Sprinkler head in Zone 4 sprays strait up and needs adjustment or repair.
- There is a head is Zone 7 located under a downspout that needs adjustments.
- Note: The sprinkler system control panel was in the OFF position upon arrival and returned to the OFF position after testing.

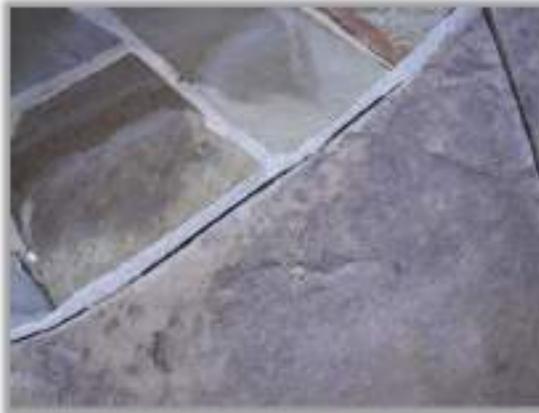
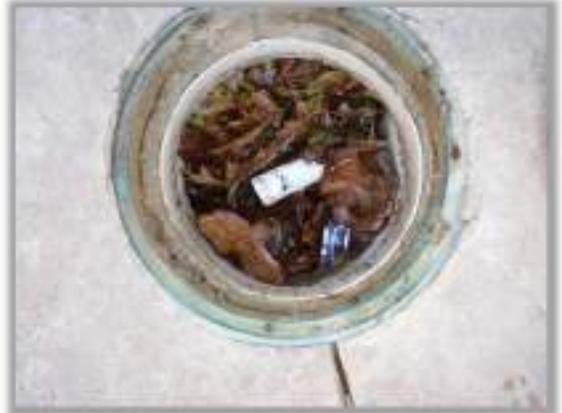
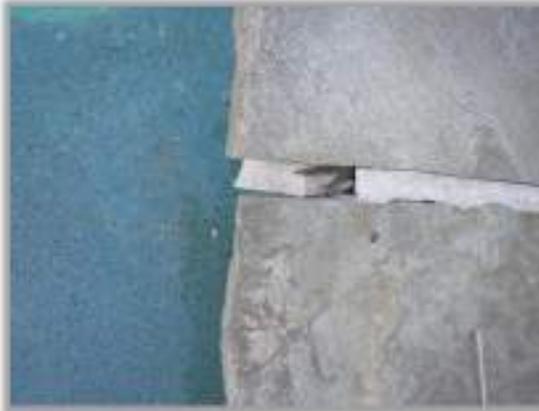
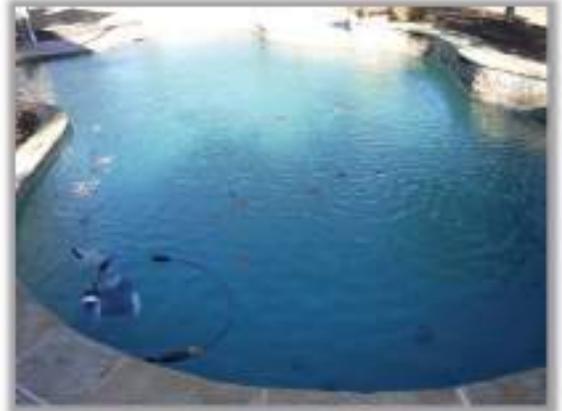
- I was unable to locate the lights switch for the lighting equipment. The owner should be consulted on the whereabouts of the switch location.
- Missing and/or failing mastic (Deck-O-Seal) was observed between the deck and coping. The mastic requires improvement at this time.
- Both skimmer baskets are full of debris and need cleaning.
- Damaged, deteriorated and/or missing tile grout/mortar should be repaired or replaced as necessary.
- All pedestrian access gates should open outward away from the pool and should be self-closing and have a self-latching device. The right side gate open into the pool area.
- Note: Due to windy conditions and a cloudy pool, the inspection of pool surface was able to be fully inspected. If any concerns of pool exist recommend following up with a pool specialist.
