Performance of Concrete Pavements

Volume I: Field Investigation

PUBLICATION NO. FHWA-RD-94-177

JULY 1997

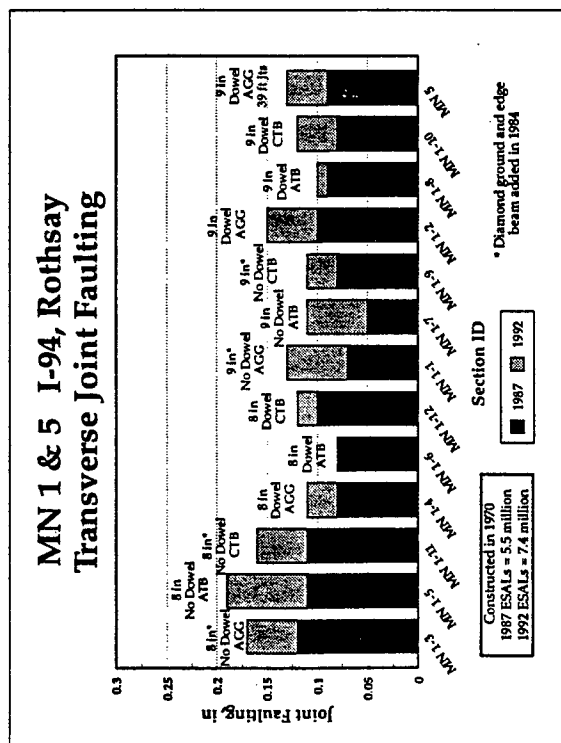
Figure 9. Performance summary for MN 1 & 5.

The 1992 data indicate, as did the 1987 data, that the sections constructed on the ATB developed a significant amount of longitudinal cracking, while the sections constructed on the AGG base display very little longitudinal cracking. This finding is confirmed by the replicate sections surveyed in the eastbound direction in 1992. In addition, nearly 90 percent of the joints on the sections constructed on the ATB exhibit joint spalling, whereas less than 50 percent of the joints on the CTB or on the AGG sections exhibit joint spalling. However, for a given method of load transfer, there are no discernible differences in joint faulting between the sections constructed on the different base types.

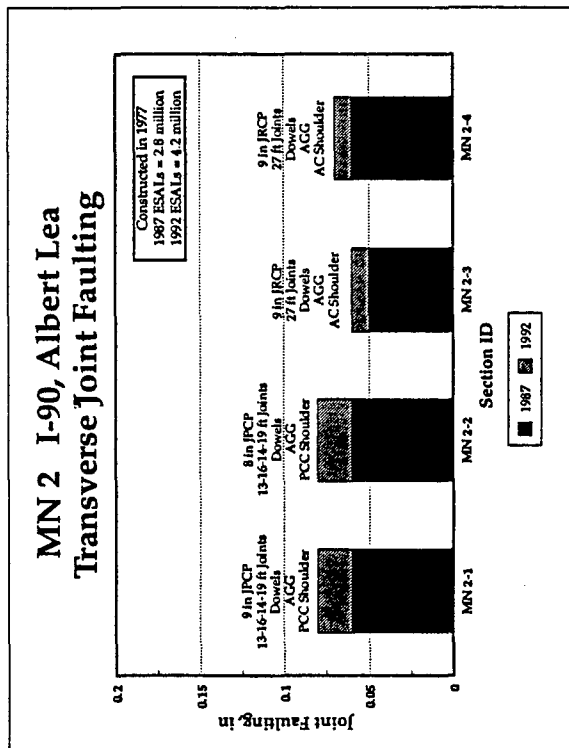
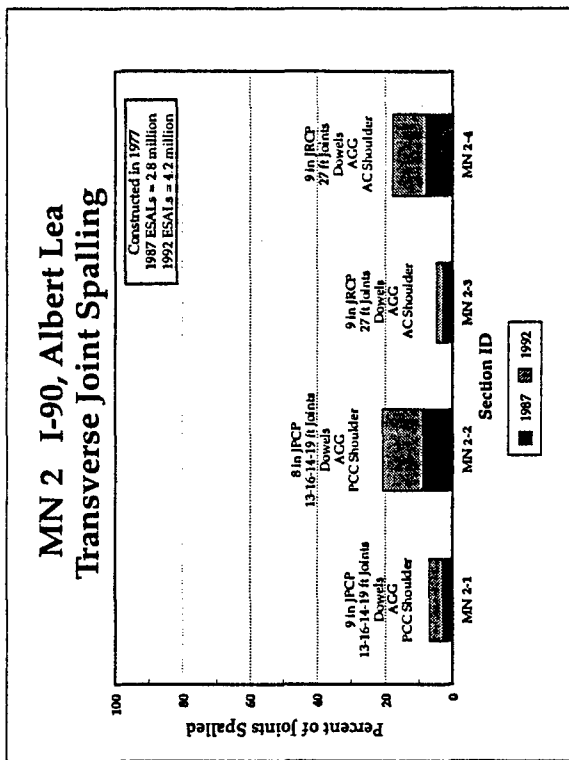
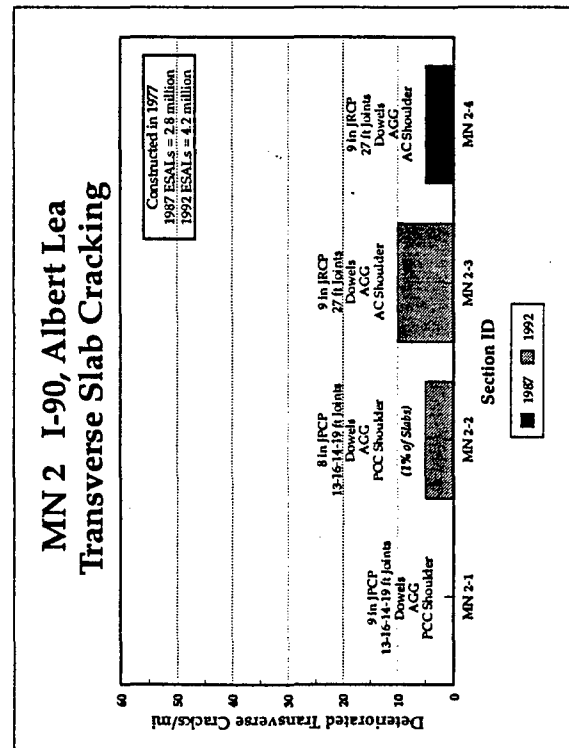
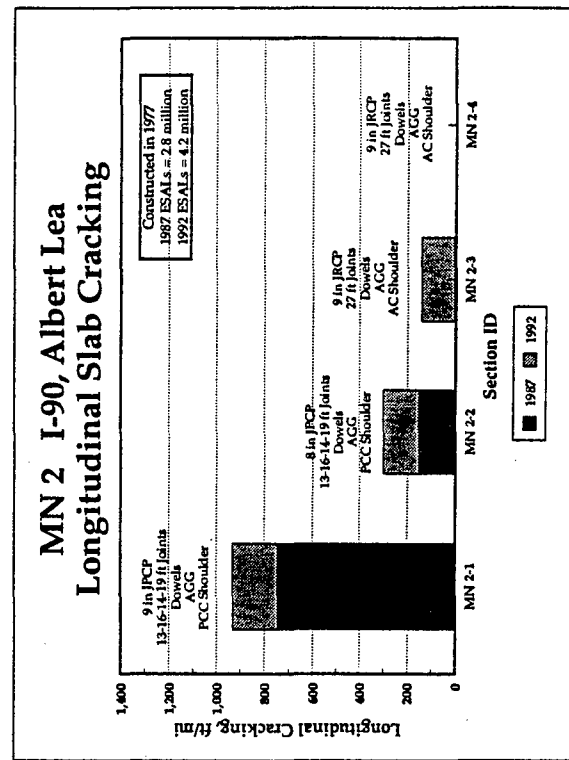
Figure 12. Performance summary for MN 2.

In assessing the performance of the different pavement types, the JRCP sections appear to be performing slightly better than the JPCP sections. The JRCP sections have slightly less faulting, less joint deterioration, and less longitudinal cracking.

However, these differences are not appreciable and the overall rideability of both JRCP and JPCP sections is similar.

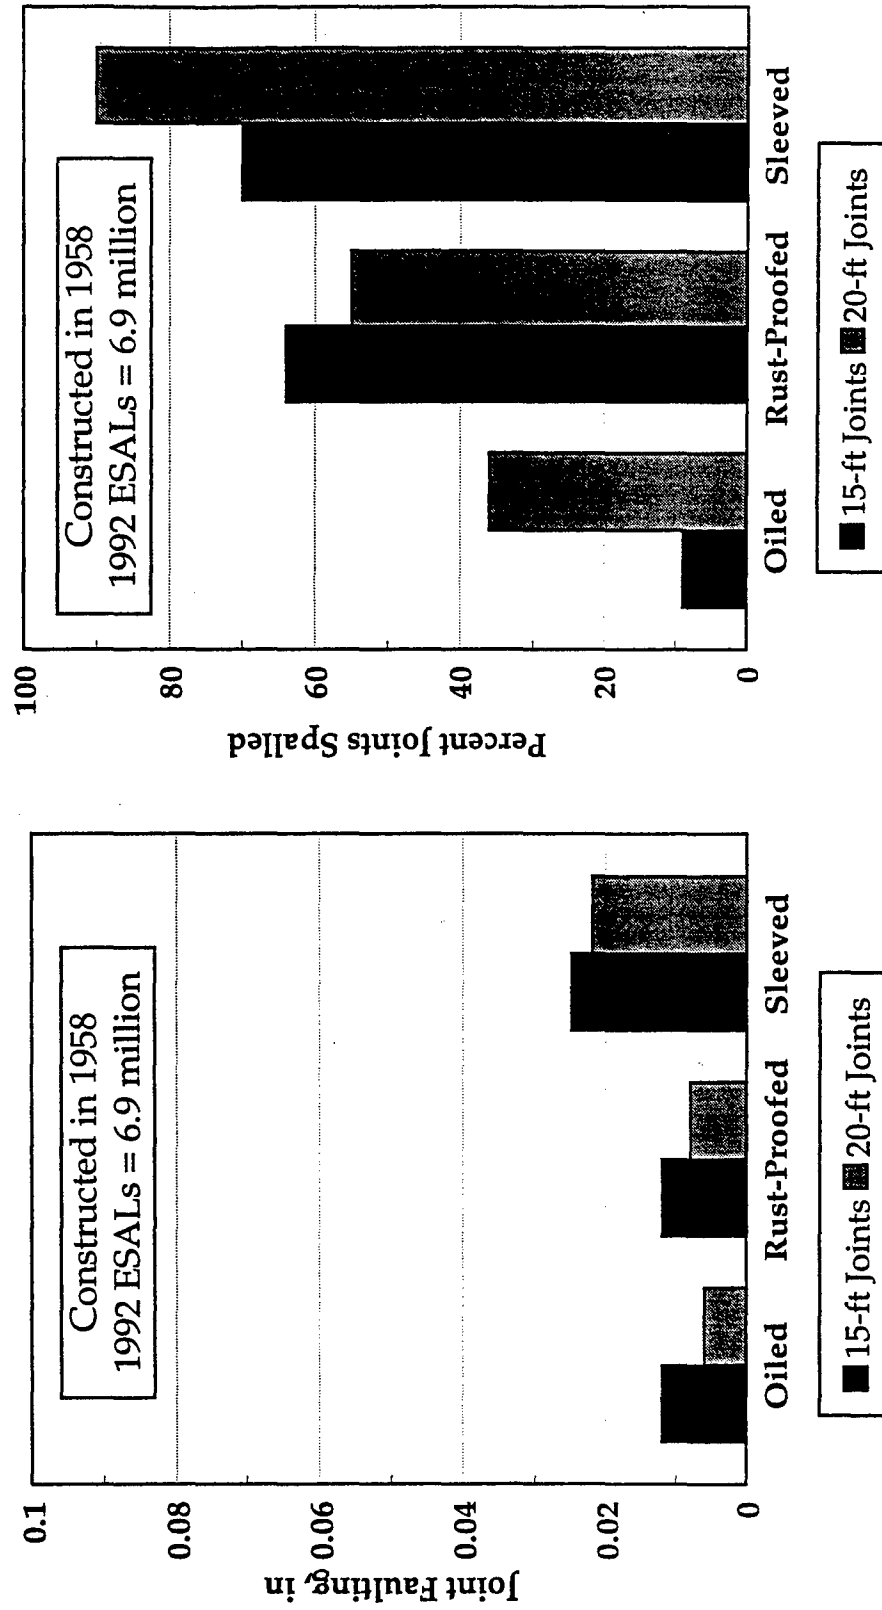
Figure 16. Performance of dowel coatings for MN 7.

affected. The joints with oiled dowels exhibited much less medium- and high-severity joint spalling than those joints with rust-proofed or sleeved dowels. The joints containing the sleeved dowels were badly deteriorated, and several had received full- and partial-depth repairs. It should be recalled that the different dowel types were placed at alternating joints.

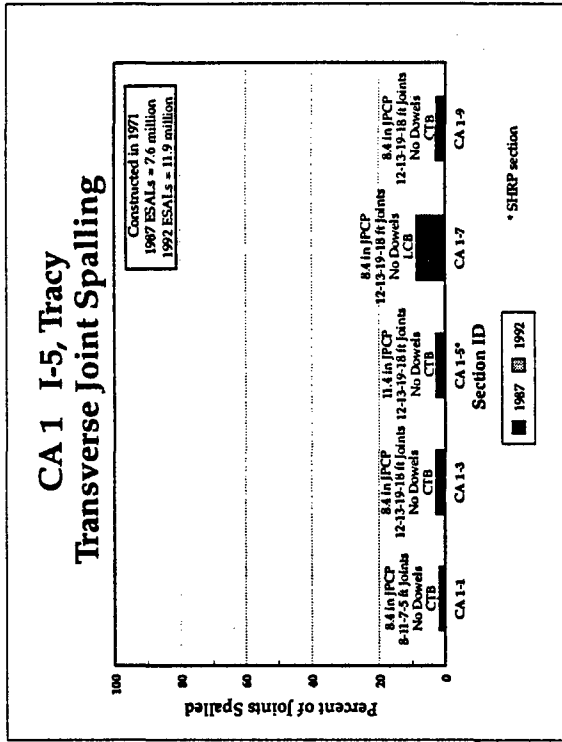
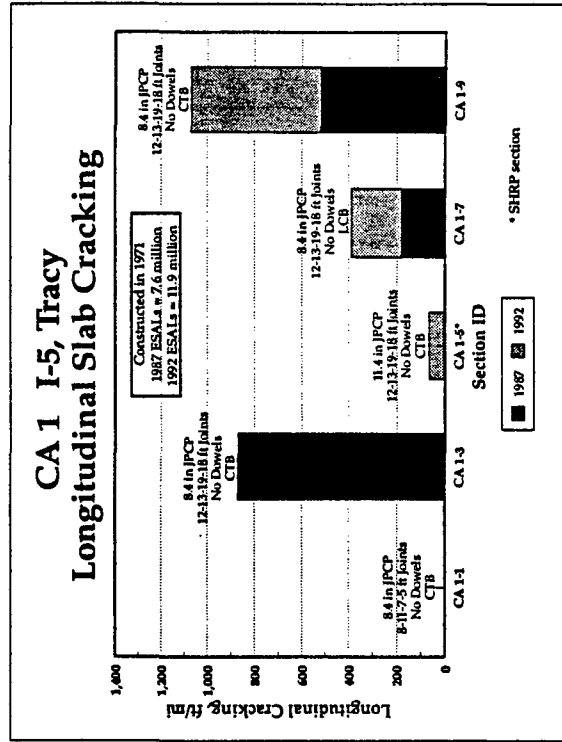
Figure 21. Performance summary for CA 1.

cracking. The high-strength replicate section (CA 1-10) had higher levels of faulting, transverse cracking, and longitudinal cracking, as well a lower PSR and higher IRI than the corresponding section (CA 1-4).

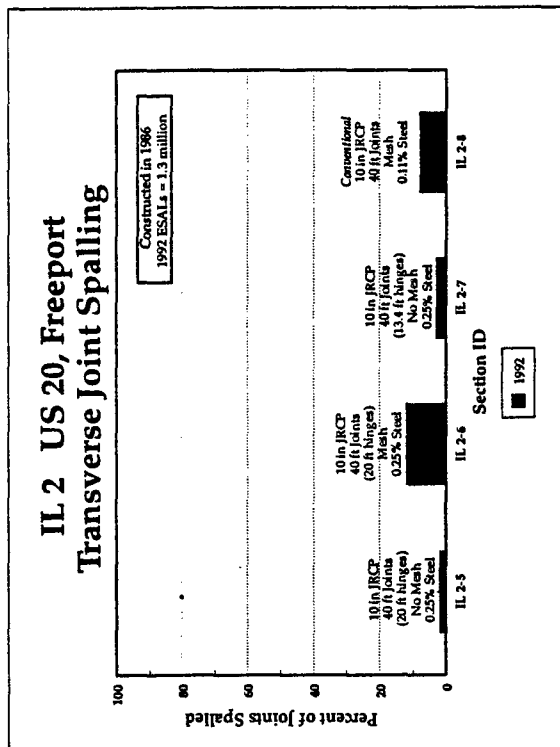
Figure 26. Performance summary for IL 2.

- The sections containing the hinge joint design are performing better than the conventional design in terms of the amount of deteriorated transverse cracking. However, there are no other significant differences in performance.
- No differences in performance exist between the different hinge joint designs.
- Roughness levels for each of the sections are not significantly different.

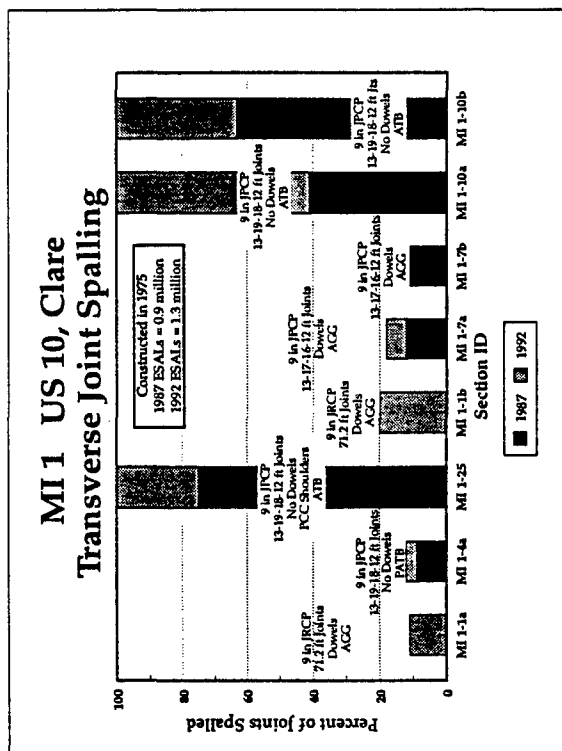
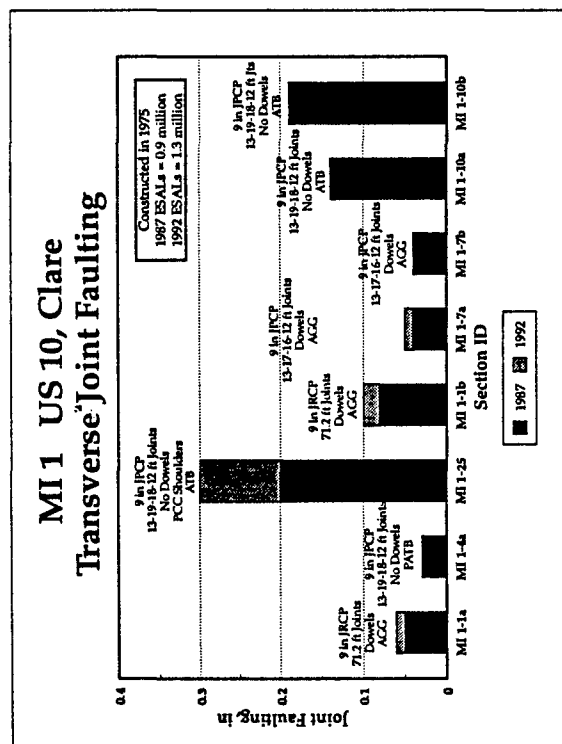
Figure 28. Performance summary for MI 1.

spalling. These ATB sections were constructed as a "bathtub" design with full-depth AC shoulders, which served to retain excess moisture within the pavement structure and resulted in the accelerated development of pavement distress.

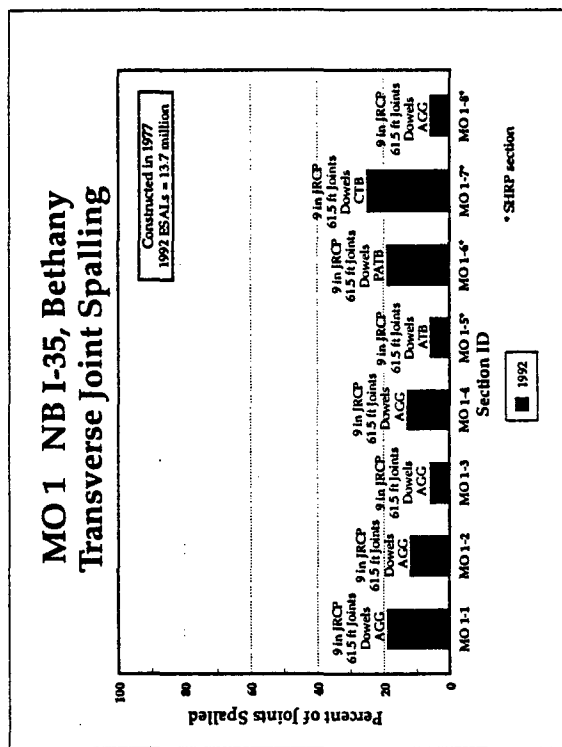
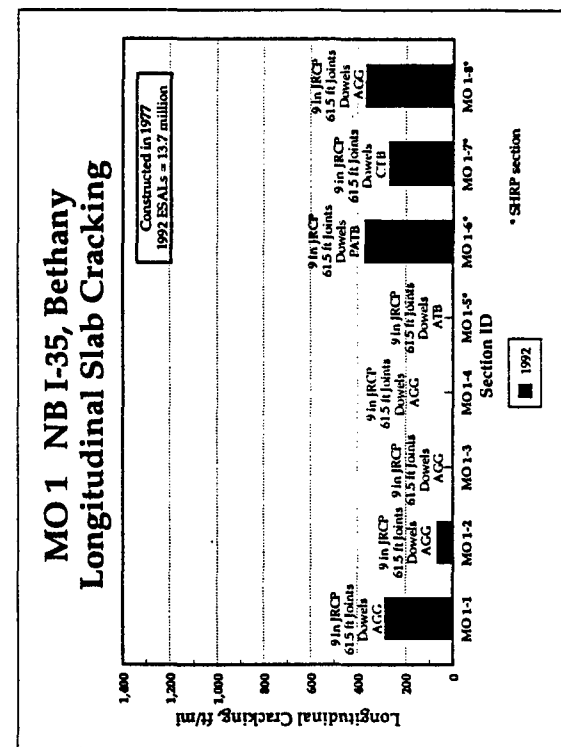
Figure 31. Performance summary for MO 1.

- No significant difference is observed between the performance of the pavement sections constructed on various base types. Levels of faulting, spalling, and transverse cracking are comparable for all sections, although pumping was

only observed on the AGG sections. The section constructed on PATB did exhibit less transverse cracking than the other sections, suggesting that a reduction in transverse crack deterioration is related to the removal of excess water from the pavement structure.

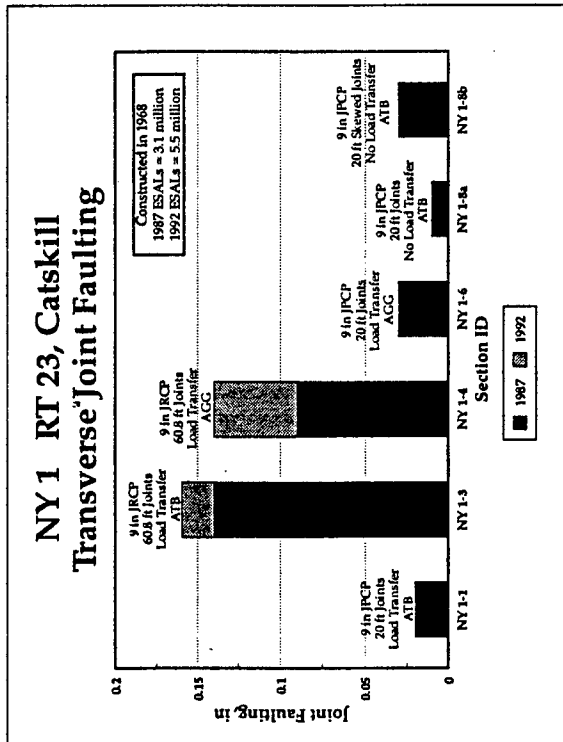
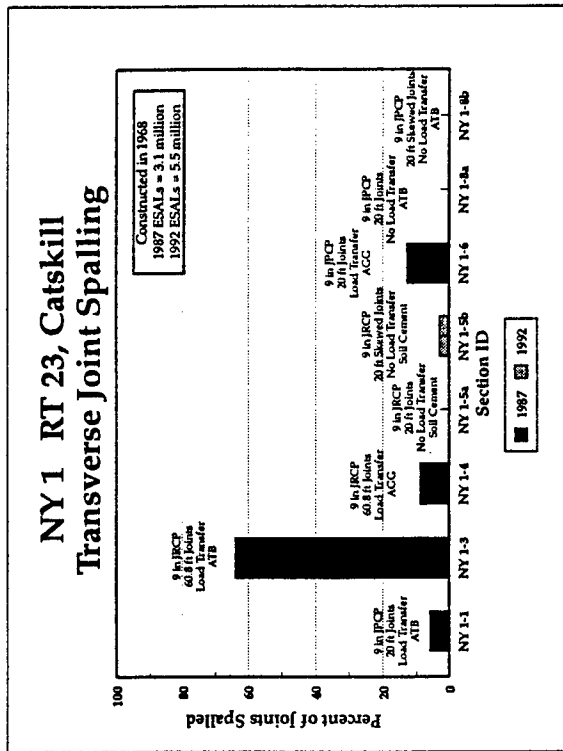
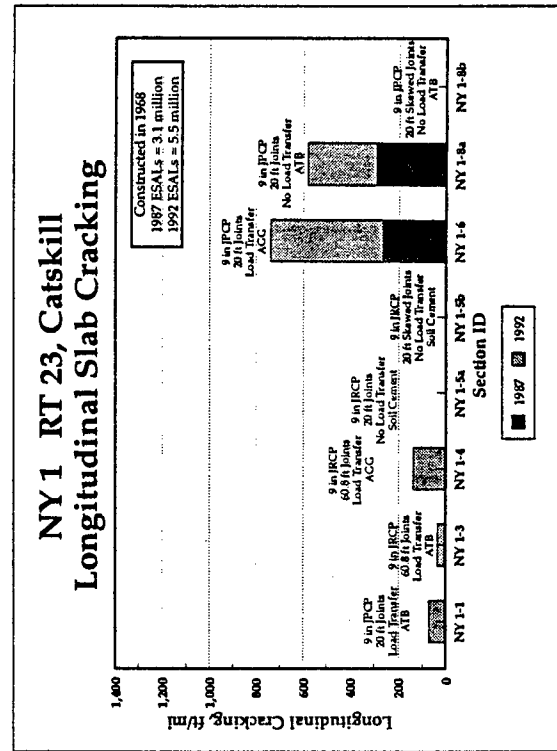
Figure 33. Performance summary for NY 1.

The effect of the ACME load transfer devices in reducing faulting can be observed by comparing the performance of NY 1-1 and 1-8a. The distress data indicate no significant difference in the performance of these sections, suggesting that the light traffic to which this project is exposed may not be a true test of the load transfer devices. Other studies conducted in New York have indicated that these devices corroded and could not be relied upon to provide positive, long-term load transfer, often failing within 5 years.⁽²⁹⁾

No definitive conclusions can be drawn regarding the effectiveness of skewed transverse joints. The section with the skewed joints displays more faulting than the corresponding section with perpendicular joints, although this difference is not significant. The section with perpendicular joints, however, displays more transverse slab cracking than the section with skewed joints.

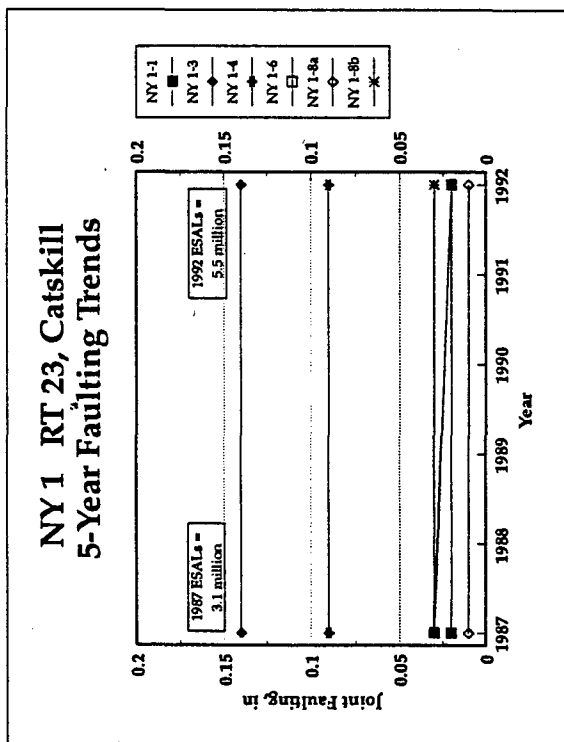
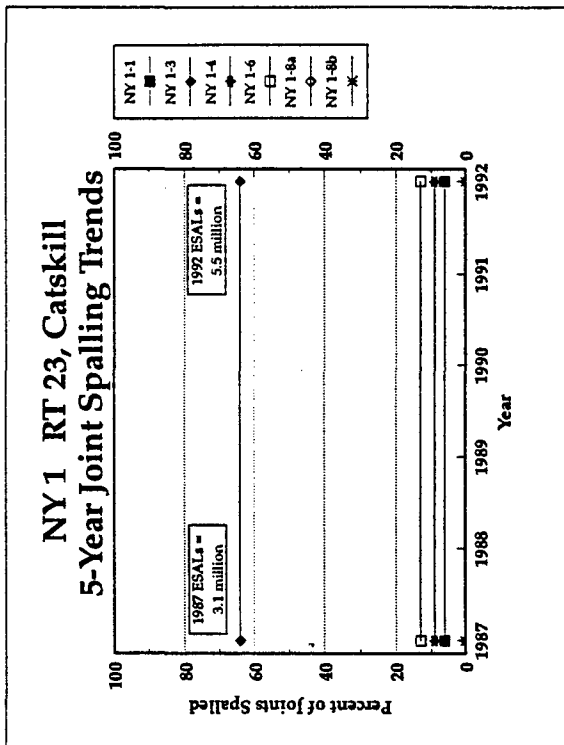
Figure 35. 5-year performance trends for NY 1.

- At this time, no performance benefits are apparent for the sections constructed with the ACME load transfer device. The faulting levels for sections with and without the load transfer device are about the same. This may be partially attributed to the low level of traffic present on the pavement.
- No definitive conclusions could be drawn regarding the effectiveness of joint skewing. The skewed section had slightly more faulting than its nonskewed counterpart, although it also had fewer deteriorated cracks.
- With the exception of the long-jointed JRCP, the pavement sections are providing satisfactory rideability. The long-jointed pavements are the roughest sections, probably due to the severe faulting that has developed.
- With the exception of transverse cracking, no significant changes in pavement condition have occurred for these sections over the last 5 years.

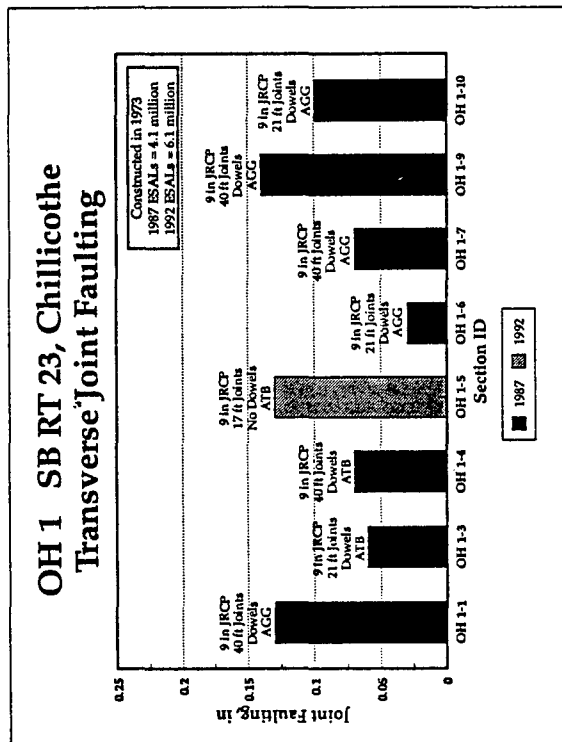
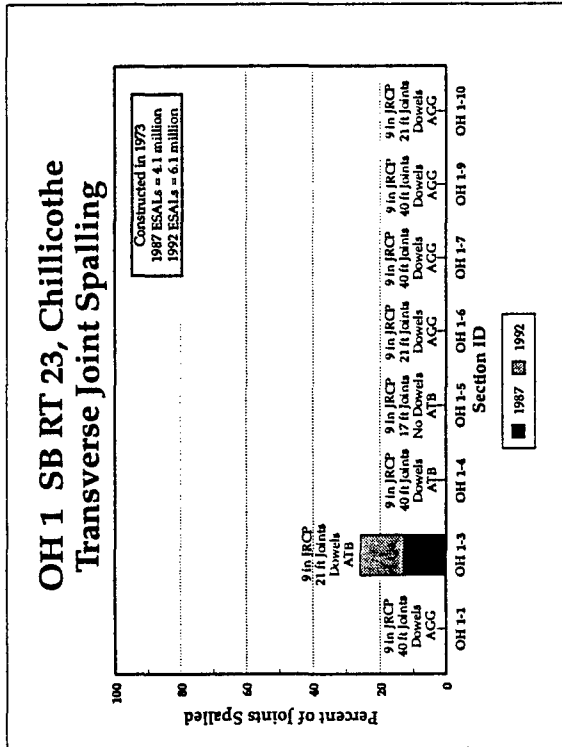
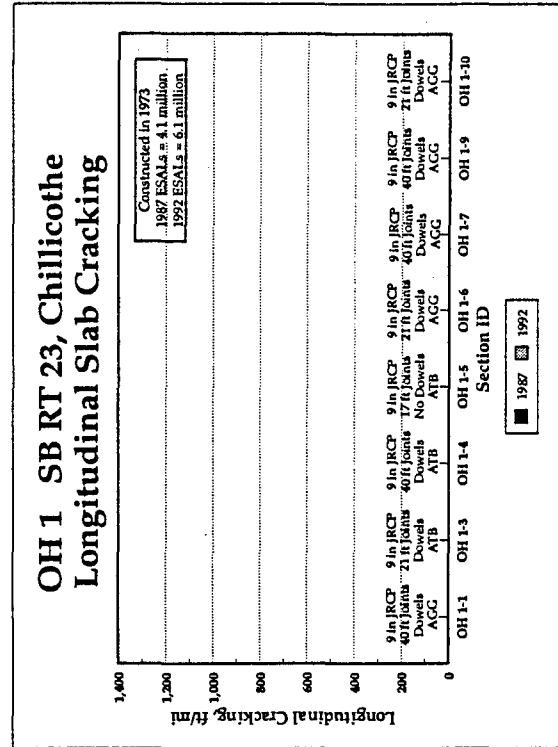
Figure 39. Performance summary for OH 1.

The sections constructed on ATB show fewer deteriorated transverse cracks and slightly less faulting than the sections constructed on aggregate base. This may speak to the ATB's greater resistance to moisture and erosion. Although one ATB section

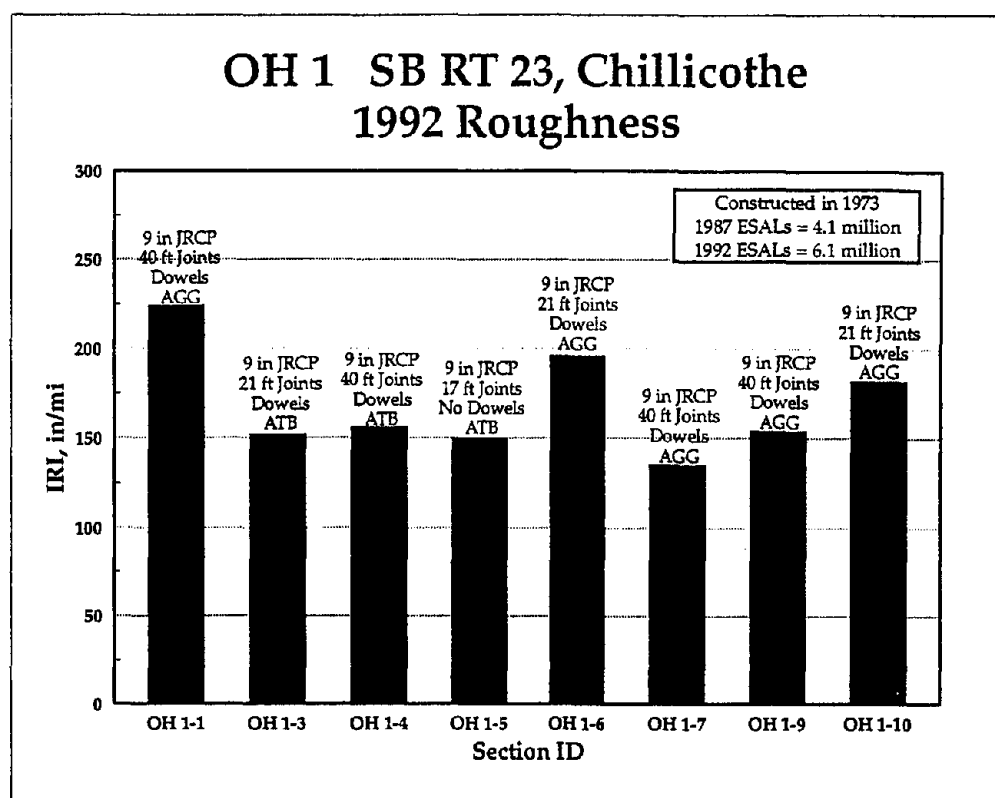
Figure 40. Roughness measurements for OH 1.

Figure 40 shows the roughness measurements recorded for the OH 1 sections. Overall, most of the sections are fairly smooth, with the sections constructed on ATB providing the smoothest riding surfaces. Three sections stand out as being particularly rough (OH 1-1, OH 1-6, OH 1-10), all of which show a significant amount of deteriorated transverse cracking. Because these sections are extremely short (typically less than 200 ft [61.0 m]), serviceability ratings were not recorded.

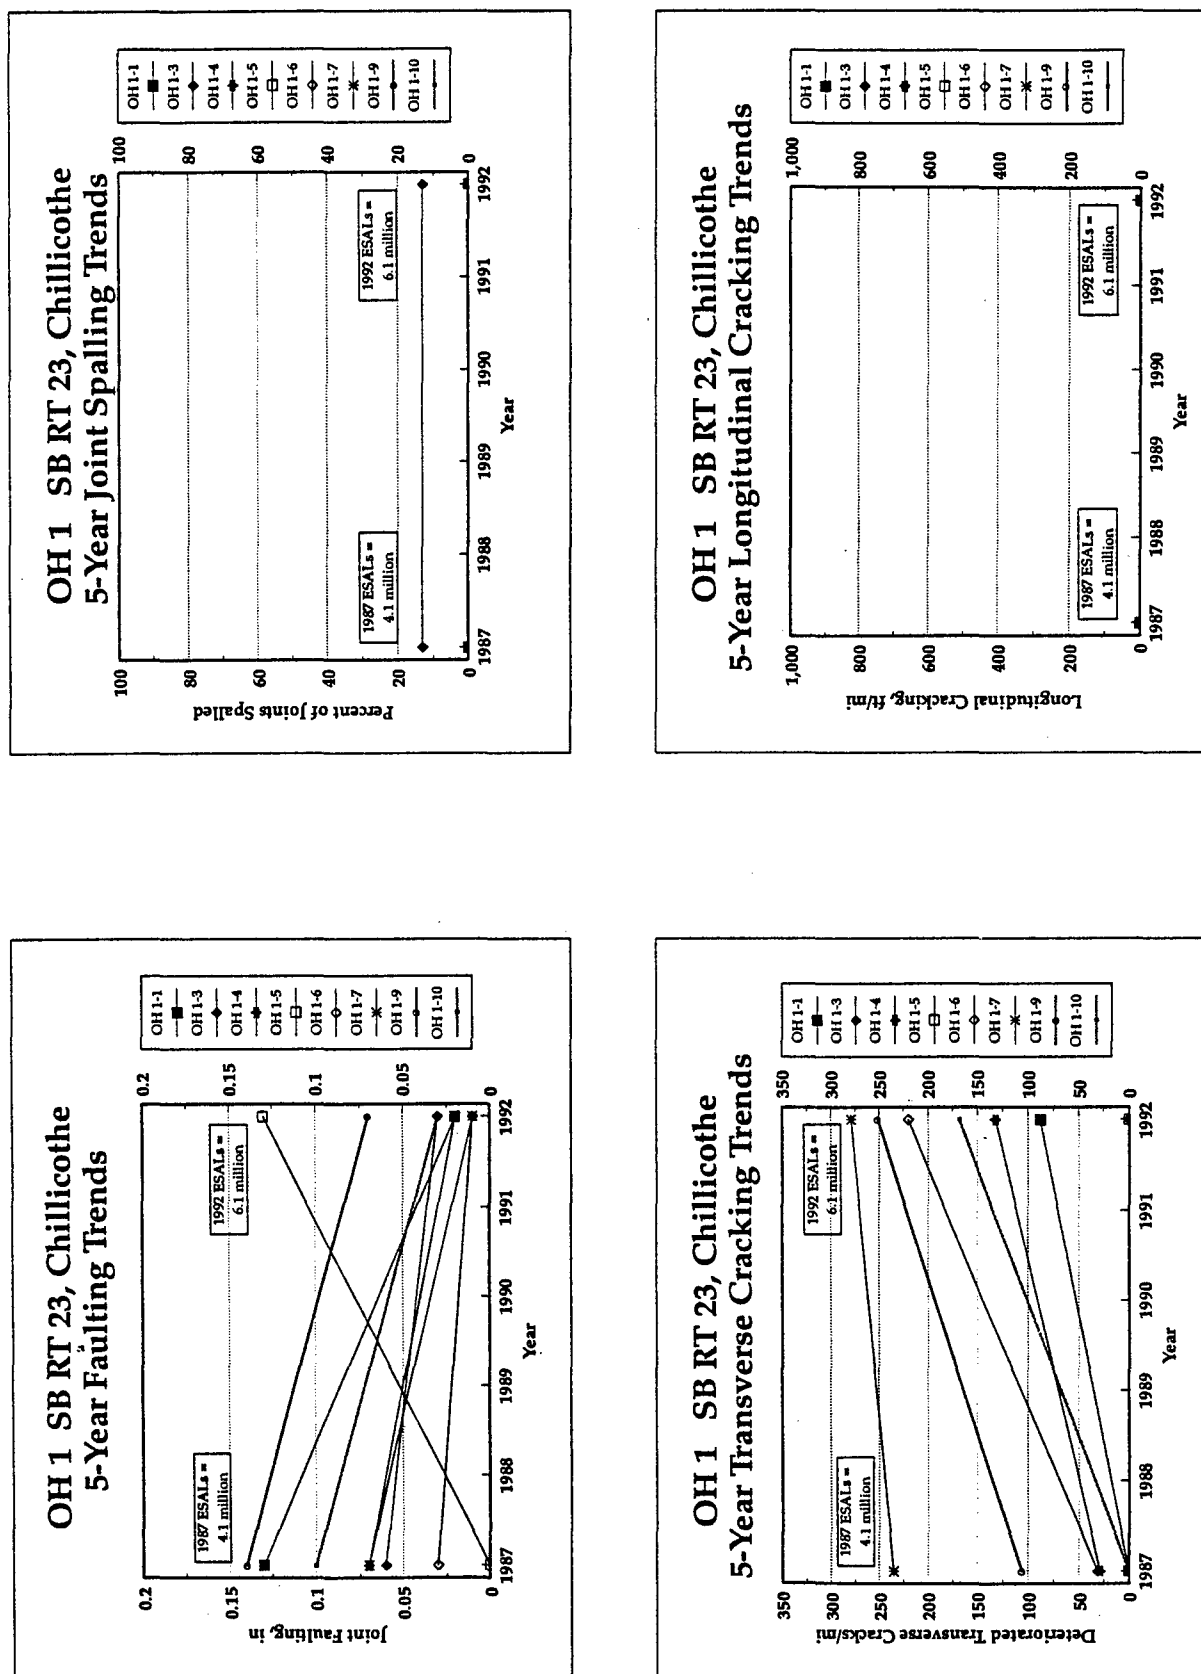
Figure 41. 5-year performance trends for OH 1.

- Only one section exhibited transverse joint spalling, and none of the sections displayed any longitudinal cracking.

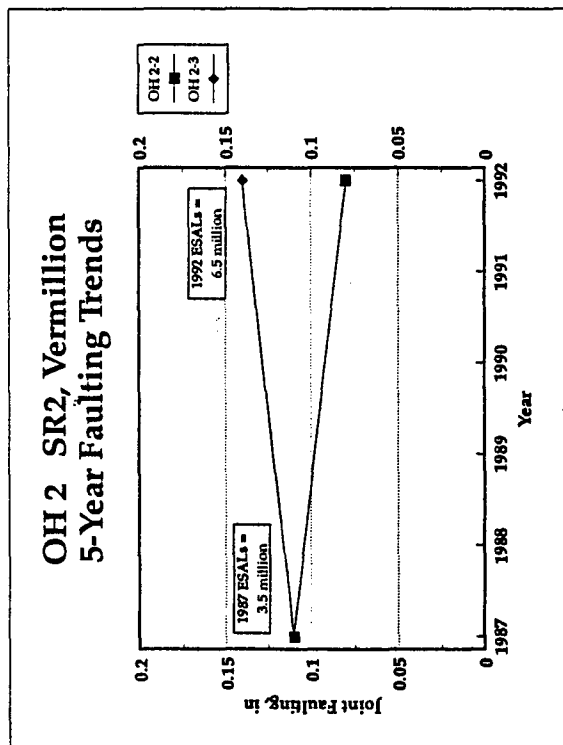
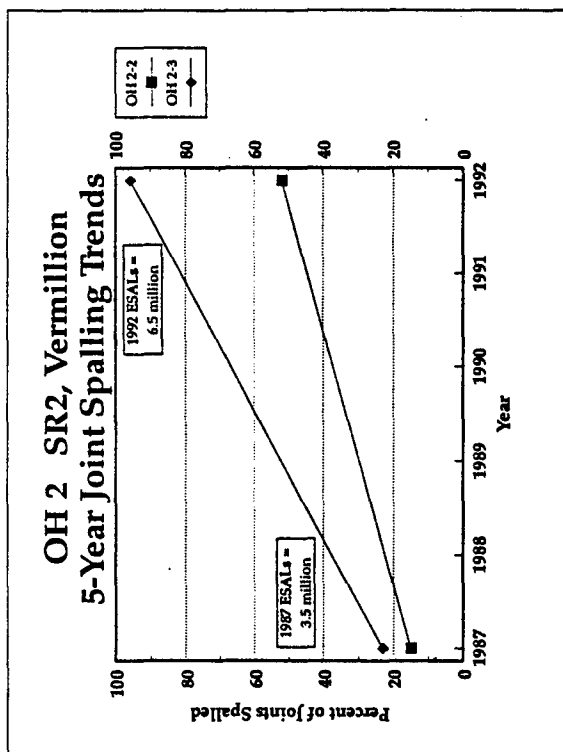
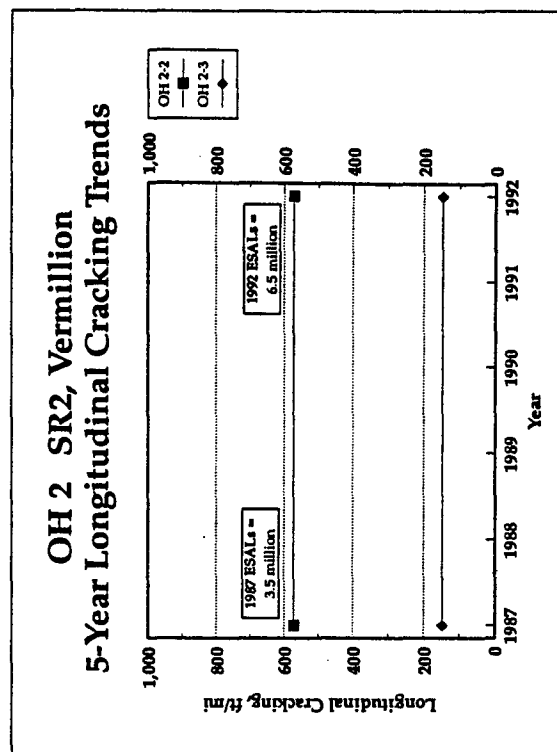
Figure 45. 5-year performance trends for OH 2 sections.

- Faulting is more severe at deteriorated cracks than at the joints. Faulting of 0.20 to 0.25 in (5 to 6 mm) is common on deteriorated cracks in this project.
- The best performers are the 40-ft (12.2-m) JRCP sections with large aggregates and edge drains constructed on ATB. These sections have very little faulting and deteriorated cracks.
- On stabilized base sections, deterioration of transverse cracks is much more severe on sections constructed with 0.5-in (13-mm) maximum-size aggregate than on the ones constructed with 1.5-in (38-mm) maximum-size aggregate.
- On aggregate base sections, the maximum aggregate size does not appear to affect deterioration of transverse cracks in JRCP.

- The 60-ft (18.3-m) JRCF sections constructed with 1.5-in (38-mm) maximum size aggregate (OH 2-9 and OH 2-11) contain the most joint spalling.
- Pumping is a severe problem in the sections placed without a subbase.

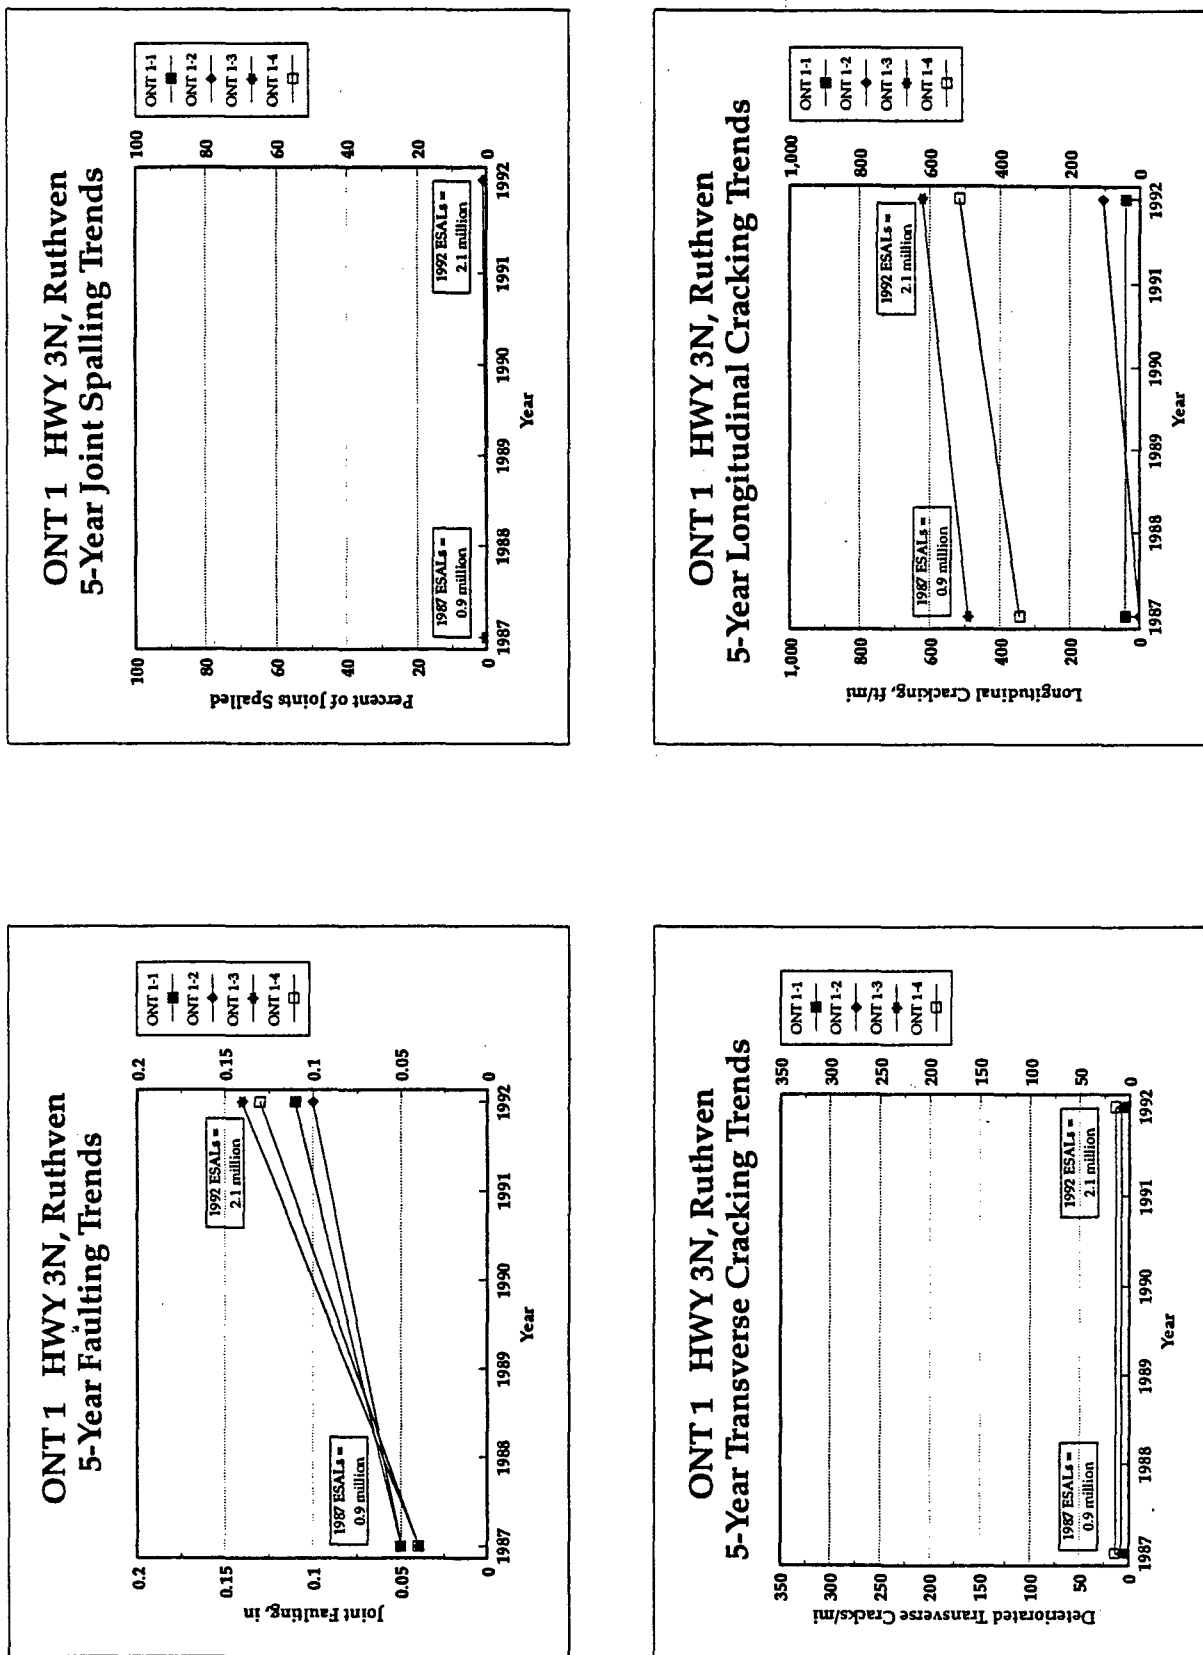
Figure 48. 5-year performance trends for ONT 1 sections.

ONT 1-2 contains narrow strips of partial-depth patches that are about 10-in (254-mm) wide and extend over several slabs. These patches are always in pairs that are about 4 ft (1.2 m) apart. Longitudinal cracking started to develop at the tip of some of these patches in this section. The reason for the presence of the partial-depth patches is not known, but the longitudinal cracking in this section is clearly not related to any of the design factors. The longitudinal cracking in ONT 1-3 and ONT 1-4 occurred very close to the centerline joint, suggesting improper sawing of the centerline joint as the prime suspect for the cause of the cracking.

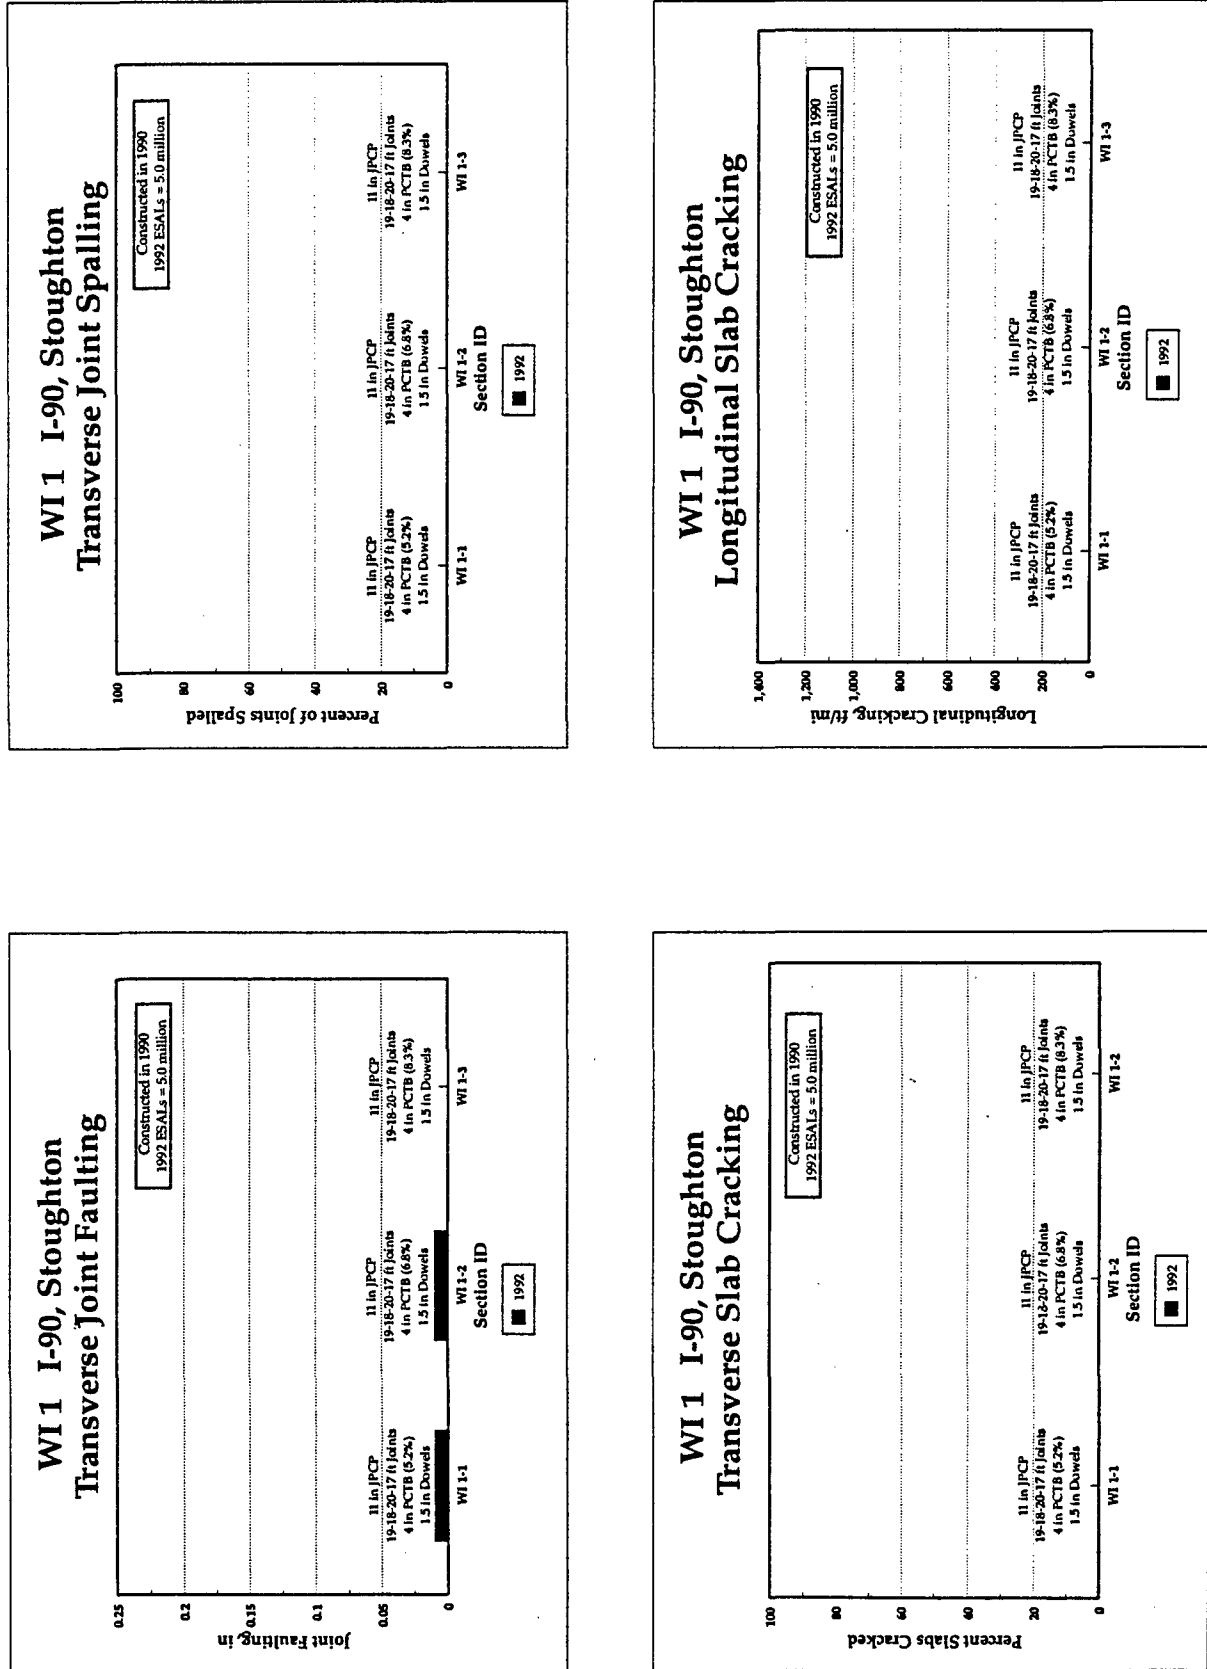
Figure 54. Performance summary for WI 1.

The usefulness of the PCTB in serving as a construction platform was one reason for constructing this experimental project. In work conducted for the Wisconsin Department of Transportation, it is reported that, prior to the placement of the concrete slab, portions of WI 1-1 and WI 1-2 (containing a lower cement content) had suffered some raveling and rutting due to the passing of haul trucks.⁽³⁶⁾ Section WI 1-3, containing the highest cement content, exhibited very little damage.

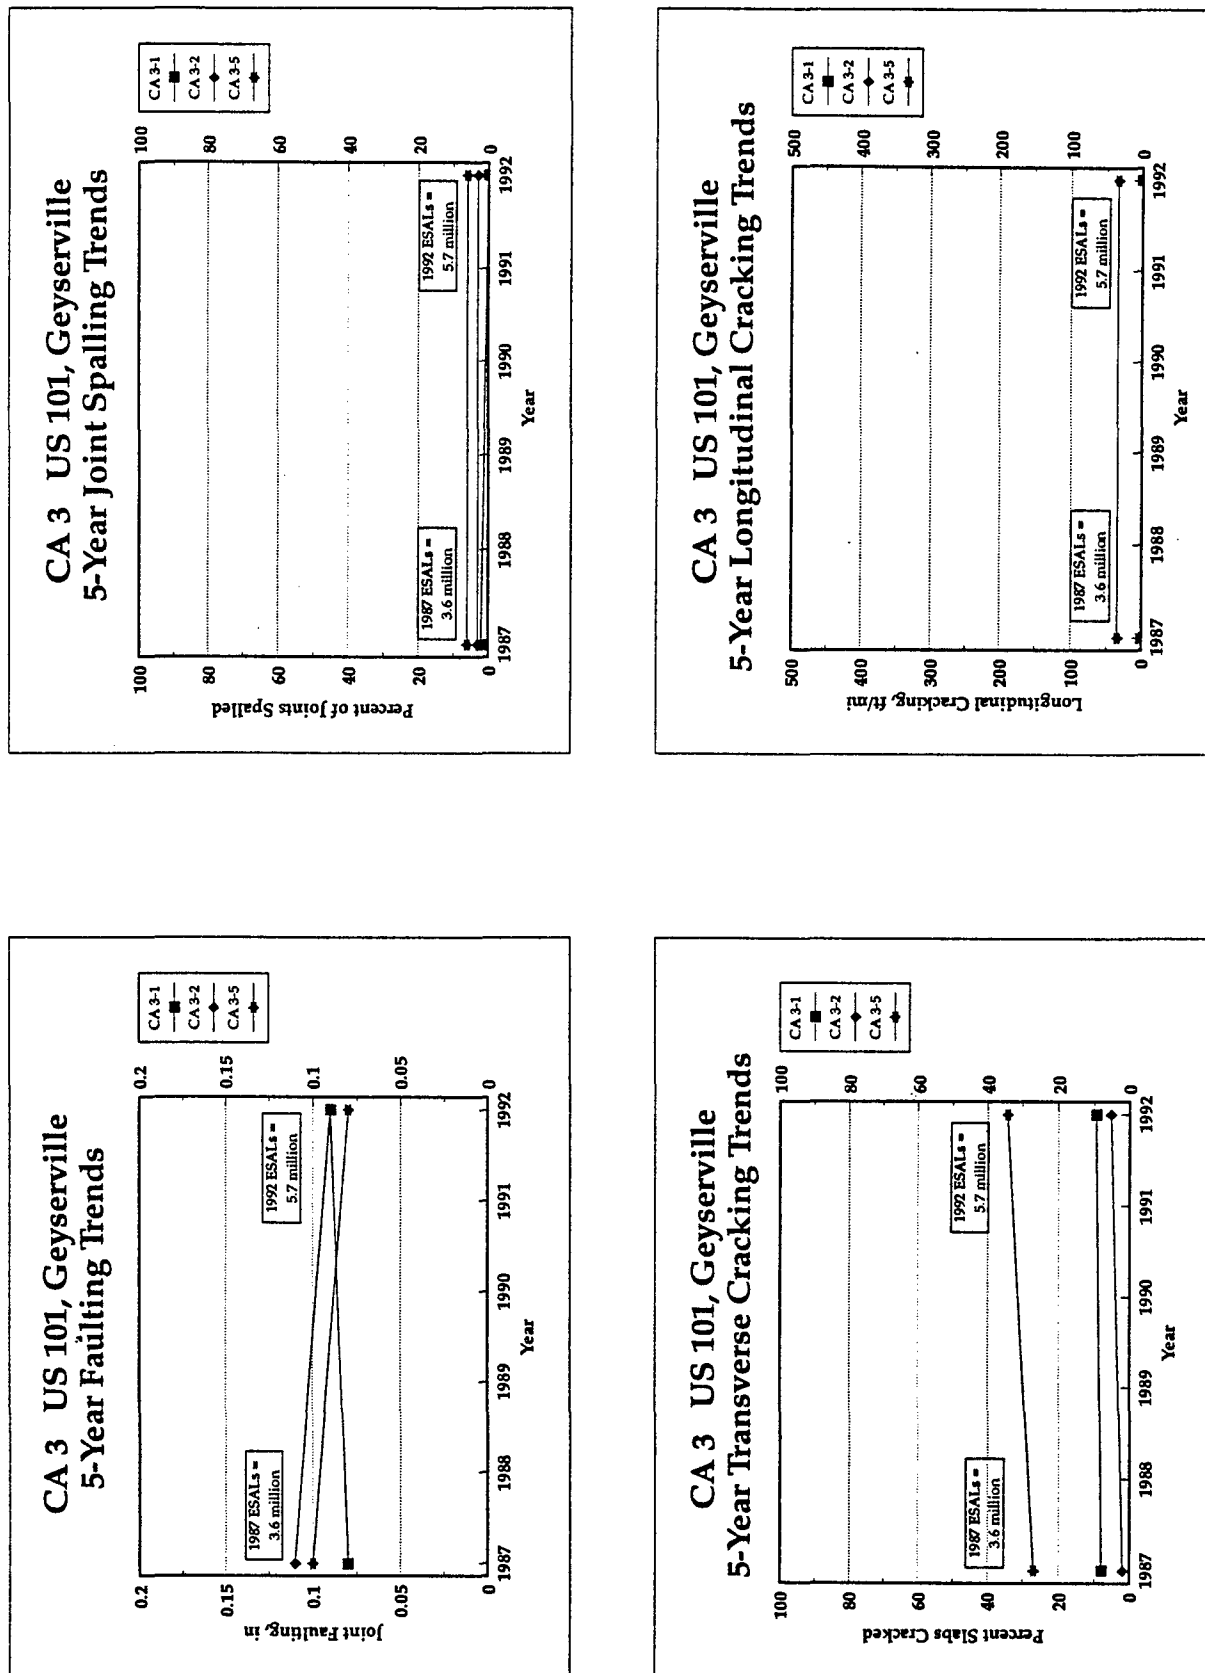
Figure 68. 5-year performance trends for CA 3.

- Overall, the roughest pavement sections were those constructed with AC shoulders. The smoothest pavement section was CA 3-6, which contained sealed transverse joints and a tied PCC shoulder. However, several sections with nontied PCC shoulders are also providing a smooth-riding surface.
- A decrease in serviceability was observed for the three sections that were surveyed in 1987 (CA 3-1, 3-2, and 3-5). The biggest decrease occurred in section 3-2, which contained a tied PCC shoulder and no joint sealant.
- An examination of the 5-year performance trends indicate virtually no changes in pavement distress since the 1987 survey. The biggest change was observed in section CA 3-5, which showed an increase in transverse cracking from 27 to 34 percent of the slabs.
