Performance of Concrete Pavements

Volume I: Field Investigation

PUBLICATION NO. FHWA-RD-94-177

JULY 1997

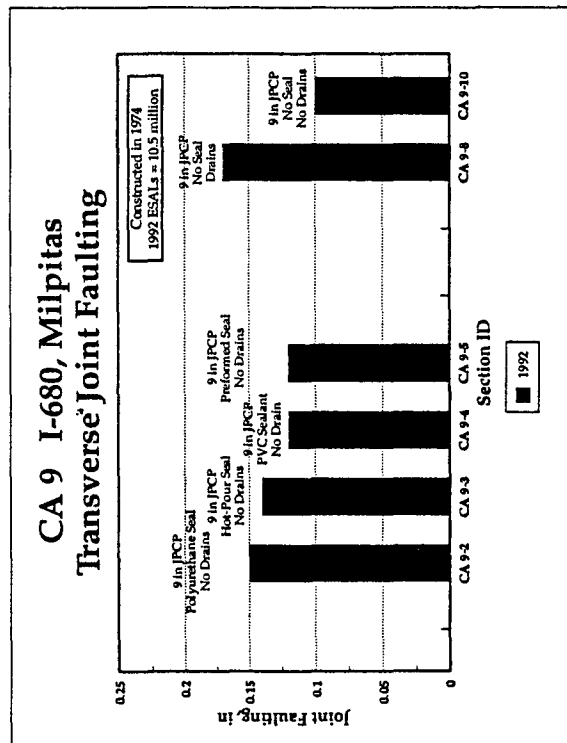
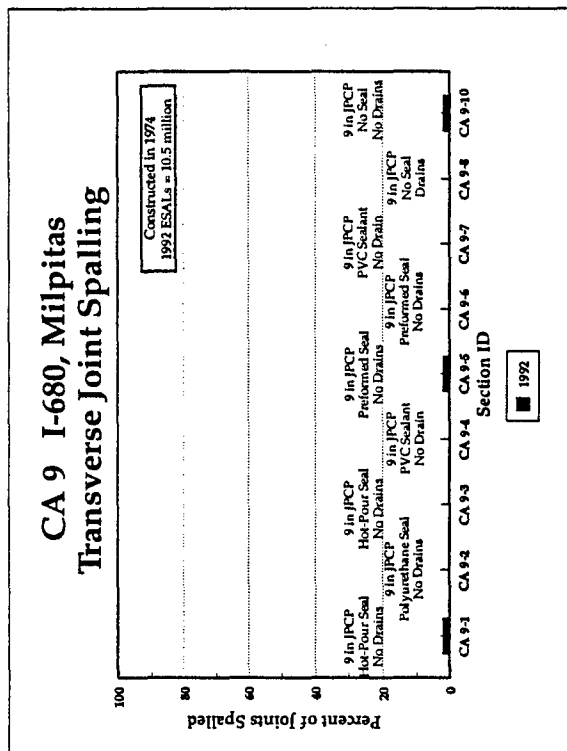
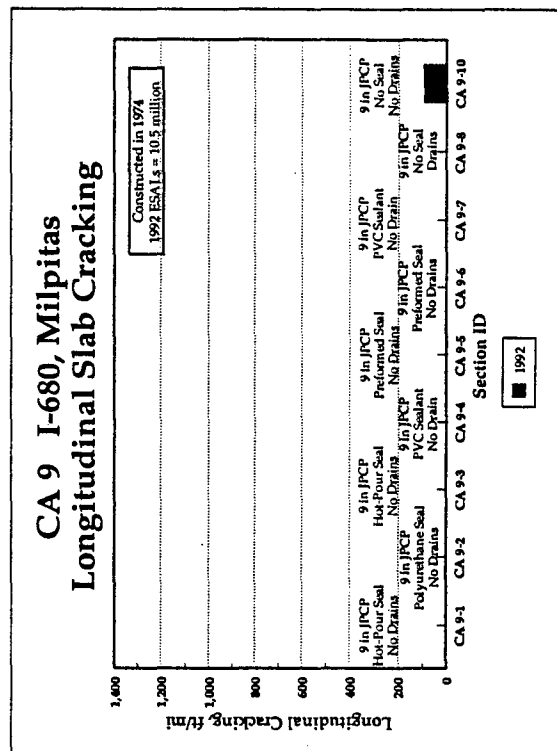
Figure 69. Performance summary for CA 9.

Overall, some of the sealed sections are performing better than the control section, particularly in terms of transverse cracking. However, even after 18 years, it remains to be seen what effects the sealants will have on joint spalling.

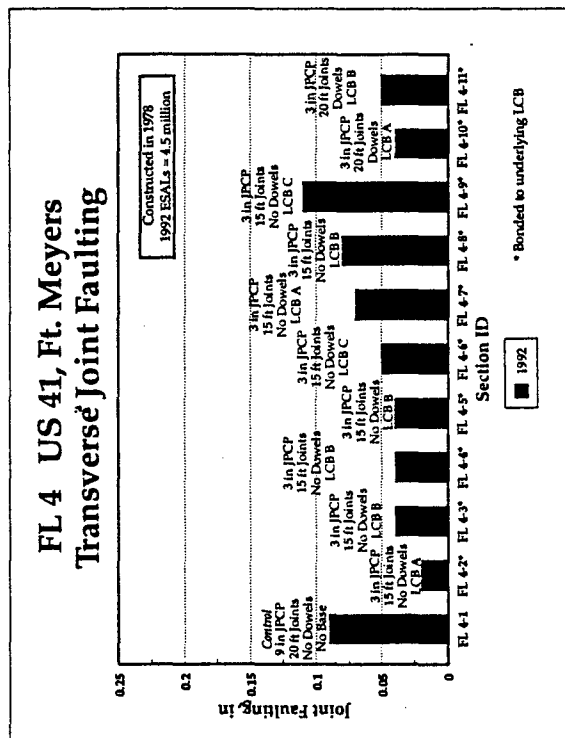
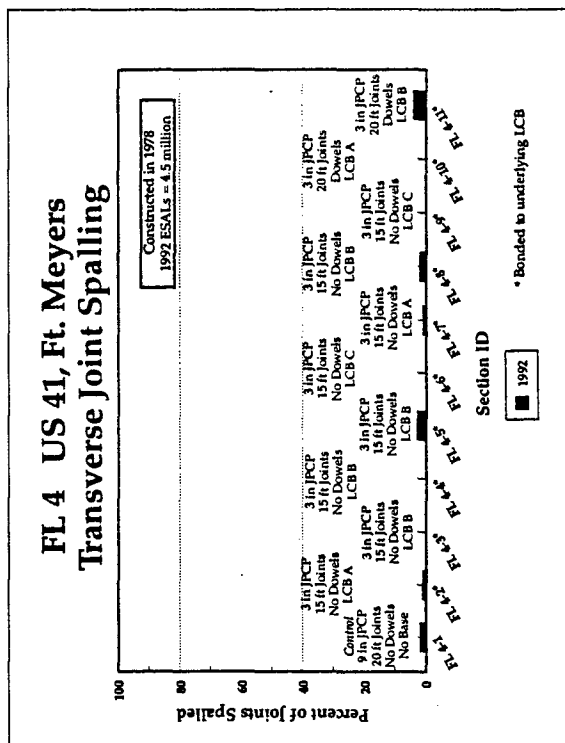
Figure 71. Performance summary for JPCP sections for FL 4.

Sections constructed on stabilized subgrades (FL 4-2 through 4-6) appear to be performing better than those on cement-treated subgrades (FL 4-7 through 4-9), although this effect is confounded by joint orientation. Sections constructed on stabilized subgrades exhibit lower levels of faulting and cracking than those constructed on the cement-treated subgrade. However, the skewed joint design also may be contributing to the lower faulting observed on the stabilized sections.

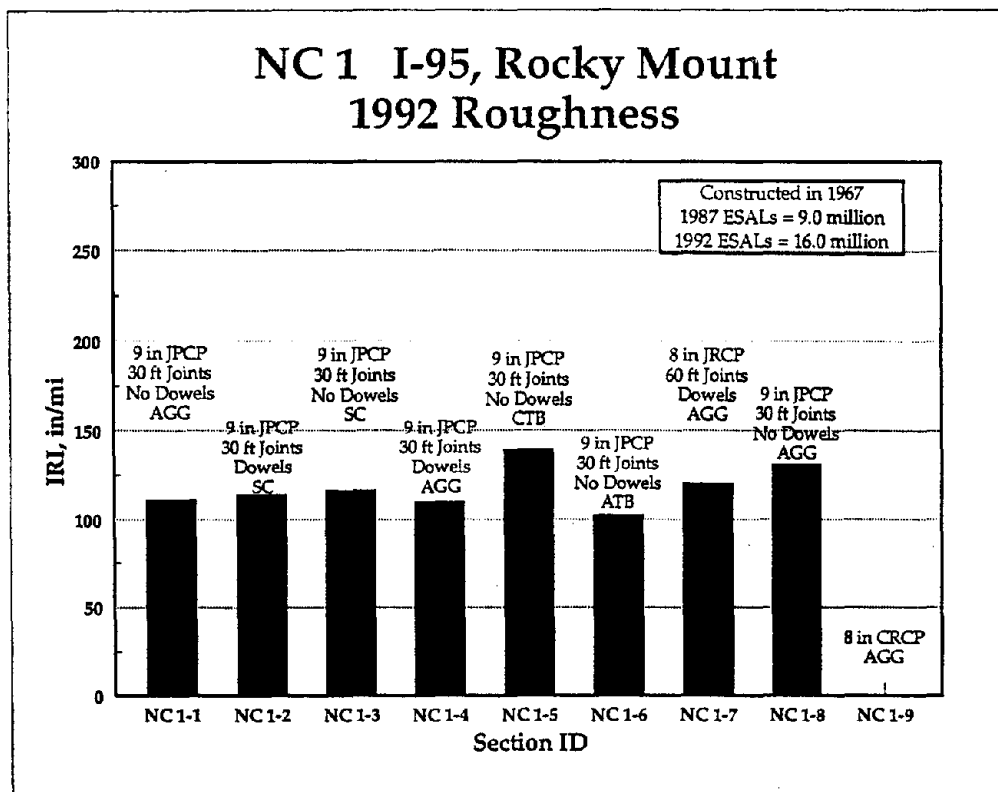
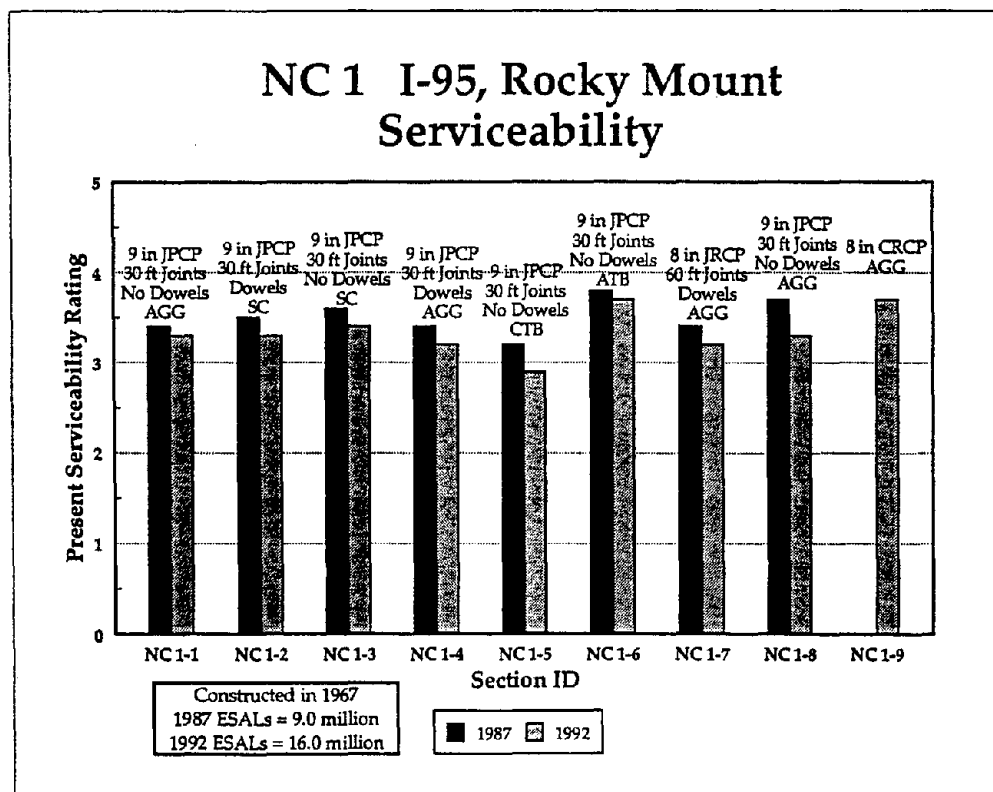
Figure 77. Roughness and serviceability for NC 1.

All sections are noted to have decreased in serviceability from 1987. Sections 1-5 and 1-8 have low serviceabilities, ones that have reached or are approaching "trigger" values for rehabilitation. Section 1-6 and section 1-9 (the CRCP design) have the highest serviceabilities. The high serviceability of the CRCP section confirms its excellent performance.

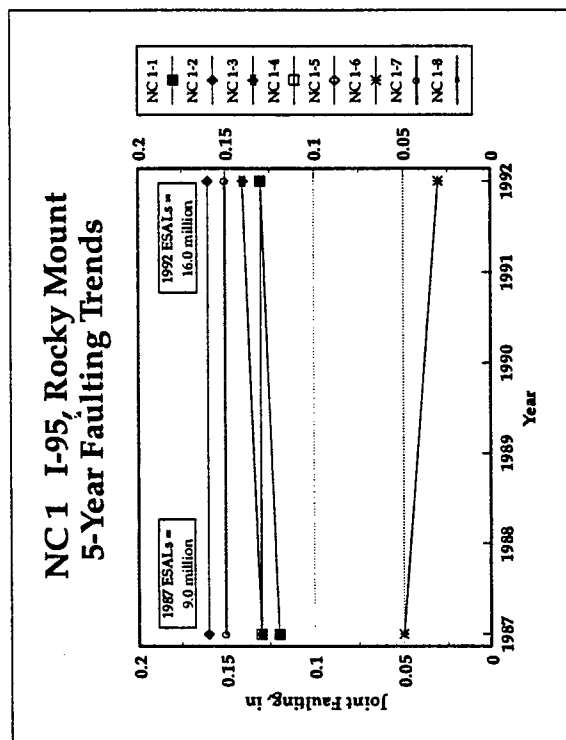
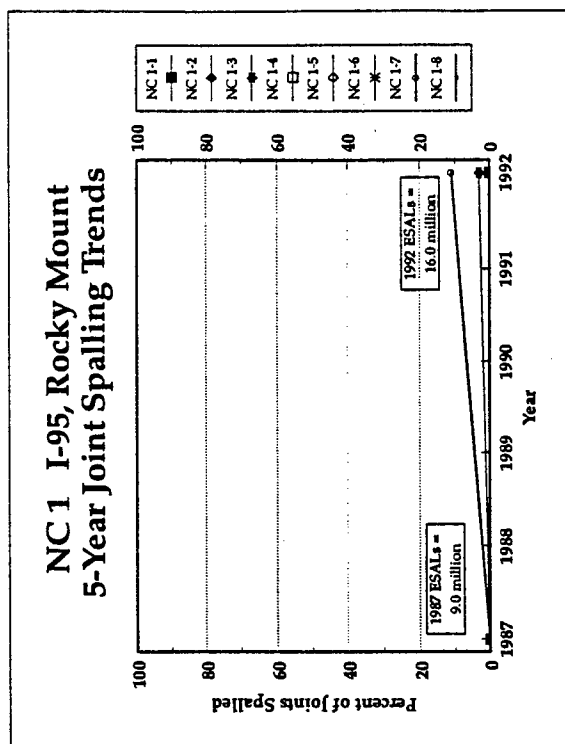
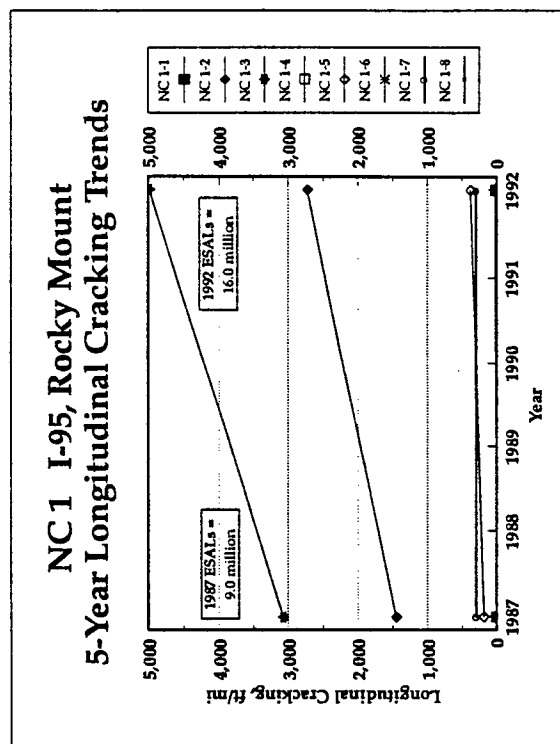
Figure 78. 5-year performance trends for NC 1.

- The 8-in (203-mm) JRCP is showing fair to good performance, certainly comparable to several of the 9-in (229-mm) JPCP sections.

- The JRCF section, with the longer joint spacing, displayed more joint spalling than any of the other sections. However, the amount of joint spalling for all sections is extremely low for a 25-year-old pavement.
